Crystal River Nuclear Plant Docket No. 50-302 Operating License No. DPR-72

July 24, 2002 3F0702-01

- Subject: Crystal River Unit 3 Supplemental Information Regarding the 15-Day Response to NRC Bulletin 2002-01, "Reactor Pressure Vessel Head Degradation and Reactor Coolant Pressure Boundary Integrity"
- References: 1. FPC to NRC letter, 3F0302-11, dated March 28, 2002, "Crystal River Unit 3 – Response to NRC Bulletin 2002-01, "Reactor Pressure Vessel Head Degradation and Reactor Coolant Pressure Boundary Integrity"
 - NRC to FPC letter, 3N0702-02, dated July 1, 2002, Crystal River Unit 3 Summary of June 12, 2002, Conference Call Regarding Response to NRC Bulletin 2002-01 "Reactor Pressure Vessel Head Degradation and Reactor Coolant Pressure Boundary Integrity" (TAC No. MB4539)

Pictures Taken During Refuel Outage 12, After the RPVH Cleaning, While the Water Had Not Yet Dried on the RPVH

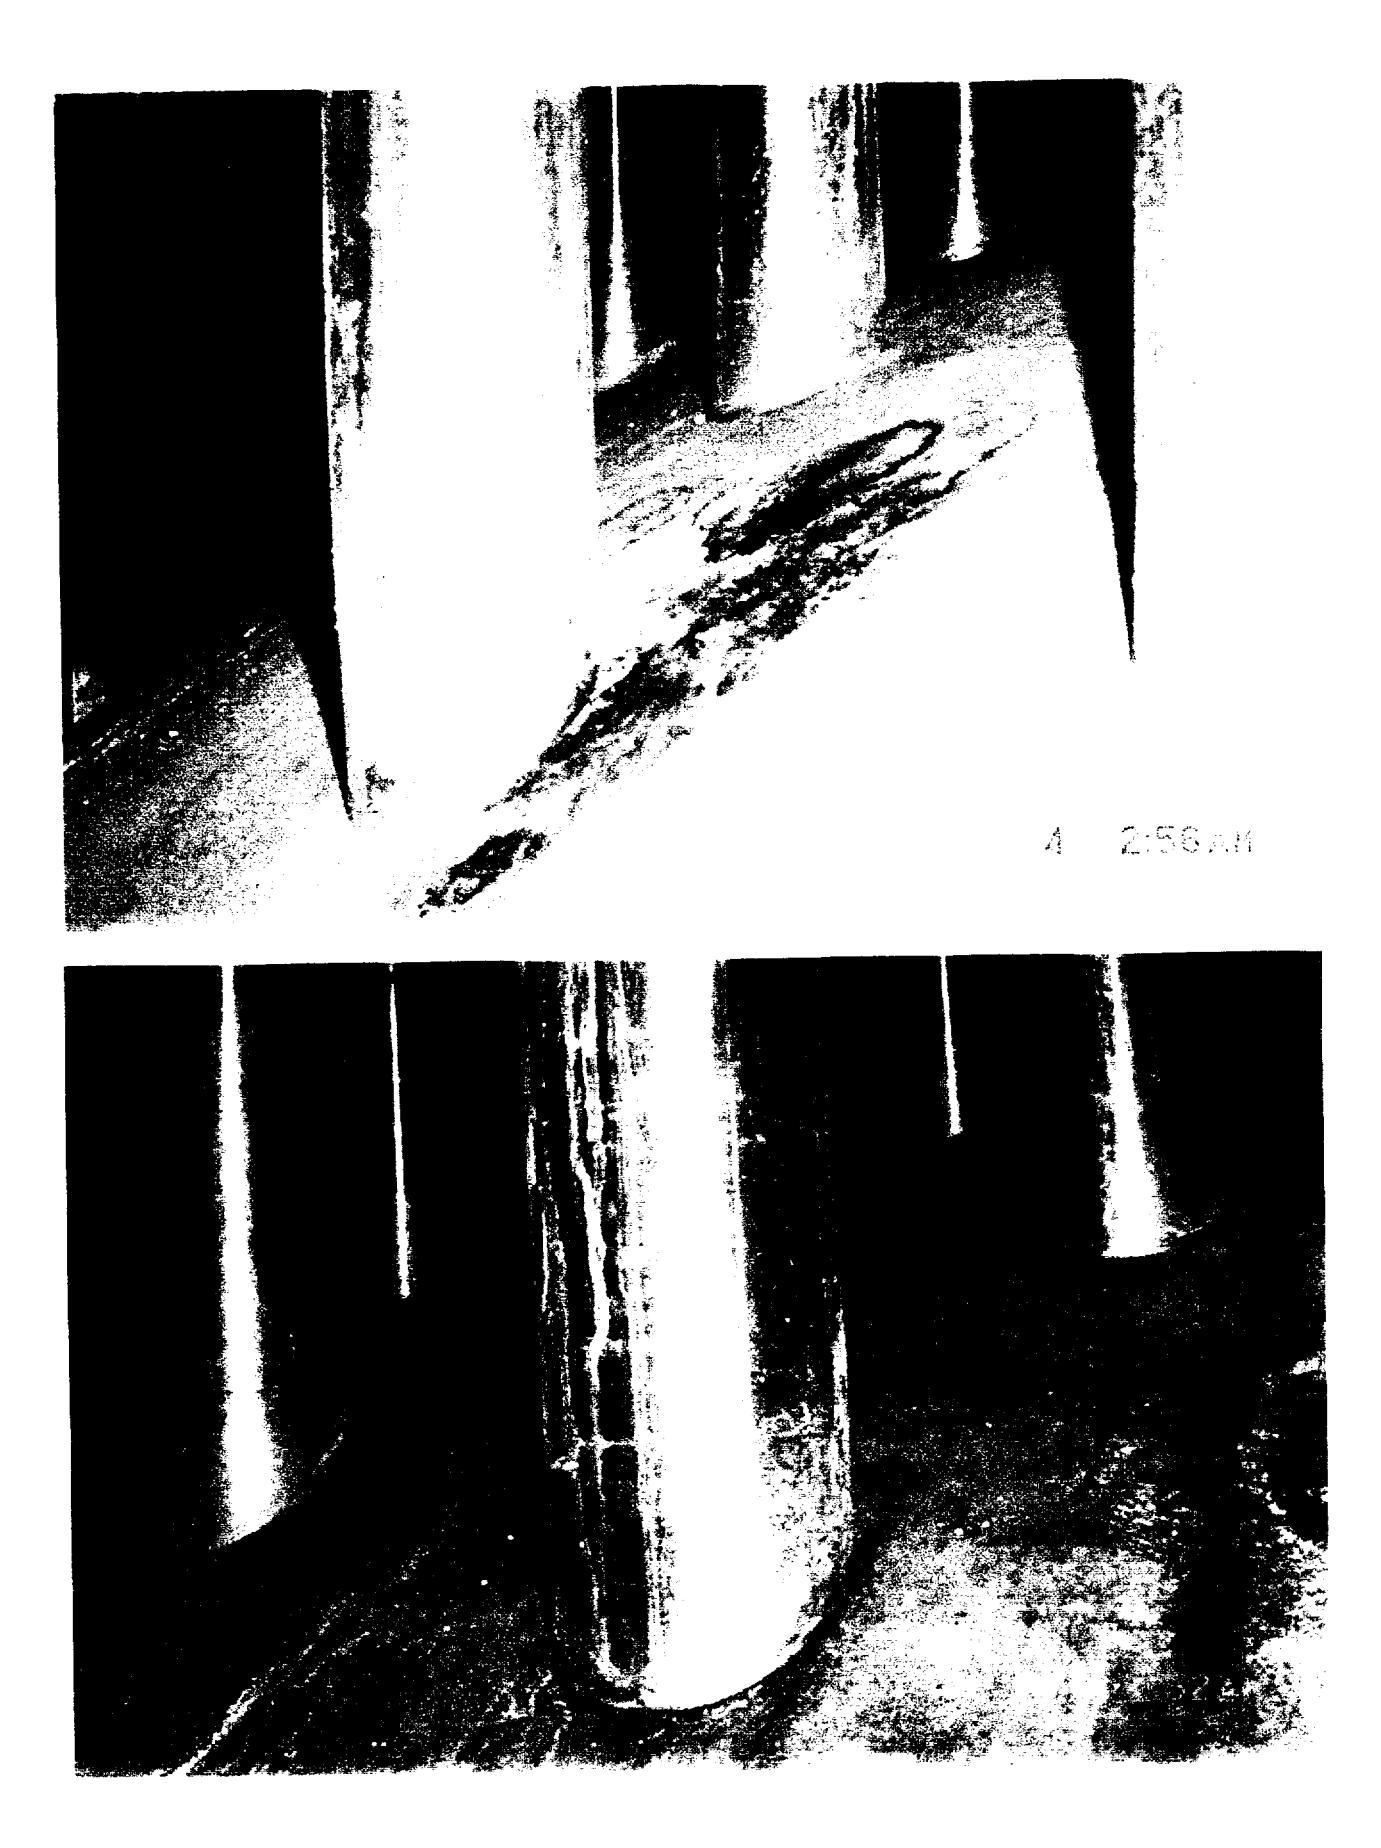
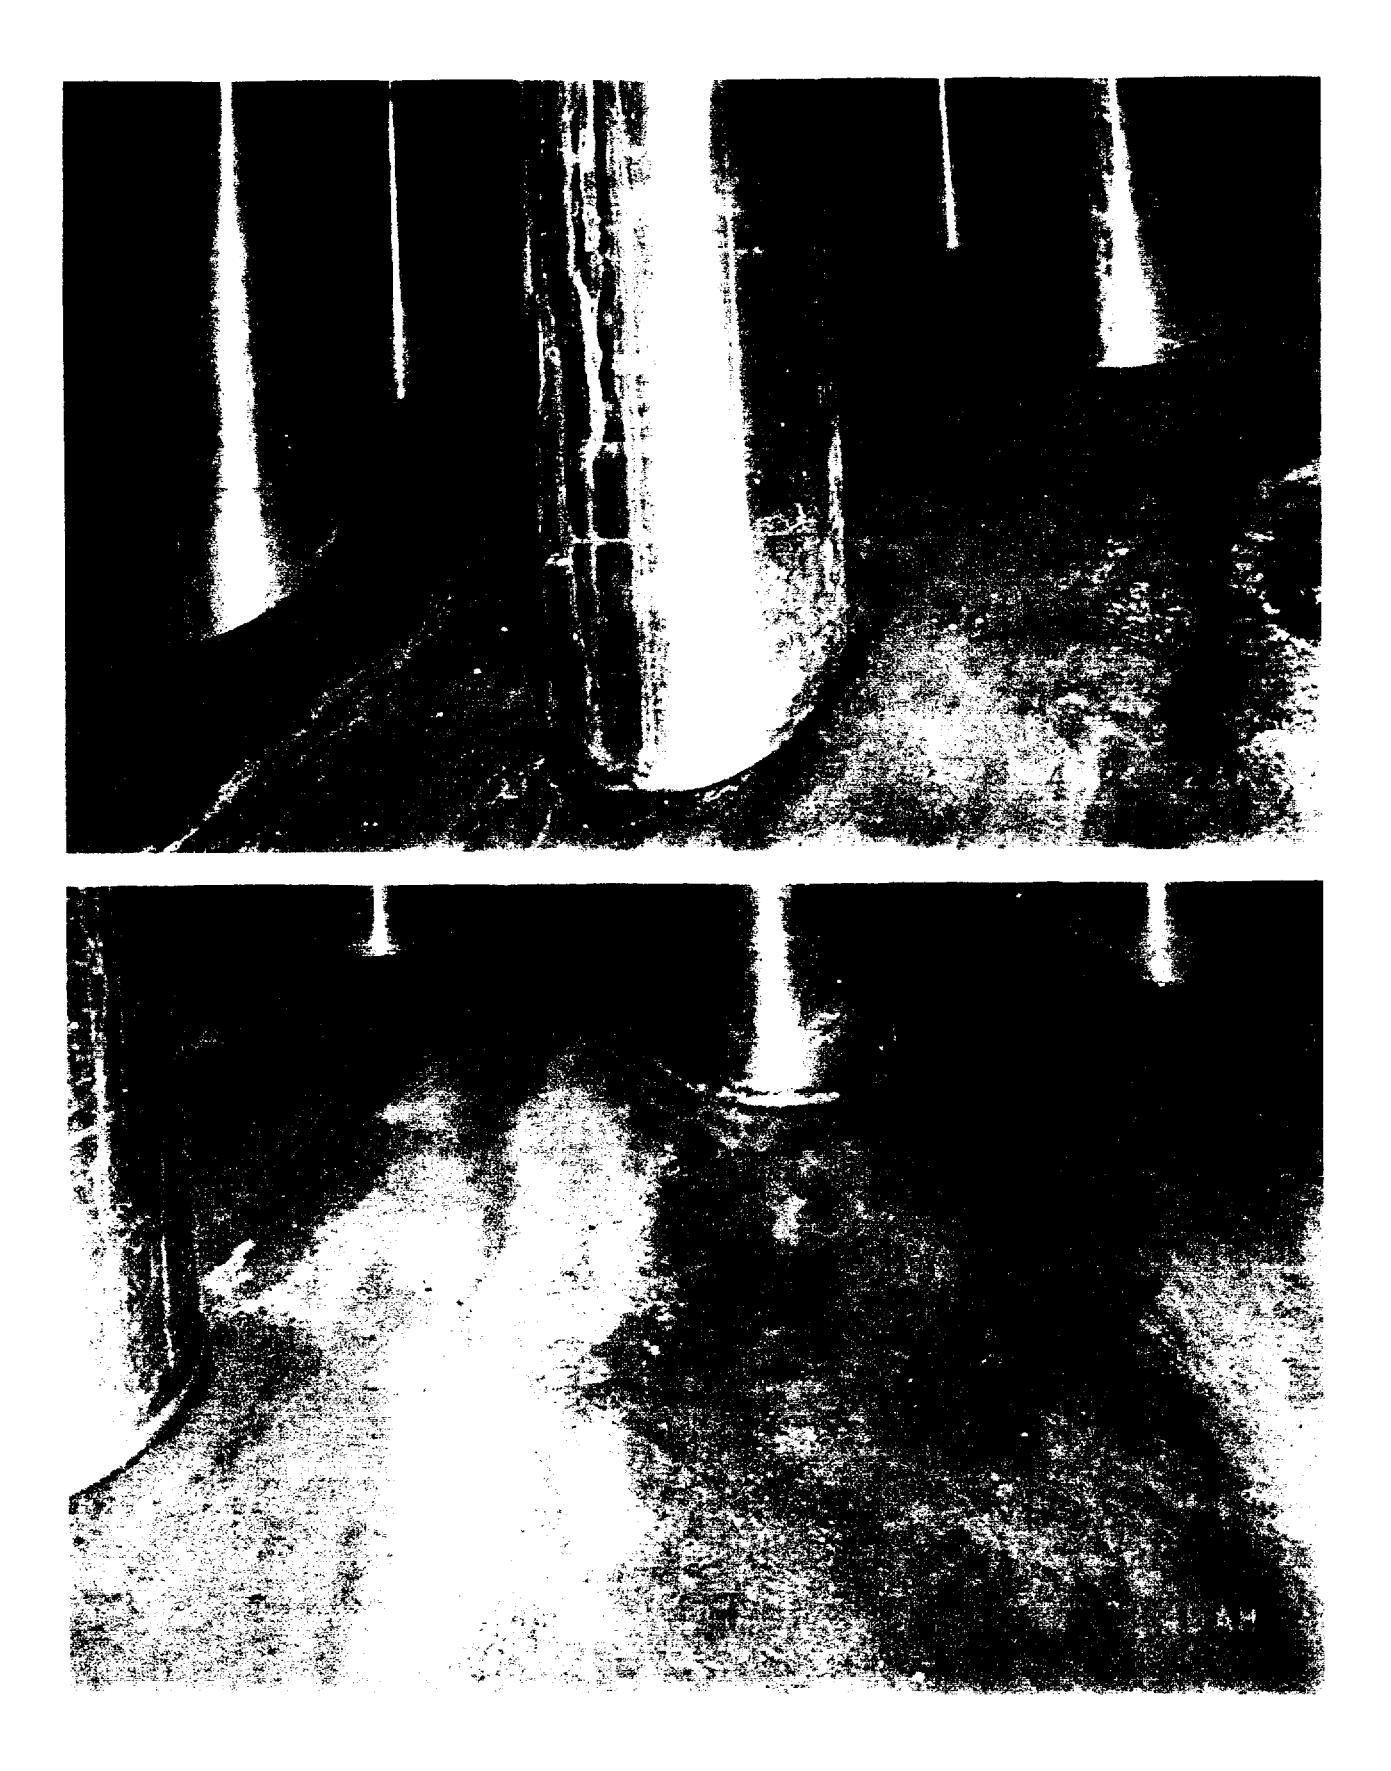
ATTACHMENT B

The Inservice Inspection (ISI) group performed the as-found RPV head inspection and subsequent head inspection after cleaning during the Fall 2001 refueling outage. The entire RPV head was visually examined. These examinations revealed evidence of boron on the RPV head. One leaking Control Rod Drive nozzle was found and repaired. Other boric acid deposits were determined to be from previous flange leakage. The deposits were cleaned with water and another visual inspection was performed. A slight sheen was left on the RPV head in some areas, but the bare metal of the RPV head was still visible. This sheen was due to old boric acid residue being left on the head after the water had dried following cleaning. Attachment B contains pictures that were taken immediately after the RPV head. Attachment C provides additional pictures that were taken after the RPV head was totally dry.

The visual inspection performed after cleaning the RPV head revealed that there were no significant deposits left on the head.
