#### Davis-Besse Nuclear Power Station

Results of Visual Examination of Reactor Head CRDM Nozzle Penetrations Performed in 1996, 1998, and 2000

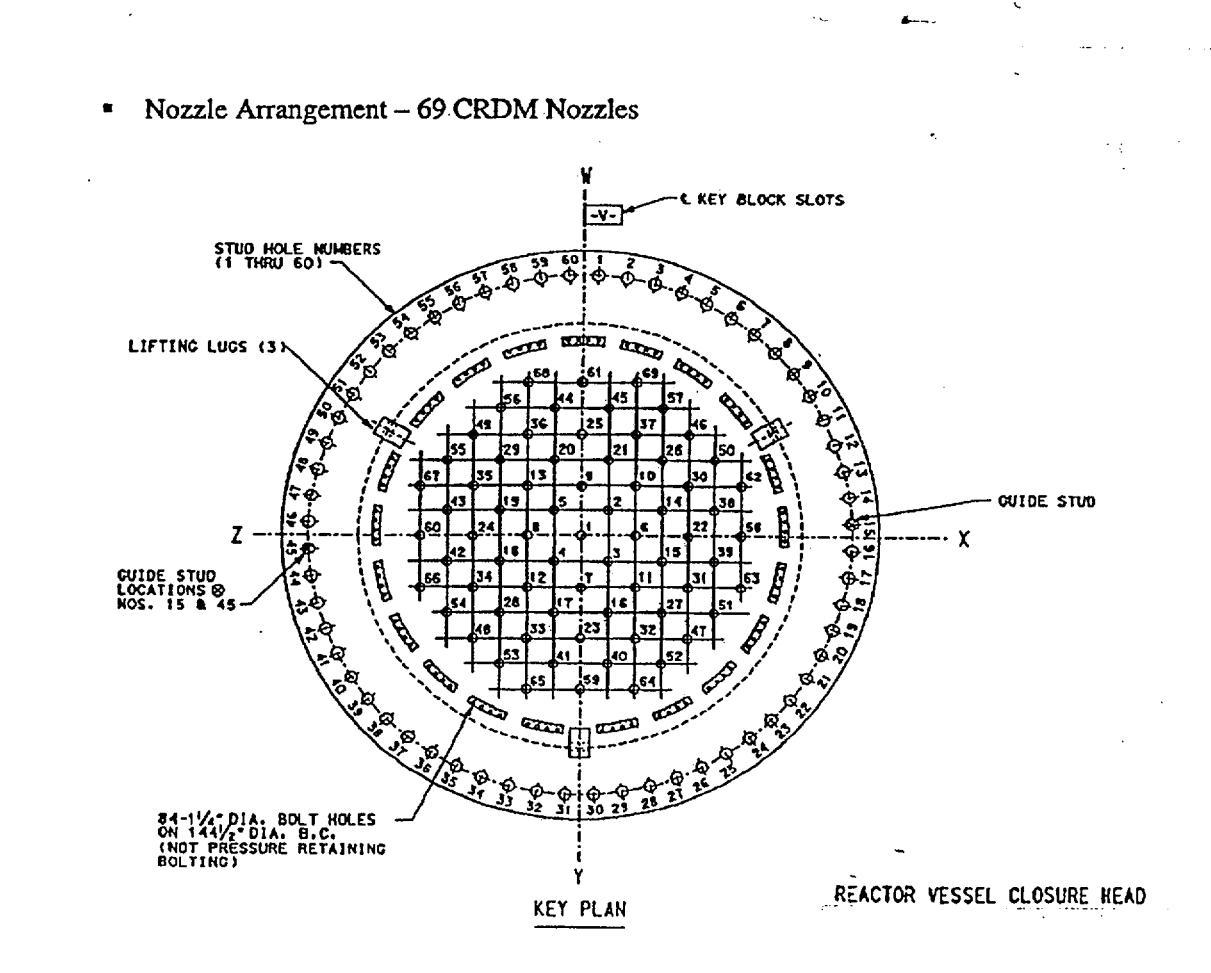
Nozzle No.	Core Locat.	Quadrant	1996 Inspection results	1998 Inspection results	2000 Inspection results
			See Note 1.0		
1	H8	1		Flange Leak Evident	Flange Leak Evident
2	G7 _	4		Flange Leak Evident	Flange Leak Evident
3	G9	1		Flange Leak Evident	Flange Leak Evident
4	K9	2		Flange Leak Evident	Flange Leak Evident
5	K7	3		Flange Leak Evident	Flange Leak Evident
6	F8	1		Flange Leak Evident	Flange Leak Evident
7	H10	2		Flange Leak Evident	Flange Leak Evident
8	L8	3		No Leak Observed	No Leak Observed
9	H6	4		No Leak Observed	No Leak Observed
10	F6	4		No Leak Observed	No Leak Observed
11	F10	1		Flange Leak Evident	Flange Leak Evident
12	L10	2		No Leak Observed	No Leak Observed
13	L6	3		No Leak Recorded	No Leak Observed
14	E7	4		Flange Leak Evident	Flange Leak Evident
15	E9	1		Flange Leak Evident	Flange Leak Evident
16	G11	1		Flange Leak Evident	Flange Leak Evident
17	K11	2		No Leak Observed	No Leak Observed
18	M9	2		No Leak Recorded	No Leak Observed

19	M7	3		No Leak Observed	No Leak Recorded
20	K5	3		No Leak Observed	No Leak Observed
21	G5	4		No Leak Observed	No Leak Observed
22	D8	1		Flange Leak Evident	Flange Leak Evident
23	H12	2		No Leak Observed	No Leak Observed
24	N8	3		No Leak Recorded	No Leak Recorded
25	H4	4		No Leak Recorded	No Leak Observed
26	E5	4		No Leak Recorded	No Leak Observed
27	E11	1		Flange Leak Evident	Flange Leak Evident
28	M11	2		No Leak Recorded	No Leak Observed
29	M5	3		No Leak Recorded	No Leak Observed
30	D6	4		No Leak Observed	No Leak Observed
31	D10	1		Flange Leak Evident	Flange Leak Evident
32	F12	1		Flange Leak Evident	Flange Leak Evident
33	L12	2		No Leak Recorded	No Leak Observed
34	1010 NC	2		NO LEAK HECORDED	NO Leak Observed
35	N6	3		No Leak Recorded	No Leak Recorded
36	L4	3		No Leak Recorded	No Leak Observed
37	F4	4		NO LEAK RECORDED	NO Leak Observed
38		4		NO LEAK HECOIDED	Flange Leak Evident
39		 		Flange Leak Evident	Flange Leak Evident

40 41	G13 K10			Fiange Leak Evident	Flange Leak Evident
41 40		2		No Leak Recorded	No Leak Observed
42 12	09	2		No Leak Recorded	No Leak Recorded
40	07 63	່ ບ 2		No Leak Recorded	No Leak Observed
44 15	(C3)	Л		No Leak Recorded	No Leak Observed
45		т+ Л		No Leak Recorded	No Leak Observed
40	04 D10	+ 1		Flange Leak Evident	Flange Leak Evident
4/	צוט	1		Fiange Leak Evident	Tanye Leak Evident

Nozzle No.	Core Locat.	Quadrant	1996 Inspection results	1998 Inspection results	2000 Inspection results
48	N12	2		No Leak Recorded	No Leak Observed
49	N4	3		No Leak Recorded	No Leak Observed
50	C5	4		No Leak Recorded	No Leak Observed
51	C11	1		Flange Leak Evident	Flange Leak Evident
52	E13	1		No Leak Recorded	Flange Leak Evident
53	M13	2		No Leak Recorded	No Leak Observed
54	011	2		No Leak Recorded	No Leak Observed
55	O5	3		No Leak Recorded	No Leak Recorded
56	MЗ	3		No Leak Recorded	No Leak Observed
57	E3	4		No Leak Recorded	No Leak Observed
58	B8	1		No Leak Recorded	Flange Leak Evident
59	H14	2		No Leak Recorded	No Leak Observed
60	P8	3		No Leak Recorded	No Leak Recorded
61	H2	4		No Leak Recorded	No Leak Observed
62	B6	4		No Leak Recorded	No Leak Observed
63	B10	1		No Leak Recorded	Flange Leak Evident
64	F14	1		No Leak Recorded	Flange Leak Evident
65	L14	2		No Leak Recorded	No Leak Observed
66	P10	2		No Leak Recorded	No Leak Recorded

67	P6	3		No Leak Recorded	No Leak Recorded
68	L2	3		No Leak Recorded	No Leak Observed
69	F2	4		No Leak Recorded	No Leak Observed

In 1996 during 10 RFO, 100% of nozzles were inspected by visual examination. Since the video was void of head orientation narration, each specific nozzle view could not be correlated by nozzle number.

Nozzles 1,2,3, and 4 which do not have sufficient interference gap were excluded.

The remaining 65 nozzles did not show any evidence of leakage.

Bold letters indicate leaking CRDM bolting flanges discovered and repaired during 12 RFO (April 2000). No Leak Observed = Visual Inspection Satisfactory, No Video Record Required.
