RE: St. Lucie Units 1 and 2
Docket Nos. 50-335 and 50-389
Request for Information
Reinitiation of ESA Section 7 Consultation

ST LUCIE PLANT SEA TURTLE INCIDENTAL LETHAL TAKES IN 2001 AND CORRECTIVE ACTIONS

5-INCH BARRIER NET IMPROVEMENTS

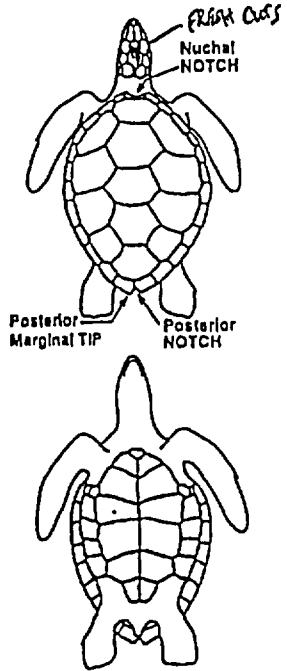
Mark wounds / abnormalities on diagrams at left and describe below (note tar or oil, gear or debris entanglement, propeller damage, epibiota, papillomas, emaciation, etc.). Please note if no-wounds / abnormalities are found.

APPARENTLY DROWNED BELOW SURFACE OF 5' MESH BARRIER NET. SLOPE OF BARRIER NET AFFECTED. DUE TO LARGE INFLUX OF DRIFT ALGAE / SEAWEED ON NET.
MORTALITY CRASAL TO PLANT OPERATION.
CARCASS HELD FOR FWCC.

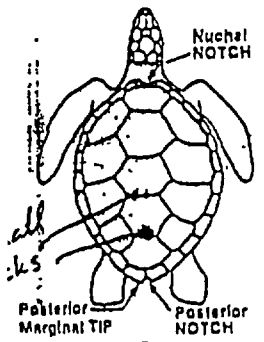
Mark wounds / abnormalities on diagrams at left and describe below (note tar or oil, gear or debris entanglement, smaller damage, epibiosis, papillomas, emaciation, etc.). Please note if wounds / abnormalities are found.
NO EXTERNAL INJURIES; SEVERELY
UNDERWEIGHT; EMACIATED, SUNKEN
PLASTIC; WEAK, HARDLY MOVING.
CLEARLY HAS BEEN IN THE CANAL FOR SOME-
TIME (MONTHS?) TO BE IN THIS CONDITION AND
MAY BE CAUSAL TO PLANT OPERATION
DEAD
