## The Embedded Flaw Process for Repair of Reactor Vessel Head Penetrations

Westinghouse Electric Company October 9, 2002

In 2001, Westinghouse applied the embedded flaw weld repair process on the J-weld surfaces for 3 CRDM penetrations on the North Anna 2 reactor vessel head

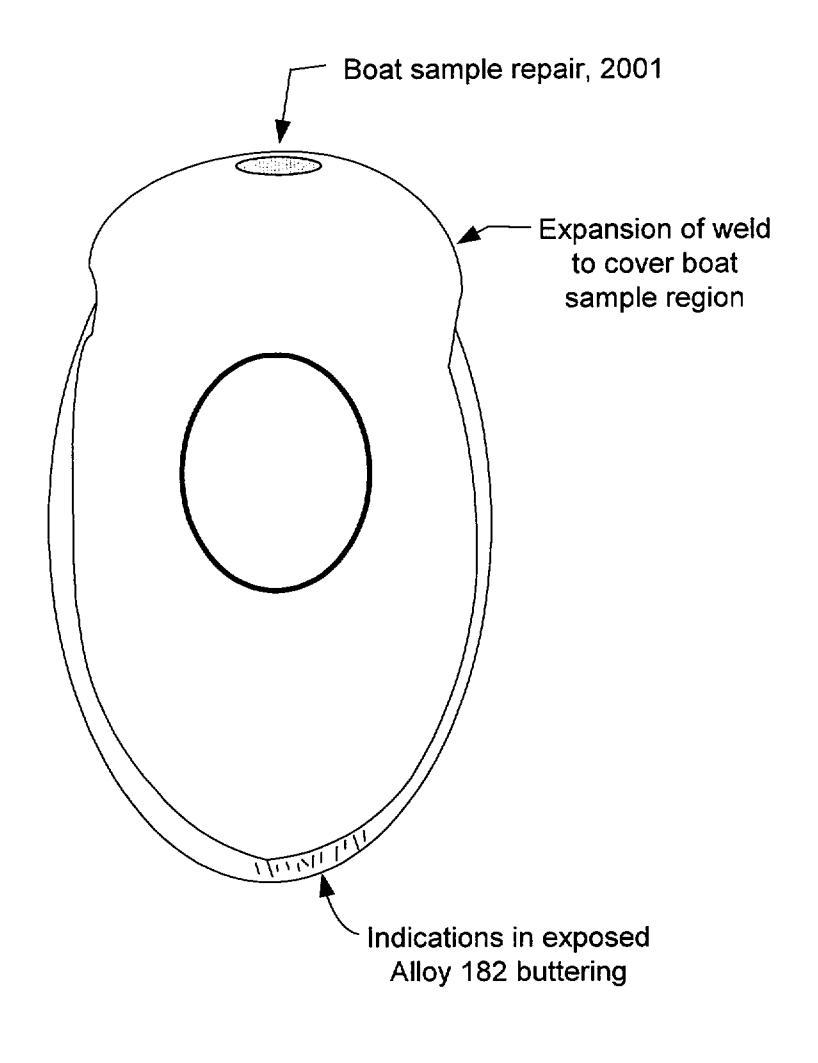
#### Sketch of Weld Repair, Penetration 62, Shows the Extension to Cover Buttering

One linear indication found on penetration 62

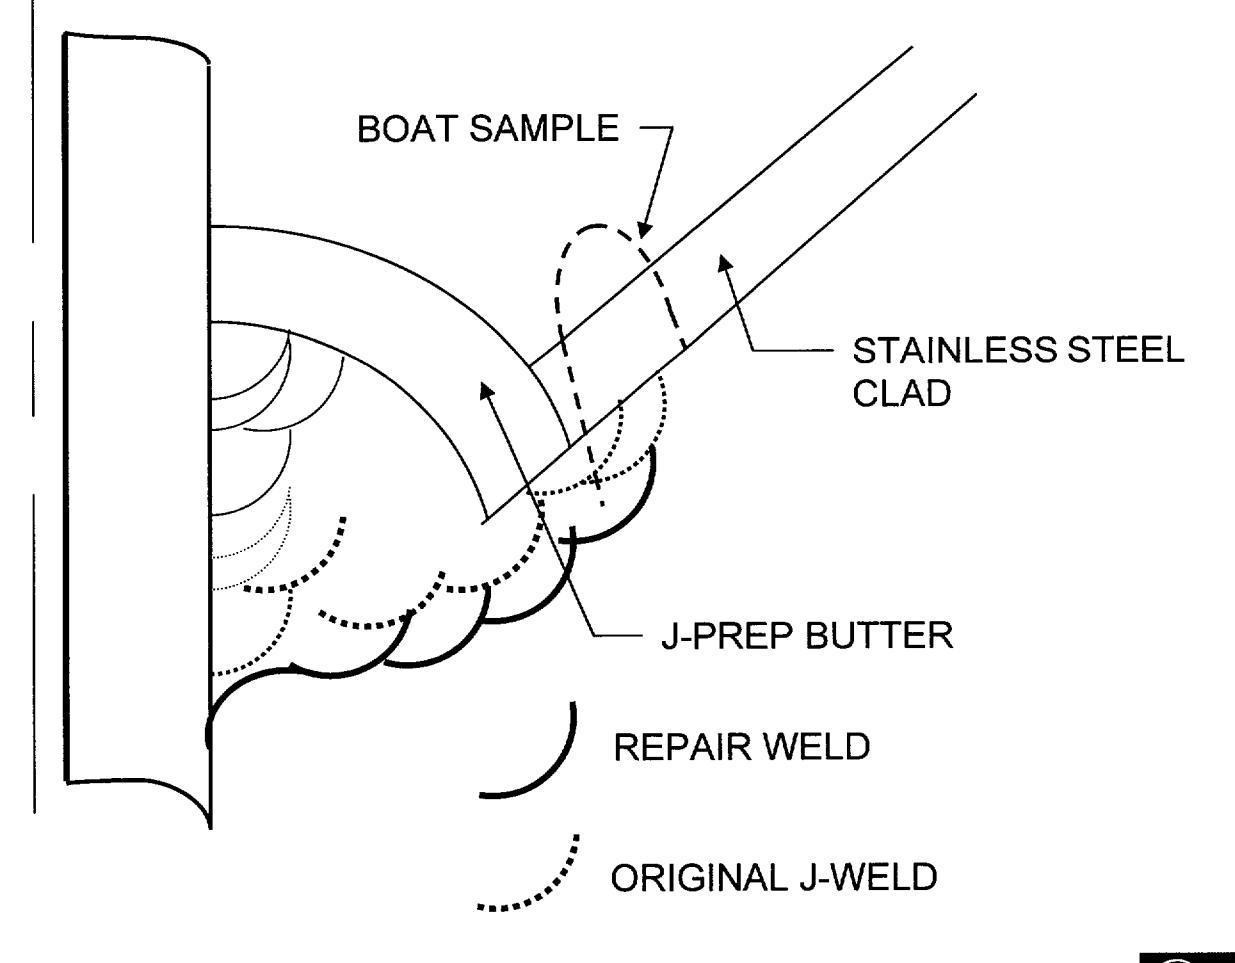
#### 2002 Boat Sample Location

Boat sample on penetration 51 demonstrates that 82/182 surface remains exposed outboard of repair weld

A Boat Sample Containing Two PT Indications at 135 degrees was Removed from the J-Weld Area of the Head

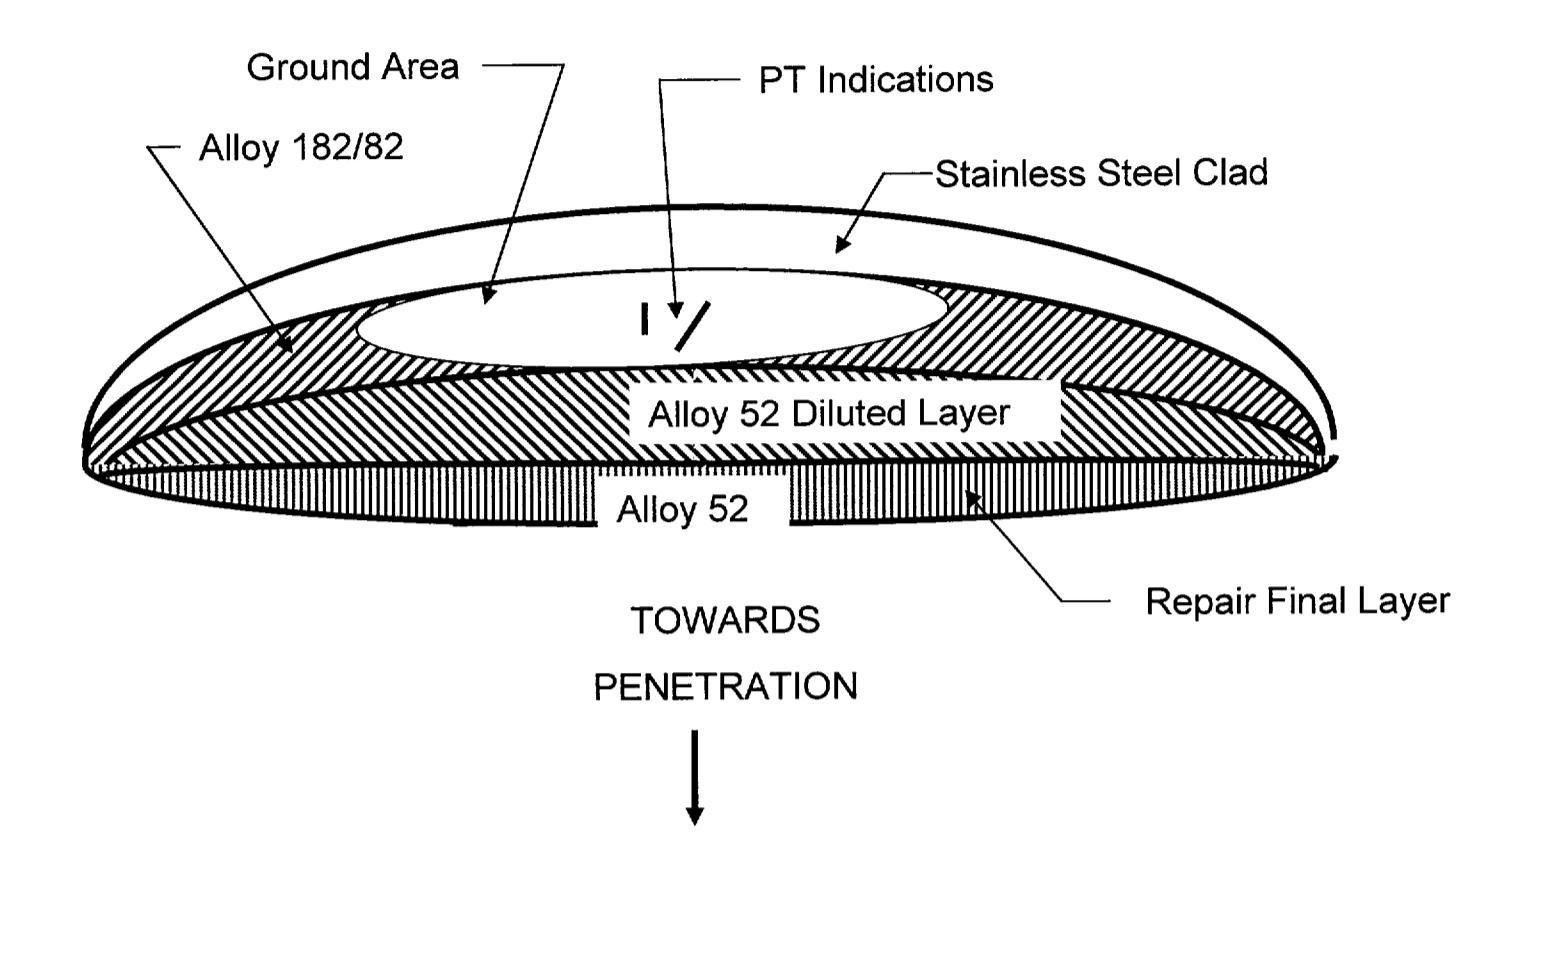
#### Wetted Surface Weld Bead Analysis

Two PT Indications were evident in an area that had been recently ground

At least one other surface indication was found in the ground area of the outboard weld bead

No surface indications were evident on any other surface with optical and SEM examinations of up to 40X

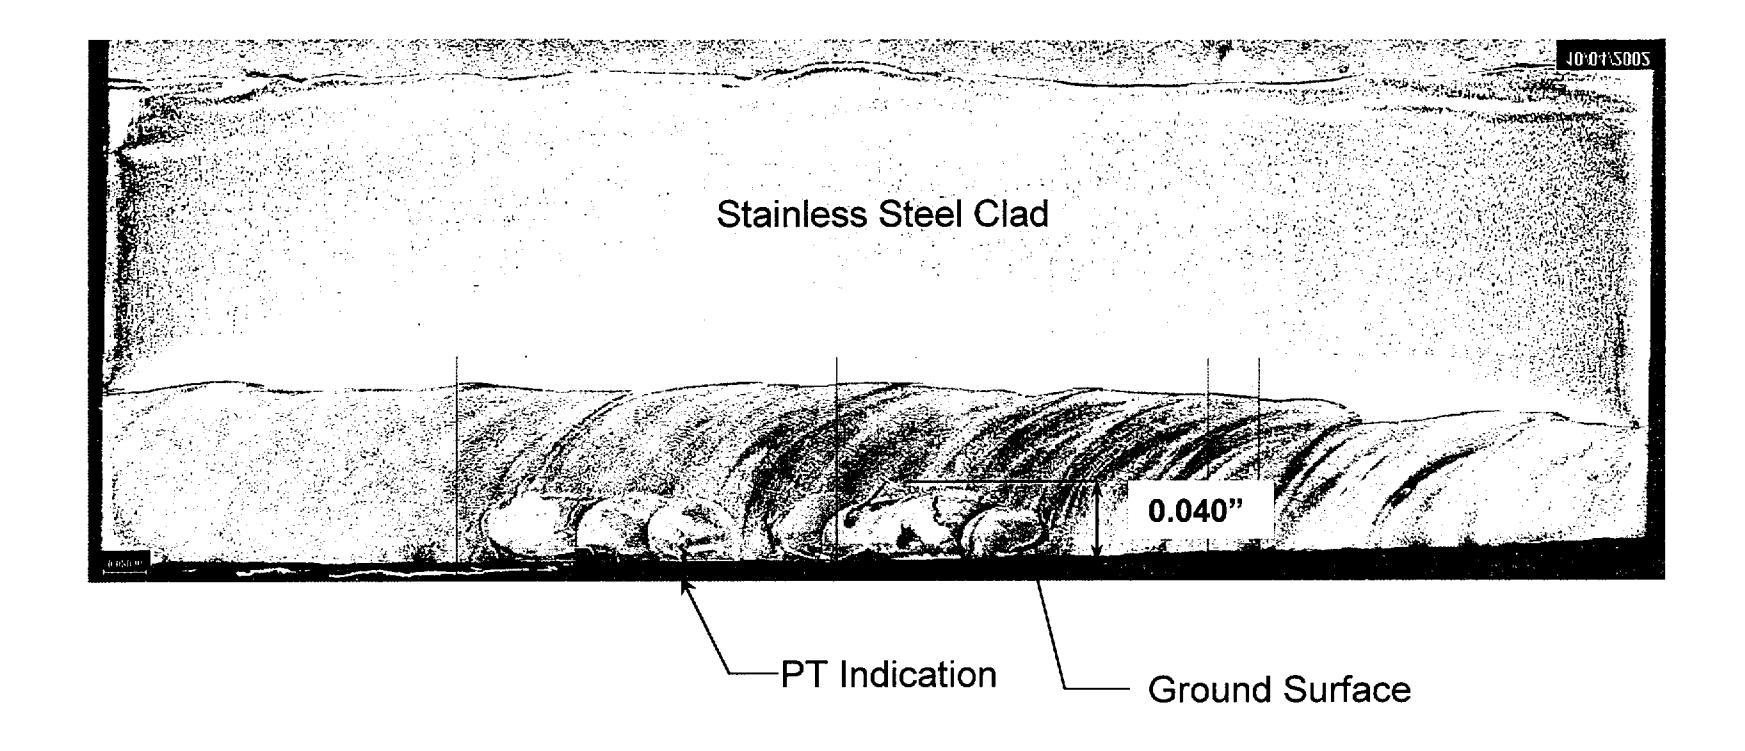
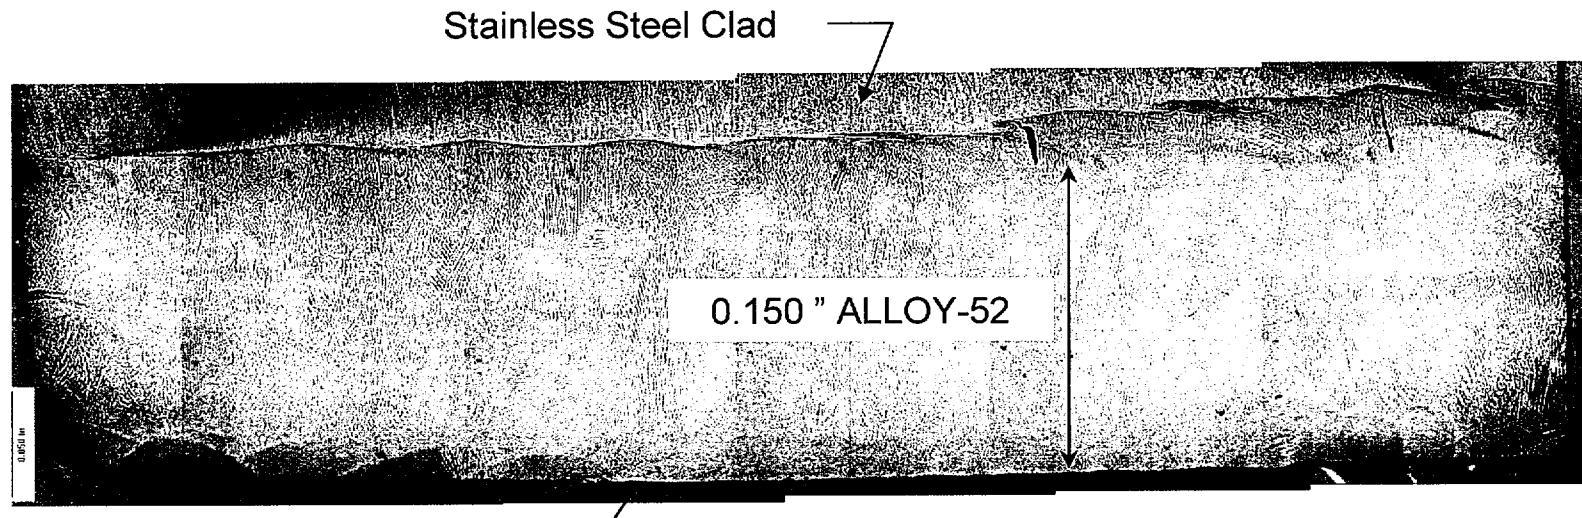
The PT Indication is Shallow and is Located at the Edge of a Diluted Weld Bead in the Ground Area

No Cracking was Identified at the Wetted Surface or within the Full-Thickness Repair

Most Hot Cracking Occurred at 308SS, Alloy-182/82 and Alloy 52 Diluted Boundaries

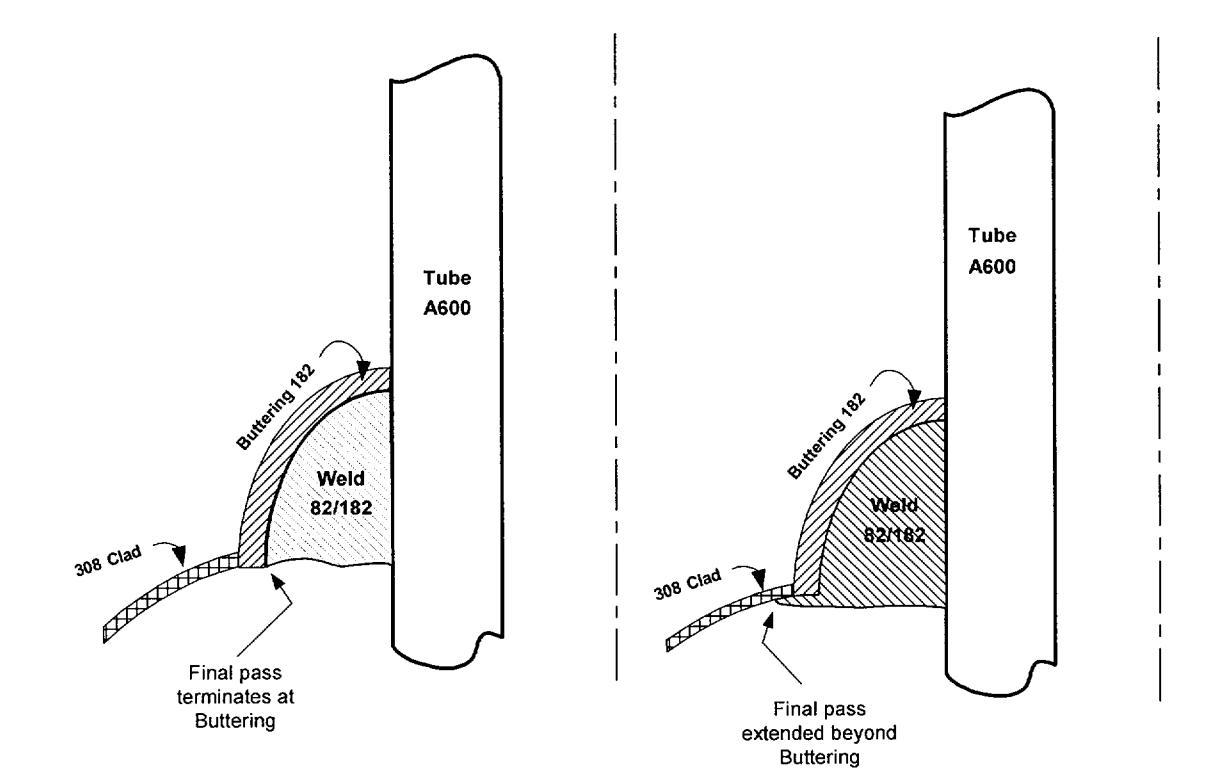
#### **J-Weld Final Pass Configurations**

Visual identification of J-groove weld toe was incorrectly interpreted as the Alloy 600 to Stainless Steel interface

There are uncertainties in the location of the interface between the stainless steel clad and the Alloy 82/182 material

Review of manufacturing records indicates latitude in application of weld that could vary the interface location

For future applications, both manufacture record reviews and on-site inspections will be performed to locate this interface
