Root Cause Analysis for CR 02-08166

Evaluation Of "D" Steam Generator Tube Cracking

FPL Energy

Seabrook Station

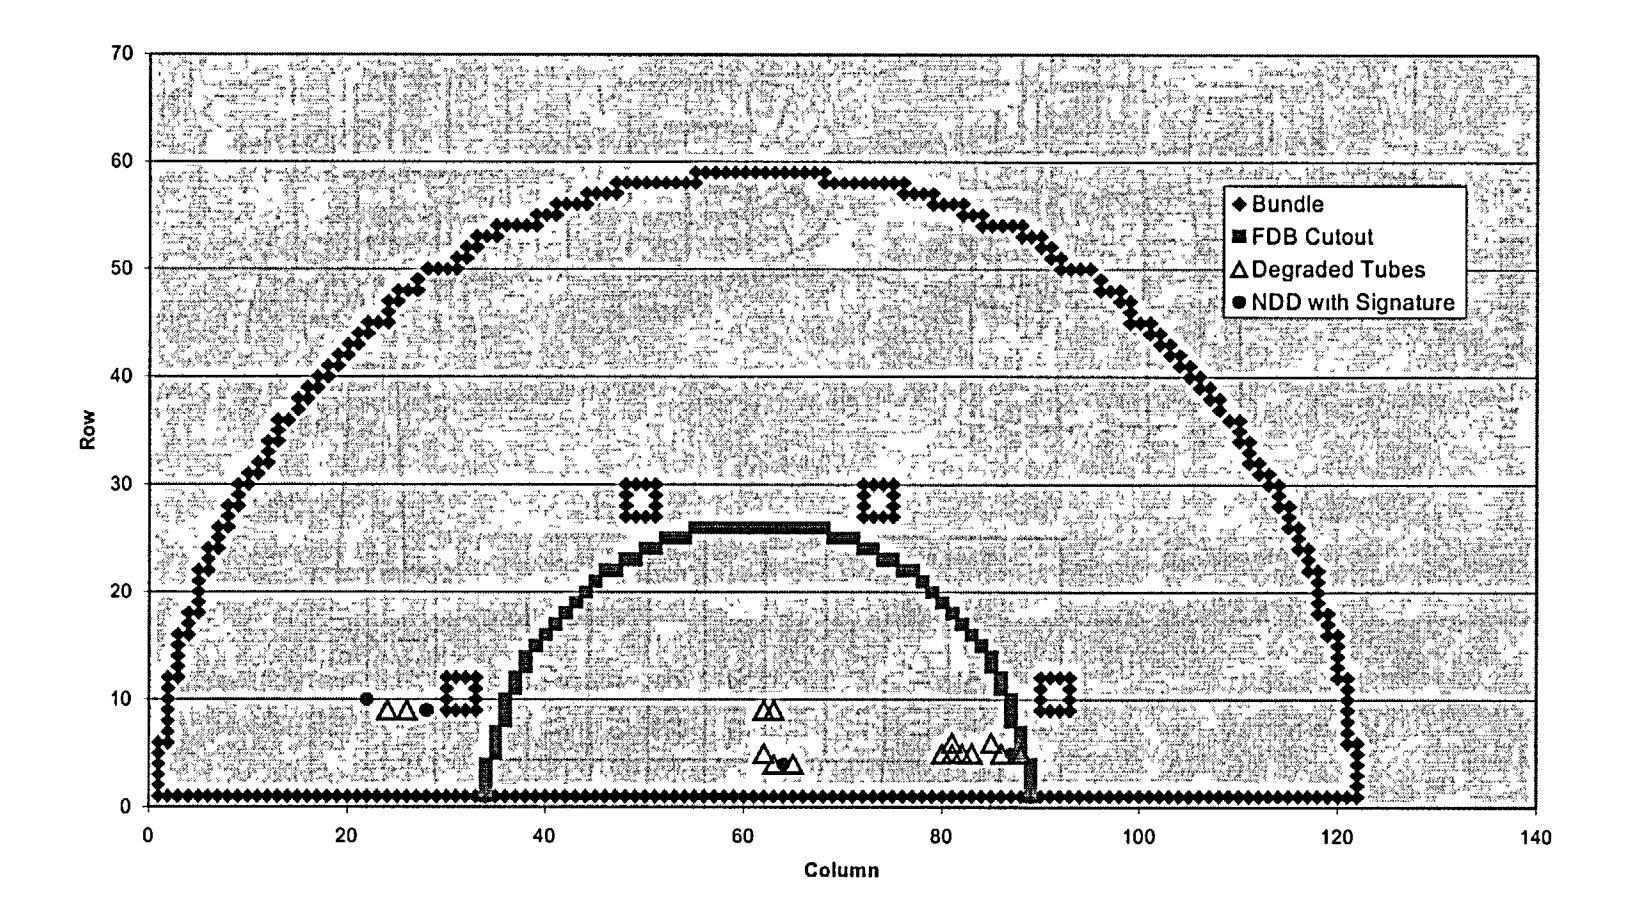
Figure 3-2 Location of Degraded Tubes

- 1. Seabrook has significantly less operating time than many of the other Model F SG plants that have not observed tube cracking; thus, these indications were unanticipated.
- 2. Indications were detected in only SG-D.
- 3. Indications were found at the TSP intersections and not at the top of the tubesheet (TTS) expansion transition where initial cracking would be expected.
- 4. Indications were reported on both the HL and CL. In all cases where a CL indication was reported, a HL indication was also reported on the same tube. CL cracking at the same time as HL cracking is unexpected due to the lower temperature on the CL.
- 5. All indications were confined to rows 4 through 9 (see Figure 3-2).

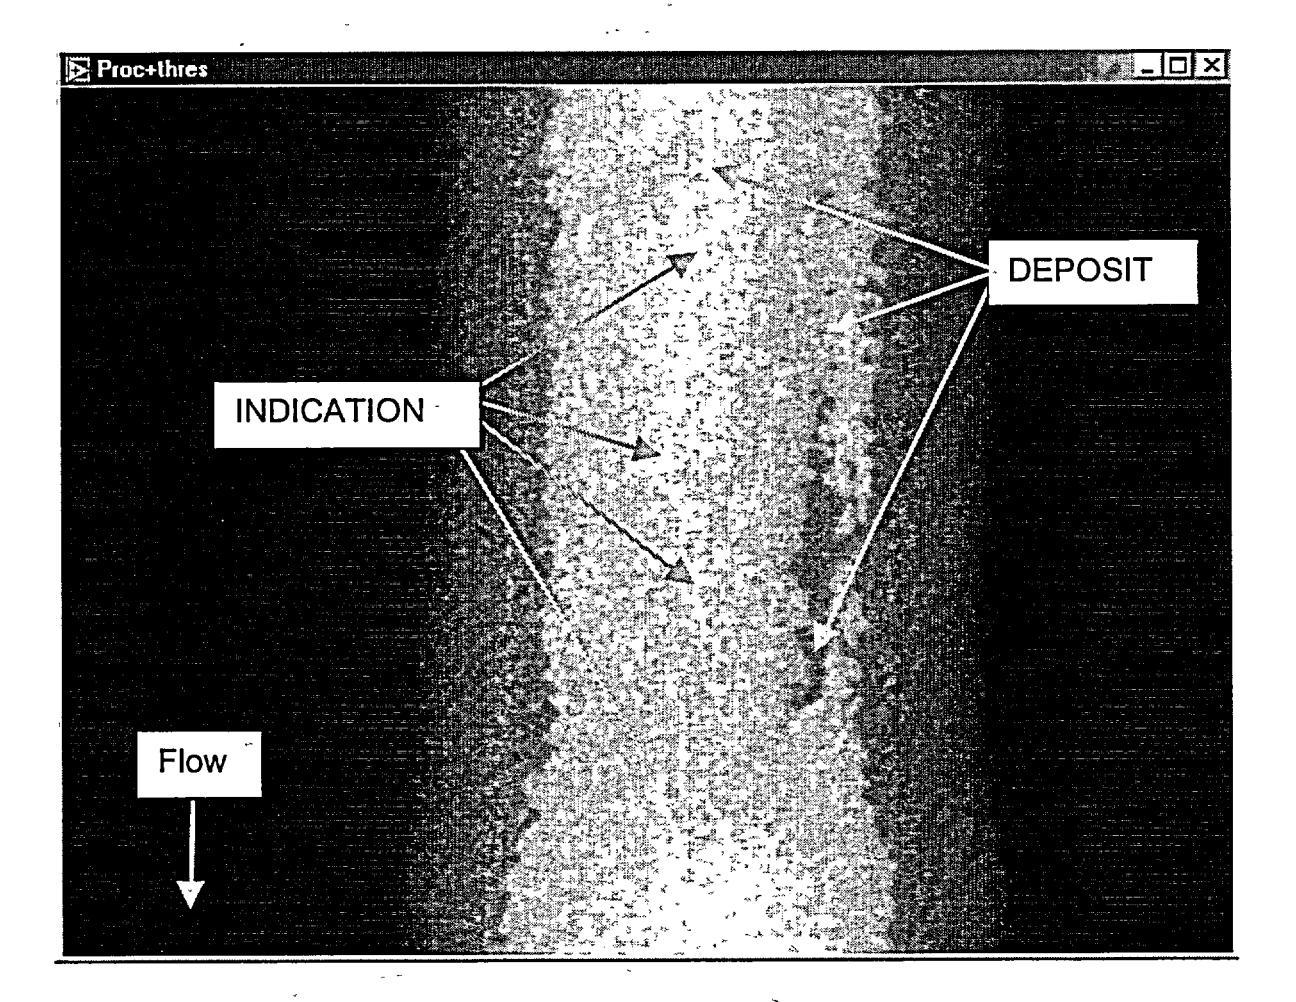
Figure 4-1 X-ray image of Seabrook tube R5C62 hot leg TSP 4 at the 210 degree orientation.

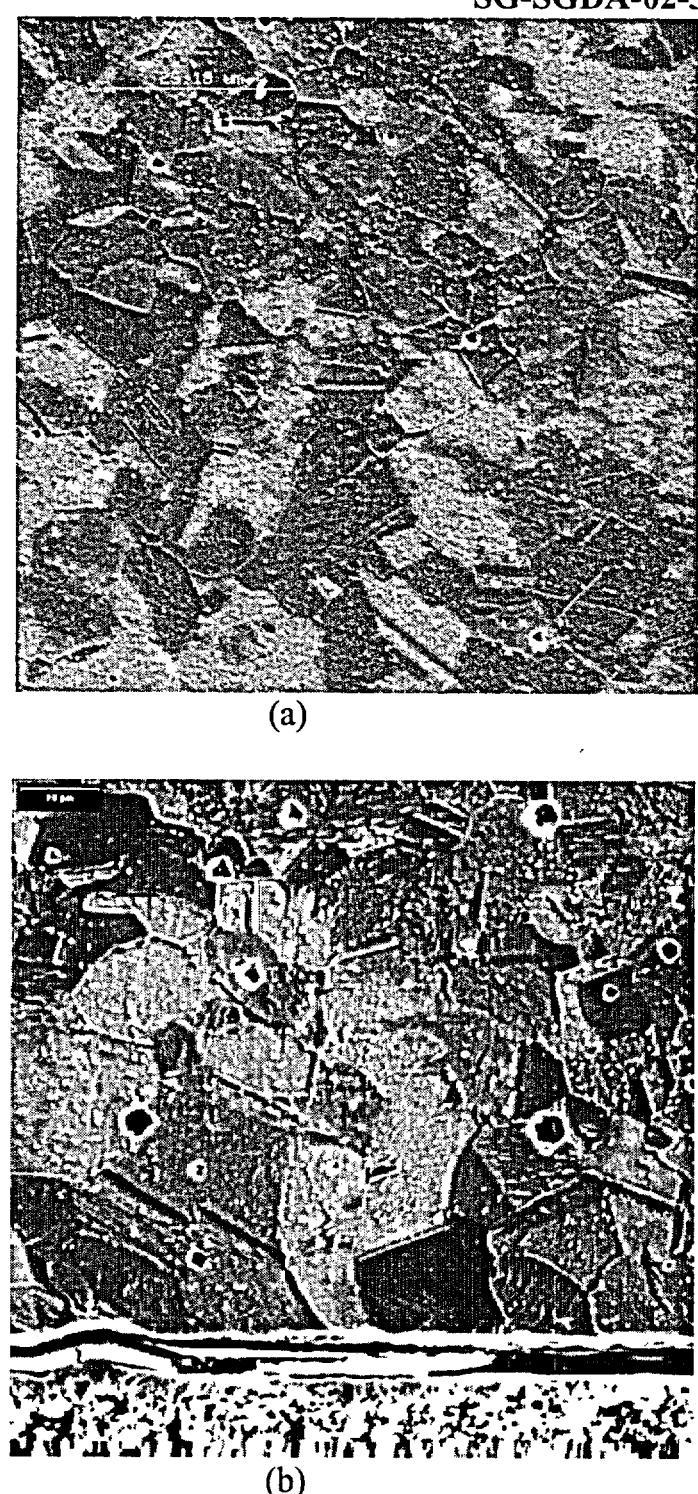
The two tubes that were pulled and examined exhibited a microstructure characterized by fine equiaxed grains with a significant variation in grain size as well as a non-uniform "banded" grain distribution. The microstructure was also characterized by intergranular and extensive intragranular carbide precipitation. This structure is considered to be not optimum but within the

(b) Figure 4-2 (a) R9C63 CL and (b) R5C62 HL are generally characterized by intragranular precipitation and fine grain size [ASTM 9-11]

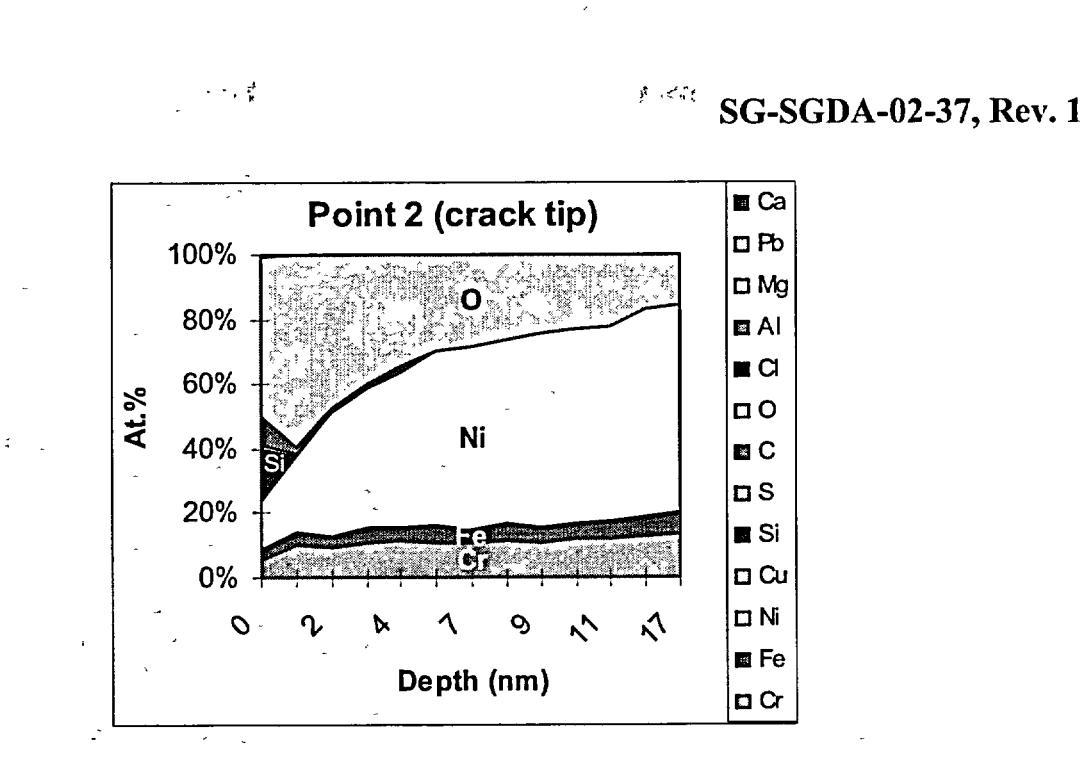
Figure 4-7 AES profile on an opened crack face from the R5C62 HL 4th TSP specimen

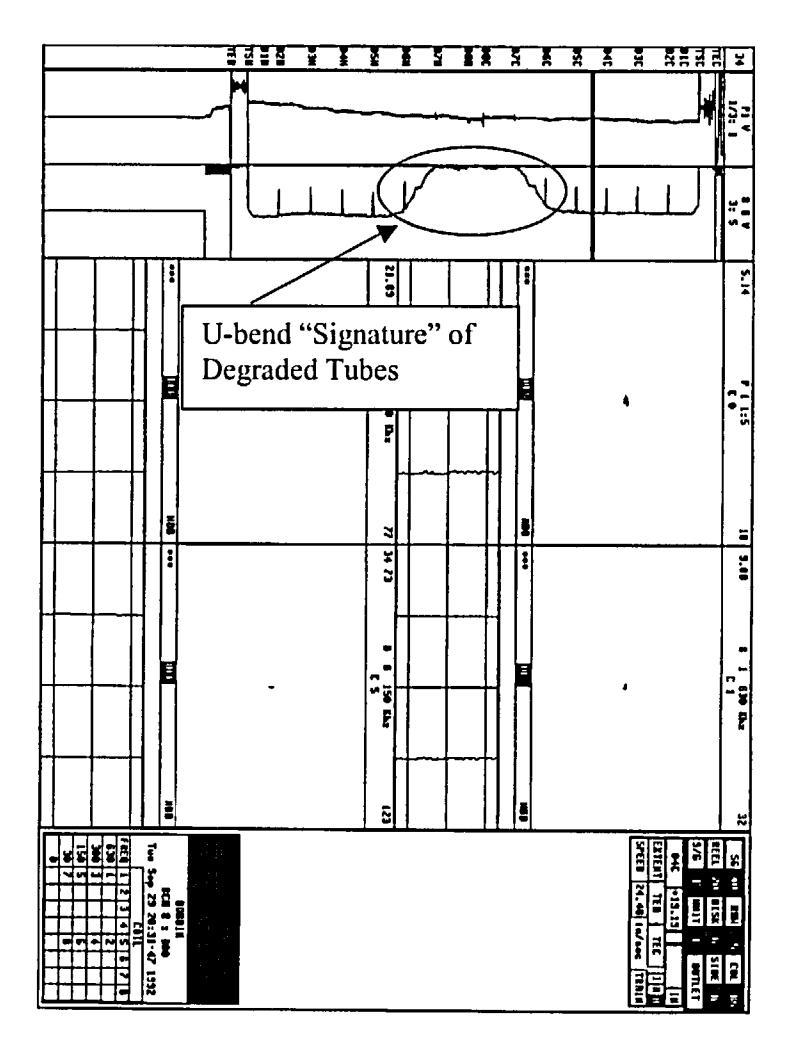
- All of the degraded tubes display a characteristic eddy current trace (i.e., "signature") that is unique when compared to the eddy current signal for the remainder of the tubes in rows 1 through 10. In addition to the 15 reported degraded tubes, four other row 10 and lower tubes (1- heat NX1374, 1- heat NX1457, 1- heat NX1439, and 1- heat NX1790) in SG-D display the same EC signature characteristic. None of the row 10 and lower tubes in the other three SGs displays this characteristic.

Figure 5-3 Eddy Current; Degraded Tubes

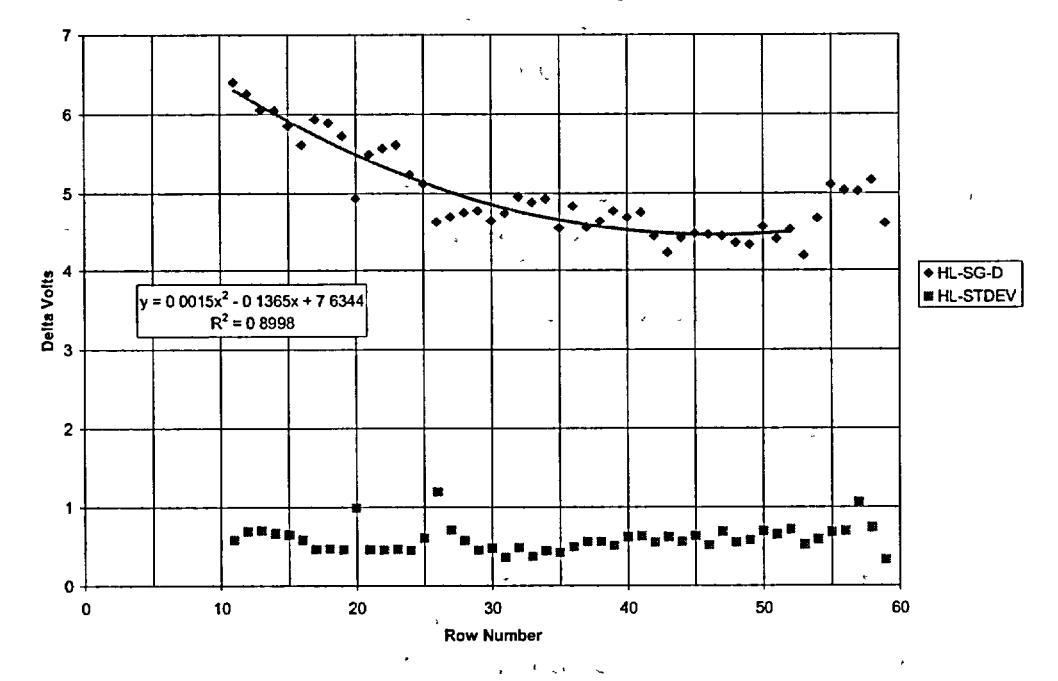
- The EC signature does not provide conclusive information regarding the potential for degradation of the tubes in Rows 11 through 59. However, the average voltage offset of the u-bend signal compared to the straight leg signal provides a good correlation with the u-bend radius. It is not possible to estimate the level of residual stress from the eddy current signature; however the signature comparison suggests that tubes in rows 11 and higher are from a common population and do not have unusually high residual stresses.

Figure 5-4 EC Signal Voltage Offset of U-bend from Straight Leg of the Tubes

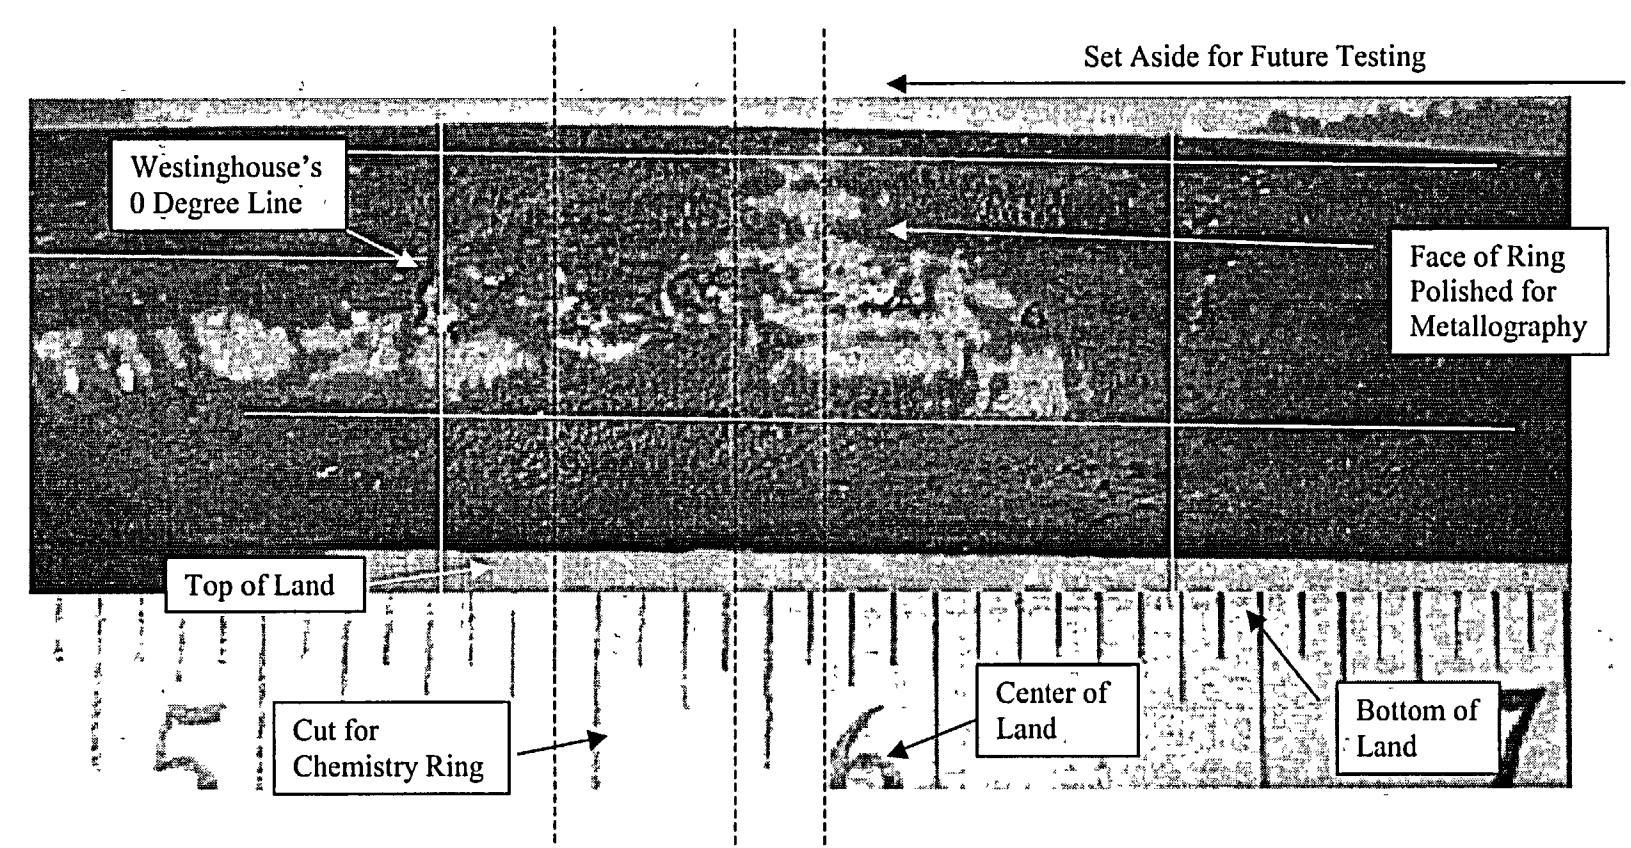
Figure 4-5. Photograph of Land Area on Cracked Sample, Scale is in Inches

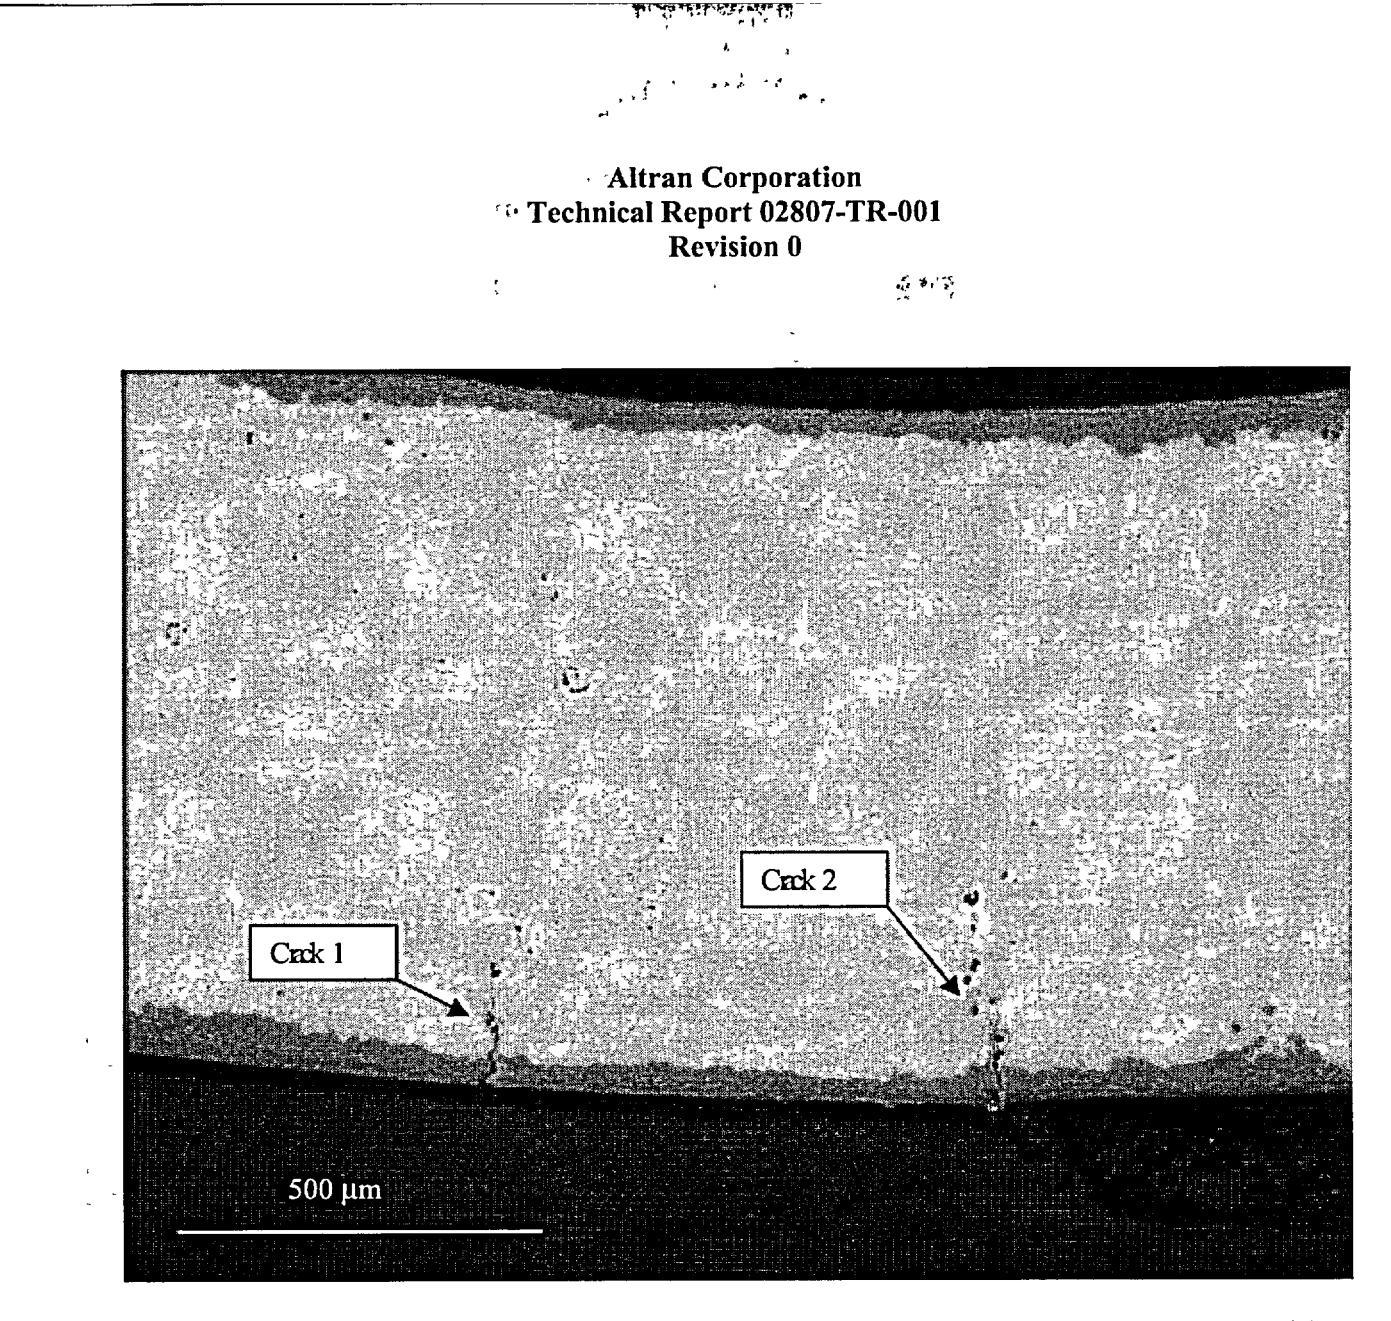
Figure 4- 6. Micrograph of Flawed Sample at the 0 Degree Position

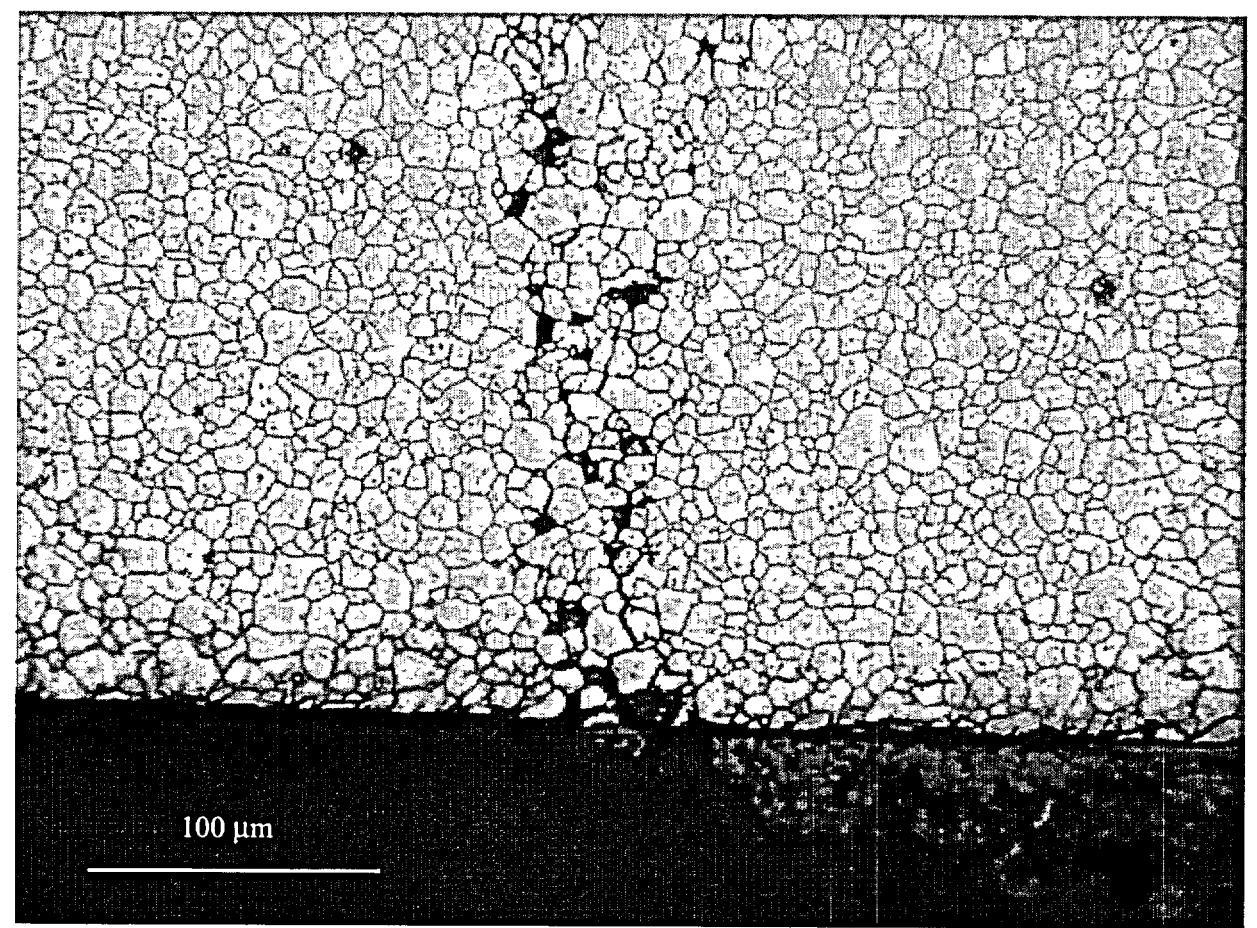
Figure 4-7. Micrograph of Crack 2 Showing an Intergranular Crack Path

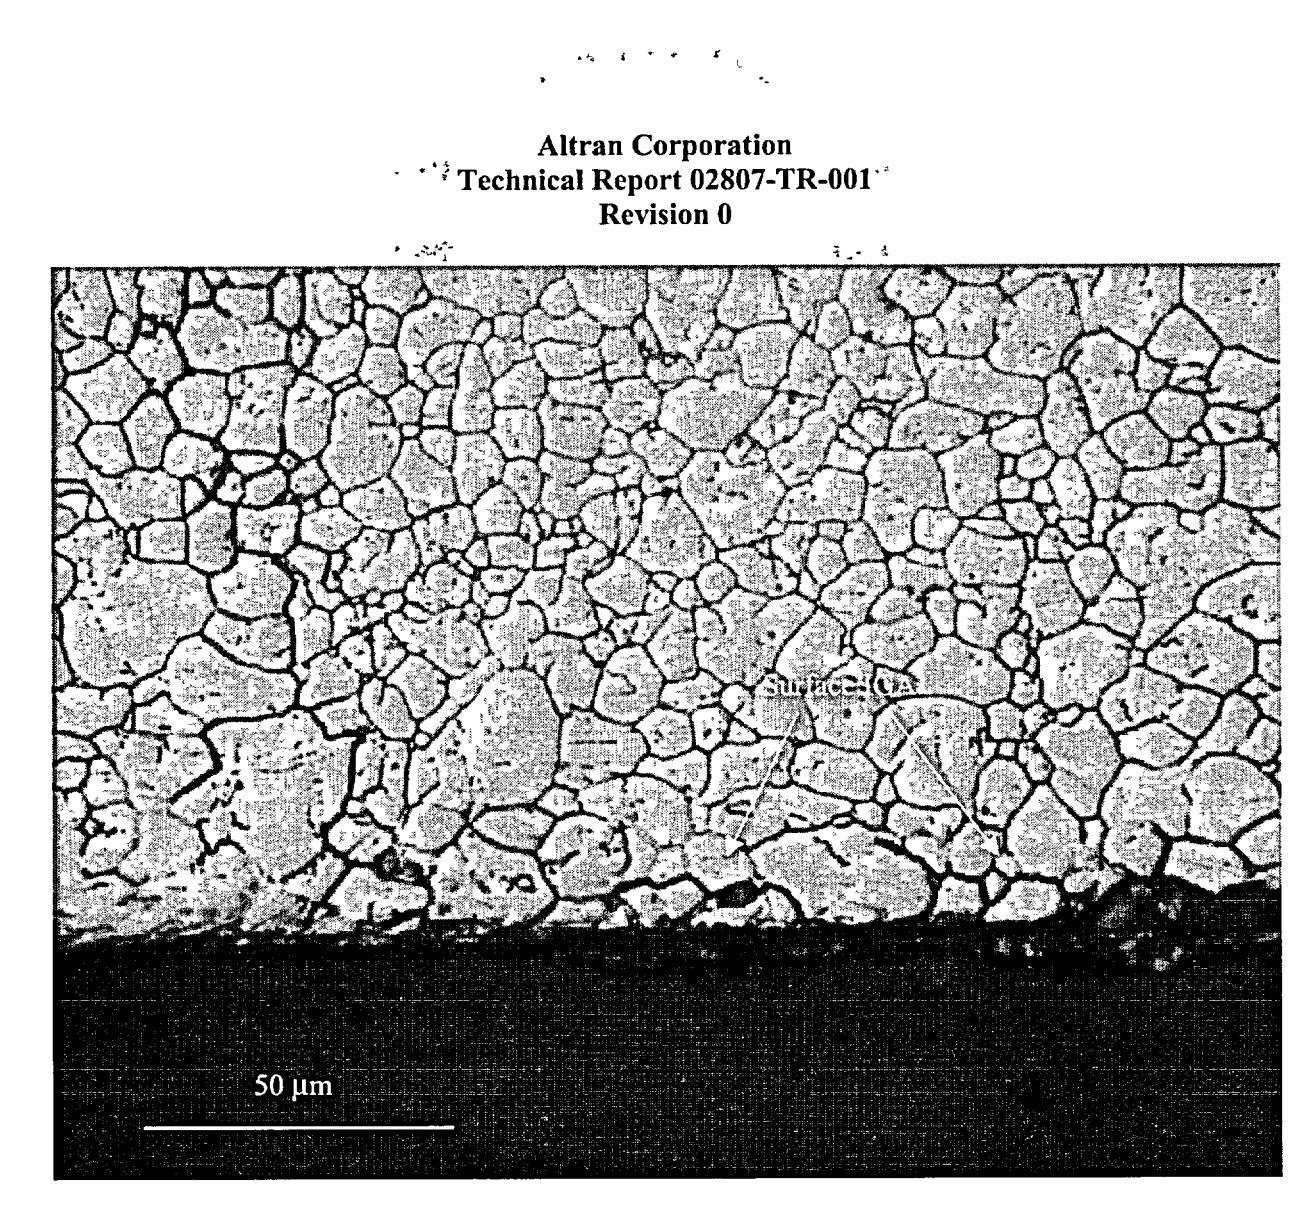
Figure 4-8. Area on the OD Surface Showing Intergranular Attack, in Land Area

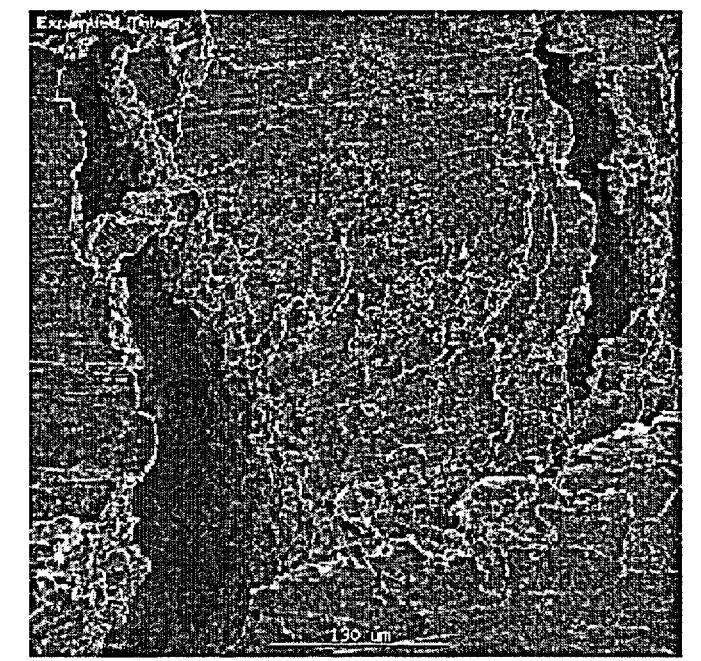
Figure 4-13. High Magnification SEM Image of Cracks
