Millstone Nuclear Power Station, Unit No. 2 Supplemental Response to NRC Bulletin 2001-01 Circumferential Cracking of Reactor Pressure Vessel Head Penetration Nozzles

ERC 25203-ER-02-0005 Reactor Vessel Head Penetration Inspection Plan for Ultrasonic Examination of Interference Fit

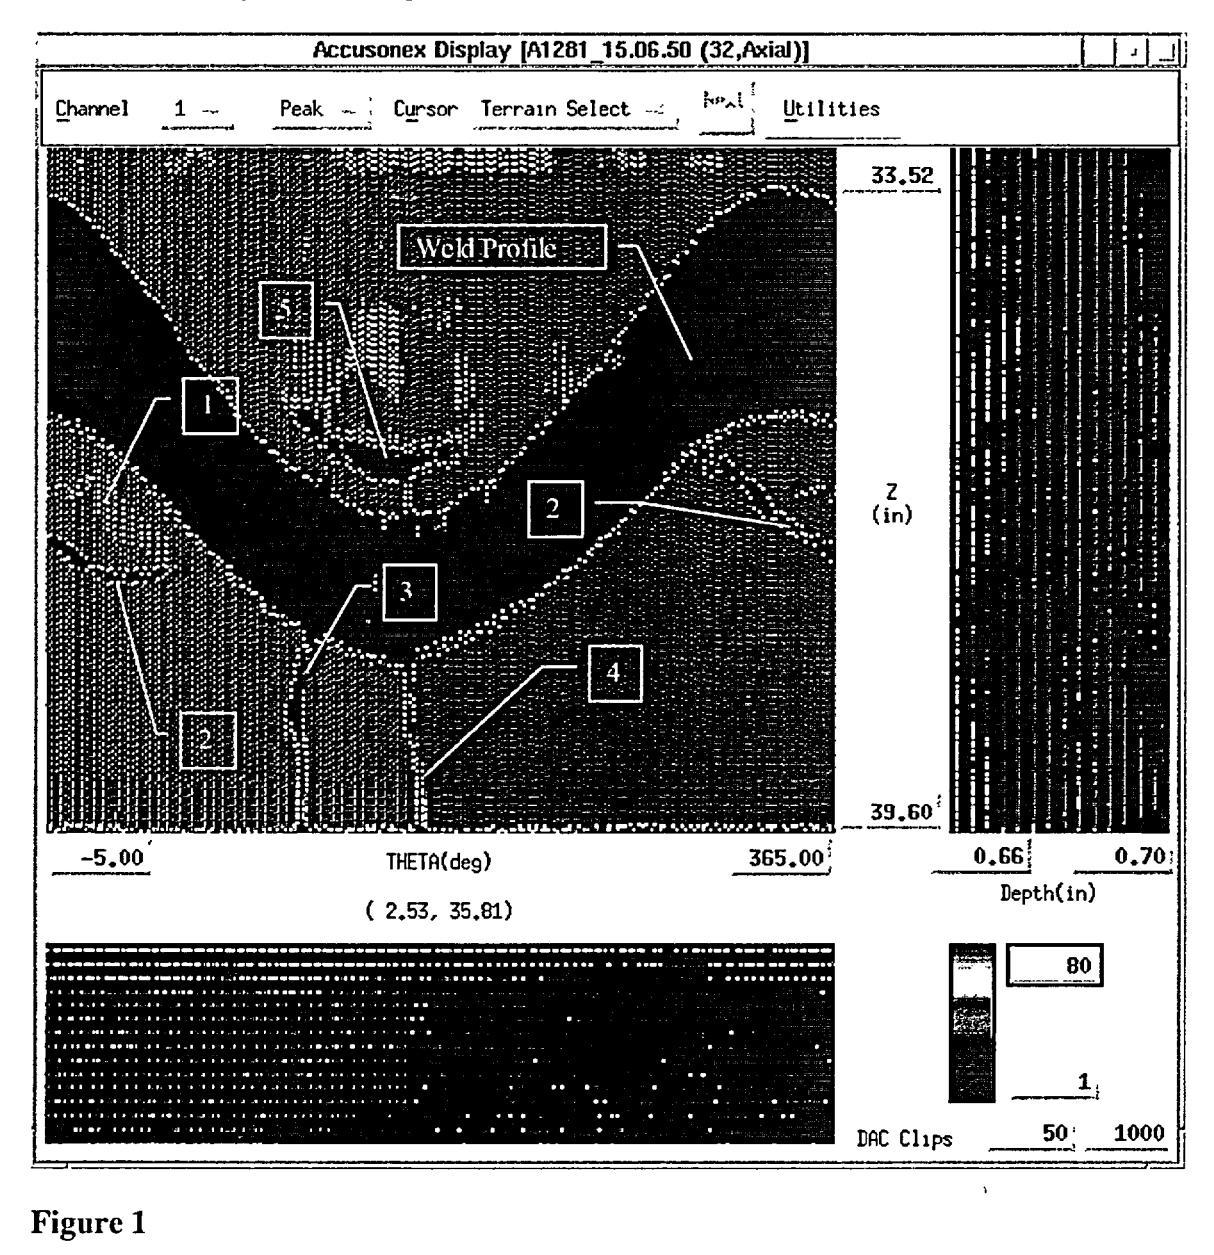
On Figure 1 (below), the analyst selected a slice of information (time/distance), which best illustrated the parameters of interest (cracks in relation to the weld). The areas of high energy are colored red and the areas of low energy are colored black. The large sinusoidal shape in the middle of the display is the weld. Note the total loss of back reflection in the area of the weld, indicating that the sound energy was allowed to propagate into the weld. The sound energy is also not reflected toward the receiving transducer at this point in time in the location of the four cracks labeled 2 through 5.

The small, vertical, multi-colored bar code in the bottom right corner of the illustration is set with a color range of 1 through 80.

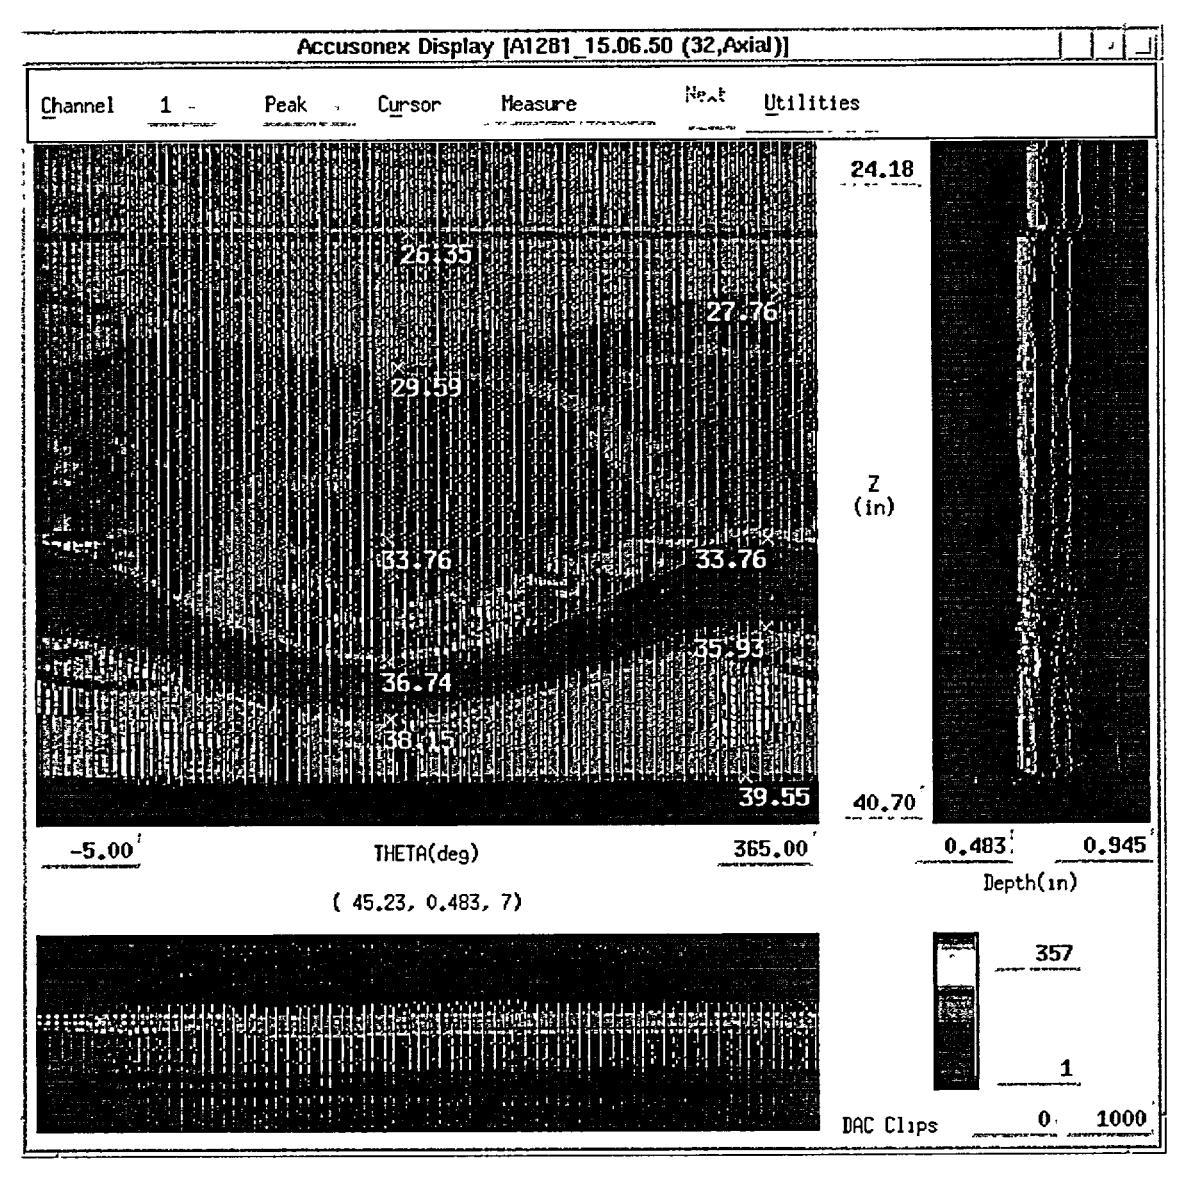
Figure 2

Figure 2, is the same penetration. In this illustration, the primary area of interest was to measure the location of the top of the vessel head, interference fit, and weld, before starting the repair. Location 26.35 is a transition area where there is a geometry change in the tube, above the top of the vessel head. Location 27.76 is the top of the vessel head on the uphill side of the nozzle and location 29.59 is the top of the vessel head on the downhill side of the nozzle. Note how the rise and fall of the vessel head conforms to the rise and fall of the weld indicating the geometry of the vessel head curvature. The area between location 29.59 and location 33.76 is the interference fit. The general area between the top and bottom of the interference fit has less sound energy reflected then any other area in this illustration other than the weld. Location 39.55 is the bottom of the nozzle. The area between 39.55 and the bottom of the weld is a metal to air interface.

Although the color scheme was set to optimize the other parameters, two distinct areas of high reflection are visible through the interference fit. These two areas are the RCS leak paths through the interference fit.

Note the color settings on the color bar code are 1 through 357.

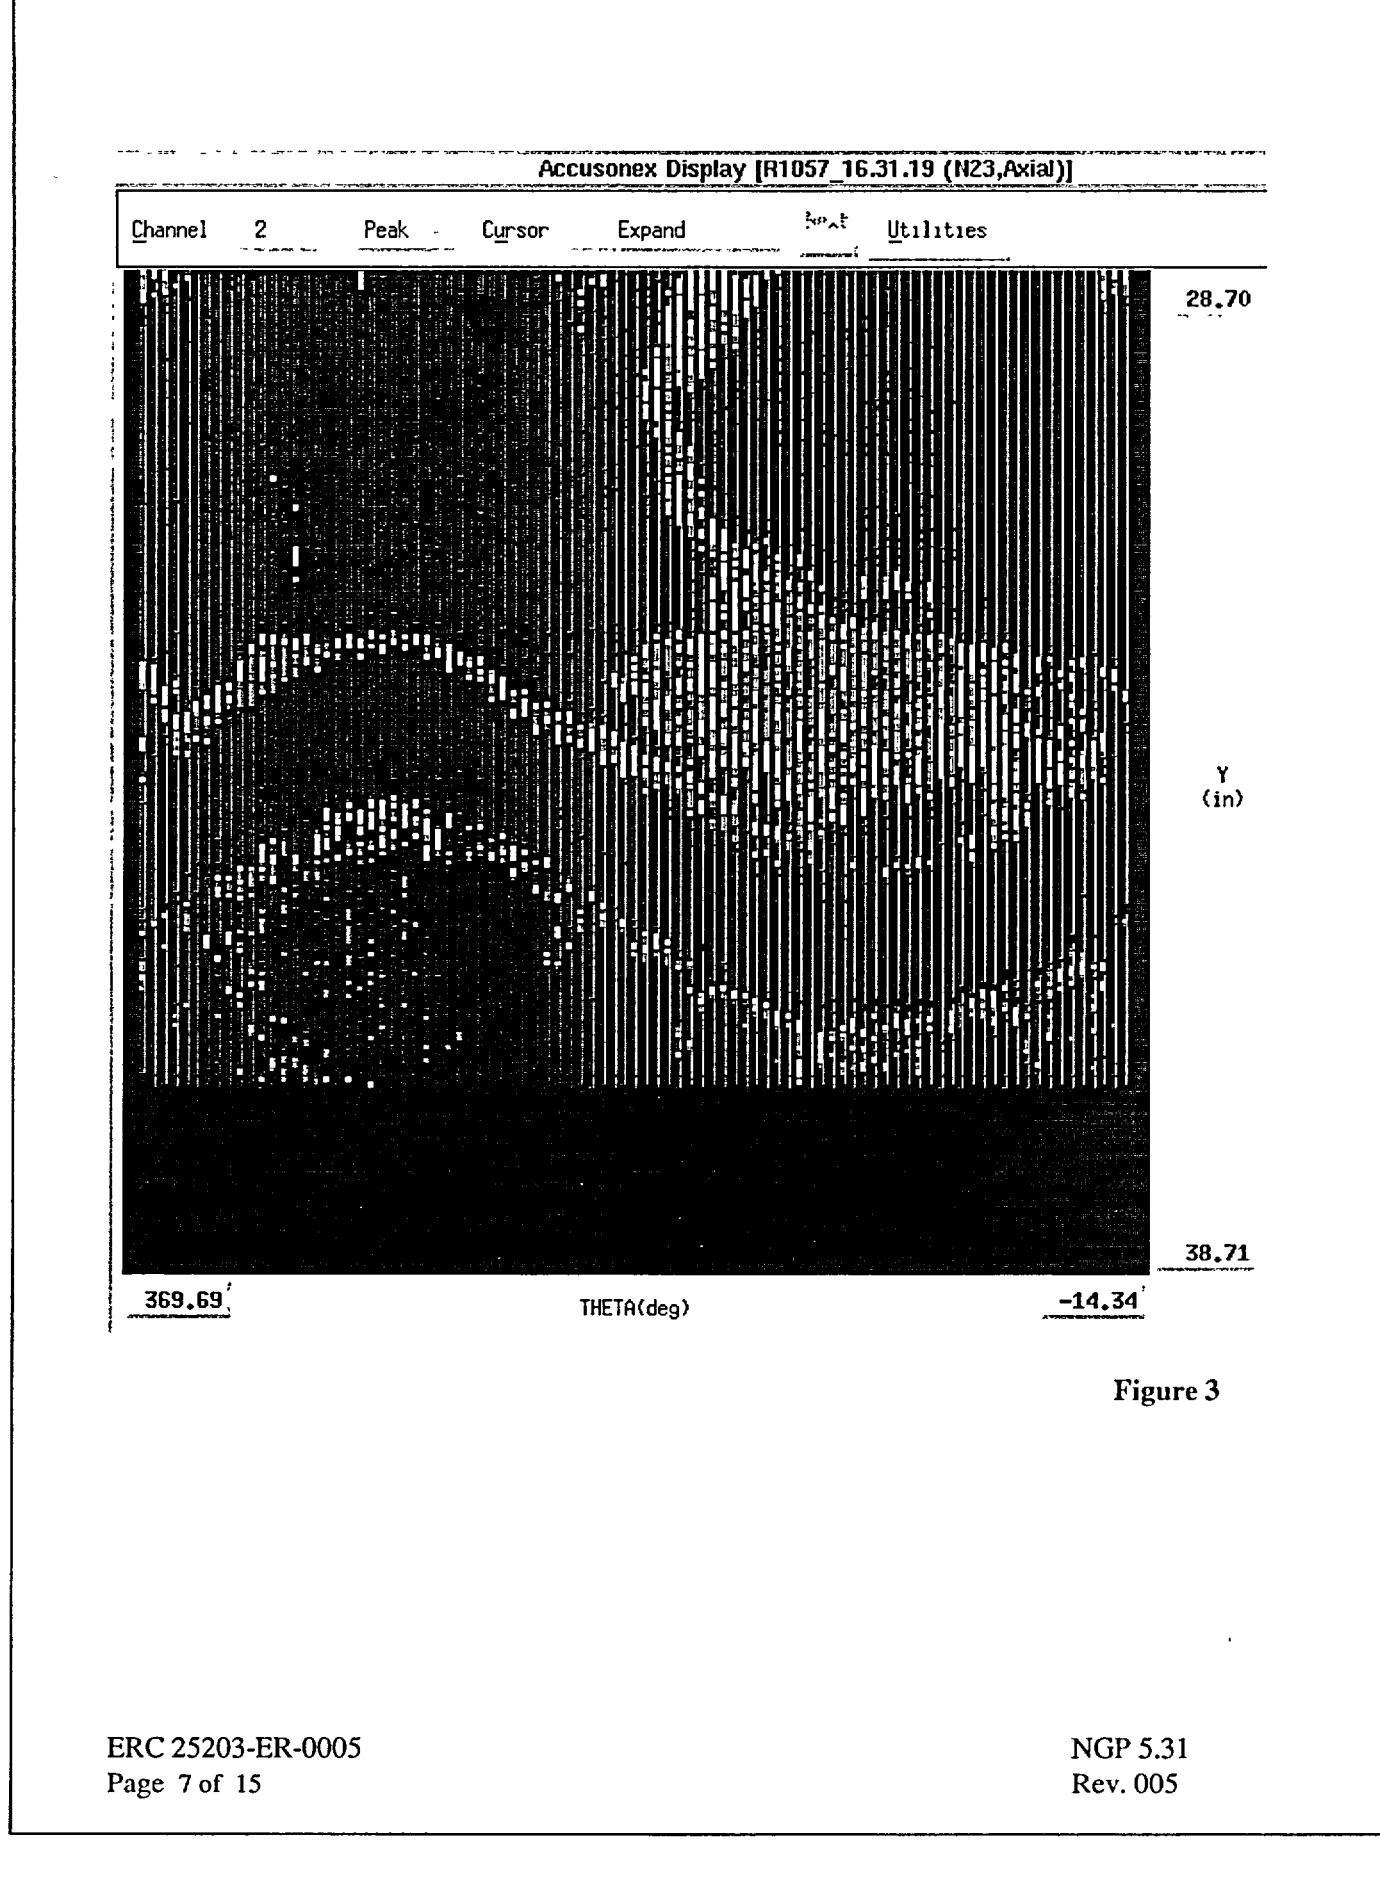
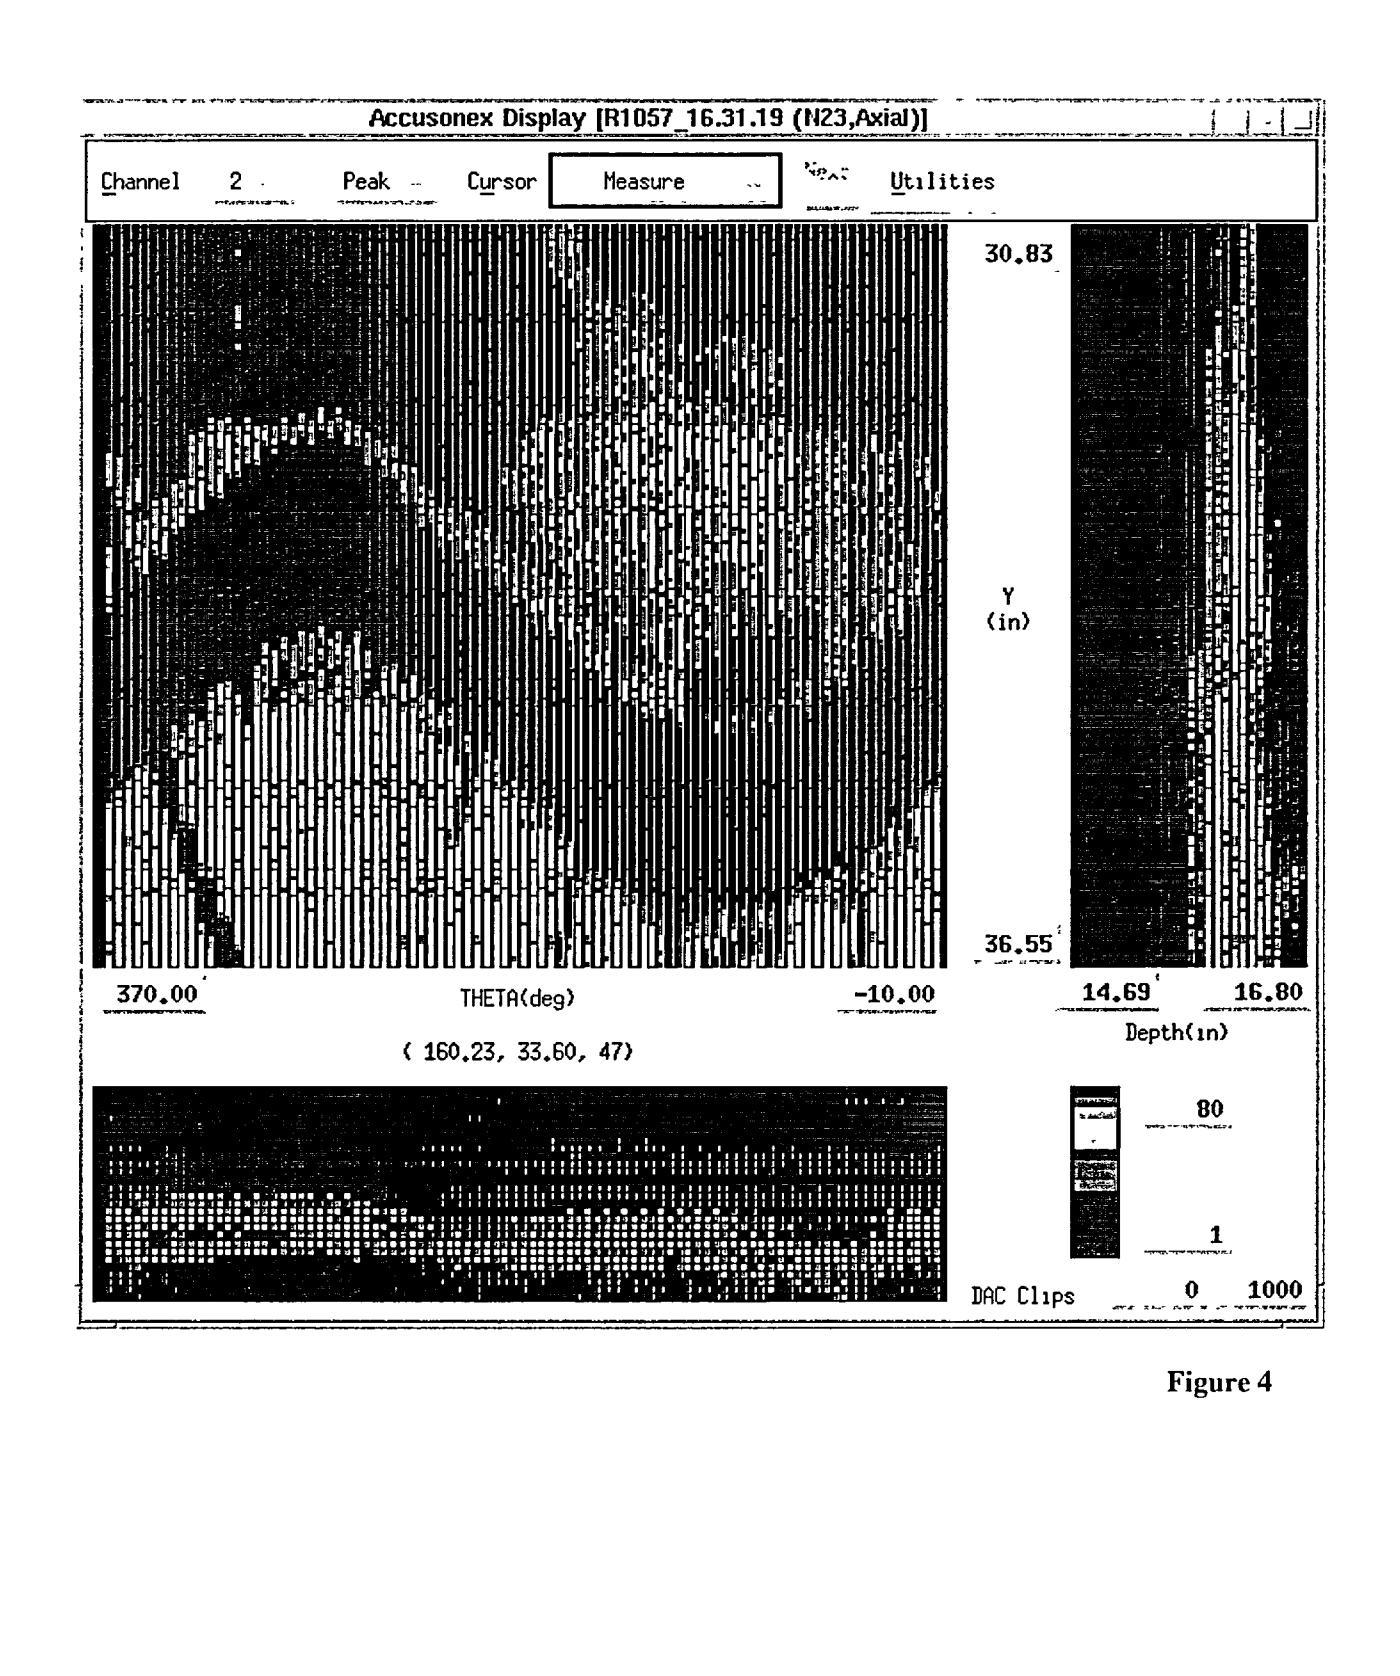
Figure 3 and Figure 4 are both of another power station. Although a different color scheme was used for both of these illustrations, the leak path is clearly visible through the interference fit portion of the annular region above the weld. The area between the low side of the weld and the interference fit has a void with very high reflectivity. Numerous crack indications lead into this void with one clear leak path leading out.

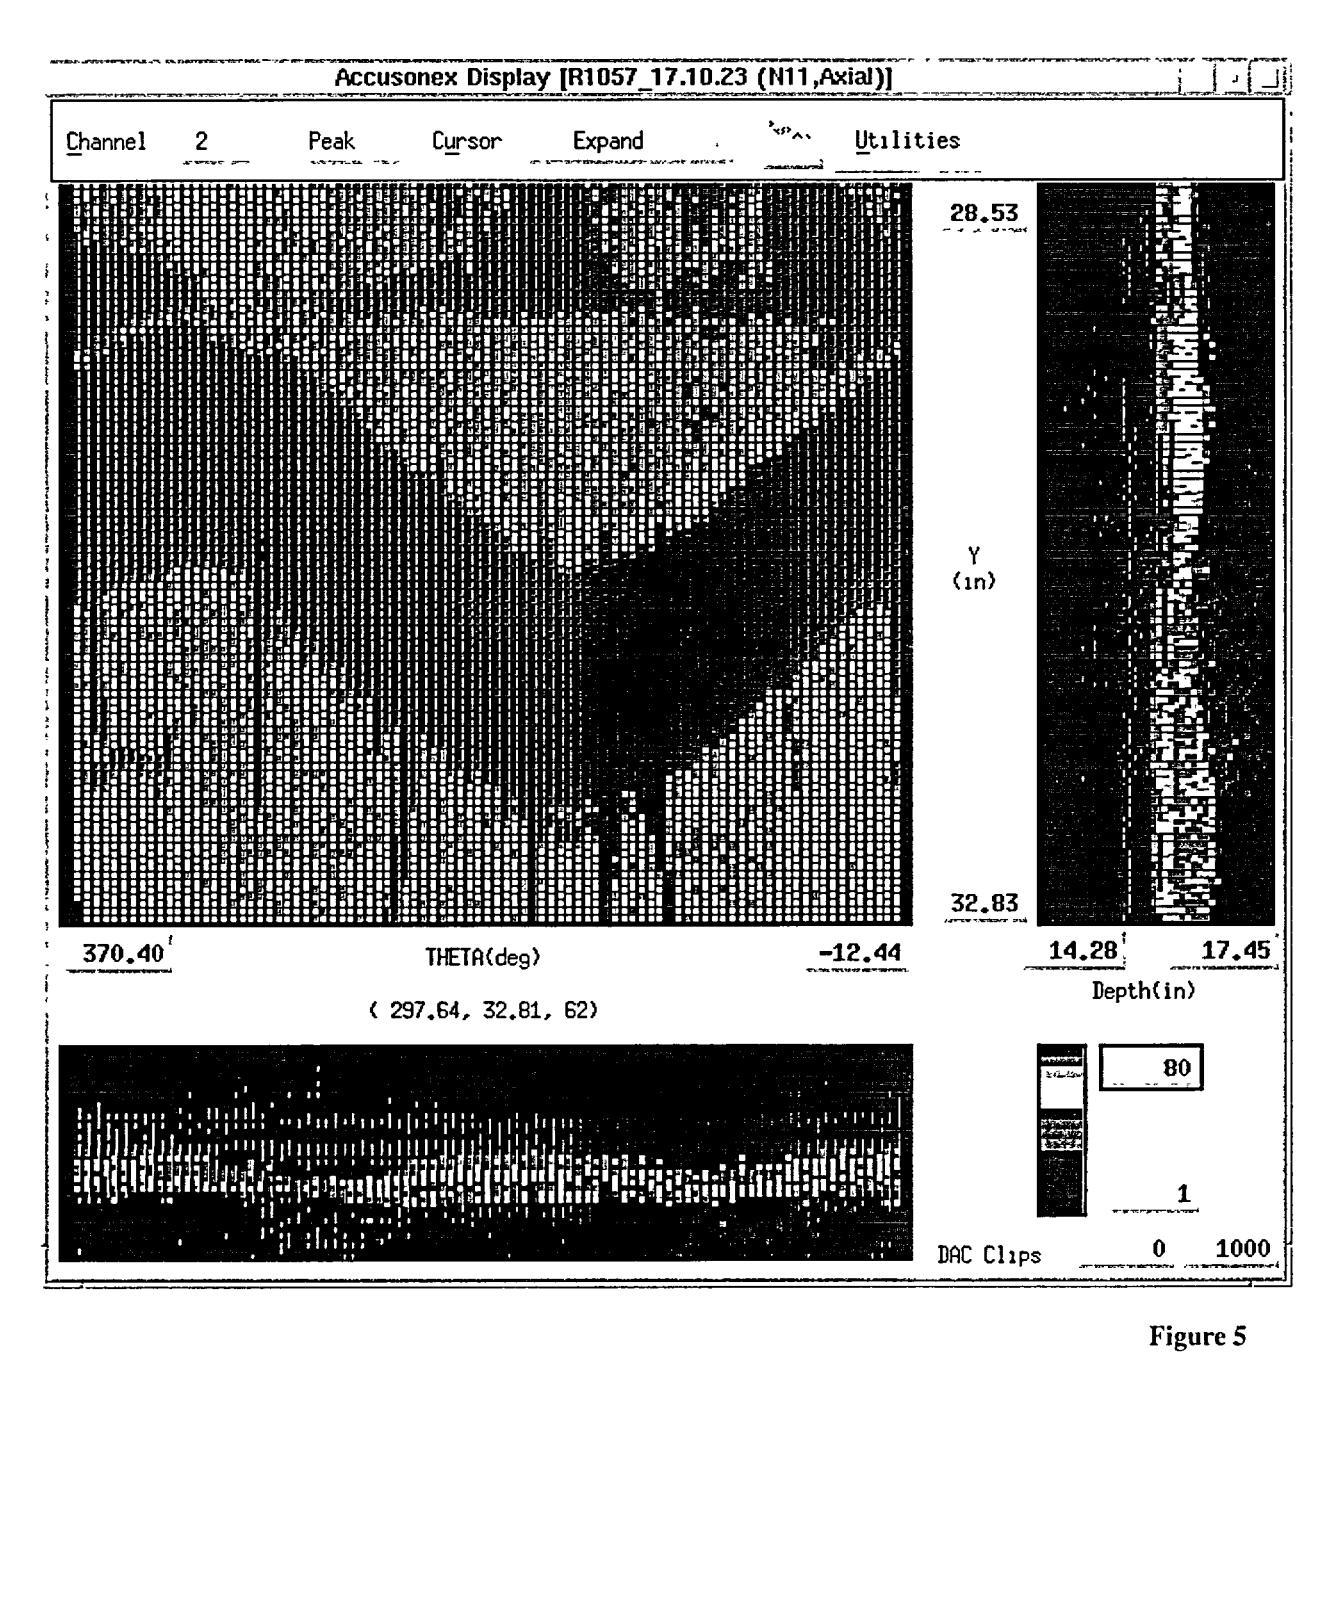
Figure 5 is a printout of the ultrasonic C-scan display from another CRDM. In this illustration, numerous cracks are depicted leaking into the area between the interference fit and the low side of the weld, just as in Figures 3 and 4. In this Figure, the leak path through the interference fit is located on the high side of the weld.

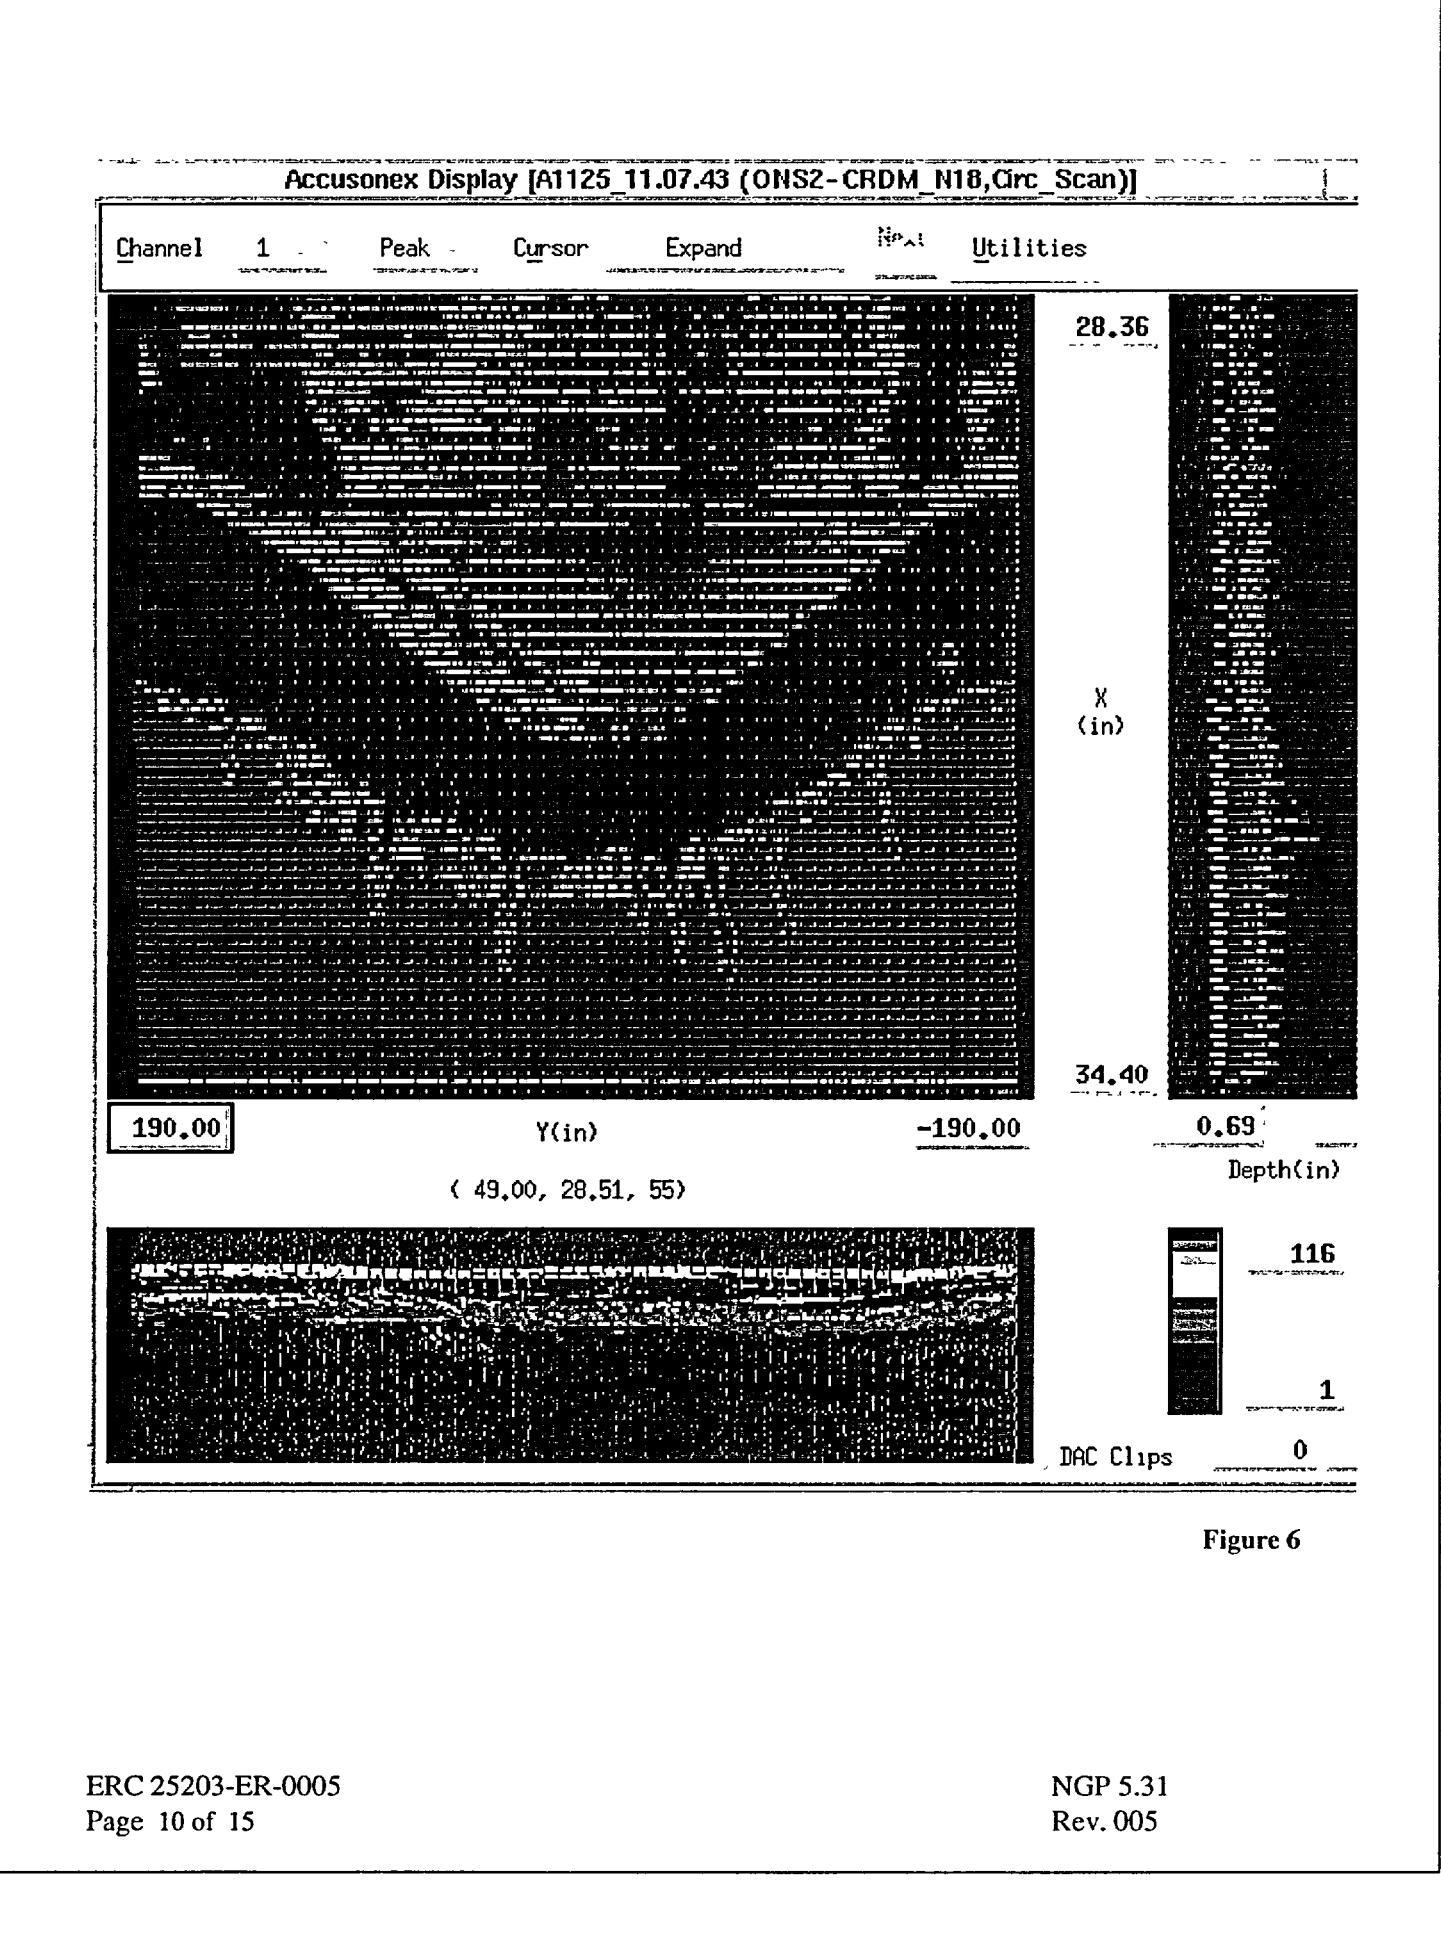
Figure 6 is a printout of another CRDM. Notice the multiple crack indications with a visible leak path directly above them and the areas of low sound reflection on the high side of the weld.

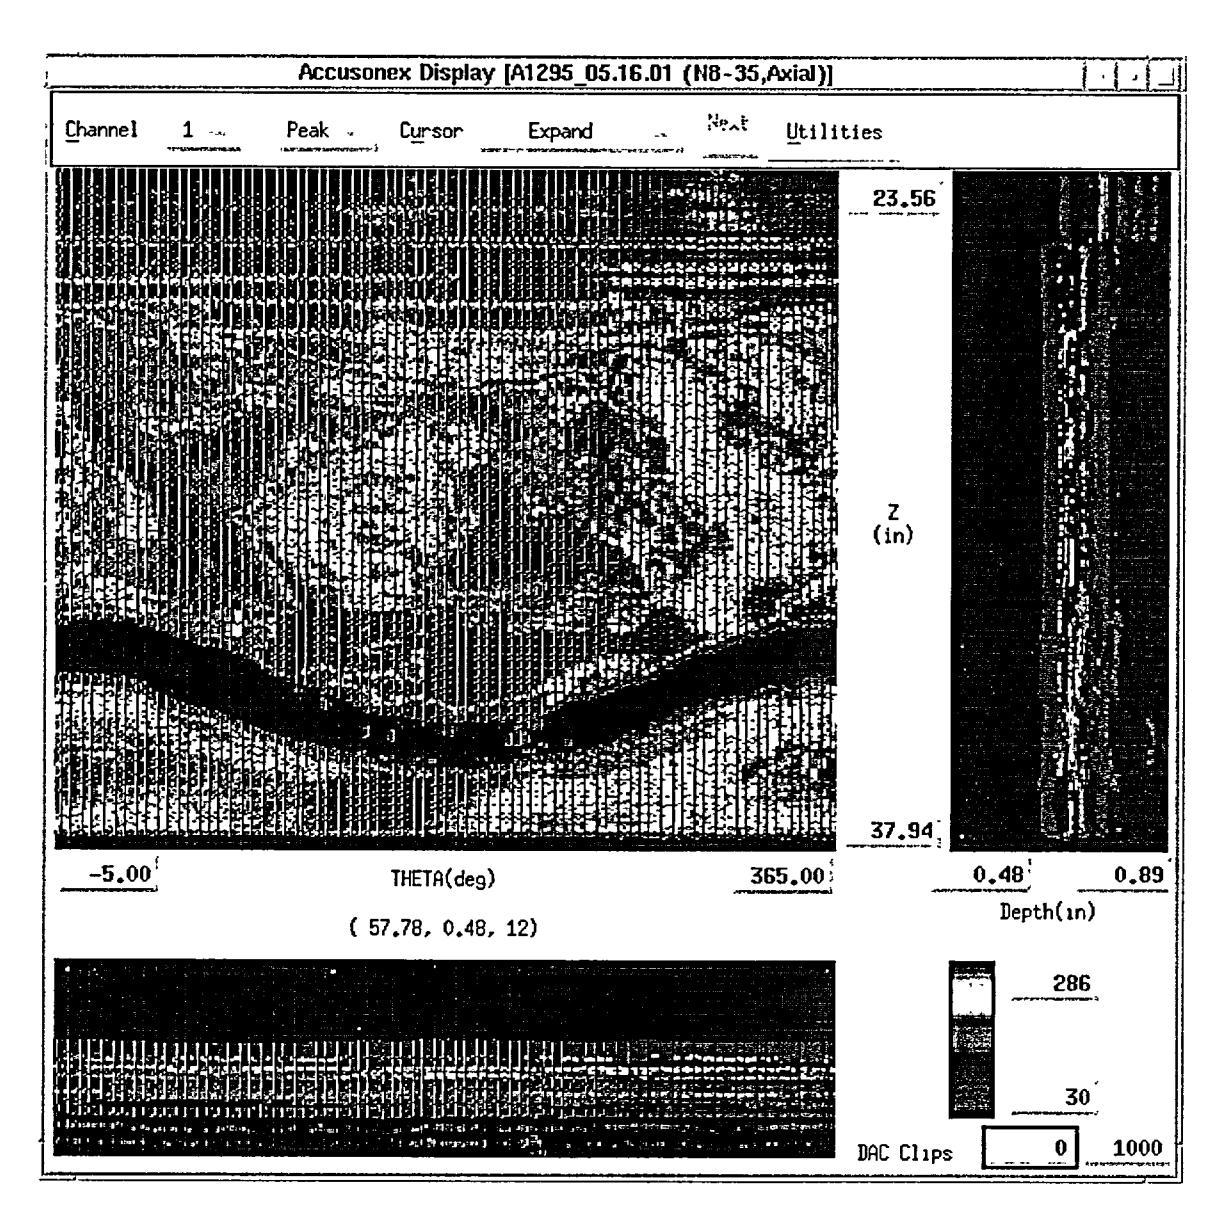
Figure 7 is a printout from a different power station. Again we see an illustration that is less than ideal for a visual study in reflected energy. The color range is 30 to 286 but more importantly, magenta appears between dark blue and black on the color bar code. If the magenta areas that appear in the interference fit and weld portions of the illustration were a color between blue and black it would be more obvious where the areas of energy transmittance are. While an optimal color range selection would provide a better presentation, it is still evident that the area above the low side of the weld and under the interference fit has extremely high reflection. Large areas of high energy reflection are observed passing through the interference fit, denoting a leak. In this particular nozzle, the crack was not detected with ultrasonic flaw detection techniques but a liquid penetrant exam did detect a through wall crack in the weld. This leak would have been detected with an ultrasonic scan of the interference fit.

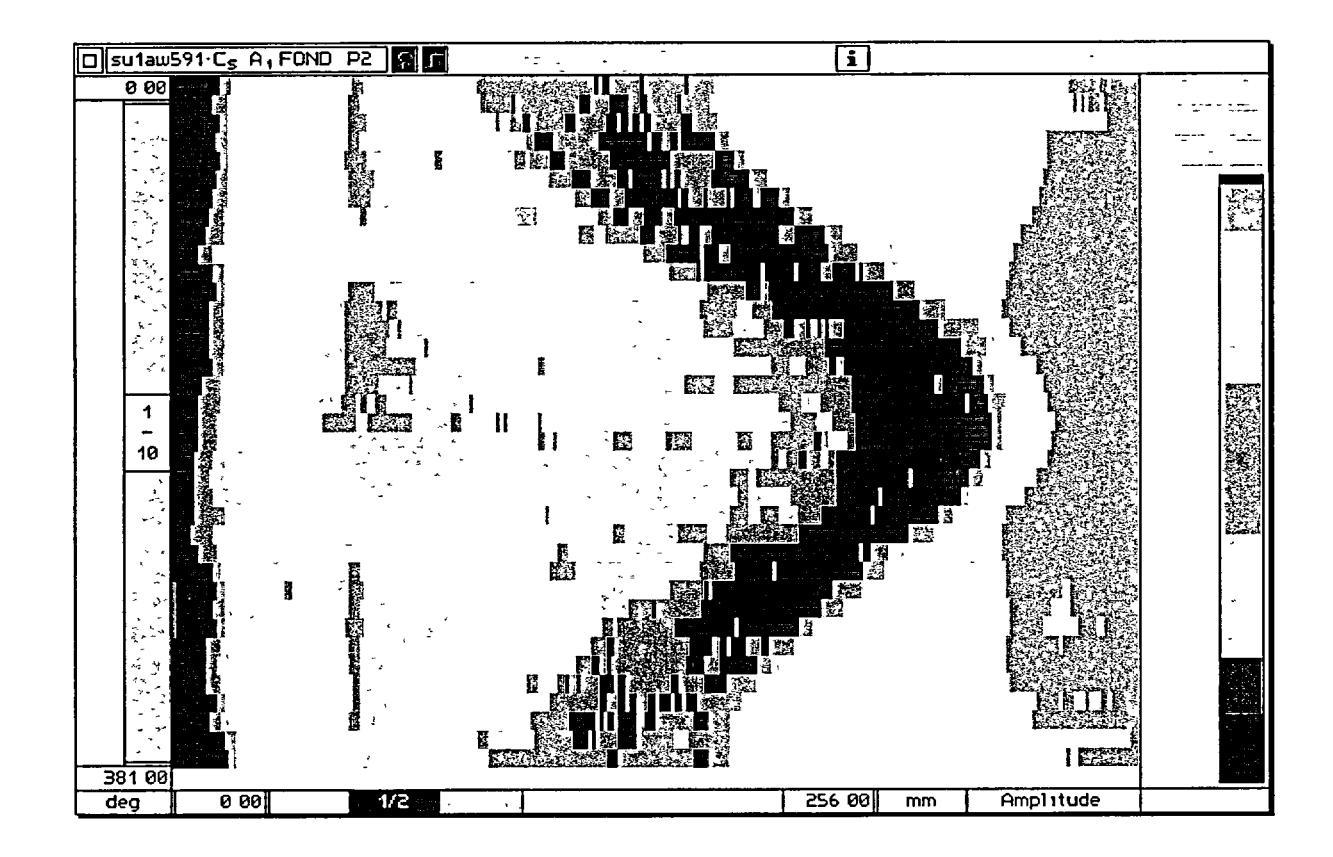
Even though the color scheme in Figure 8 has a light blue shade between the beige and green and also a light blue shade between green and dark blue on the color code bar, it is obvious that there are no leak paths or areas of high energy reflection in the interference fit, (which now appears on the right side of the illustration).

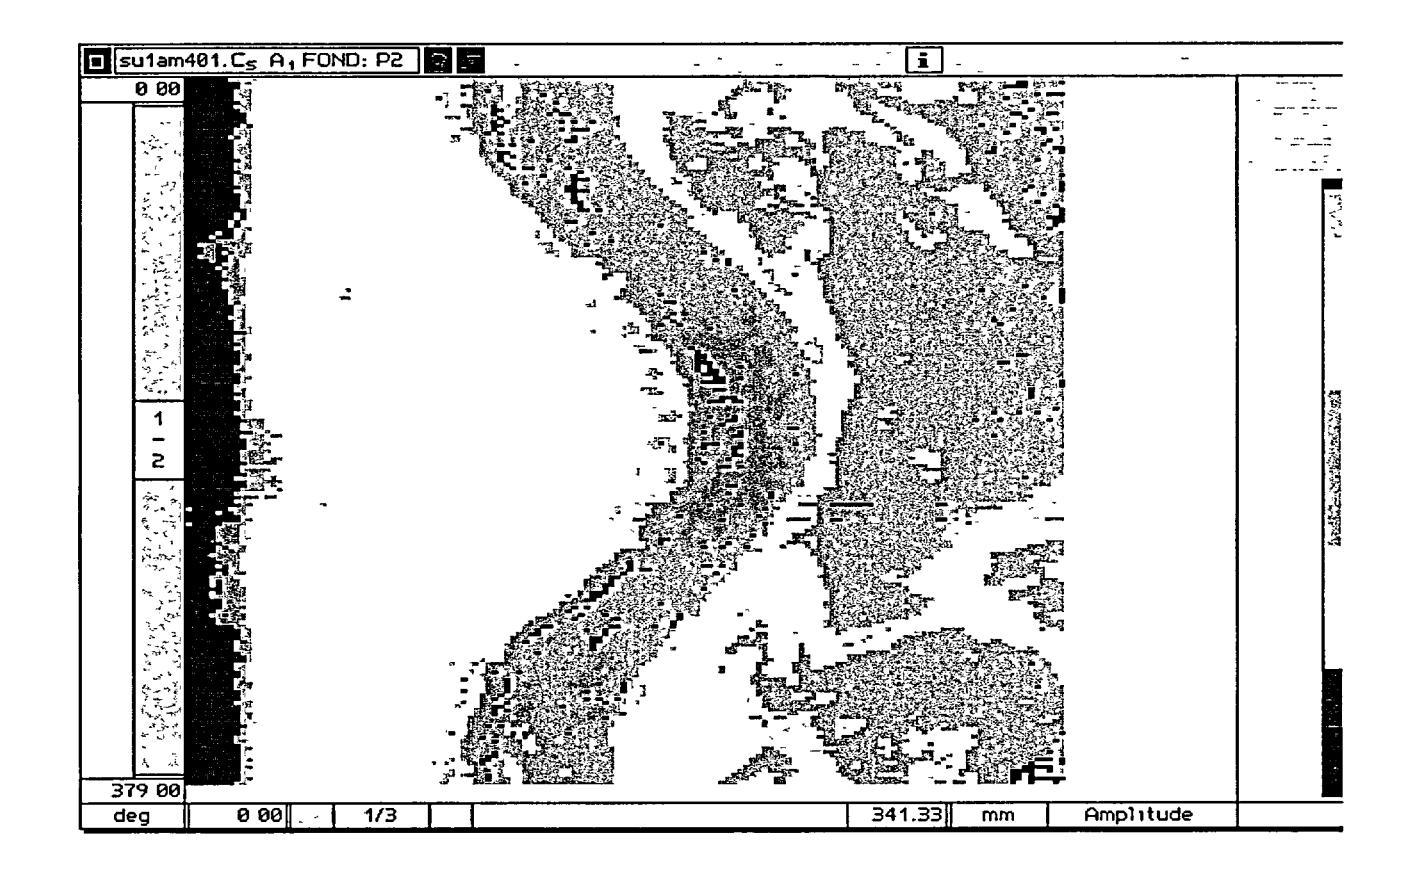
Figure 9

In Figure 9, there is an area above the weld and below the interference fit that displays an area of high energy reflection. The leak path through the interference fit is also visible. Although no cracks were detected with the ultrasonic flaw detection technique, a liquid penetrant test of the weld did produce an indication that turned out to be a through wall leak in the weld.

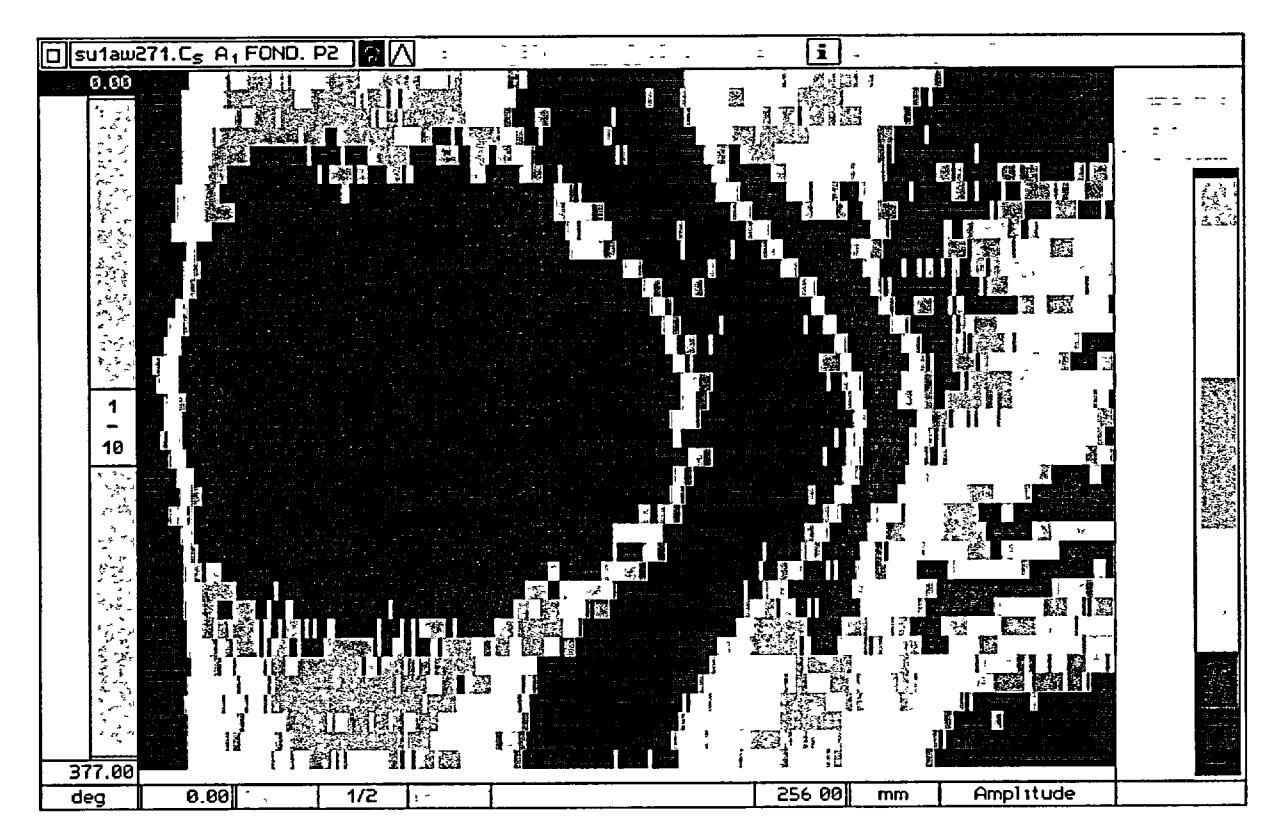
Figure 10 also depicts a leak path through the interference fit on a nozzle that contained a crack in the weld that was not detected with the ultrasonic flaw detection technique.
