RE: Irigaray-Christensen Operations Annual Inspection Report, Permit No. 478

ANNUAL INSPECTION REPORT

Subject:	COGEMA Mining Inc.'s Irigaray and Christensen Ranch In Situ Uranium Operations
Permit No.:	478
Inspectors:	Glenn Mooney, Senior Geologist
Person Contacted:	John Vaselin, COGEMA Mining, Inc.
Date of Inspection:	October 15, 2002

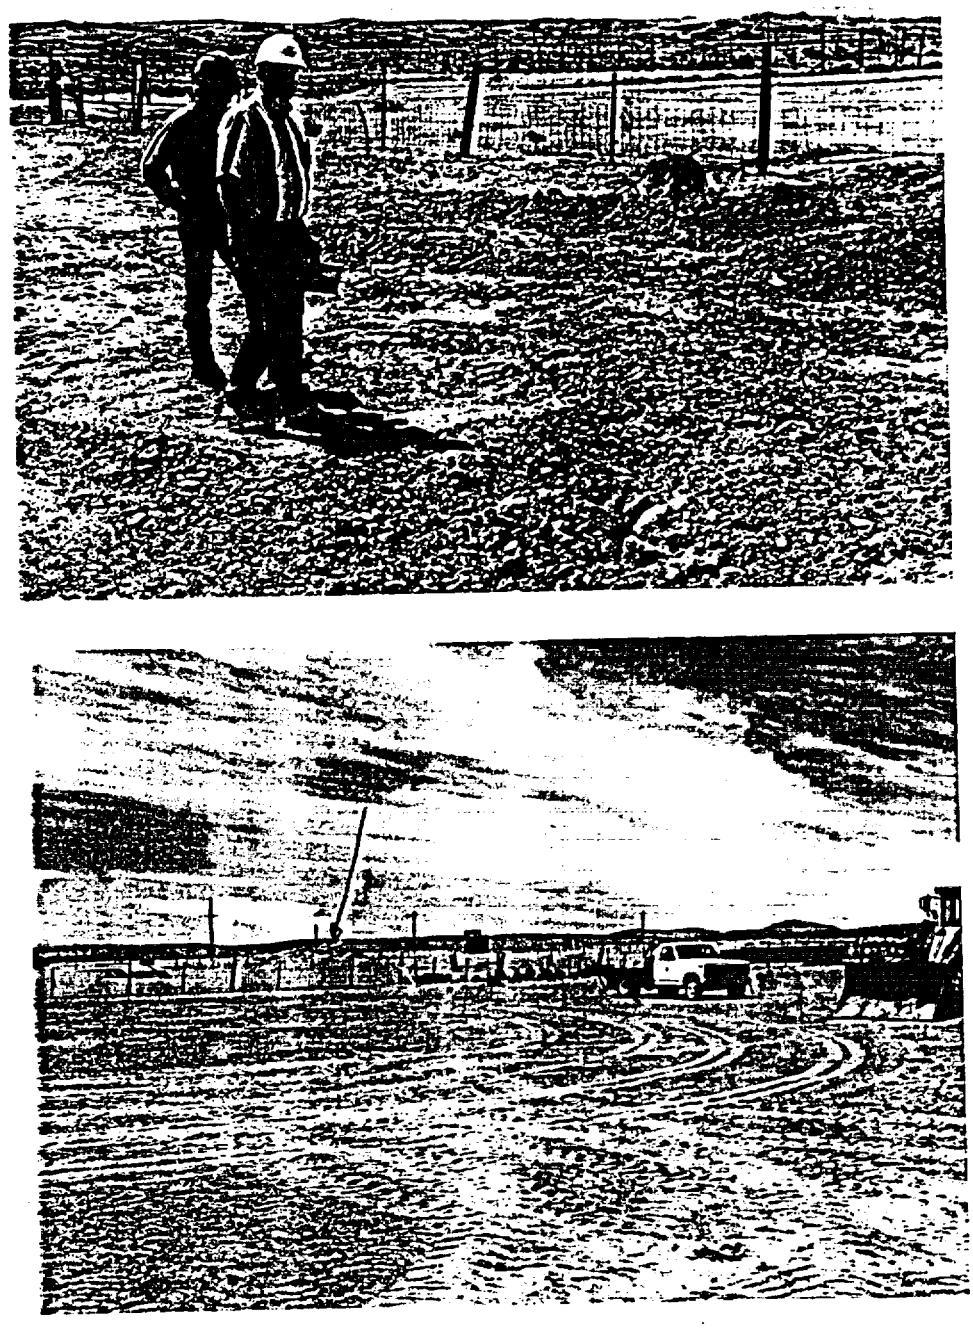
Photo No. 1

Some gravel has been removed from the 517 site, but considerably more needs to be removed. Some remaining gravel is between 6 and 8 inches thick and was planned atop native topsoil back when the site was active in the mid-1970's (Photo No. 1). When most of the gravel has been removed, Mr. Vaselin said he would have the site tilled to remove compaction and prepare a good seed bed. Any removed gravel can easily be disposed by placing it on the nearby main access road.

Looking west at area on western side of 517 site where some gravel has been removed from in-place topsoil. The main access road and fenced pond area are partially visible in right distance.

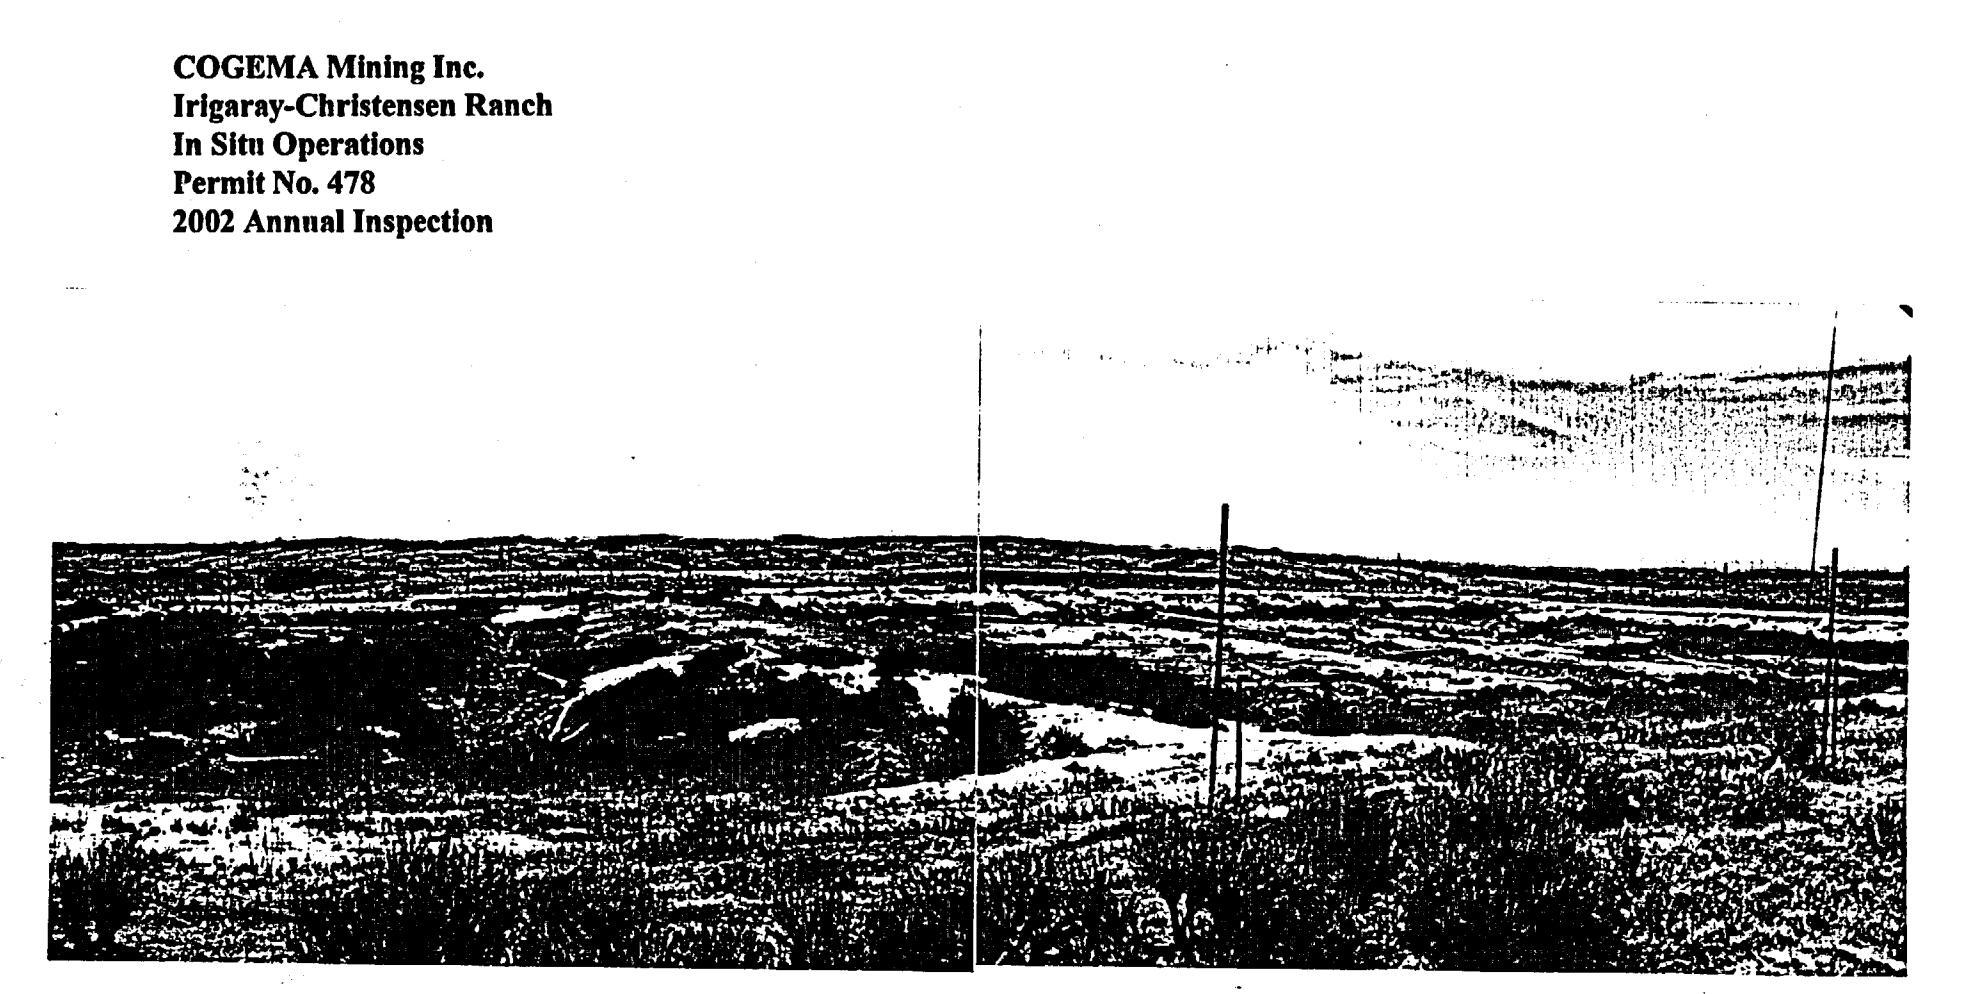
Photos Nos. 6,7

COGEMA has largely completed reclamation of the 517 ponds. The liners and sludge have been removed to the Shirley Basin licensed disposal area. The earthen basins of the ponds remain (Photos Nos. 6, 7). The leak detection piping has been removed and the site radiometrically

surveyed. Material which did not pass was shipped to Shirley Basin. Mr. Vaselin said they were waiting on NRC approval of their survey results before the site can be declared decontaminated and the pond areas completely regraded and reseeded. He indicated he hoped at least some of this reclamation work could be done this fall.

Looking west at the 517 site ponds where the liners and sludge have been removed and the leak detection tubes have been dug up and are waiting on a radiological survey before final disposal.

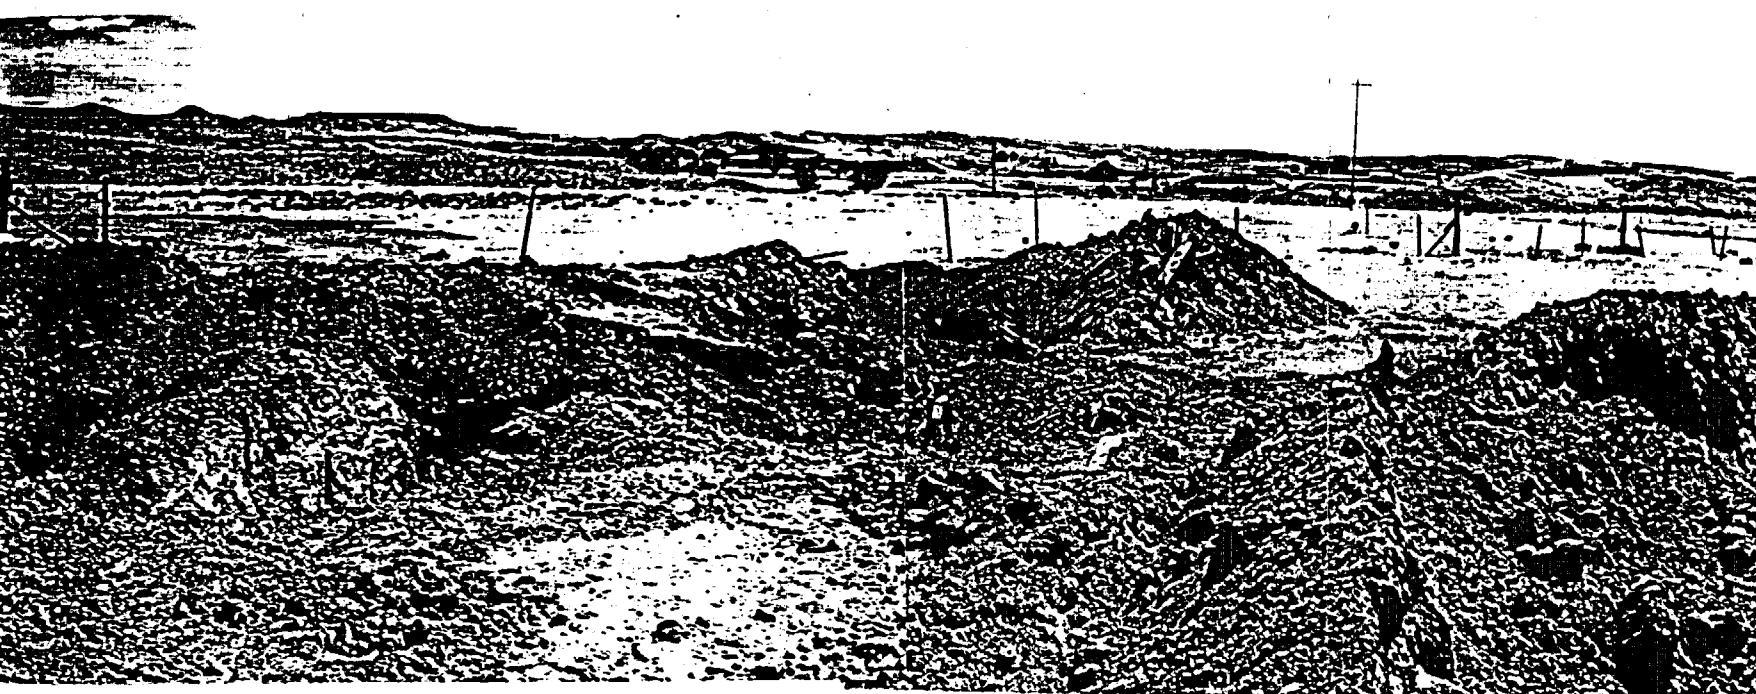
Photos Nos. 3, 4, 5 and 6

Also in the 517 site area, an old waste pit has been excavated and surveyed. A quantity of radiologically contaminated material was removed and shipped to Shirley Basin (Photos Nos. 3, 4 and 5). This material was generated during operation of the 517 plant back in the 1970's.

Looking east to southeast at partially excavated disposal pit on eastern side of 517 site. Some radiologically contaminated trash has been found here and some has been already hauled to Shirley Basin for permanent disposal. The Irigaray plan building is visible in the upper right distance.
