January 30, 2003
MEMORANDUM TO:	Loren R. Plisco, Director
	Division of Reactor Projects
	Region II
FROM:	Ledyard B. Marsh, Deputy Director Division of Licensing Project Management /RA/
	Office of Nuclear Reactor Regulation
SUBJECT:	RESPONSE TO TASK INTERFACE AGREEMENT (TIA) 2002-04 - SAFETY/RELIEF VALVE OPERABILITY AT EDWIN I. HATCH NUCLEAR PLANT

NRC INFORMATION NOTICE 2003-01:

FAILURE OF A BOILING WATER REACTOR TARGET ROCK MAIN STEAM SAFETY/RELIEF VALVE

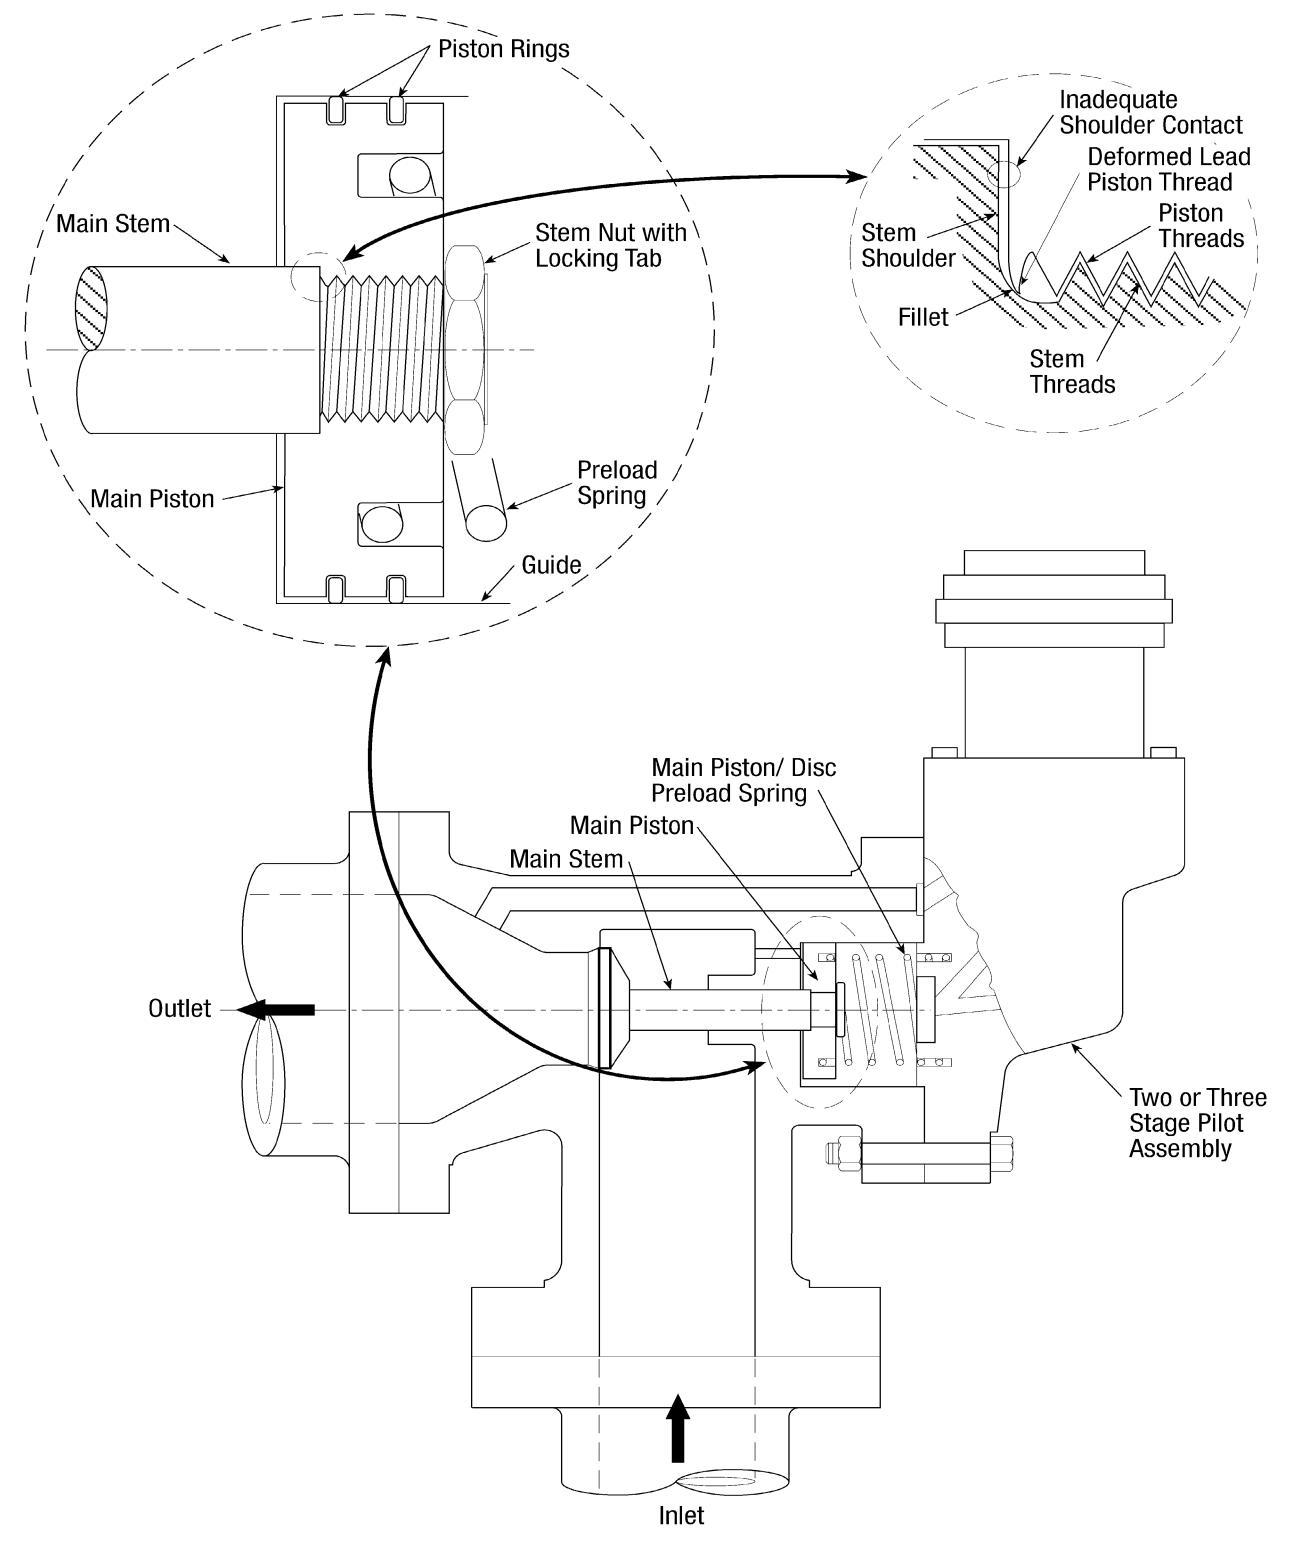
Figure 1 Target Rock Safety/Relief Valve

The S/RVs installed in Unit 1 are Target Rock two-stage S/RVs. The main stage valve internals (shown in attached Figure 1) are assembled by screwing the main piston onto the main stem so that the piston moves inside the guide, installing a locking tab washer, and installing the stem nut against the washer's locking tab. The piston is torqued to 100 ft-lbs, the stem nut is torqued to 50 ft-lbs, and the locking tab is bent to capture the stem nut. During the S/RV inspection after the April 2002 shutdown, the failed valve was found to have a .003-inch clearance between the main disc and its seat. When the valve was disassembled, the stem nut and the

piston were found to be loose. The stem nut was removed by hand and the piston was also unthreaded by hand from the stem. However, the threads on the stem were severely damaged. The piston was unthreaded by working it up to the good threads under the stem nut and threading it onto this portion of the stem. The inside of the guide was heavily grooved and was also worn by the piston edge wearing on the guide. The piston was visibly cocked on the valve stem.

The licensee believes the loss of torque and damage of the valve internals can be attributed to the manufacturing tolerances of the valve stem and piston and to the lengthy service time without adequate inspection and maintenance. The valve is designed so the valve stem screws into the piston. The stem has a shoulder that seats against the piston shoulder. For the valves that show little to no thread damage, the stem apparently seats properly against the piston and most of the valve actuation force is carried by the stem and piston shoulders. For the valves with thread damage, the licensee believes that the end of the lead thread of the piston contacts the fillet that is machined into the shoulder of the valve stem. As shown in Figure 1, when this occurs, the shoulder of the stem does not properly seat against the shoulder of the piston. Thread damage starts with the first actuation on the test stand, resulting in a loss of torgue. Over time, vibration from normal plant operations causes fretting and wear of the valve stem shoulder and threads. The piston rocks in the guide and wears grooves where the piston rings contact the guide. Eventually the piston could significantly cock on the stem and wedge in the guide during valve actuation, which would prevent proper opening or closing of the valve. The licensee has not been able to determine the time in operation required to damage a valve to the point of failure. The licensee believes the failed 1J valve and the damaged 1F valve were in service for approximately 20 years without maintenance. The licensee is currently removing several S/RVs during each plant outage to ensure that all installed S/RVs are inspected and maintained at least every 6 years. There are 11 S/RVs installed in each unit.
