# RADIOLOGIC AND ENGINEERING ASSESSMENT

DOE ID NO.: GJ-13028-RS ADDRESS: 829 WEST MAIN STREET

JULY 1985

## URANIUM MILL TAILINGS REMEDIAL ACTION PROJECT OFFICE

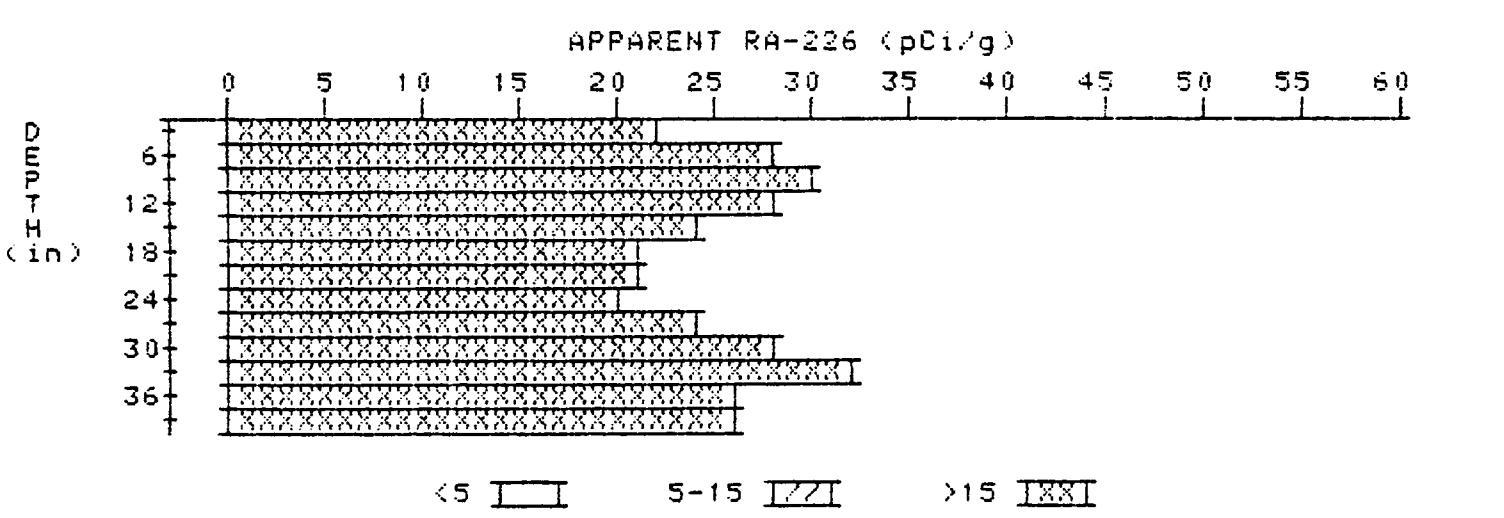
PROPERTY NUMBER: GJ-13028-RS HOLE NUMBER: 3 LOCATION: 135241

Depth (in)	Apparent Radium-226 (pCi/g) Undeconvolved	Apparent Radium-226 (pCi/g) Deconvolved
3	21.7	21.7
6	24.9	27.9
9	26,4	30.0
12	25.9	28.0
15	24.2	23.7
18	22.8	21.2
21	22.3	20.9
24	22.6	19.9
27	24.4	23.7
30	26.6	28.2
33	27.9	32.0
36	26.9	26.4
39	26.2	26.2

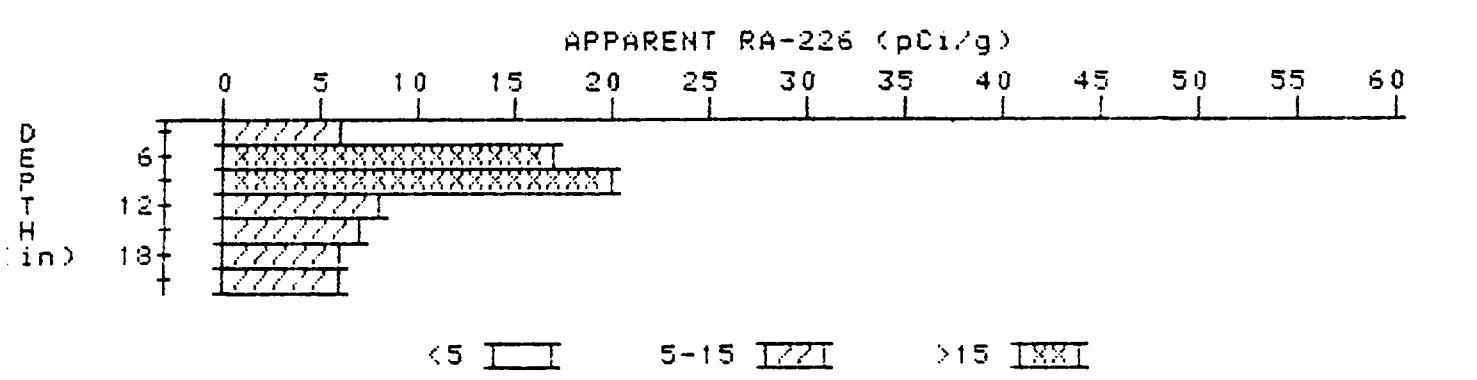
ROPERTY NUMBER: GJ-13028-RS HOLE NUMBER: 9 LOCATION: 138254

D∈pth (in)	Apparent Radium-226 (pCi/g) Undeconvolved	Apparent Radium-226 (pCi/g) Deconvolved
3	6.1	6.1
6	10,9	16.8
9	12.4	20.0
12	9.6	7.6
15	7.9	6.3
18	6.8	5.7
21	6.3	6.3

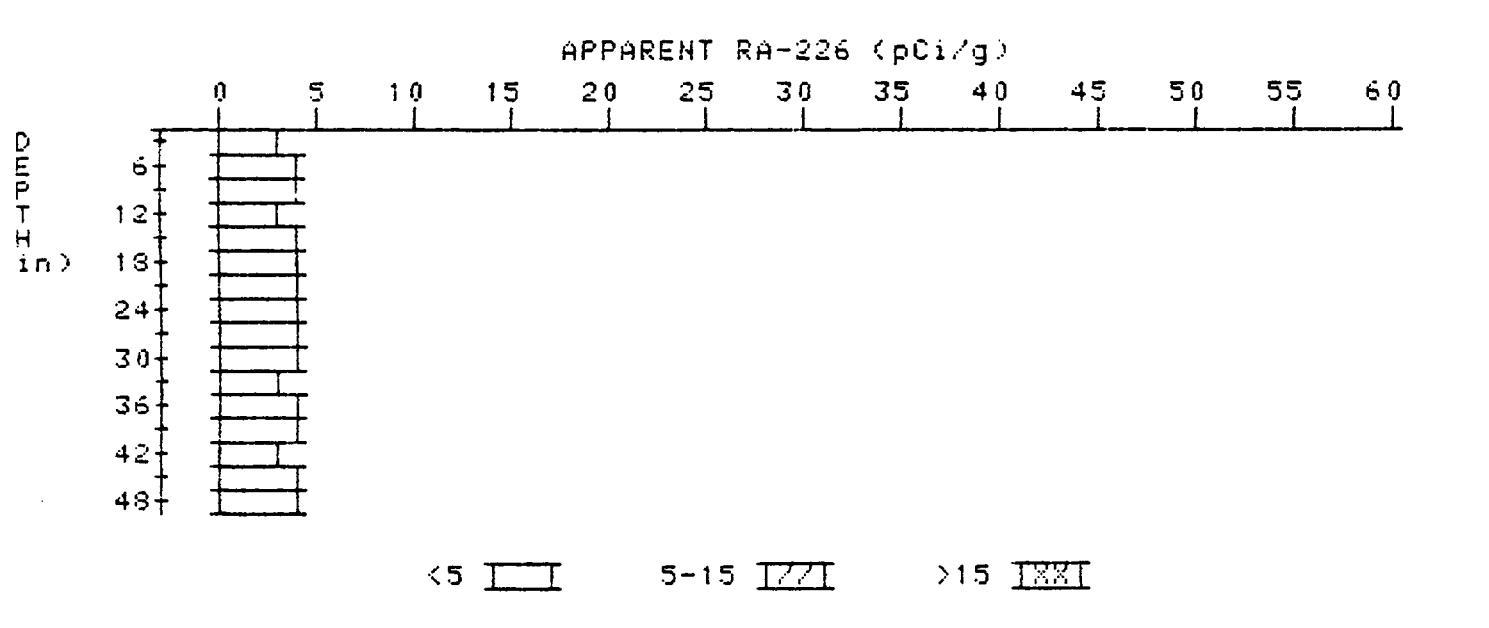
ROPERTY NUMBER: GJ-13028-RS HOLE NUMBER: 17 LOCATION: 183242

Depth (in)	Apparent Radium-226 (pCi/g) Undeconvolved	Apparent Radium-226 (pCi/g) Deconvolved
_ = = = = = = = = = = = = = = = = = = =		
3	3.1	3.1
6	3.4	3.6
à	3.6	4.0
12	3.6	3.4
15	3.7	3.7
18	3.8	4.0
21	3.8	4.0
24	3.7	3.5
27	3.7	3.7
30	3.7	3.9
33	3.6	3.4
36	3.6	3.6
39	3.6	3.8
42	3.5	3,3
45	3.5	3,5
48	3.5	3.5

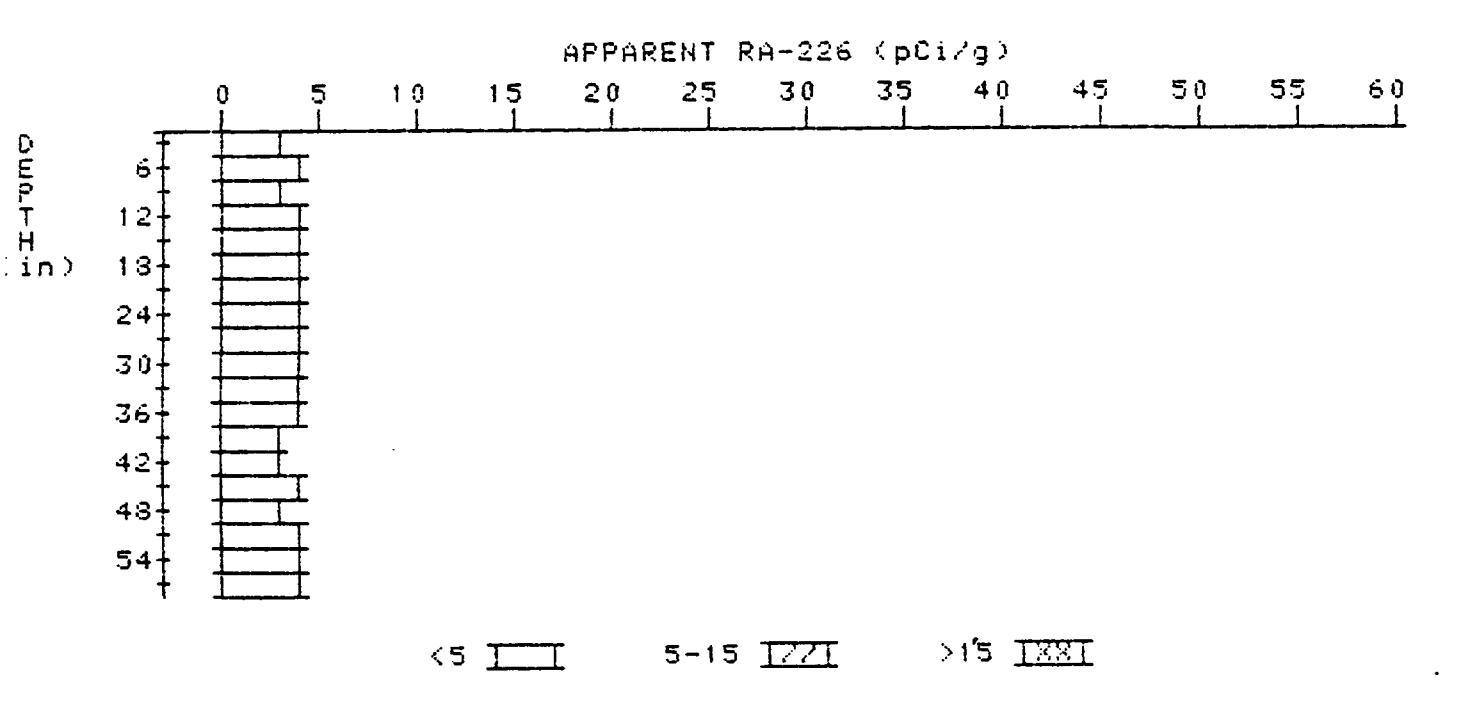
ROPERTY NUMBER: GJ-13023-RS HOLE NUMBER: 13 LOCATION: 188220

Depth (in)	Apparent Radium-226 (pCi/g) Undeconvolved	Apparent Radium-226 (pCi/g) Deconvolved
3	2.8	2.8
6	3.2	3.6
9	3.4	3.4
12	3.6	3.8
15	3.7	3.7
18	3.8	4,0
21	3.8	3.8
24	3.8	4, 0
27	3.7	3.5
30	3.7	3.7
33	3.7	3.9
36	3.6	3.6
39	3.5	3,3
42	3.5	3.3
45	3.6	4.0
48	3.5	3.1
51	З.б	3.8
54	3,6	3.6

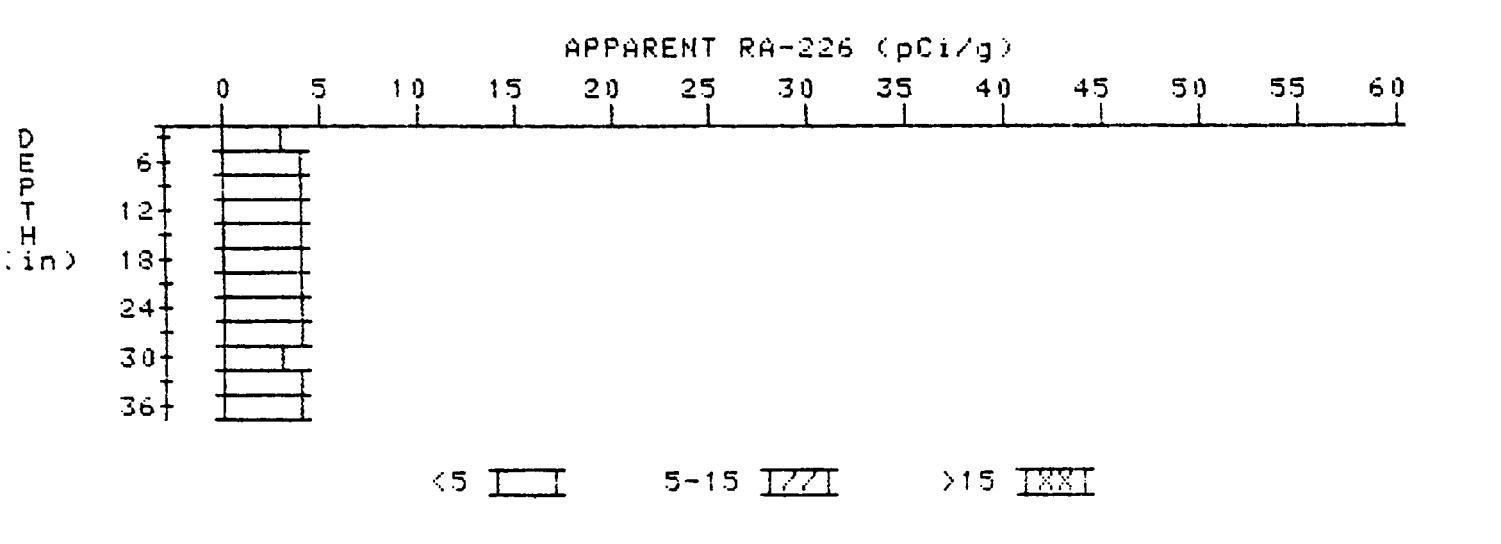
PROPERTY NUMBER: GJ-13028-RS HOLE NUMBER: 19 LOCATION: 206220

Apparent	Apparent
	Radium-226	Radium-226
Depth	(pCi/g)	(pCi/g)
(in)	Undeconvolved	Deconvolved
===================	2202222222222	
3	3.4	3.4
6	3.5	3.5
9	3.6	3.6
12	3.7	3.9
15	3.7	3.7
18	3.7	3.7
21	3.7	3.7
24	3.7	3.7
27	3.7	3.9
30	3.6	3.2
33	3.7	4.2
36	3.5	3.5

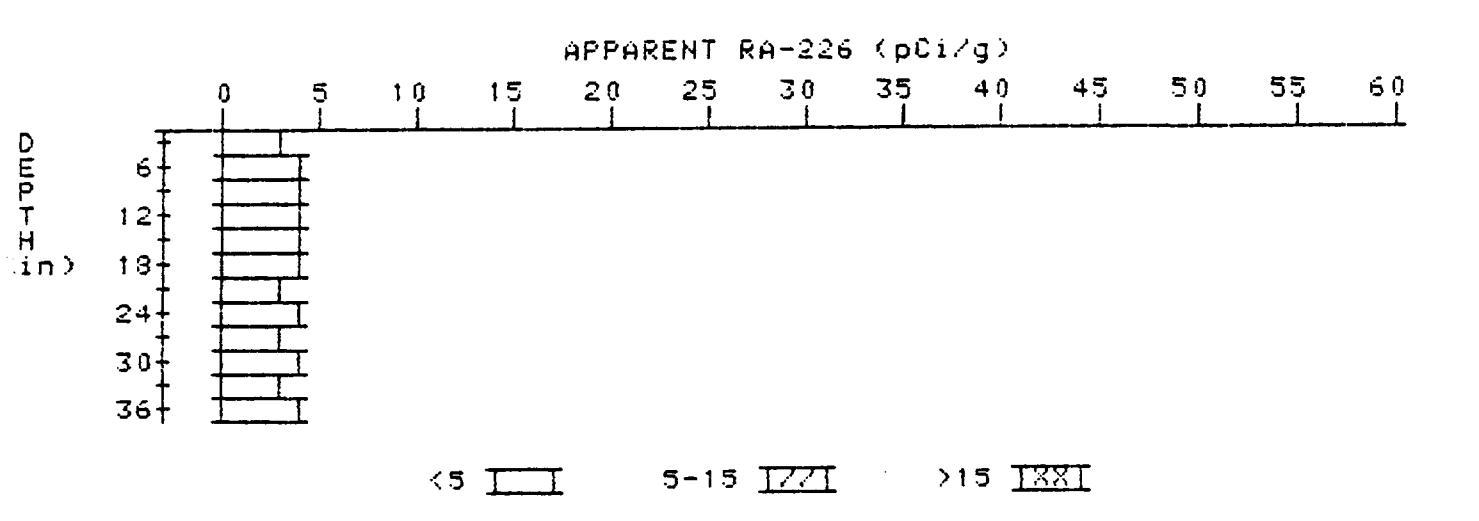
ROPERTY NUMBER: GJ-13023-RS HOLE NUMBER: 20 LOCATION: 240240

Depth (in)	Apparent Radium-226 (pCi/g) Undeconvolved	Apparent Radium-226 (pCi/g) Deconvolved
.3	3.0	3.0
6	3.4	3.8
9	3.6	3.8
12	3.7	3.9
15	3.7	3.7
18	3.7	3,9
21	3.6	3.2
24	3.7	4.2
27	3.5	3.0
30	3.6	3.3
33	3.6	3.4
36	3.7	3.7
