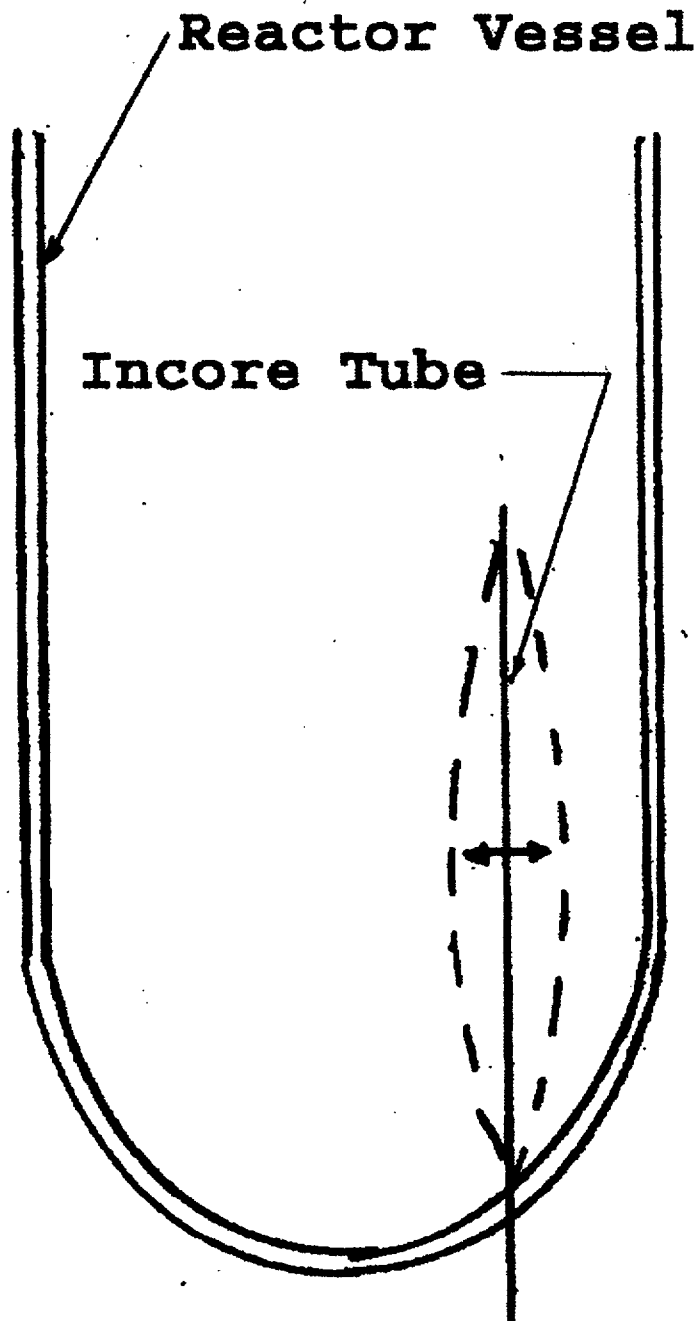
**Sketch 1**

Could I talk to you about the lower head deposits? Originally the Incore tubes had a problem. I am thinking that if the problem was vibration, perhaps they moved as I have shown in my Sketch 1. This would present a possible fatigue problem at (or near) the weld fastening them to the reactor vessel lower head.

A recent slide showed two welders working at the bottom of a reactor vessel (or mock-up) changing the support for the Incore tubes above the reactor vessel lower head. It would appear that if the fatigue problem mentioned above was 2 or so inches above the lower head, it got removed.

Original (?) Incore Tube

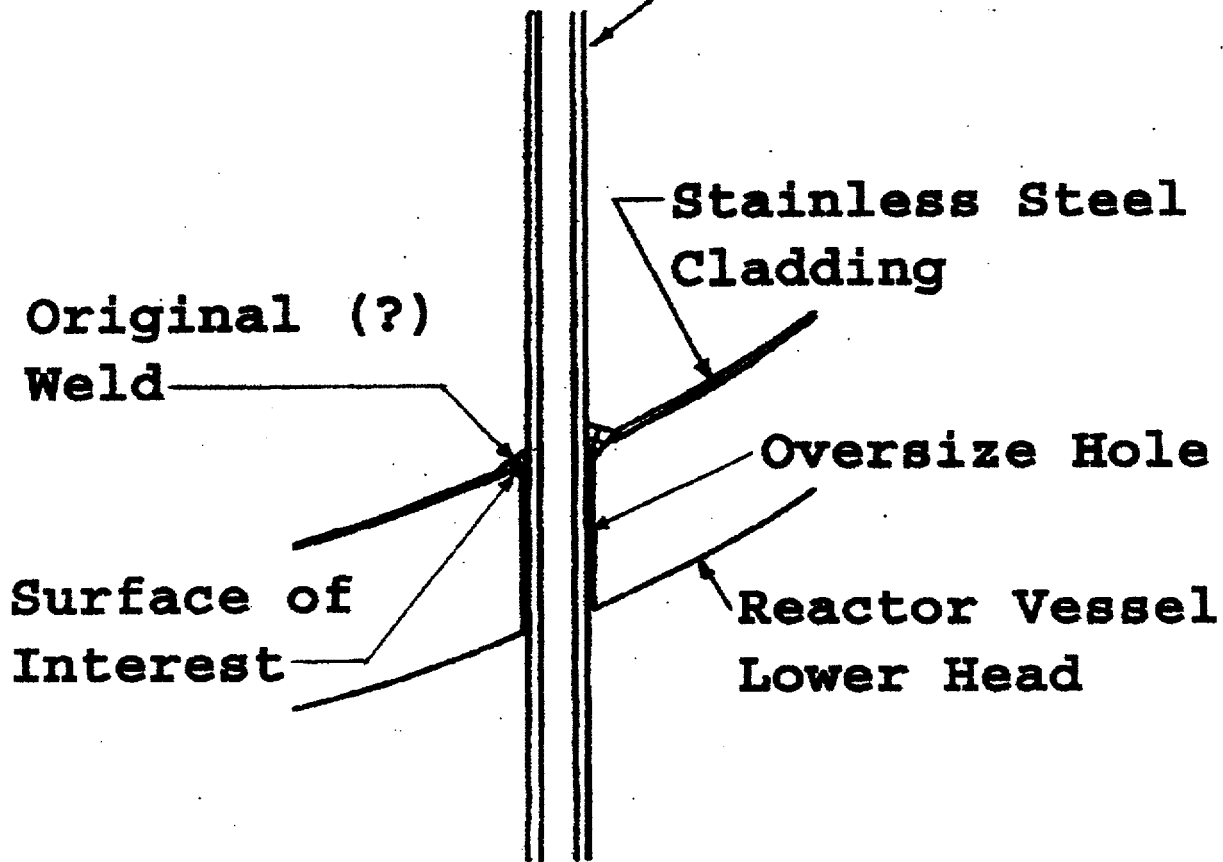
Sketch 2

If the stainless steel cladding on the Davis-Besse reactor vessel lower head was put on a "battered" layer of another weld metal that was first welded to the carbon steel reactor vessel, there would be some challenging weld metal selection decisions needed for what I

have labeled the "Surface of Interest" on my Sketch 2. Note that it continues all around the Incore tube.

If there has been leakage of reactor coolant at my "Surface of Interest," it appears that it will drain away since there is no interference fit of the original Incore tube. However, if the Contingency Repair is made, this will no longer be the case. The weld(s) at the bottom of the head will pool any coolant just above them. Also, the severed tube will allow further leakage into the Incore tube, where, I guess, it would attack the Incore monitoring wires.

At the top of the lower head, the modification added a second weld, probably on top of the first. (The November 26 Contingency Repair slide shows one weld.)

At the bottom of the lower head, I think there is one weld symbol, but there are two welds.

"PT" only will reveal fractures extending to the surface of the weld: in effect, the two new weld volumes will be uninspected (in my opinion).

I think may be worth while to have a review done of the (previously done) Incore tube modification process with particular attention to the possibility of weld fracture at the bottom of the original weld. Secondly, I would hope that attention would be paid to the selection of weld metals used and their ability to resist boric acid. Thirdly, I would think that the maximum allowed amount of heat to be deposited by welding during any specified period of time should also be checked, as should any requirements for metal preheating.
