9 Twin Orchard Drive Oswego, NY 13126 December 5, 2002

Mr. John A. Grobe, Director Division of Reactor Safety US Nuclear Regulatory Commission 801 Warrenville Road Lisle, IL 60532-4351

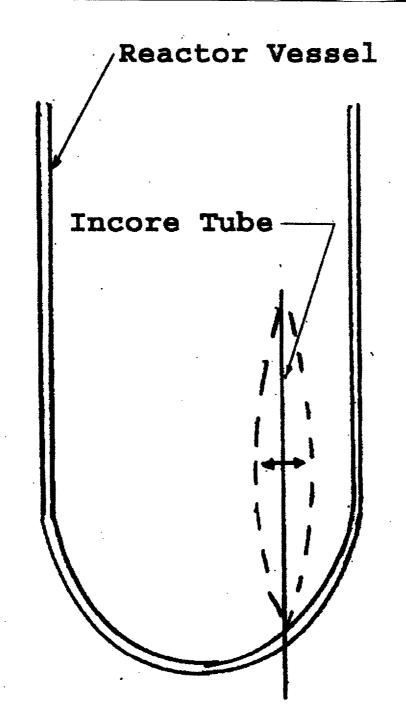
Sketch 1

Could I talk to you about the lower head deposits? Originally the Incore tubes had a problem. I am thinking that if the problem was vibration, perhaps they moved as I have shown in my Sketch 1. This would present a possible fatigue problem at (or near) the weld fastening them to the reactor vessel lower head.

I think may be worth while to have a review done of the (previously done) Incore tube modification process with particular attention to the possibility of weld fracture at the bottom of the original weld. Secondly, I would hope that attention would be paid to the selection of weld metals used and their ability to resist boric acid. Thirdly, I would think that the maximum allowed amount of heat to be deposited by welding during any specified period of time should also be checked, as should any requirements for metal preheating.

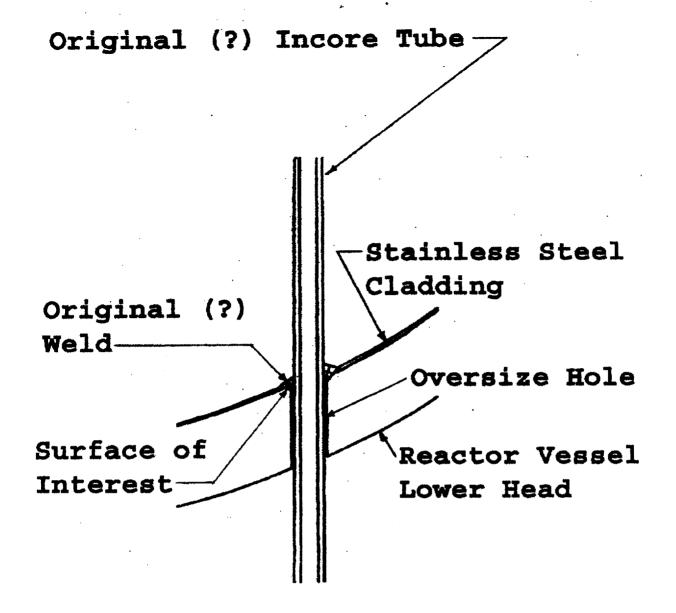
Sketch 2

If the stainless steel cladding on the Davis-Besse reactor vessel lower head was put on a "buttered" layer of another weld metal that was first welded to the carbon steel reactor vessel, there would be some challenging weld metal selection decisions needed for what I

have labeled the "Surface of Interest" on my Sketch 2. Note that it continues all around the Incore tube.

If there has been leakage of reactor coolant at my "Surface of Interest," it appears that it will drain away since there is no interference fit of the original Incore tube. However, if the Contingency Repair is made, this will no longer be the case. The weld(s) at the bottom of the head will pool any coolant just above them. Also, the severed tube will allow further leakage into the Incore tube, where, I guess, it would attack the Incore monitoring wires.
