Point Beach Nuclear Plant

SOCKET-WELD FAILURES IN AUXILIARY FEEDWATER PUMP **RECIRCULATION PIPING**

RCE 99-081, Revision 1

March 15, 2000

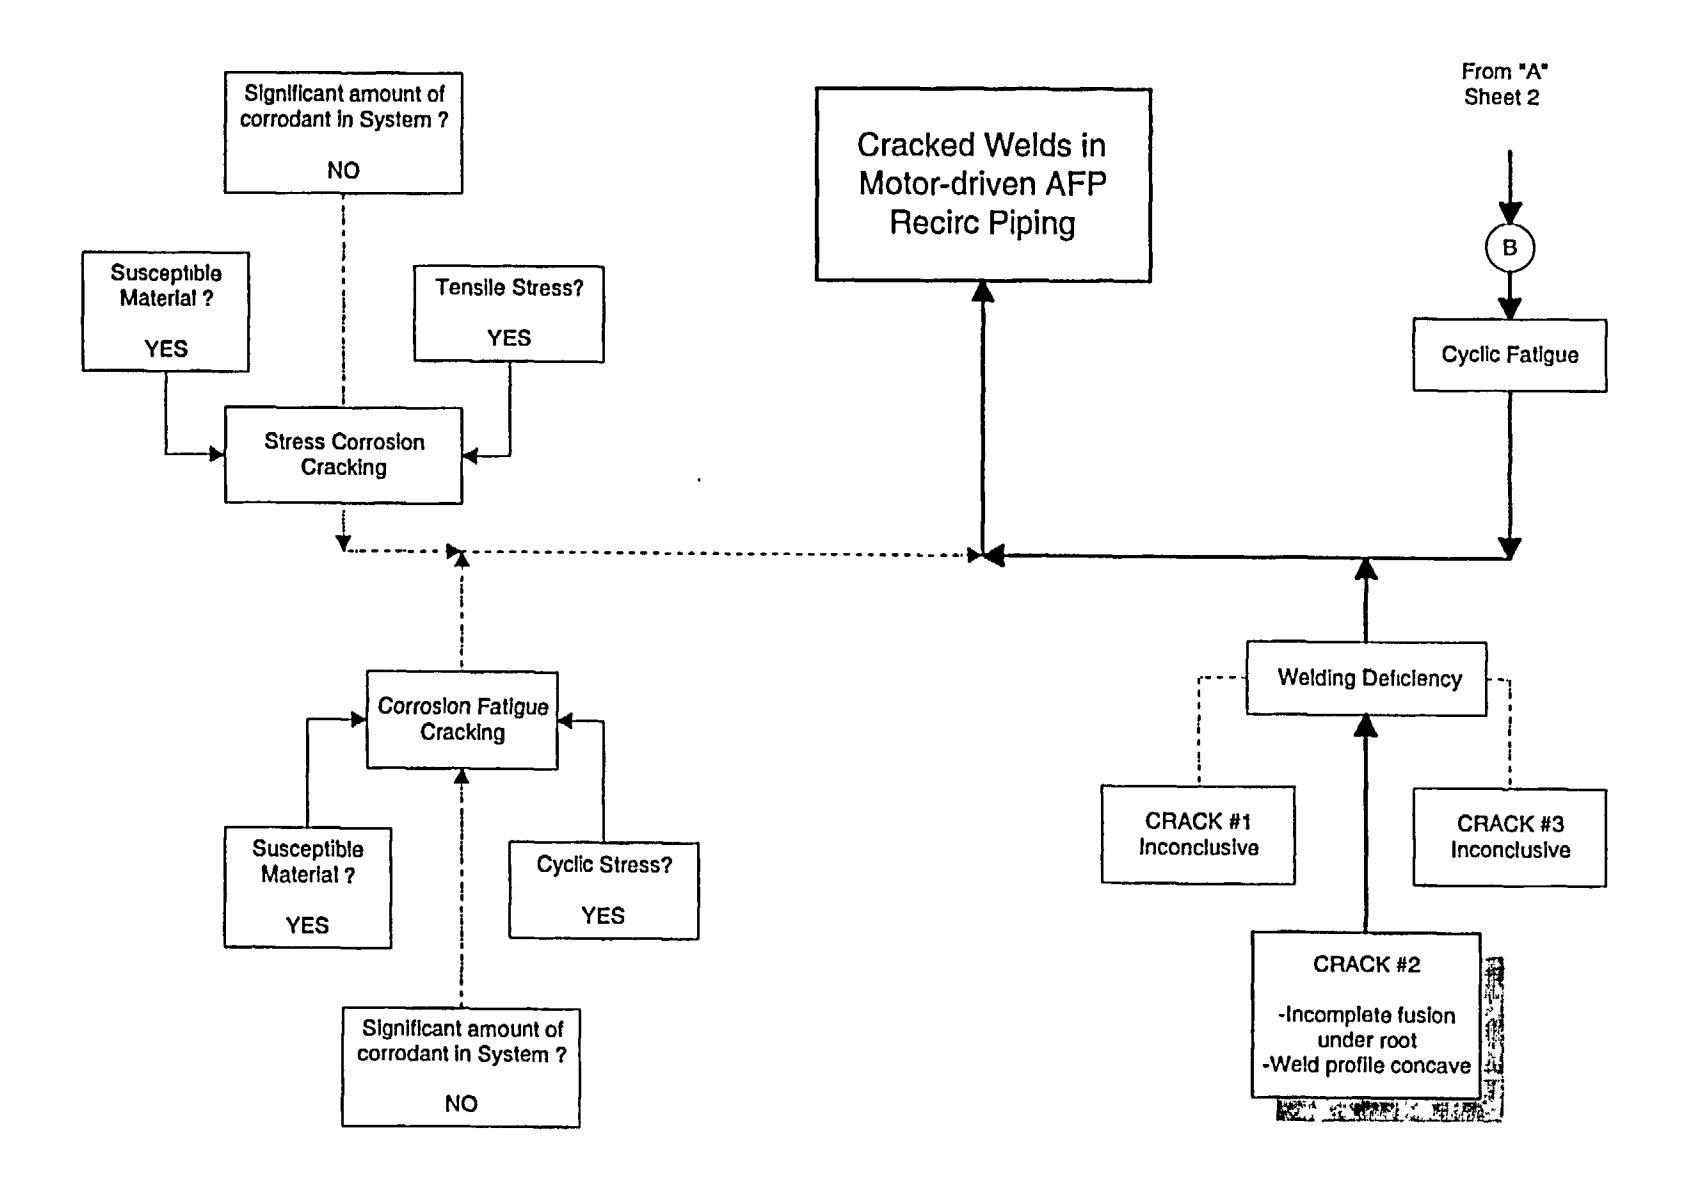
ATTACMENT 2 Sheet 1

Based on metallurgical failure analyses and vibration analysis, apparent contributions to the three cases of weld cracking have been identified from the following failure modes:

RCE 99-081, Rev. 1 WELD CRACKING FAILURE MODE DIAGRAM

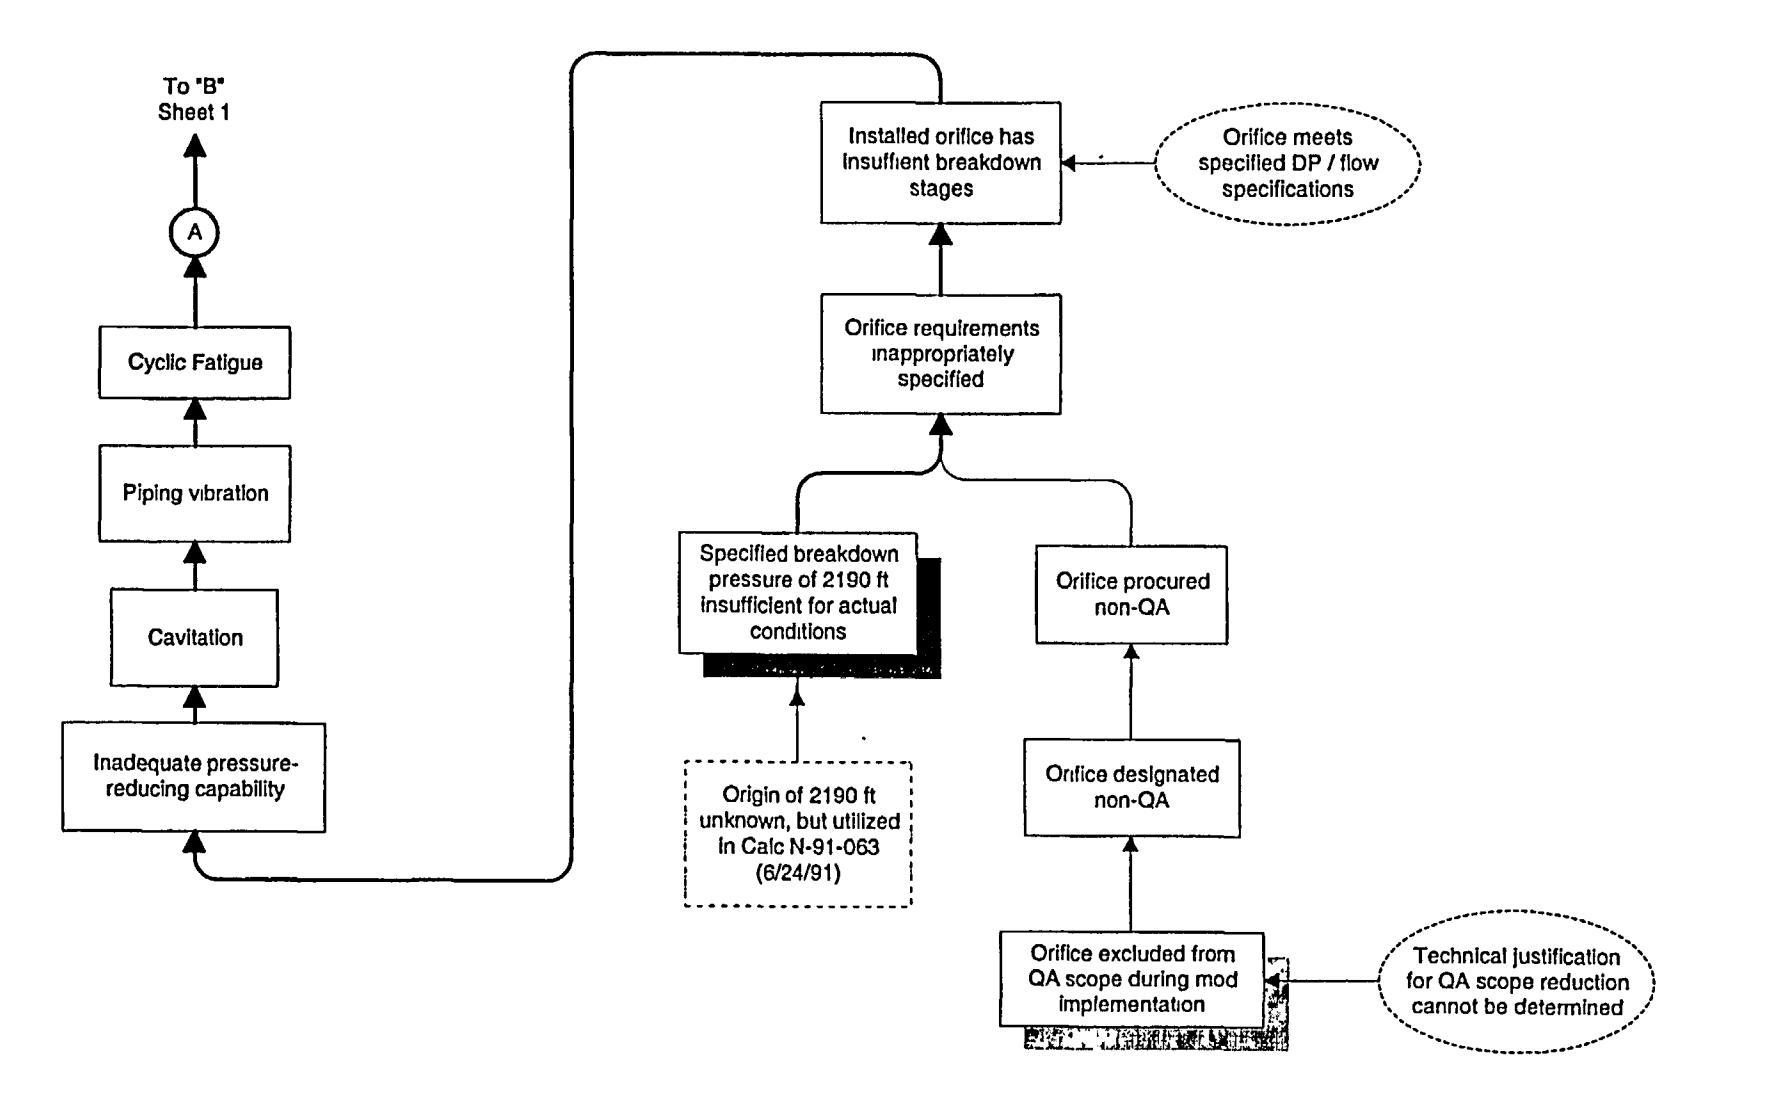
RCE 99-081, Rev. 1 WELD CRACKING FAILURE MODE DIAGRAM
