M Leisvie Finoc T. Mendiala, IPP <mkleisure@firsteneraycorp.com> <ajm@nrc.gov> 9/10/02 10:22AM Sample Plan Phase 3 Subject:

As you requested this morning, attached is Condition Report (CR) 02-05705 on the clad cracks and related photos. I have also attached a copy of CR 02-05536 regarding a circumferential J-groove weld crack indication that was described in the status update of 9/3 that was transmitted to Jon Hopkins on 9/6.

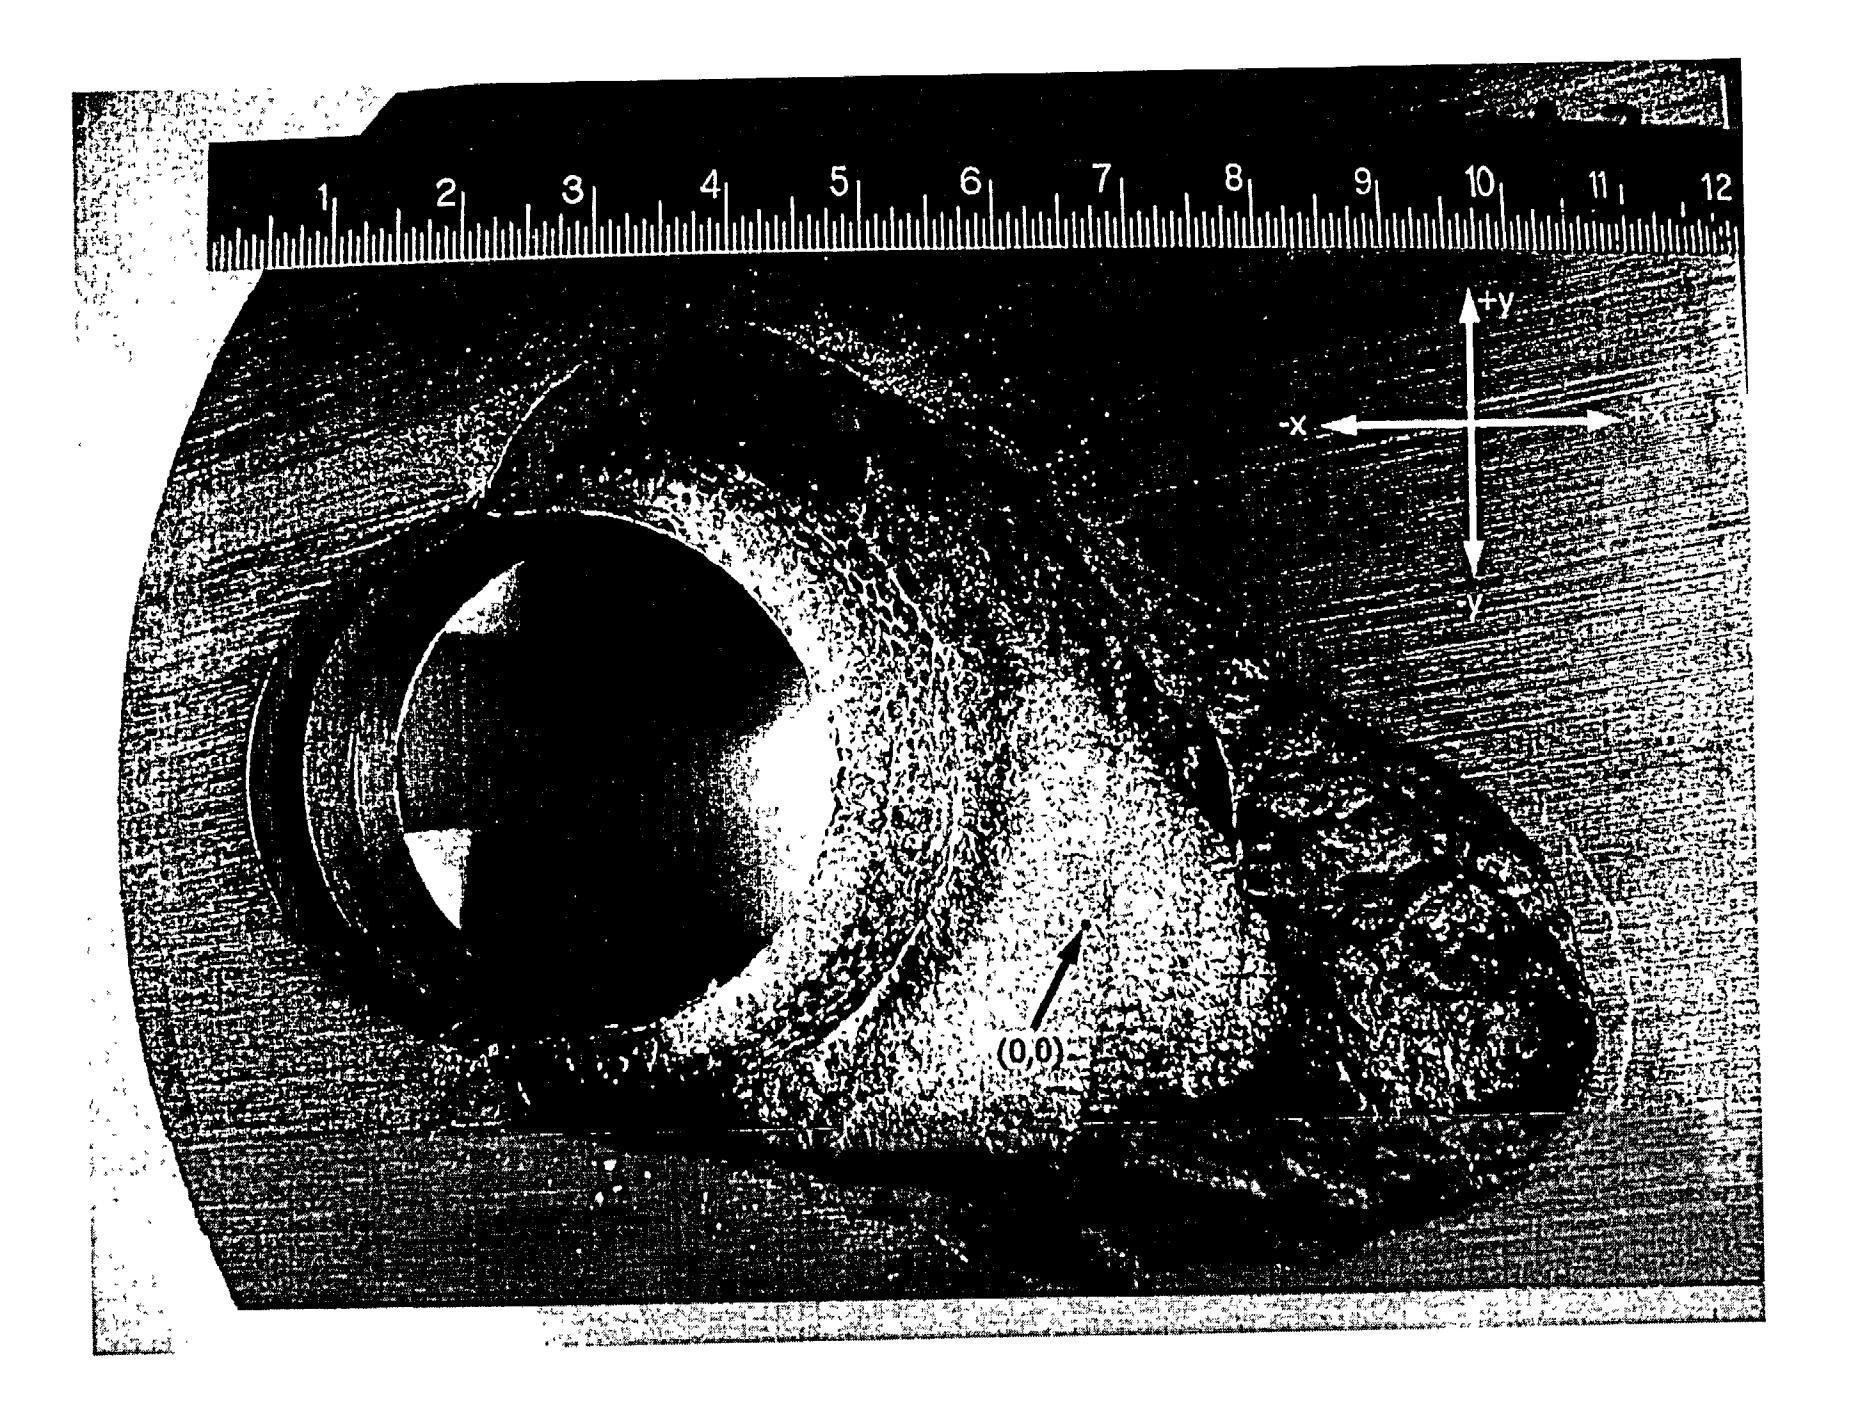
I discussed the clad crack issue with Hongging Xu of Framatome. He confirms that there are no indications that the crack is through wall He also confirms that the cracks appear to be at a junction between two weld beads and are running parallel to the direction of the weld beads. All lab activities with this sample are on hold Hongqing is working on updating the Sample Plan to discuss and address the discovery of the clad cracks

CR Number				
тп	02-05705				
	DISCOVERY DATE TIME EVENT DATE TIME EVENT DATE TIME EVENT DATE	ATE TIME SYSTEM / ASSET# N/A N/A N/A			
0 R G N A T 0 N	DESCRIPTION OF CONDITION and PROBABLE CAUSE (if known) Summarize any attachments. Identify what, when, where, why, how. The 17" diameter specimen that was removed from the original Davis-Besse Reactor Pressure vessel is currently undergoing examination in a laboratory. The laboratory informed Davis-Besse today that a crack approximately 3/8" long was found in the center of the exposed cladding area of the cavity. This new information will need to be evaluated for possible effects on the safety significance analysis. The laboratory also performed cladding thickness measurements. The results were as follows: Average - 0.256" Minimum - 0.202" Maximum - 0.314" These results will also need to be evaluated to determine their effect on the safety significance analysis. SUPV COMMENTS / IMMEDIATE ACTIONS TAKEN (Discuss CORRECTIVE ACTIONS completed, basis for closure.) NA
