April 4, 2003 L-03-064

Subject: Beaver Valley Power Station, Unit No. 1 and No. 2 BV-1 Docket No. 50-334, License No. DPR-66 BV-2 Docket No. 50-412, License No. NPF-73 Supplemental Information Supporting Proposed Alternative Repair Methods for Reactor Vessel Head Penetrations (Relief Request No. BV3-RV-04)

WCAP-15986

The Embedded Flaw Process for Repair of Reactor Vessel Head Penetrations and Its Application at North Anna Unit 2

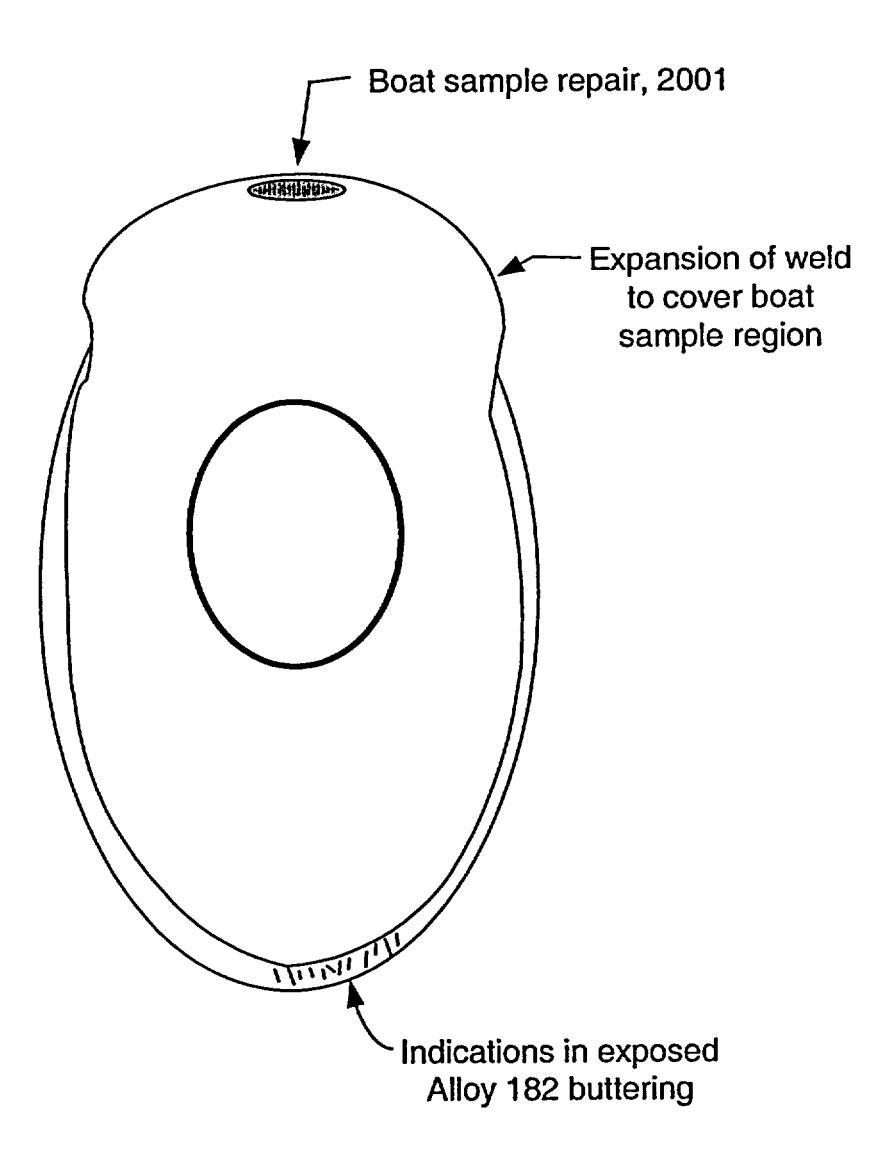
extend out far enough, and some of the Alloy 82/182 was left exposed to the PWR environment after the repair. This finding was verified on penetration 62, as described below.

In studying the penetrant results for penetration 62, it was noted that the repair weld was extended outward along the top portion to cover the area where the boat sample had been taken. The results of the boat sample were reported in reference [9] and showed that the boat sample was almost entirely in the buttering. Therefore, the extension of the weld repair in the upper portion of the penetration, in this case, fully covered the buttering. It seems possible that the indication at the bottom portion of this penetration may have resulted from the incomplete extension of the repair weld in that region.

Figure 3-1 Sketch of Weld Repair on Penetration 62, showing the extension to cover the buttering and the portion of the butter that was exposed.

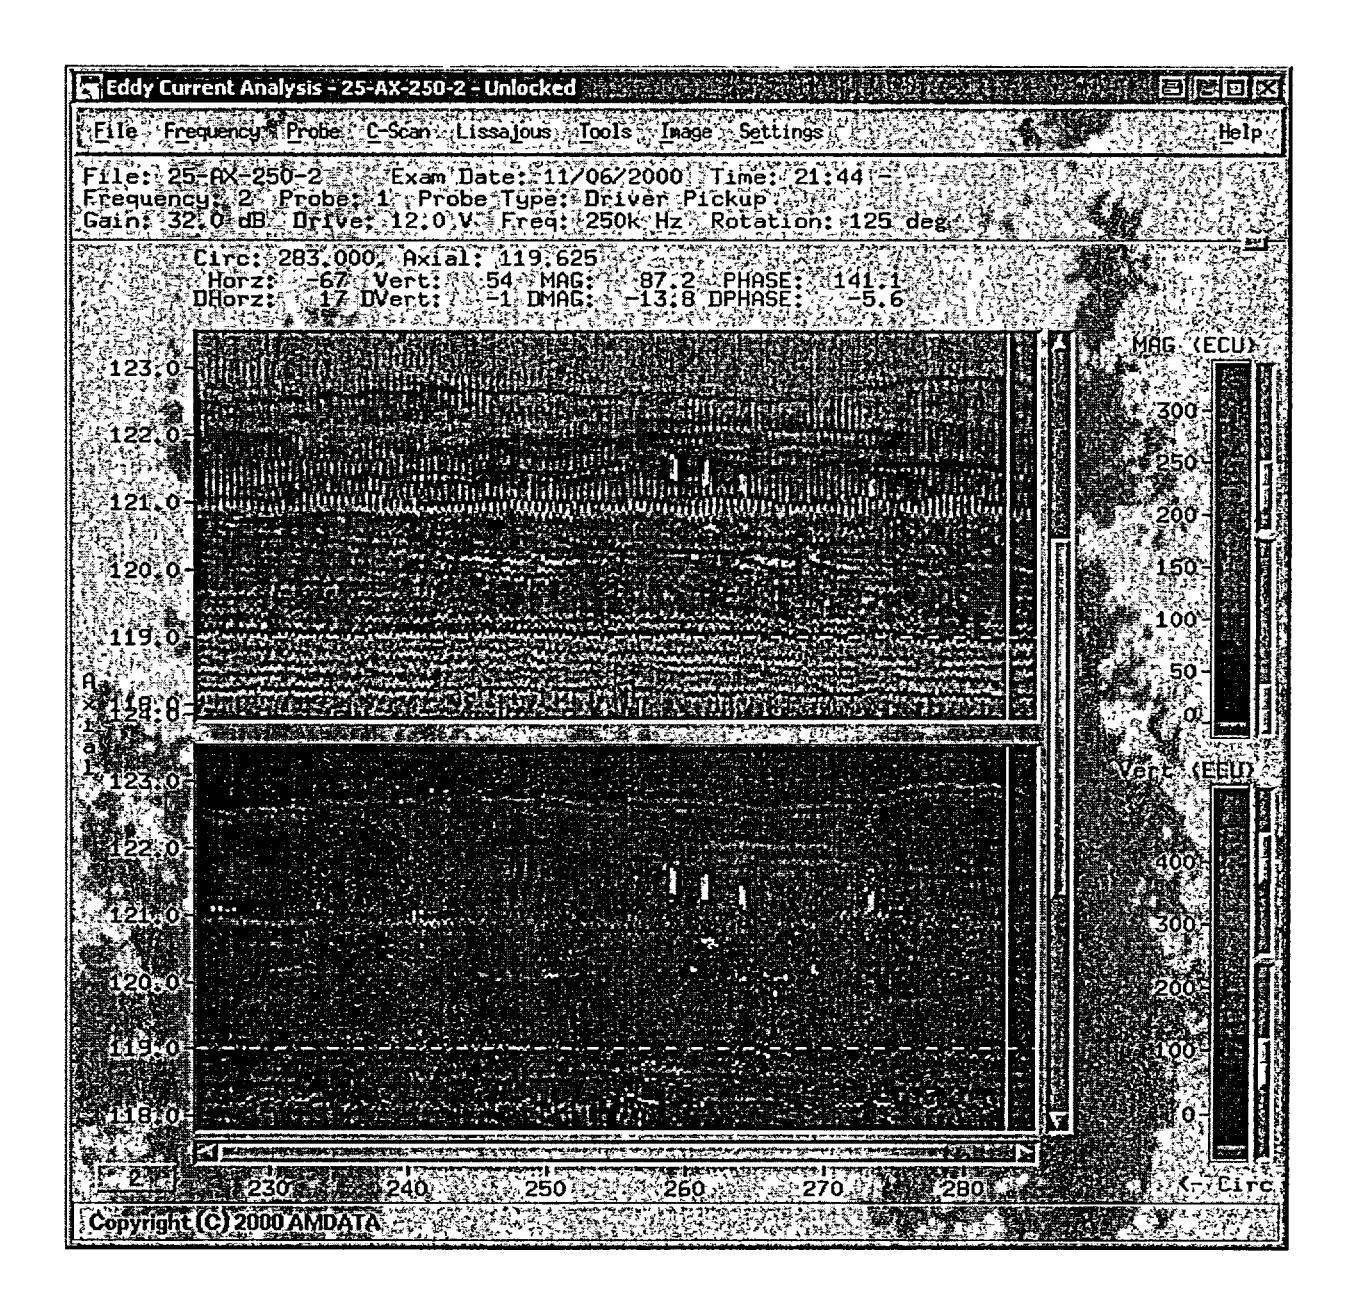
The alternative approach is to apply a nondestructive test to determine the boundary of the stainless steel clad to Alloy 182 surface. The technique of choice is an eddy current test that can distinguish the change in conductivity and permeability between stainless steel and Alloy 82/182. This method has been previously used during the inspection of an Alloy 82/182 safe end weld attached to a stainless steel clad reactor pressure vessel nozzle. Figure 5-1 shows actual field data employing this technique to identify the stainless/Alloy 82/182 boundary. In this image, a stainless steel pipe (upper green region) is attached to an Alloy 82/182 weld (middle blue region, which also has several crack indications) and then to the stainless steel clad vessel (lower green region). The demarcation between the Alloy 182/82 weld and the stainless cladding is very distinct.

Figure 5-1 ET Result from Alloy 182 Safe End Weld Attached to a Stainless Steel Pipe (top) and Stainless Steel Cladding (bottom)

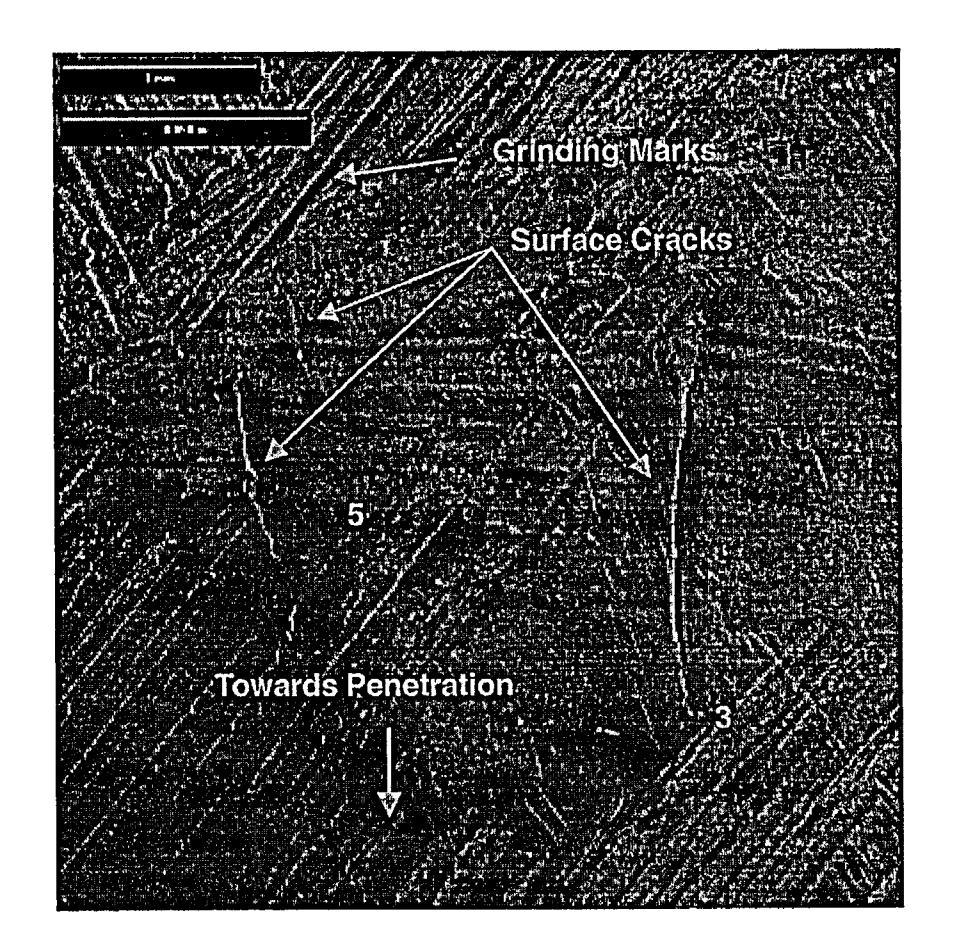
Figure B-4 Surface Cracks in Ground Area at Linear PT 135° Location

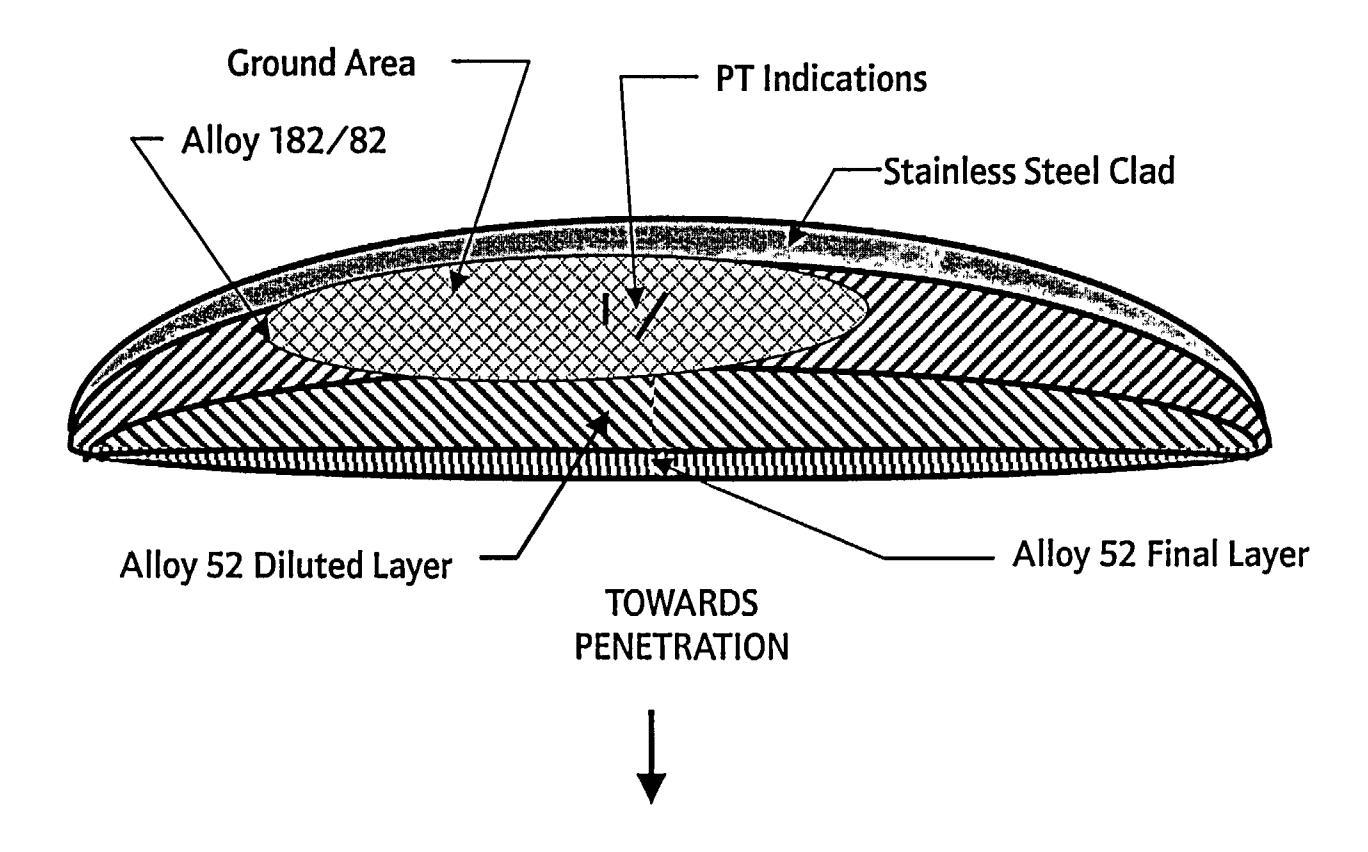
Figure B-5 Sketch of Wetted Surface Plan View with Weld Material Determination based on EDS Analysis in Table B-1

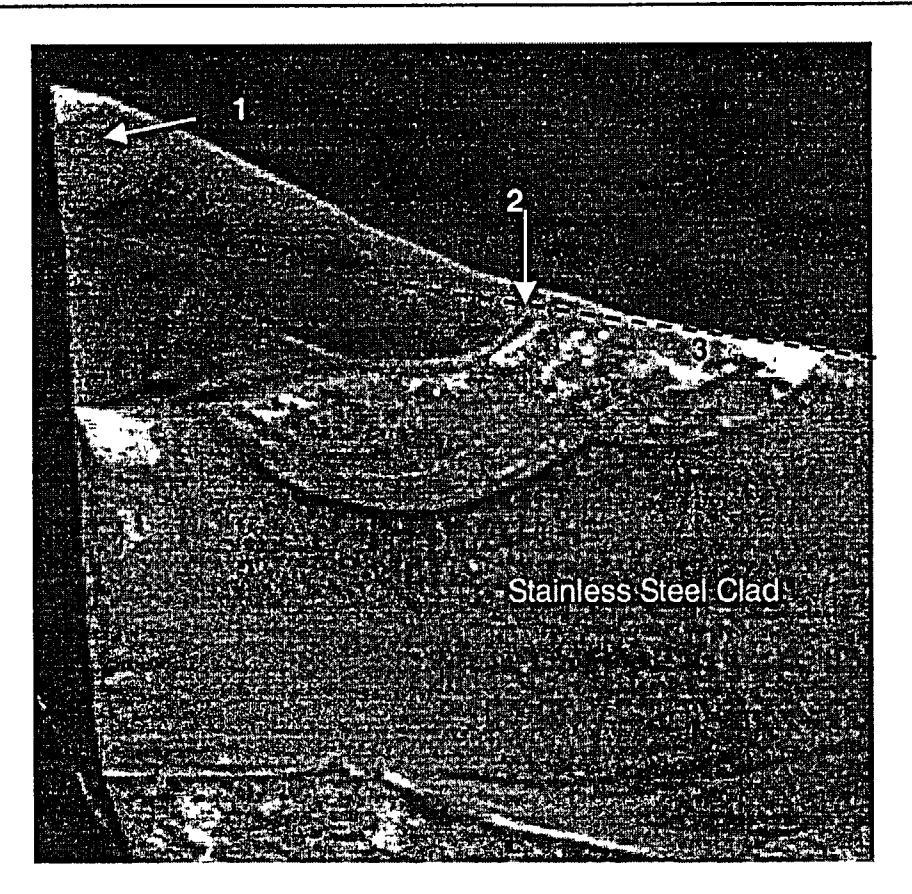
Figure B-6A Metallographic Section A-A Ground Repair Weld Configuration with EDS Analyses

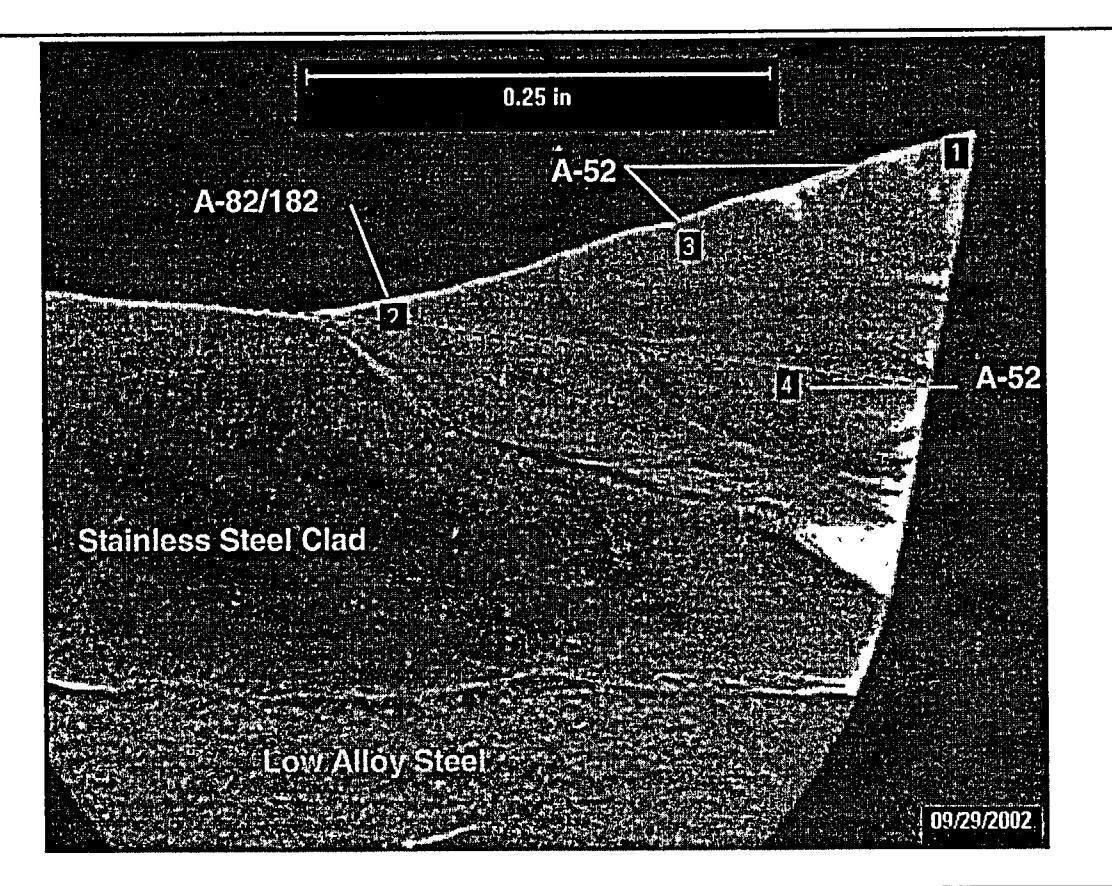
Figure B-6B Metallographic Section C-C Full Depth Repair Weld Configuration with EDS Analyses

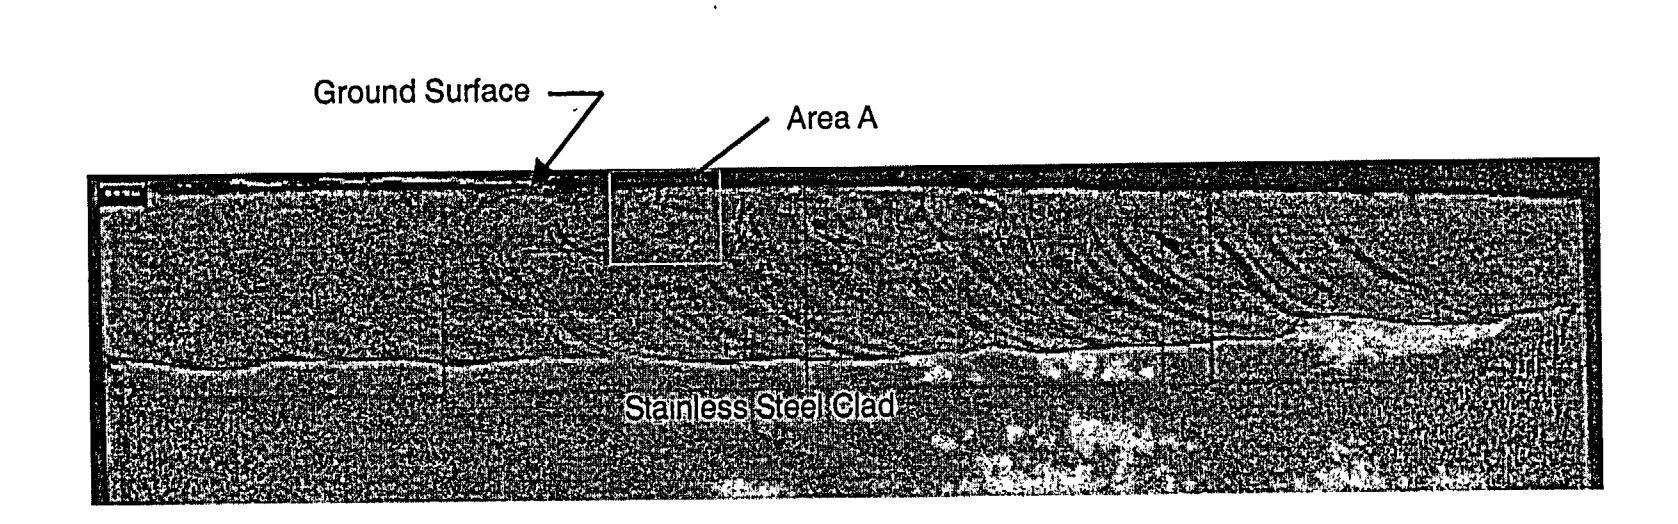
These indications are shallow hot cracks in the Alloy 52 that originated during the welding process, and were revealed as surface indications as a result of grinding subsequent to the first PT. [More details on this finding will be provided when the boat sample analysis report is completed.]

Figure B-7 Section B1 at Tip of PT Indication showing Hot Cracking at Weld Layer Interfaces

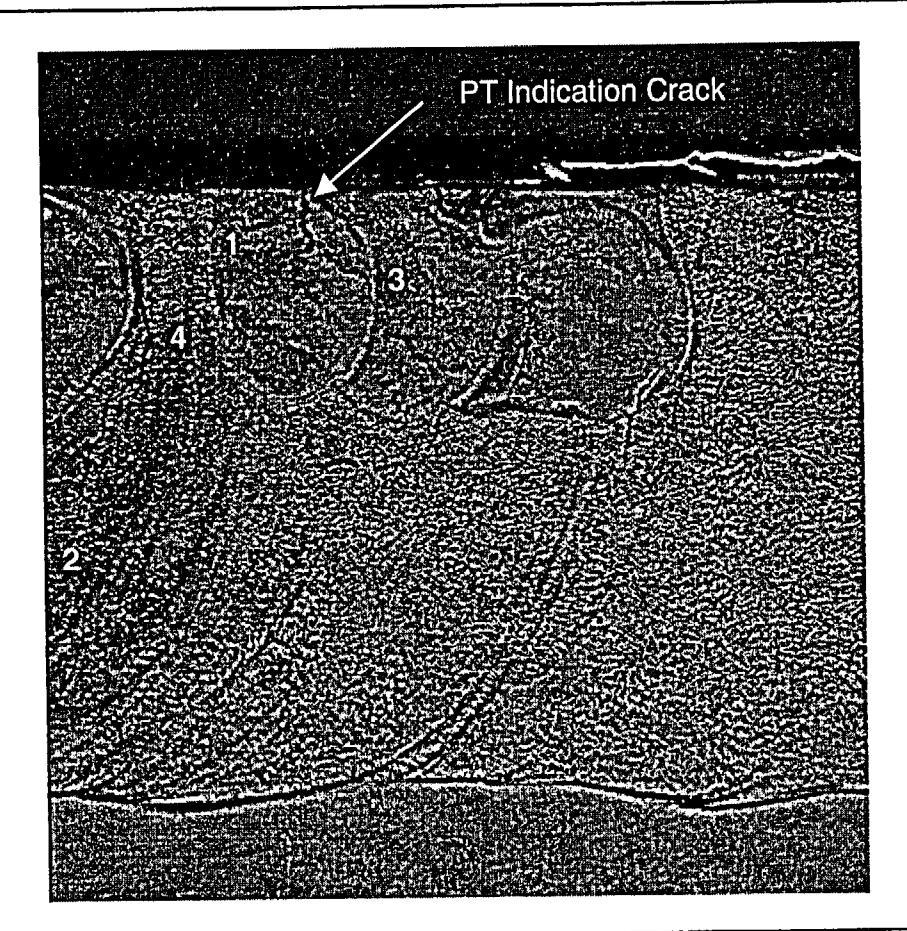
Figure B-7A Area A from Figure B-7 showing PT Indication and Other Hot Cracking with EDS Analyses

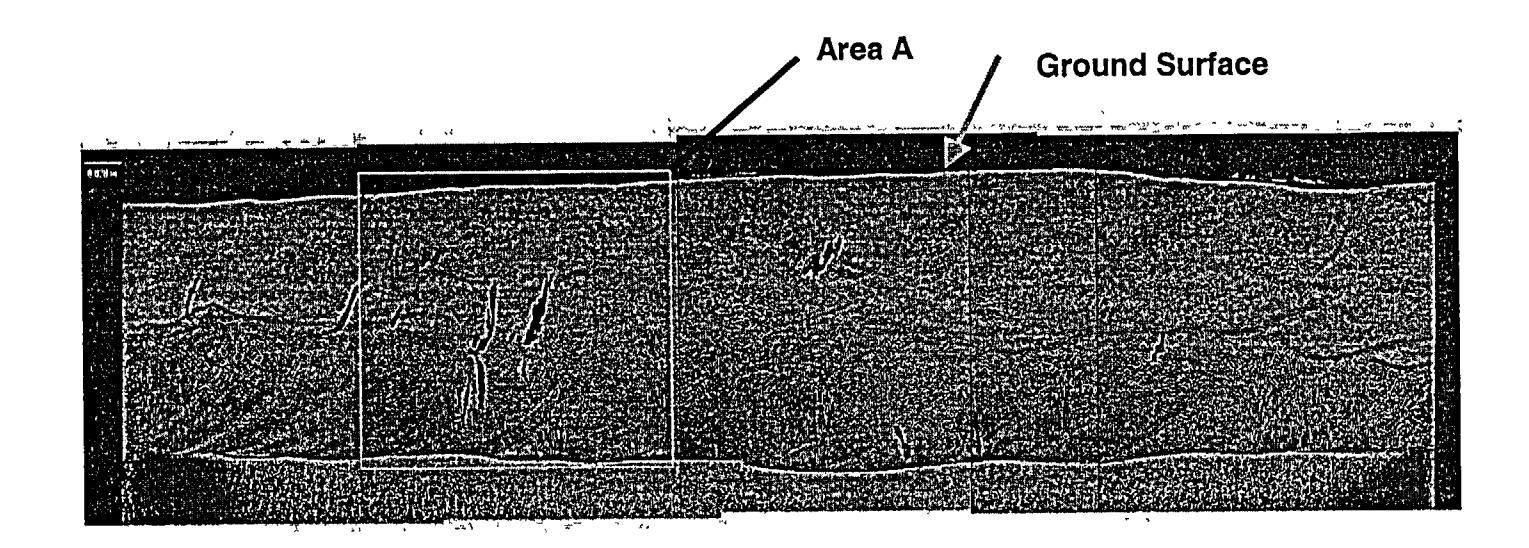
Figure B-8 Section B2 showing Hot Cracking at Weld Layer Interface
