UNITED STATES NUCLEAR REGULATORY COMMISSION OFFICE OF NUCLEAR REACTOR REGULATION WASHINGTON, D.C. 20555-0001

January 21, 1998

NRC INFORMATION NOTICE 98-03: INADEQUATE VERIFICATION OF OVERCURRENT TRIP SETPOINTS IN METAL-CLAD, LOW-VOLTAGE CIRCUIT BREAKERS

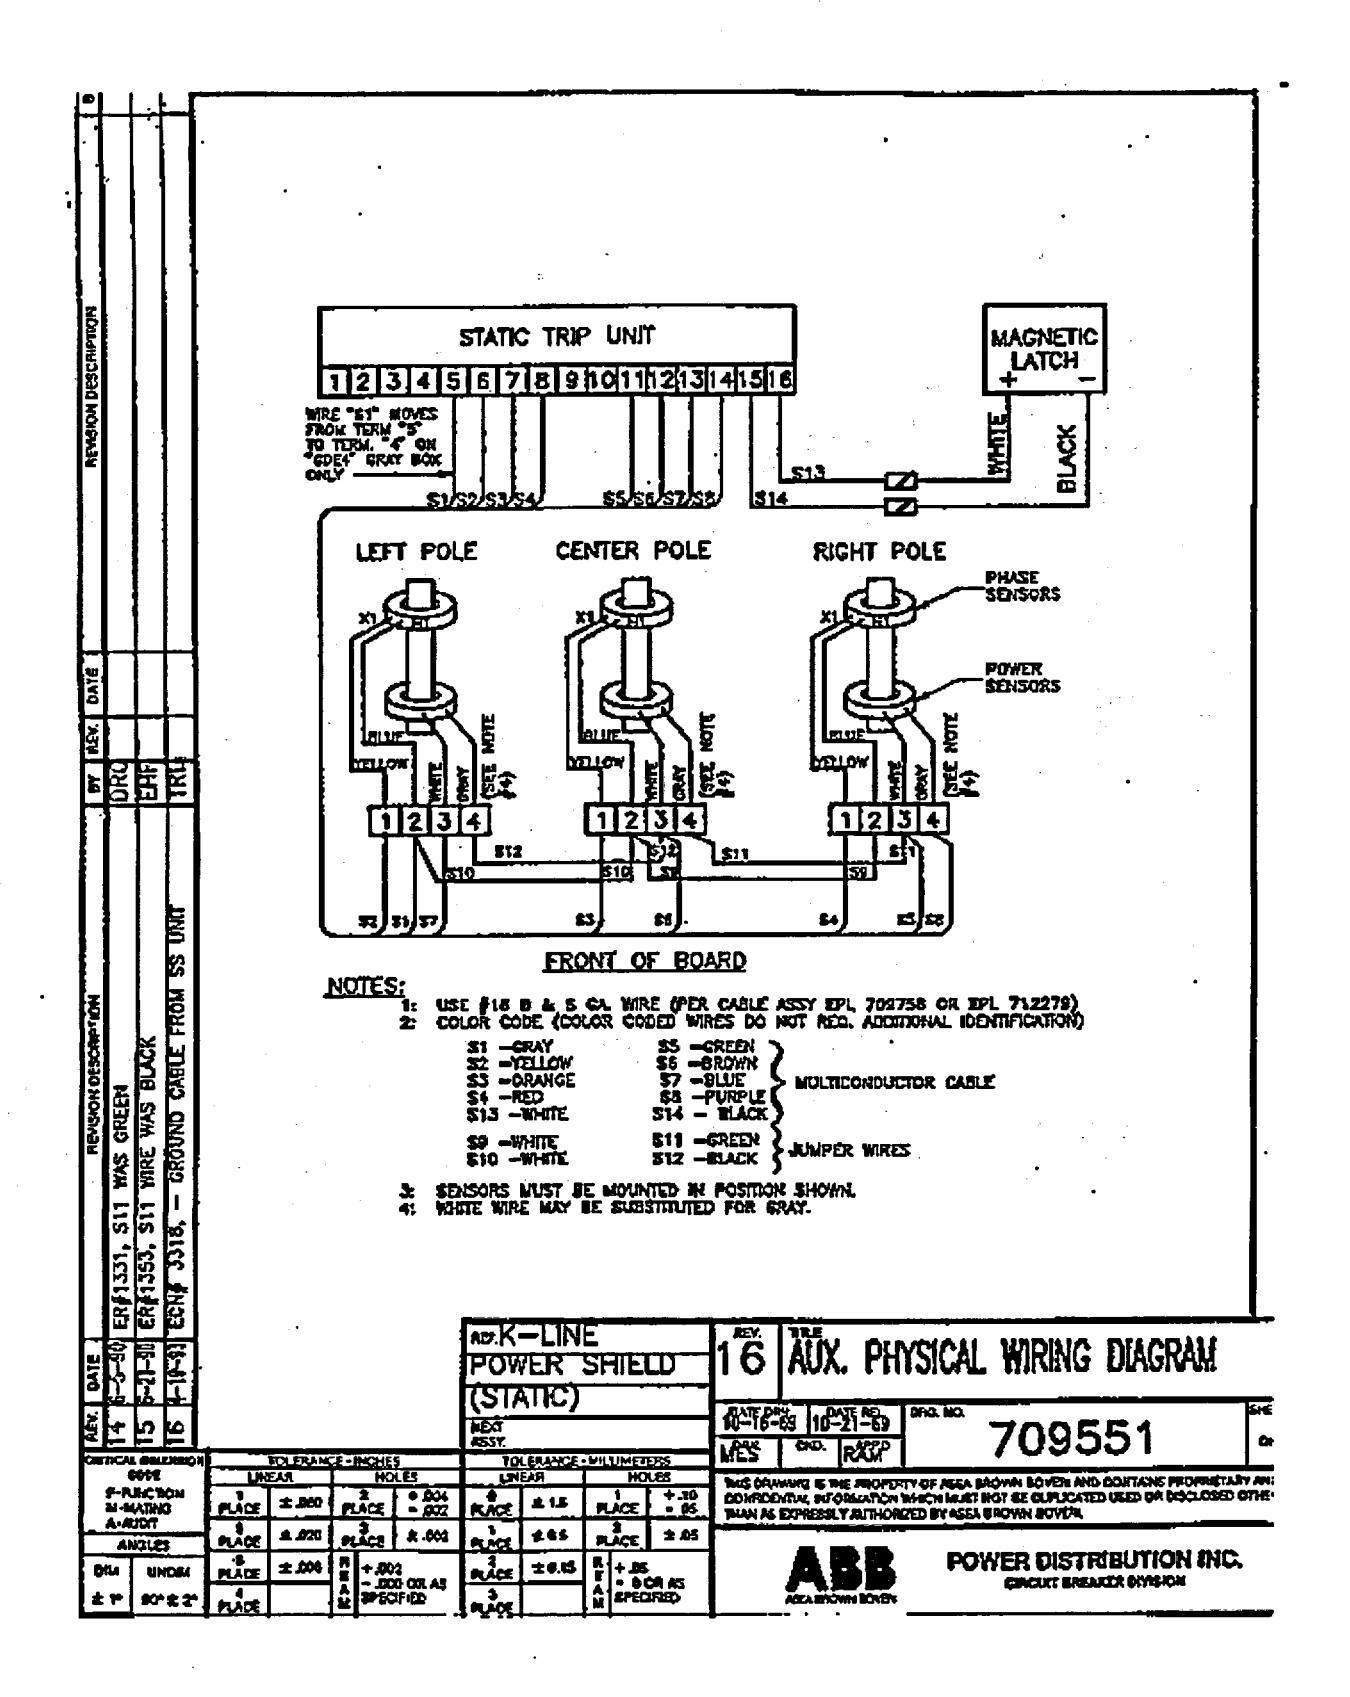
Attachment 1 IN 98-03 January 21, 1998 Page 1 of 1

A typical metal-clad ABB K-line circuit breaker has six CTs. Three of these six CTs are referred to as "phase sensors," and are used to detect fault currents. The remaining three CTs are referred to as "power sensors," and are used to develop a trip reference signal within the Power Shield trip unit. Two CTs, a phase sensor and a power sensor, are installed on each phase of the circuit breaker. The leads from all six CTs are terminated on three terminal blocks attached to the front of the moulded CT mounting board near the bottom of the circuit breaker. These three terminal blocks, in turn, are connected to the Power Shield solid-state trip unit by a multiconductor wiring harness. Attachment 1 to this notice is a copy of ABB Wiring Diagram 709551, Revision 16, for reference. Attachment 2 to this notice is a photograph of the CT mounting board at the bottom of a K-line breaker to aid in interpreting the drawing. Typical wiring and assembly errors that have been discovered in ABB K-line circuit breakers include the following:

- CT leads were terminated on the wrong terminals of the lower terminal blocks.
- Multiconductor cable conductors were terminated on the wrong terminals of the lower terminal blocks, or on the wrong terminals of the Power Shield Trip Unit.
- CTs were installed upside down but were correctly terminated on the lower terminal blocks (same effect as reversing the leads).
- After the wires on terminals 6, 7, and 8 of the Power Shield trip unit are lifted to perform continuity checks of the phase sensors, or the wires on terminals 11, 12, 13, and 14 are lifted to conduct calibration tests, the wires are relanded incorrectly.

However, such an unexpected phase shift in CT secondary output current is not detected during single-phase primary current calibration and testing. Therefore, additional inspections or tests may be necessary to adequately verify proper operation of circuit breakers equipped with solid-state trip units. ABB's procedure to check phase sensor polarity for solid-state trip devices, Types SS-3, -4, -5, -13, -14, and -15 is as follows:

- 1. On the static trip (Power Shield) unit terminal strip, connect an analog meter (i.e., conventional electromechanical d'Arsonval meter movement), set to measure current (100 mA scale) as follows to check the phase sensors for each pole: Negative test lead at Terminal 5, Positive test lead successively for each test at Terminals 6, 7, and 8 for the left, center, and right poles respectively.

- 2. Connect the NEGATIVE (-) terminal of a 1.5-volt battery to the finger assemblies of the breaker's LOWER primary disconnects for each of the above corresponding poles for each test. Then while observing the meter, touch a test lead from the POSITIVE (+) battery terminal to the corresponding pole's UPPER primary disconnect successively for each test.

- 3. Check that there is a momentary deflection of the meter needle in the positive direction as the positive battery lead is touched to each upper primary disconnect. A positive deflection indicates that the polarity of the signal from the CT as read at the static trip unit is correct.
