## UNITED STATES NUCLEAR REGULATORY COMMISSION OFFICE OF NUCLEAR REACTOR REGULATION WASHINGTON, D.C. 20555

### June 15, 1988

NRC INFORMATION NOTICE No. 88-38: FAILURE OF UNDERVOLTAGE TRIP ATTACHMENT ON GENERAL ELECTRIC CIRCUIT BREAKERS

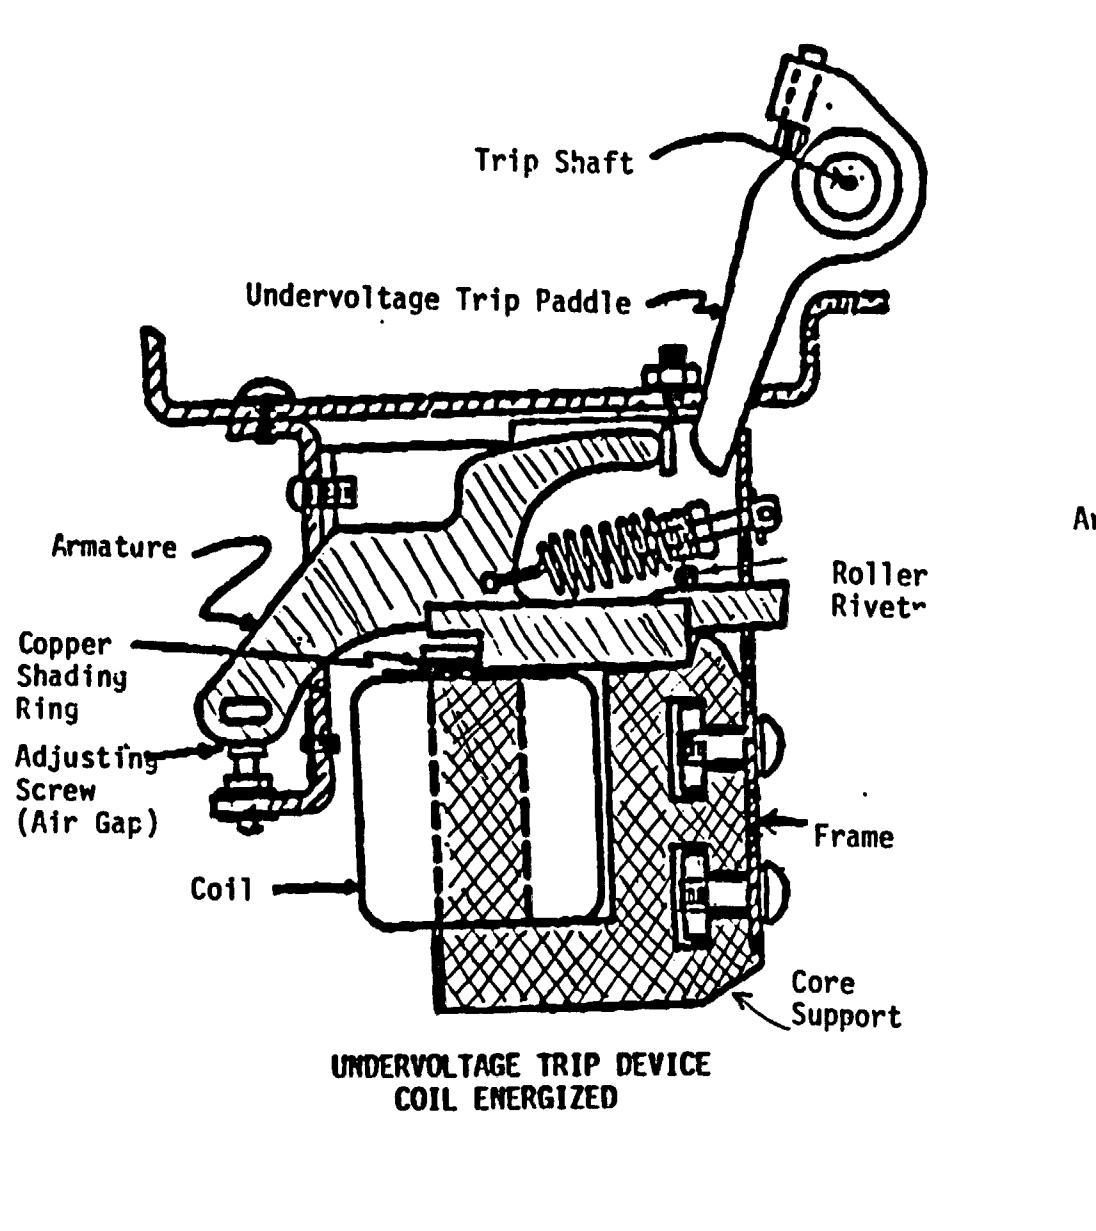
Figure 1 shows the normal pre-trip position of the UVD. On a valid undervoltage trip signal, the coil is deenergized, releasing the armature. The spring attached between the armature and the UVD frame causes the armature to pivot in a clockwise direction between the roller rivet and coil core support. The small circular disk welded to the armature then contacts the trip paddle causing it to engage and rotate the circuit breaker's trip bar. Figure 2 shows the normal post-trip configuration of the UVD.

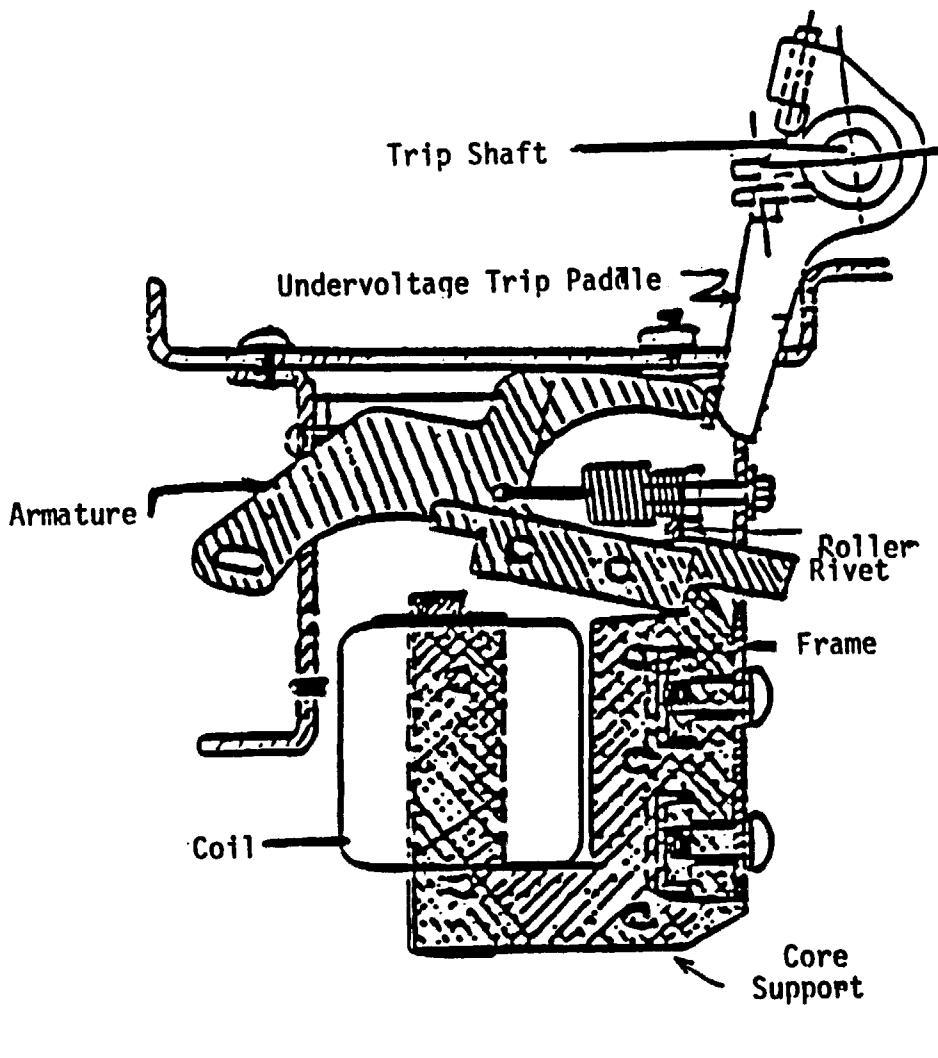
Figure 2

UNDERVOLTAGE TRIP DEVICE

COIL DE-ENERGIZED

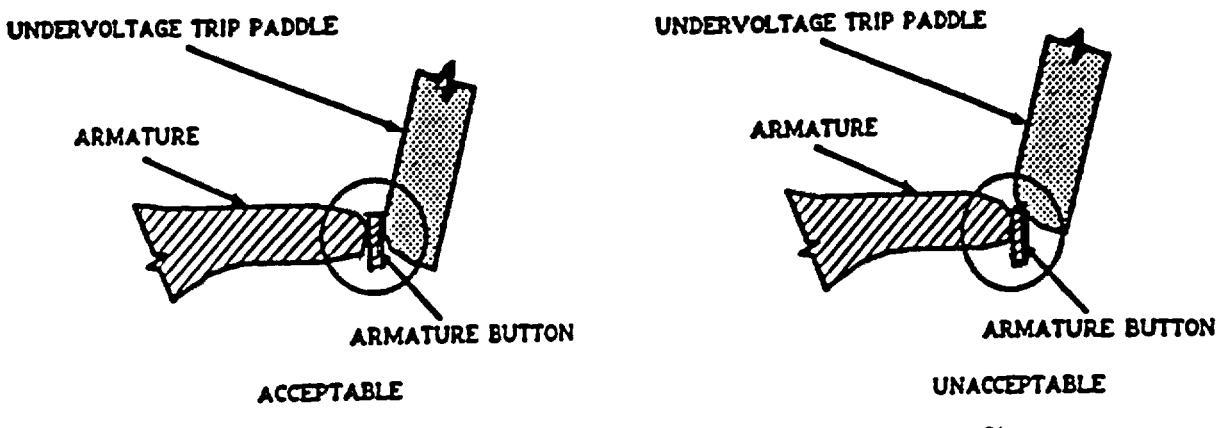
Figure 3a

Because of the mechanical oscillation inherent in an ac powered electromagnet, the armature of the UVD vibrates continuously. Since the armature disk and trip paddle were in contact, these vibrations eventually created a groove in the upper portion of the armature disk and in the end of the trip paddle. As long as the grooves in the disk and trip paddle were in a certain configuration, the device operated properly. However, when the disk/trip paddle groove relationship was disturbed (side movement), the disk would bind on the trip paddle resulting in failure of the UVD to trip the breaker (Figure 4). The affected breaker was removed from service and a spare breaker was installed. All RTBs were taken out and visually inspected for the anomalies identified above; no abnormal UVDs were identified. The licensee has also modified its preventive maintenance procedure to ensure that all known problems with these breakers have been addressed to preclude the recurrence of these problems.
