Attachment 1 IN 92-67 September 10, 1992 Page 1 of 6

> SHEARON HARRIS NUCLEAR POWER PLANT UNIT 1 DOCKET NO. 50-400/LICENSE NO. NPF-63 <u>10CFR PART 21 REPORT</u> MAIN FEEDWATER PREHEATER BYPASS VALVES

POTENTIAL FAILURE OF MAIN FEEDWATER PREHEATER BYPASS VALVES

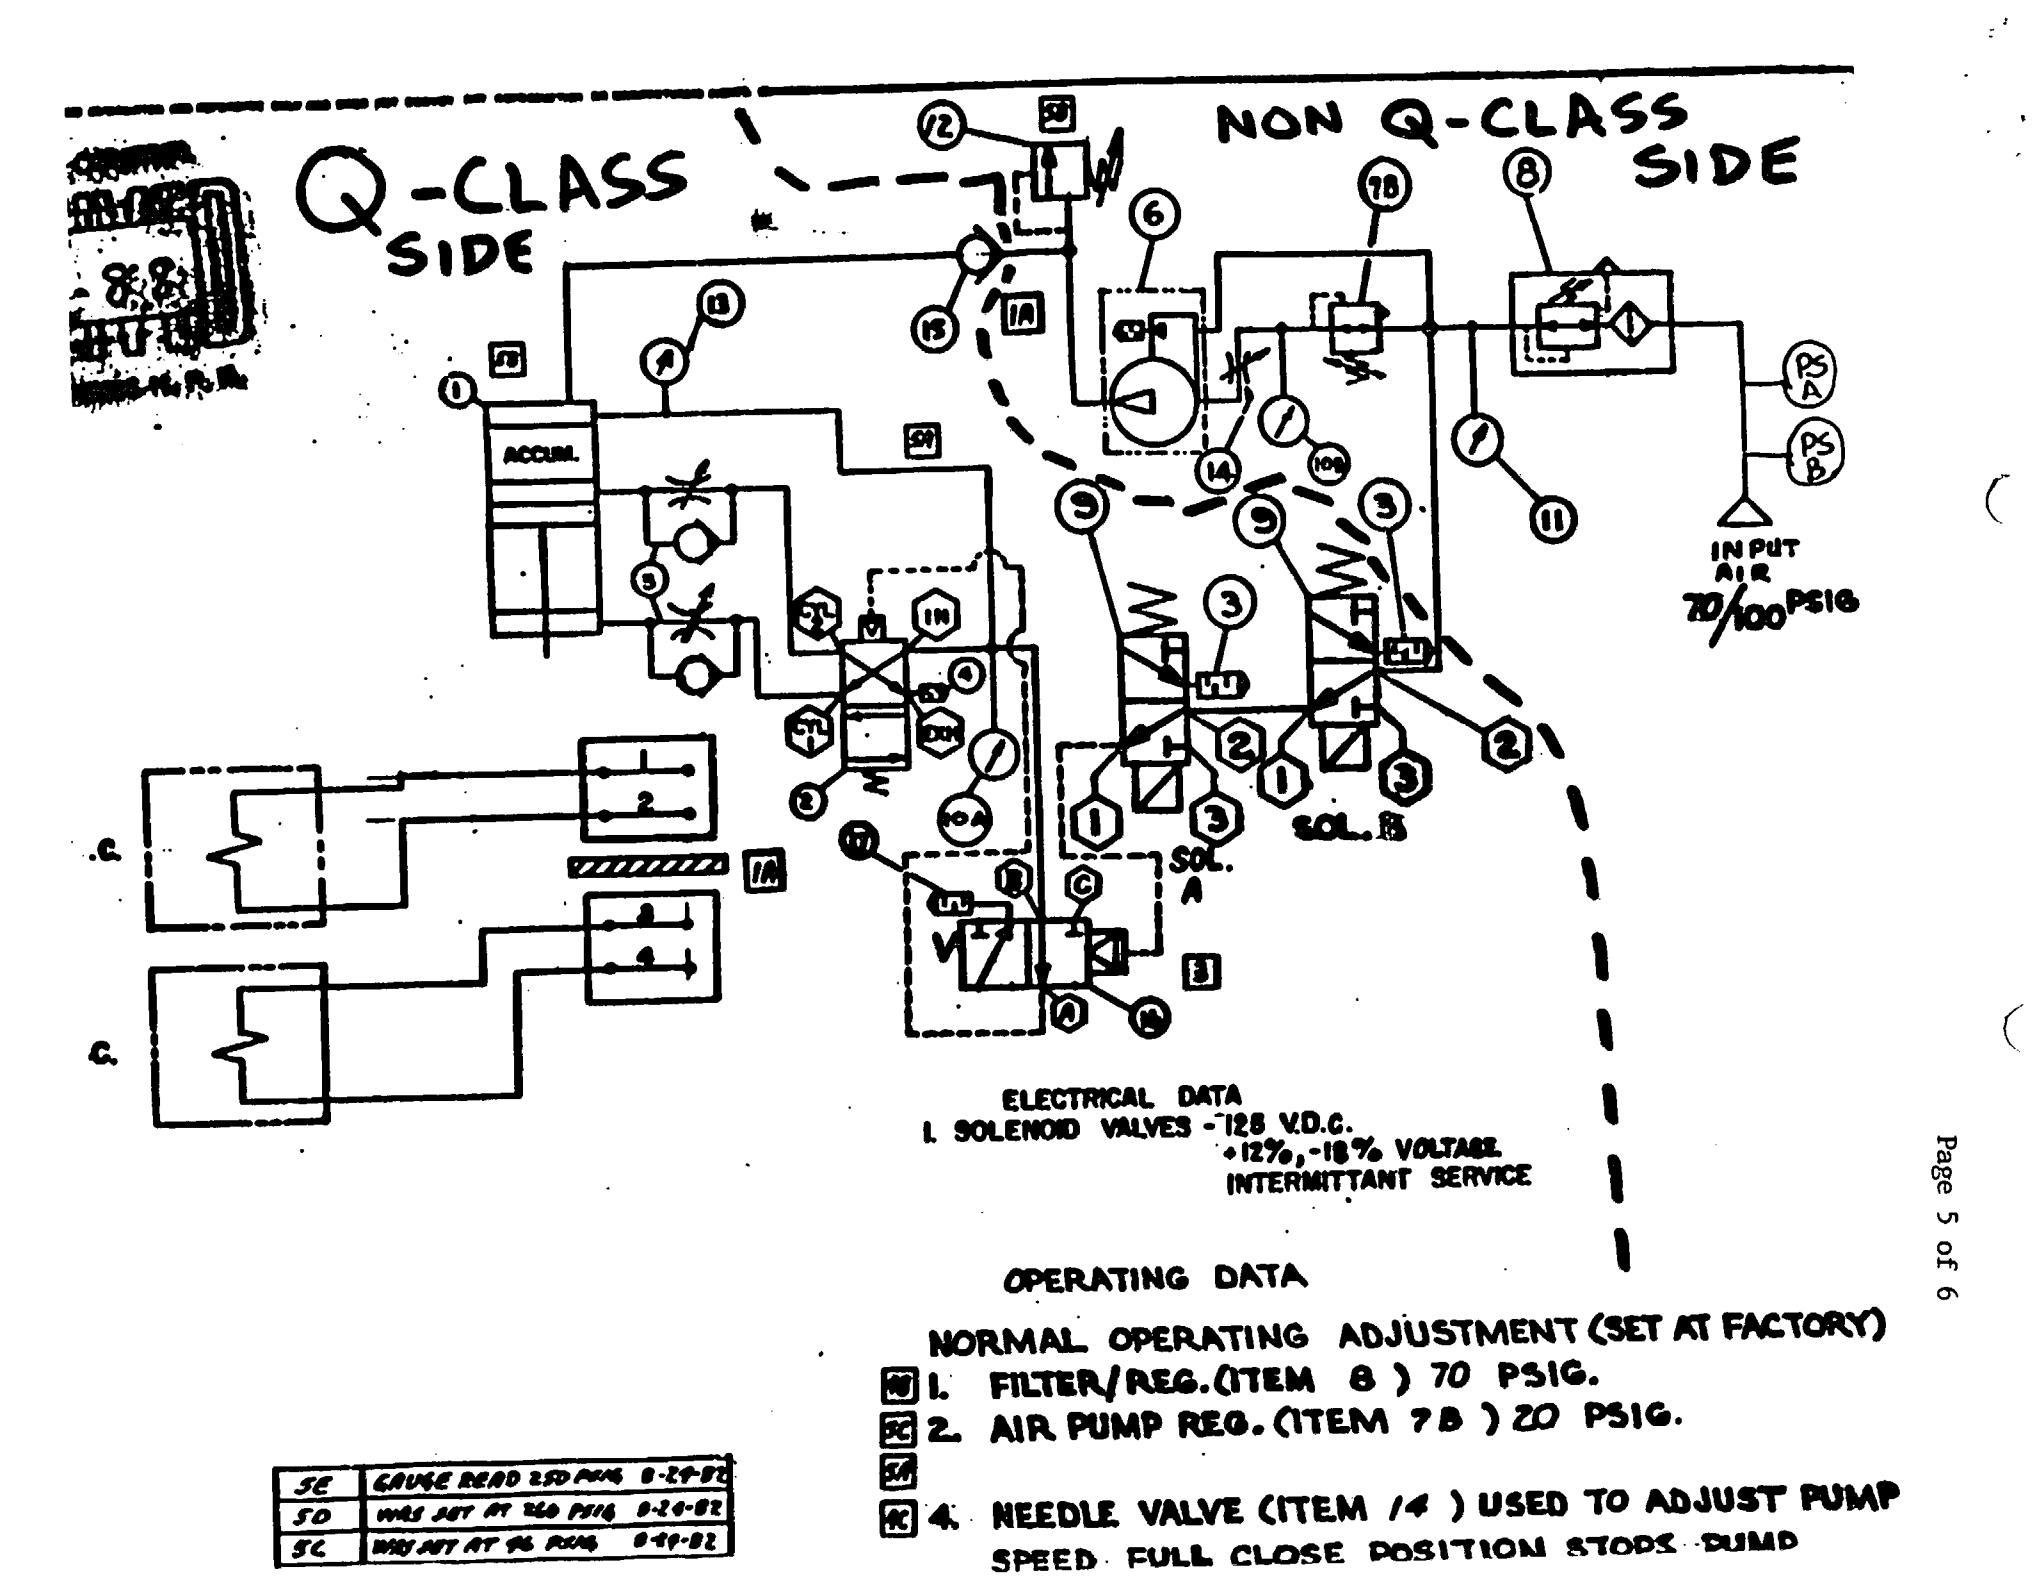
A potential failure mechanism existed where the failure of a non-Q component could result in the inability of a Q-class component to perform as designed. Specifically, a postulated failure of the air pump (item 6 on attached drawing), could cause a situation where normal leakage of the accumulator (item 1) from its normal 150 psig pressure would go undetected by redundant pressure switches (PS A and B). These switches provide the valves an auto close signal when pressure drops to 66 psig in the input air header.

The values are containment isclation values and are required to close within 10 seconds of a feedwater isolation signal. If accumulator pressure drops from its normal 150 psig to below 122 psig, it may not close within the required time. If accumulator pressure drops to approximately 20 psig, there may not be sufficient force to reposition the value and maintain it closed against maximum differential pressure.

Upon discovery of this condition on January 7, 1992 a two hour surveillance interval was commenced to verify the actuators' components were functioning properly and the accumulators were fully pressurized. On January 12, 1992 a plant change request (PCR 06158) was implemented which replaced the non-Q components with suitable components. Testing was completed satisfactorily and the two hour surveillance interval was suspended.
