Subject: Type HFA relay with latching mechanisms.

RELAY AND ACCESSORY SERVICE ADVICE LETTER

Subject: <u>HFA RELAYS WITH LATCHING MECHANISMS</u>

Number 190.1

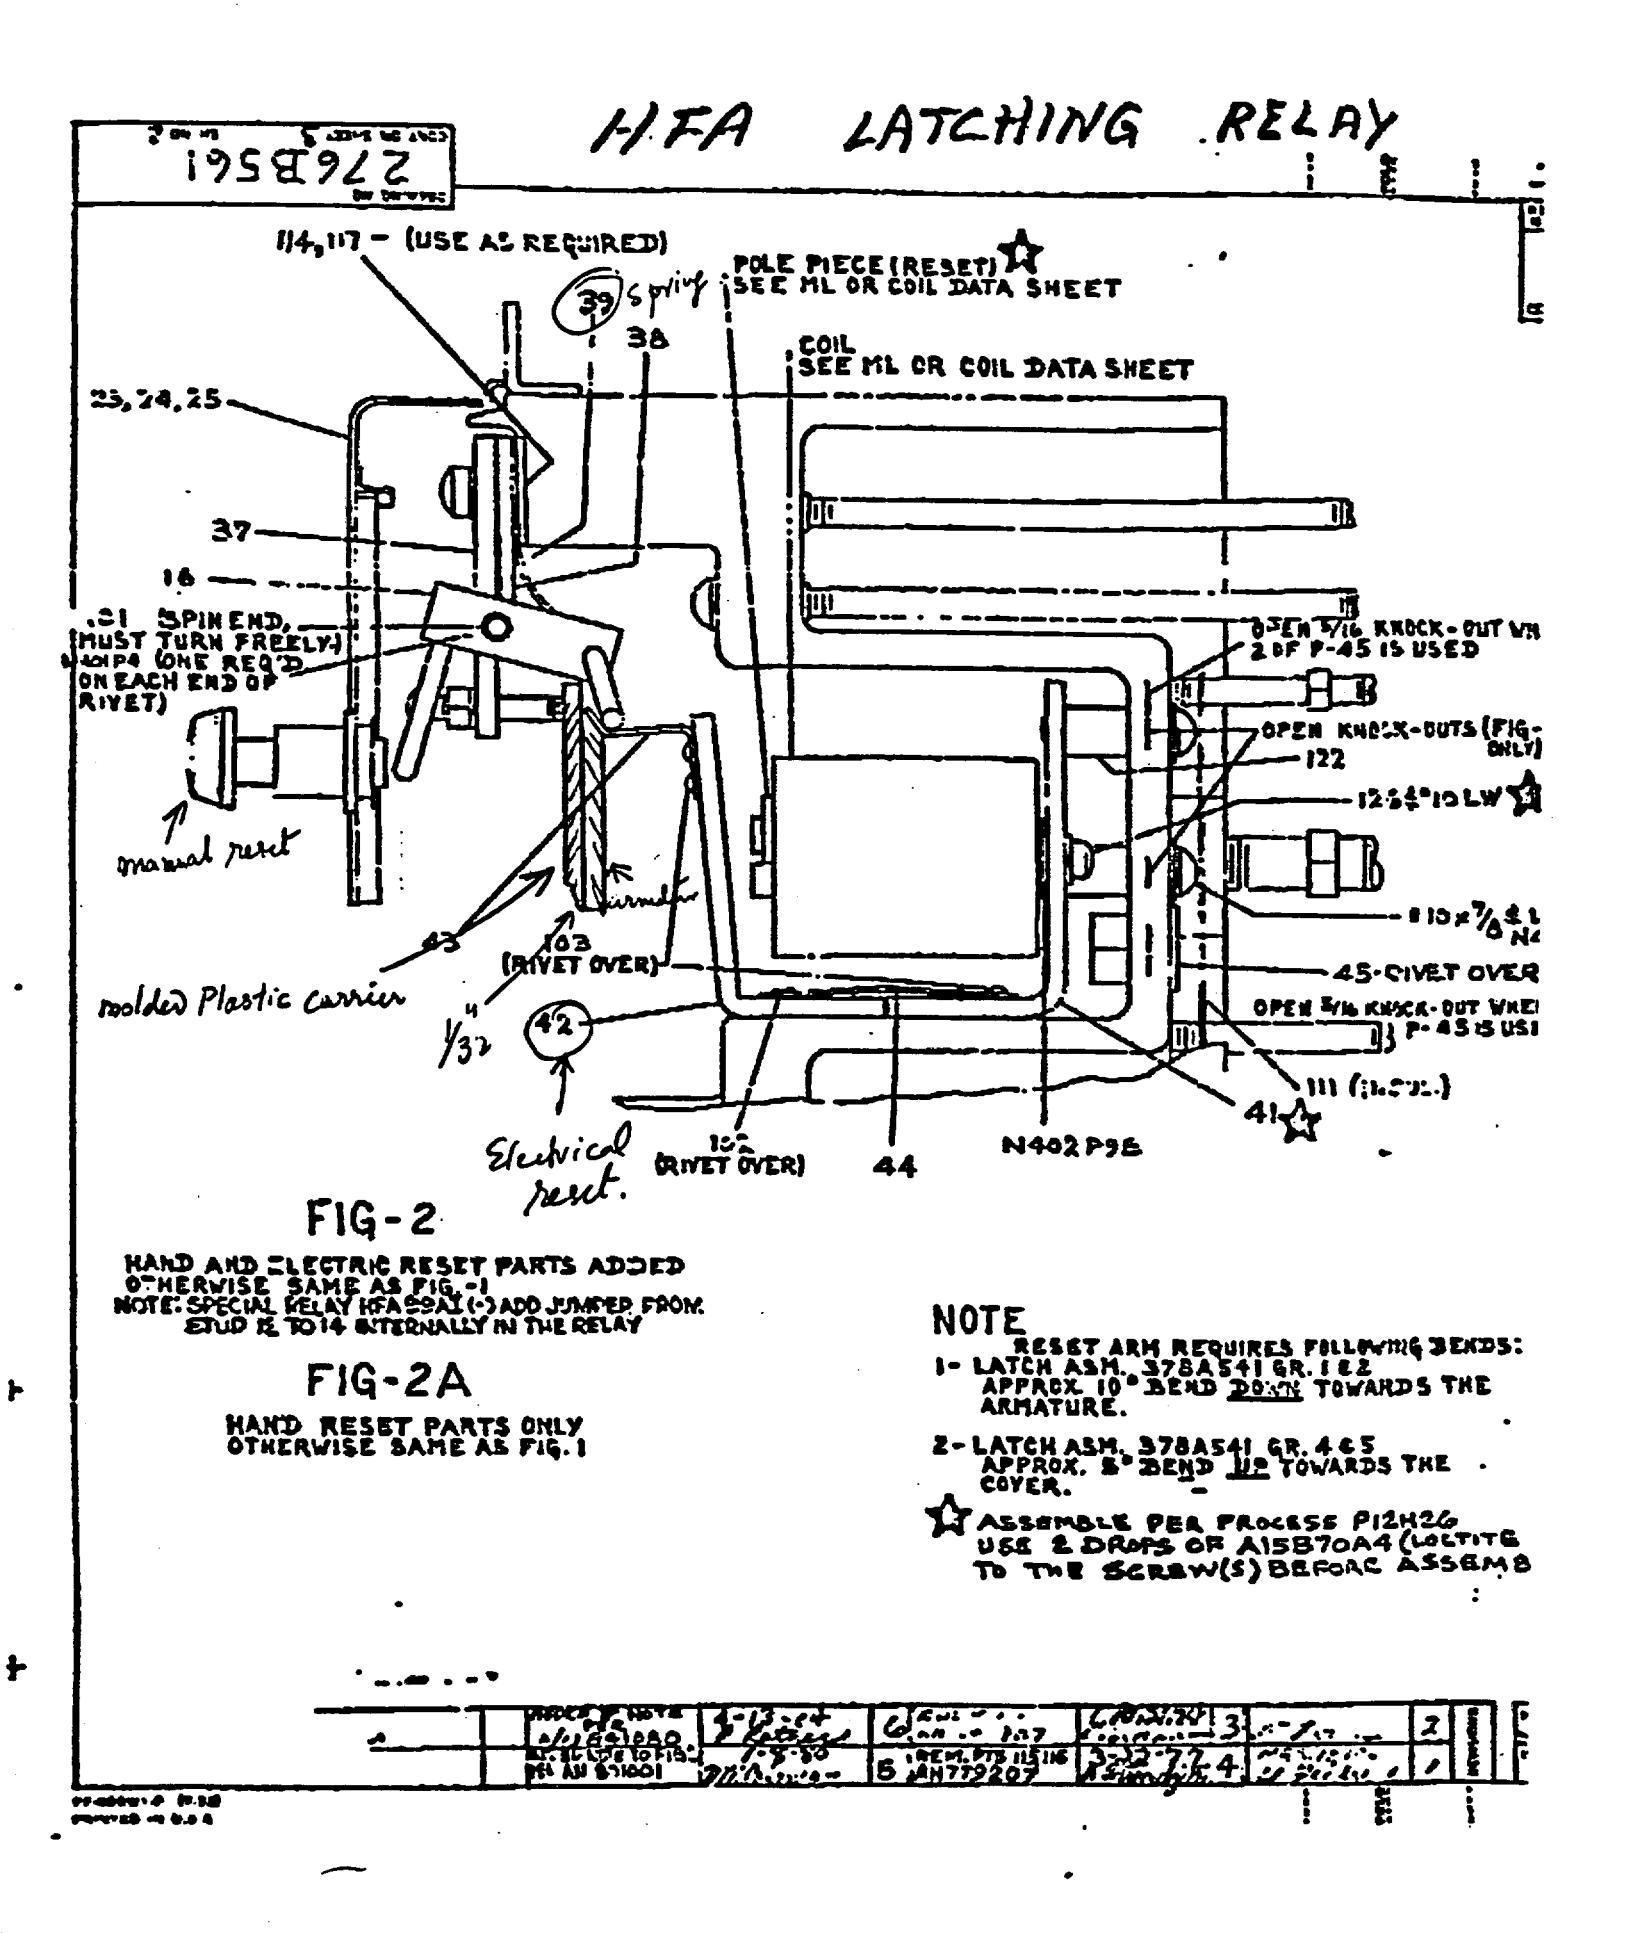
FIG. 2 (2025781) #FA154 RELAY, FRONT CONVECTED, SURFACE NOUNTED (FRONT VIEW)

One user of latching-type HFA Relays has reported finding several Relays on which the latch engagement was less than the recommended minimum. With the armature in the latched position, each leg of the U-shaped latch should engage the top of the armature by at least 1/32 inch. There is a possibility that with less than the recommended minimum latch engagement, the relay could unlatch incorrectly.

Our investigation into this report has led us to conclude that latch engagement of less than 1/32 inch may be caused by two circumstances. If there is insufficient clearance between the top of the relay armature and the top of the molded moving contact carrier, it could prevent the mechanical latch from reaching the minimum 1/32 inch engagement. The second reason could be insufficient tension by the formed leaf spring that rotates the latch to its fully engaged position. If this leaf spring does not have proper tension, there is a possibility that the spring will relax before full engagement between the latch and armature is achieved.

- a. If there is insufficient clearance between the top of the molded moving contact support and the top of the armature, a small portion of the molded support can be removed by filing. This can be done as follows:

- 3. File approximately 1/16 inch from the top of the contact carrier.
 - 4. Reassemble armature assembly, maintaining original orientation of contact springs and moving contacts, and recheck for at least 1/32 inch clearance, as mention in (A1).

- 2. Re-form leaf latch spring to have less curve (flatter spring).
 - 3. Reassemble latch assembly and check for full rotation.
 - 4. If relay is electric reset, check to ensure that relay resets with 60% of rated voltage applied to the reset coil circuit.
