Monticello Nuclear Generating Plant Operated by Nuclear Management Company, LLC

MONTICELLO NUCLEAR GENERATING PLANT DOCKET 50-263 LICENSE No. DPR-22

RESPONSE TO REQUEST FOR ADDITIONAL INFORMATION ON THE FOURTH 10-YEAR INSERVICE TESTING INTERVAL RELIEF REQUEST NO. PR 03 (TAC NO. MB6807)

NMC RESPONSE TO NRC REQUEST FOR ADDITIONAL INFORMATION

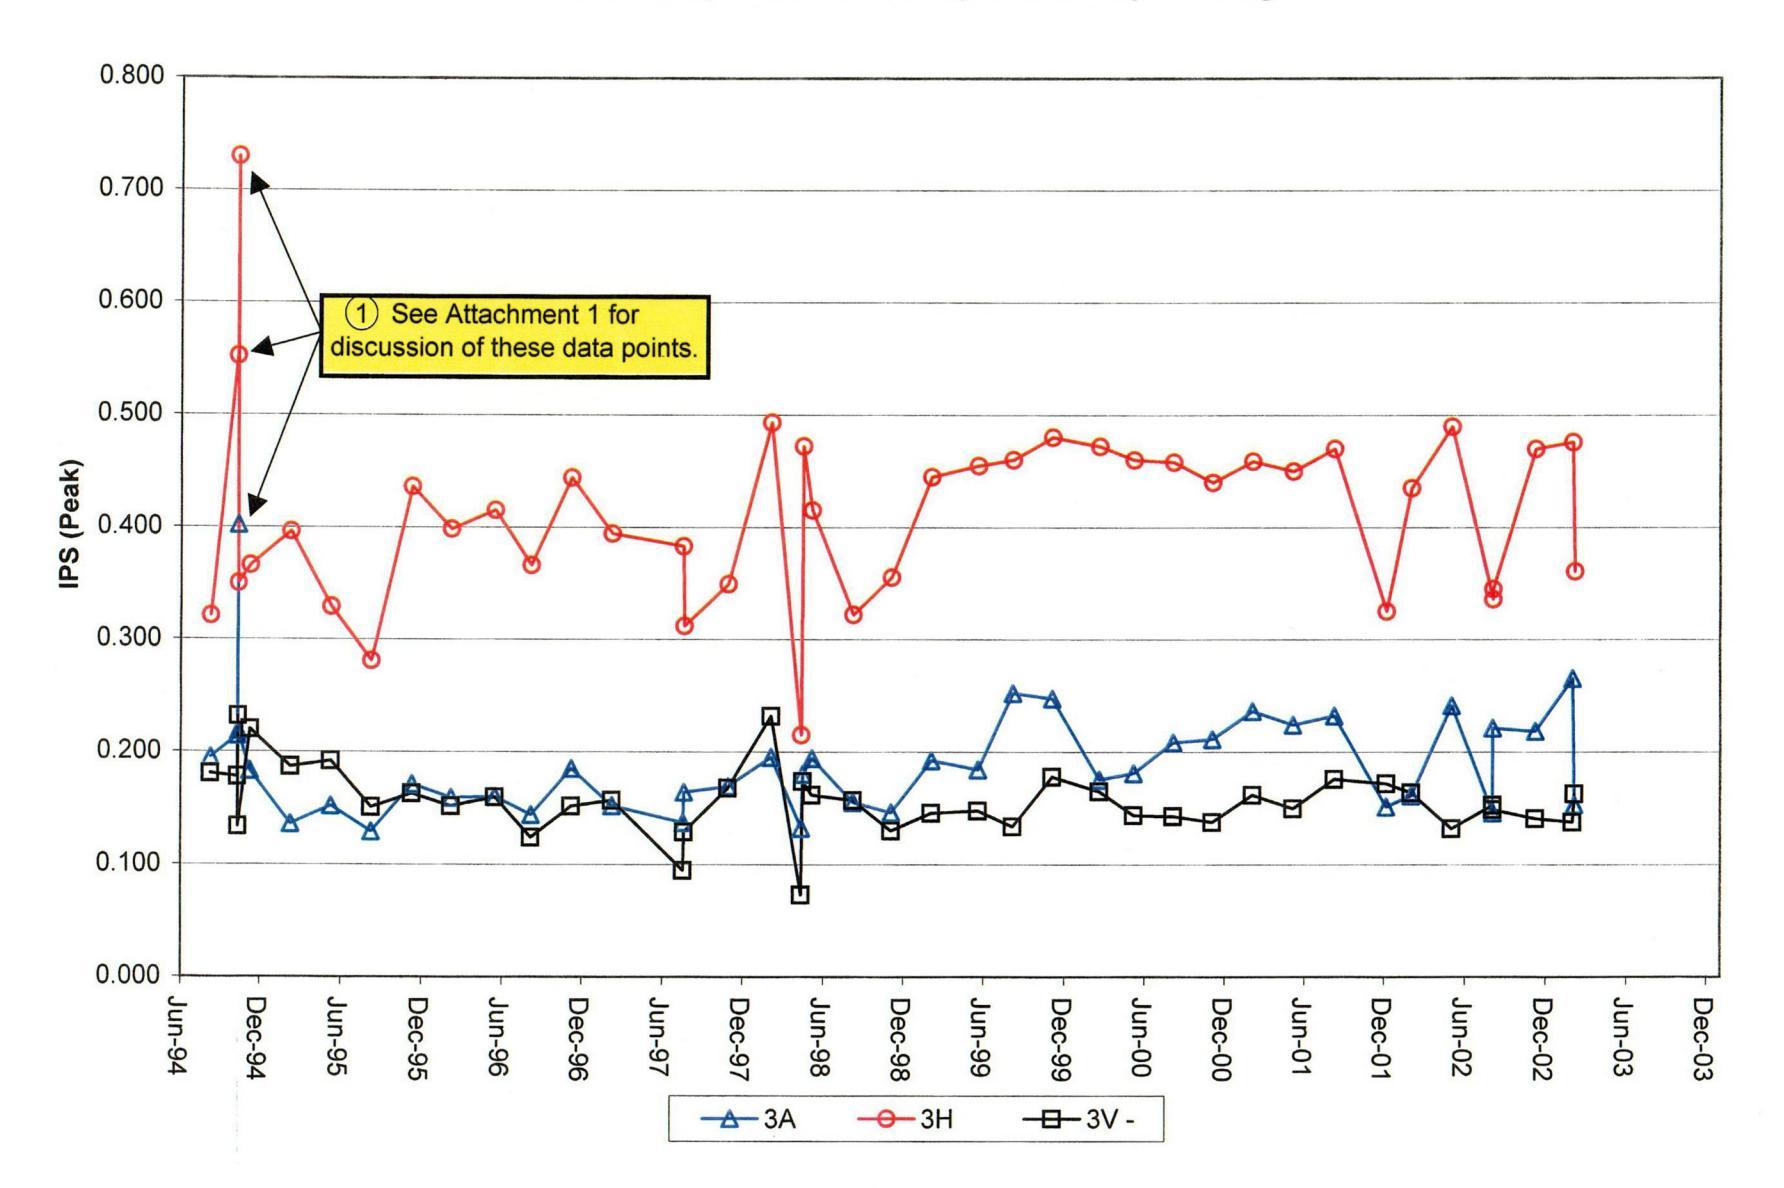
Inboard (relative to driver) Main Pump Bearing

① Identified points on graph entitled, Inboard (relative to driver) Main Pump Bearing:

The identified points correspond to data, which is above the alert range for the HPC pump vibration limits. The points are discussed below:

- o Data taken on 10/24/94 exceeded the 0.500 in/sec limit on point 3-H for IST.
- Data taken on 10/26/94 exceeded the 0.700 in/sec limit on point 3-H and the 0.325 in/sec limit on point 3-A for IST.

When the above readings were found the HPC pump was declared inoperable. In accordance with the referenced site practices, a condition report was initiated and an evaluation of the data was performed to determine the cause of the high vibration.

The results of the evaluation indicated that the above conditions were attributed to a turbine speed oscillation and other indication that was not reading accurately. This resulted in the turbine speed being set higher than the specified speed requirement for Section XI testing requirements. Although only point 3-H was specifically discussed in the engineering evaluation, the higher-than-normal vibration reading on point 3-A on 10/26/94 should have also been attributed to the same condition.

When the speed control problem was corrected and associated instruments were repaired and calibrated, the pump vibration test was re-performed on 10/27/94. The vibration data obtained was within the ASME Code and Relief Request limits, as applicable for the specific points.
