June 27, 2003 BW030054

> Braidwood Station, Unit 1 Facility Operating License No. NPF-72 NRC Docket No. STN 50-456

### Results of the Visual Inspections of the Braidwood Station Unit 1 Reactor Vessel Head

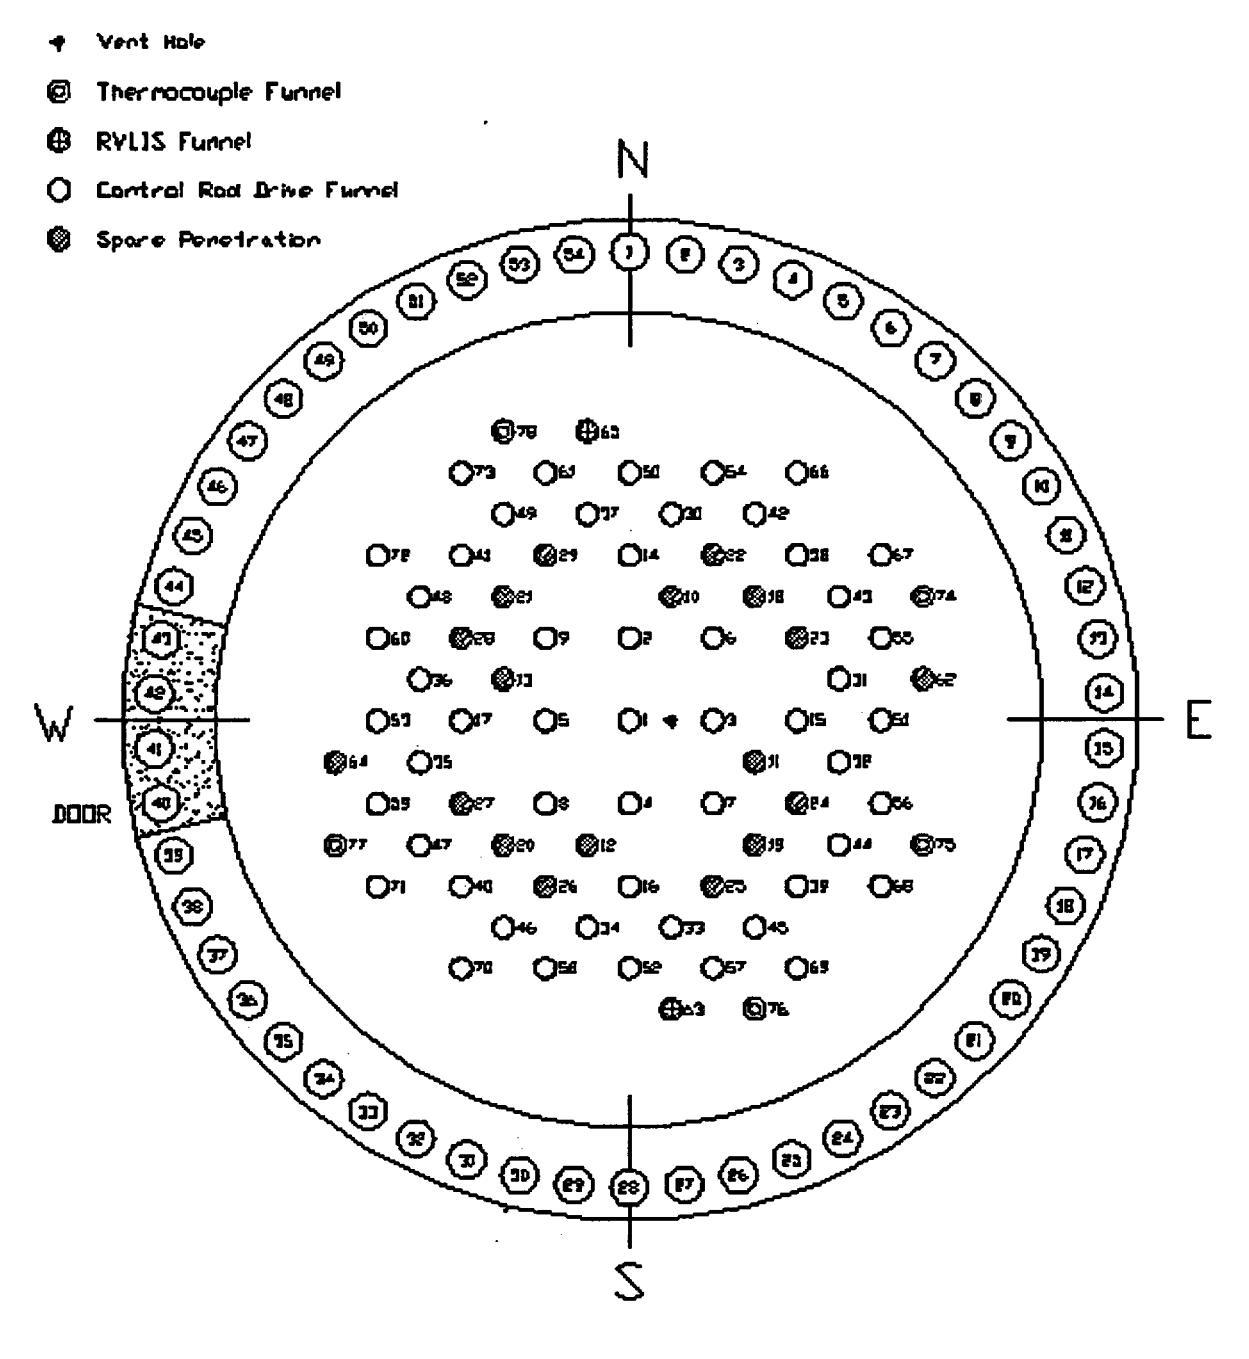
Figure 1 Braidwood Unit 1 VHP Map

The examination consisted of a qualified visual exam that covered 100% of the RPV surface including all 79 vessel head penetrations (VHPs). These VHPs include two Reactor Vessel Level Indication System (RVLIS) penetrations, 5 thermocouple penetrations, one vent pipe, 53 control rod drive mechanism penetrations, and 18 spare penetrations, (see Figure 1). The inspections were performed and the results evaluated by certified VT-1/VT-2/VT-3 examiners. The as-found and as-left examinations were performed using remote camera equipment with the inspections and results recorded on videotape.

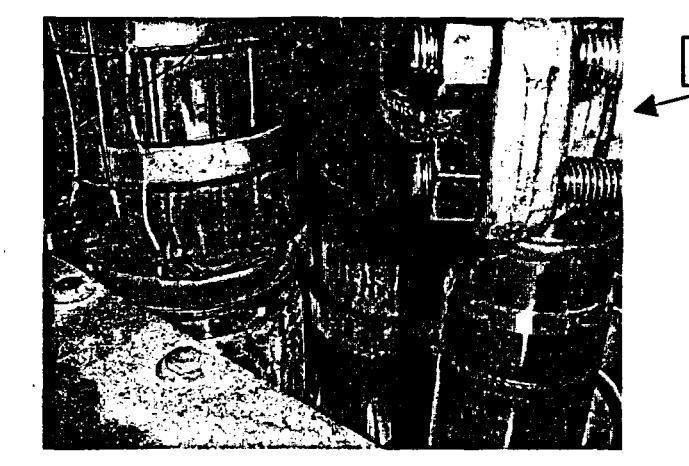
Photograph 6

footnote 2). Three smear samples from the area around the RVLIS #65 connection were collected and analyzed for isotopic activity. Based on the age calculations for Cesium and Cobalt, the conclusion was that the deposits were greater than 12 years old and consistent with the 1989 RVLIS connection leakage.

**RVLIS connection #65**
