Oyster Creek Generating Station  
Facility Operating License No. DPR-16  
NRC Docket No. 50-219

**Subject:** Response to Request for Additional Information Concerning the Fourth Ten-Year Interval Inservice Inspection Program

**Damage Mechanism Assessment for  
Class 1 and 2 Piping Systems at Oyster Creek**

**Report No. SIR-03-078  
Revision No. 0  
June 2003**

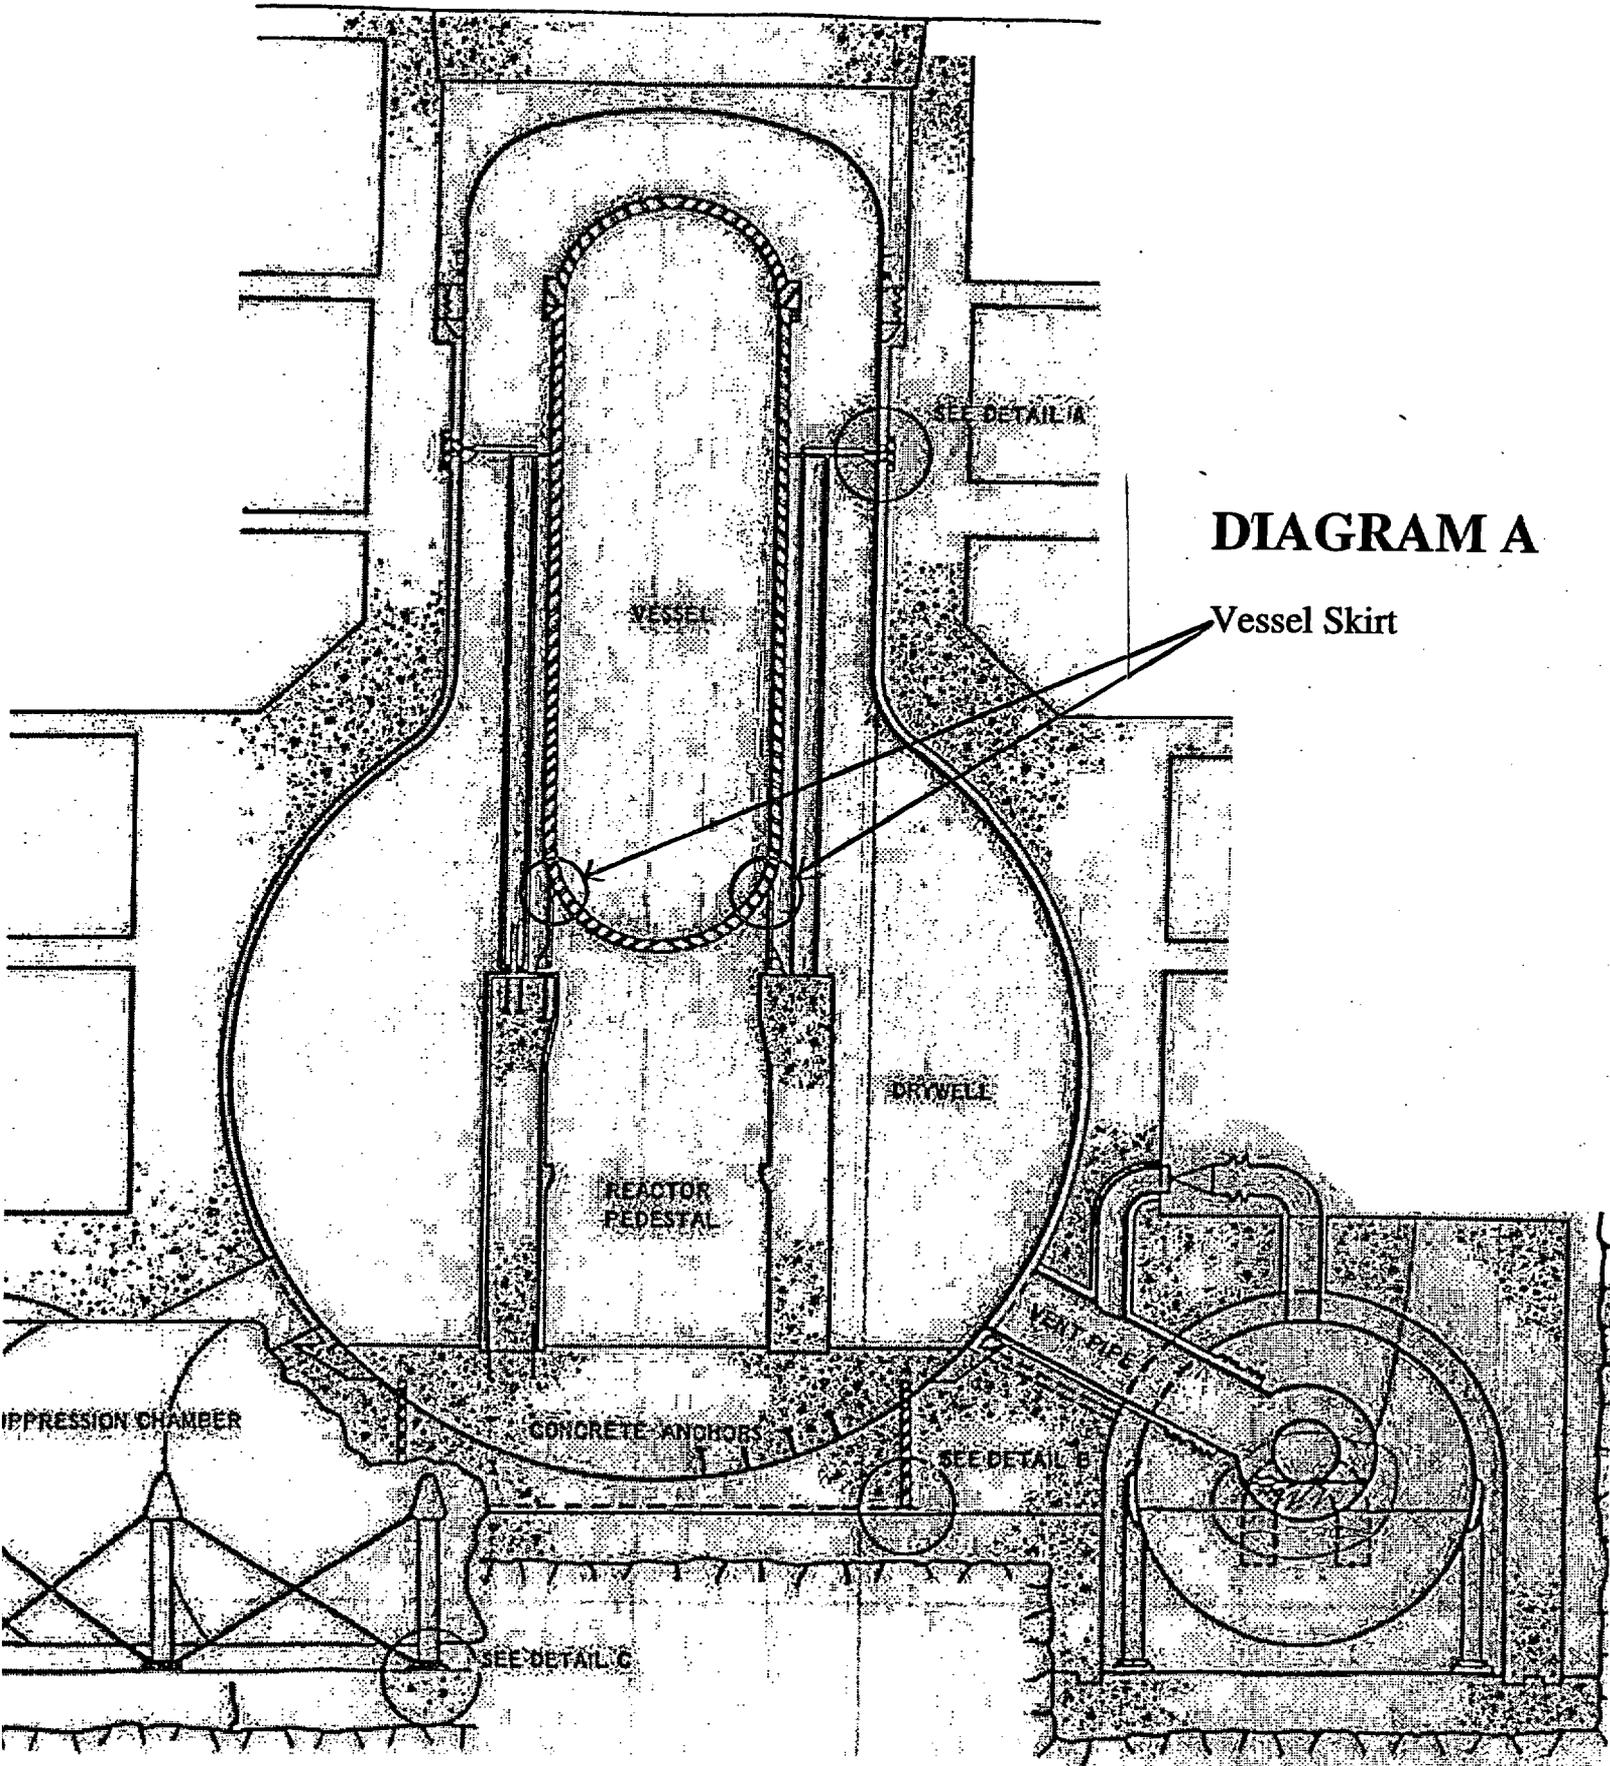
DIAGRAM A

The support skirt does not contain personnel access holes or inspection ports that would allow examination of the C-D surface area to the extent required by the Code. Attached Diagram A provides a view of the Oyster Creek vessel and the location of the vessel skirt. As discussed in our relief request, control rod drive housings and incore housings restrict access for examination of area C-D. Diagram B shows the location of the skirt, and as shown on Diagram B, no access points are provided for examining area C-D. Diagram C provides a closer view of the skirt and refers to Detail "E" which is shown in Diagram D. As discussed in the relief request, an ultrasonic examination was considered as an alternative, but as shown on Diagram D, the 1 1/2 inch radius demonstrates the limited capability to perform this type of exam. As discussed in the relief request, as an alternative to the code requirements, AmerGen proposed to perform a surface examination of area A-B, and perform a VT-3 visual examination of the IWB boundary as shown in Figure IWB-2500-13 of the relief request. This examination would inspect for support member degradation, which includes surface indications or defects.
