July 31, 2003

SUBJECT: NRC SPECIAL INSPECTION TEAM REVIEW AND NRC STAFF EVALUATION OF SOUTH TEXAS PROJECT, UNIT 1, REACTOR PRESSURE VESSEL BOTTOM-MOUNTED INSTRUMENTATION PENETRATION LEAKAGE INVESTIGATION AND REPAIR ACTIVITIES

Bottom-Mounted Instrumentation Nozzle Leakage Investigation and Repair Activities

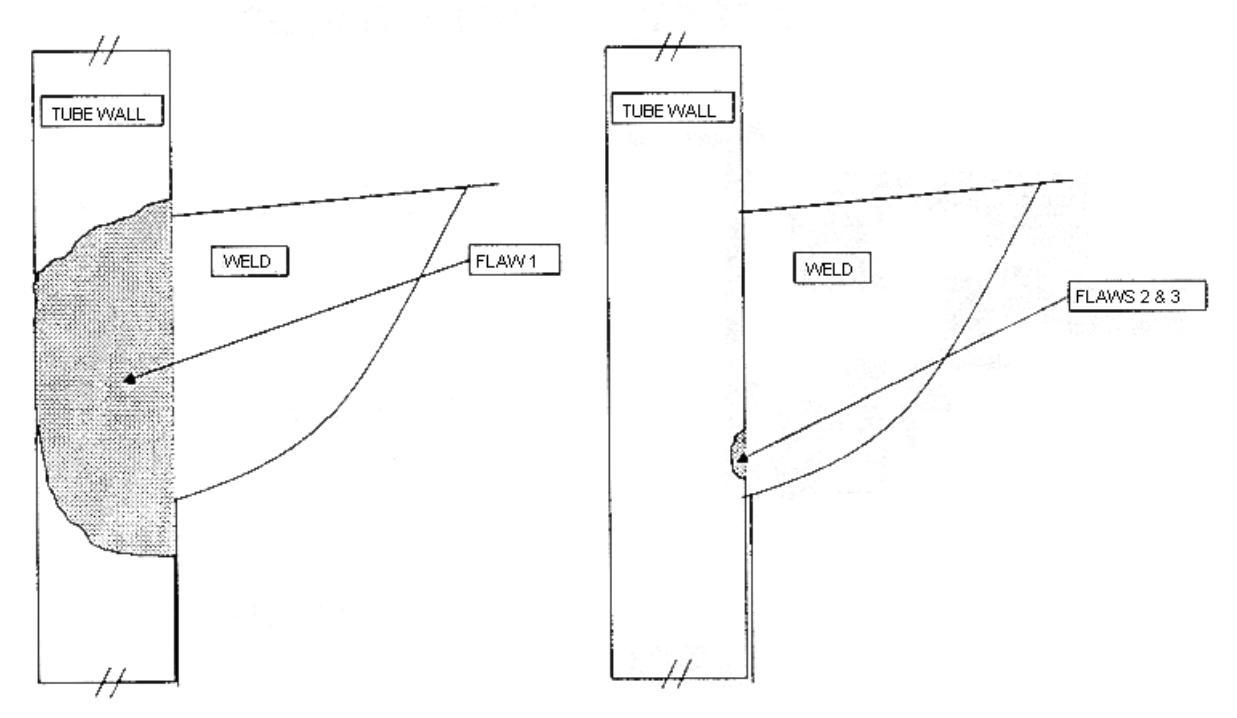
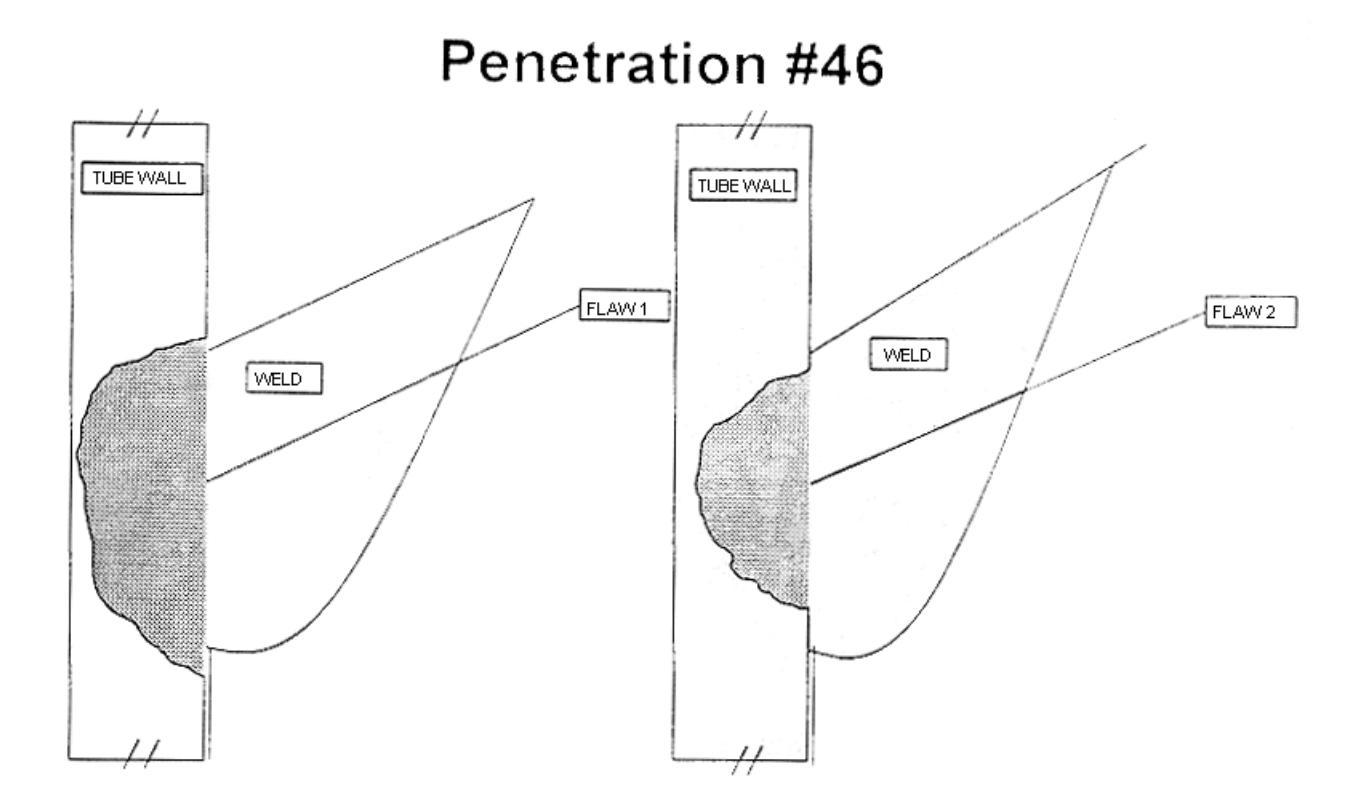
Penetration #1

As a result of NDE activities (1) and (3) above, the licensee reported three axially-oriented crack-like indications in the penetration 1 nozzle wall and two axially-oriented crack-like indications in the penetration 46 nozzle wall. As depicted in Figure 2, one of the indications in penetration 1 was characterized as an axial crack with a length of about 1.38 inches, surface breaking on the OD of the nozzle above and below the J-groove weld, as well as surface breaking on the ID of the nozzle. The ID surface breaking nature of this flaw was confirmed by the bobbin coil ETC. The other two indications in penetration 1 were characterized as being small, embedded (i.e., non-surface breaking) cracks near the interface between the nozzle wall and the root pass of the J-groove weld. As depicted in Figure 3, one of the indications in penetration 46 was characterized as an axial crack with a length of about 0.98 inches, surface breaking on the OD of the nozzle above and below the J-groove weld. The other indication in penetration 46 was characterized as an embedded crack having an axial length of 0.95 inches. Figures 2 and 3 were submitted to the NRC as part of the licensee's presentation at a public meeting held at NRC Headquarters on June 5, 2003. However, the UT inspections conducted by the licensee were not demonstrated to be effective for the purpose of examining the subsurface volume of the J-groove weld. Therefore, the licensee's depictions of the indications as shown in Figures 2 and 3 may be incomplete with respect to subsurface cracking of the J-groove weld material. No crack-like indications were identified in any of the other 56 STP, Unit 1, BMI nozzle penetrations [Reference 2].
