> July 30, 2003 LIC-03-0100

# SUBJECT: Response to Request for Additional Information - Ft. Calhoun Station Steam Generator Report (TAC No. MB6954)

## Response to NRC Request for Additional Information Ft. Calhoun Station Steam Generator Report

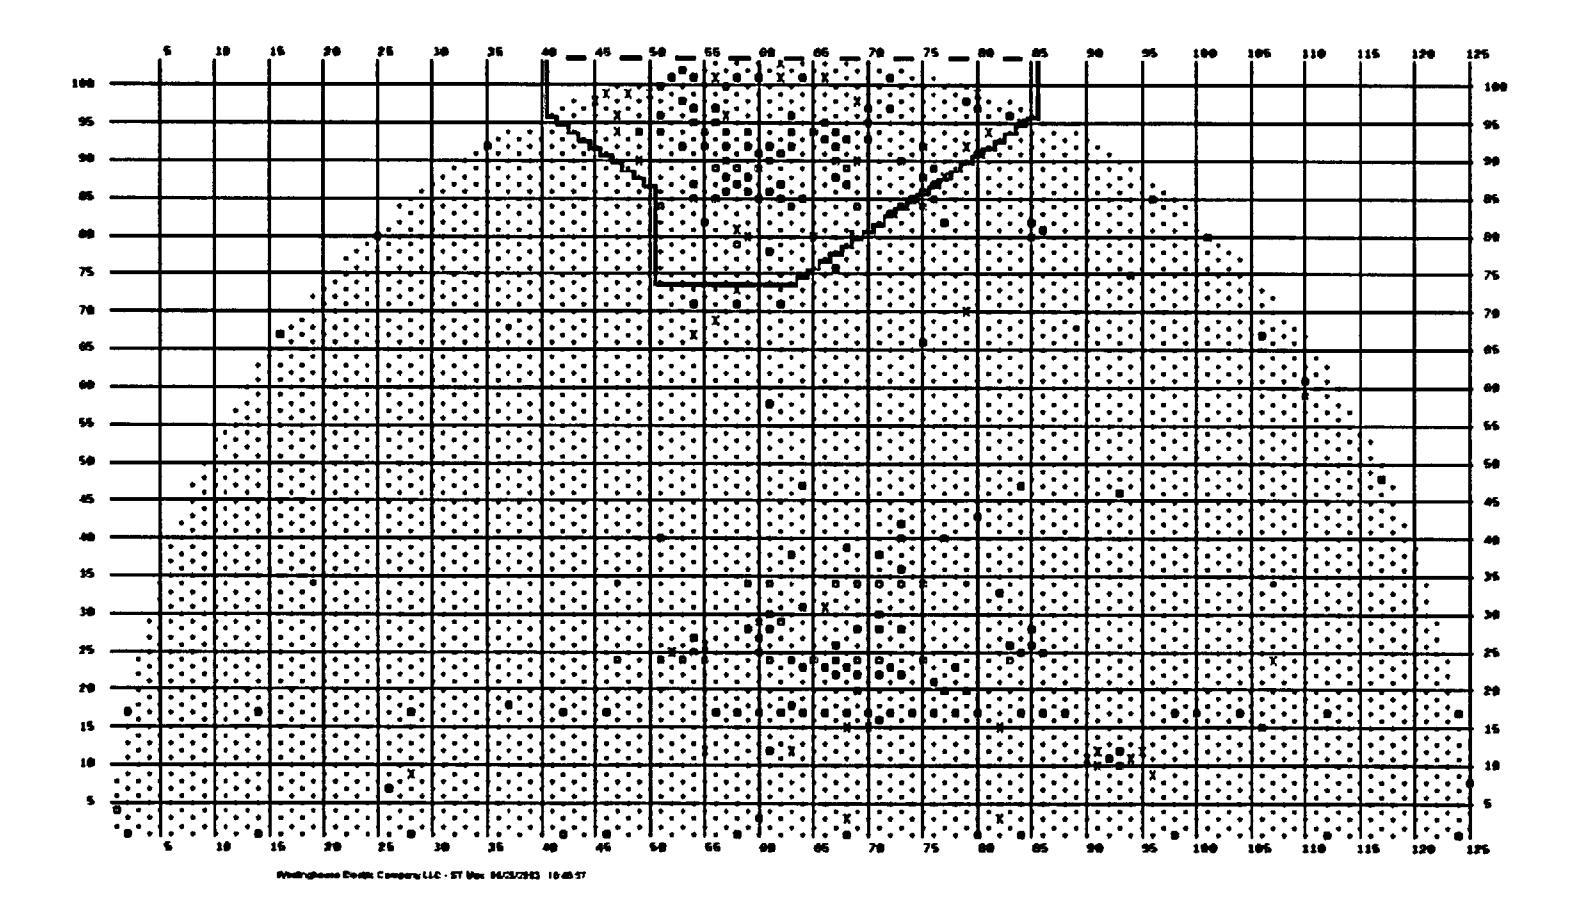
# Figure 1

Tables 3 and 4 provide this information for all of the flaws detected in the last examination and figures 1 and 2 are tubesheet maps with the locations of flawed tubes and their proximity to the critical area. ODSCC indications were identified in the critical area which were only detected by the MRPC probe. However none of these flaws were challenging from a leakage or structural integrity perspective (the deepest was estimated at 40% TW based on plus point amplitude sizing). In addition, no degradation of the type defining the CA were observed in the buffer zone and additional program expansion was not required per the EPRI PWR Steam Generator Examination Guidelines, Revision 5.

#### SG - A TUBES REPAIRED DURING 02RFO

X 44 TUBE PLUGGED IN 2002

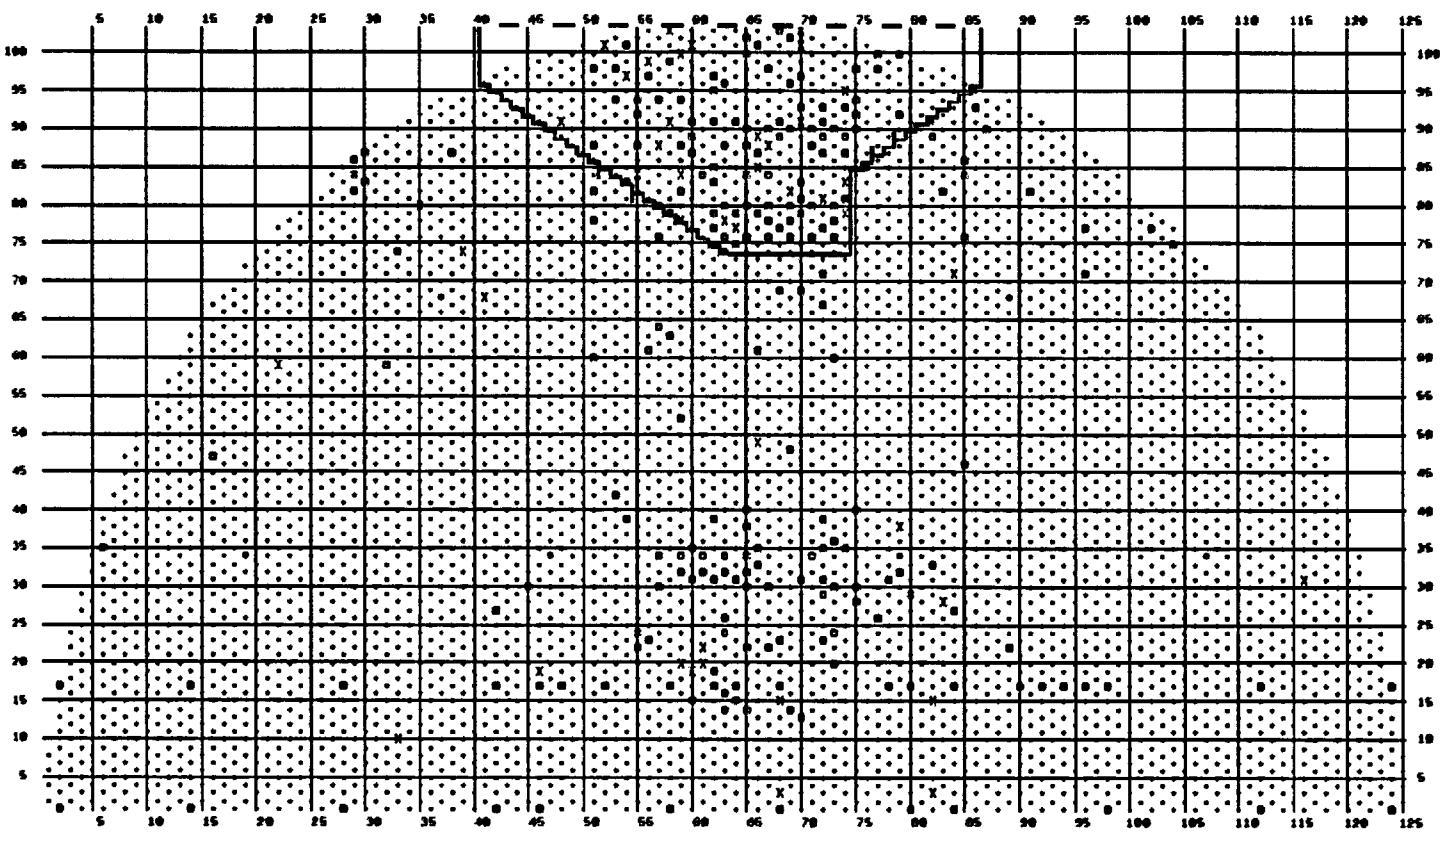
# Figure 2

## SG - B TUBES REPAIRED DURING 02RFO

X 44 TUBE PLUGGED IN 2002
