SUBJECT: Indian Point Nuclear Generating Unit No. 2  
Docket No. 50-247  
**Proposed Change to Technical Specifications:  
One-Time Change to the Indian Point 2 Steam  
Generator Tube Inspection Requirements**

**ATTACHMENT I**

**PROPOSED CHANGE TO TECHNICAL SPECIFICATIONS:**

**ENTERGY NUCLEAR OPERATIONS, INC.  
INDIAN POINT NUCLEAR GENERATING UNIT NO. 2  
DOCKET NO. 50-247**

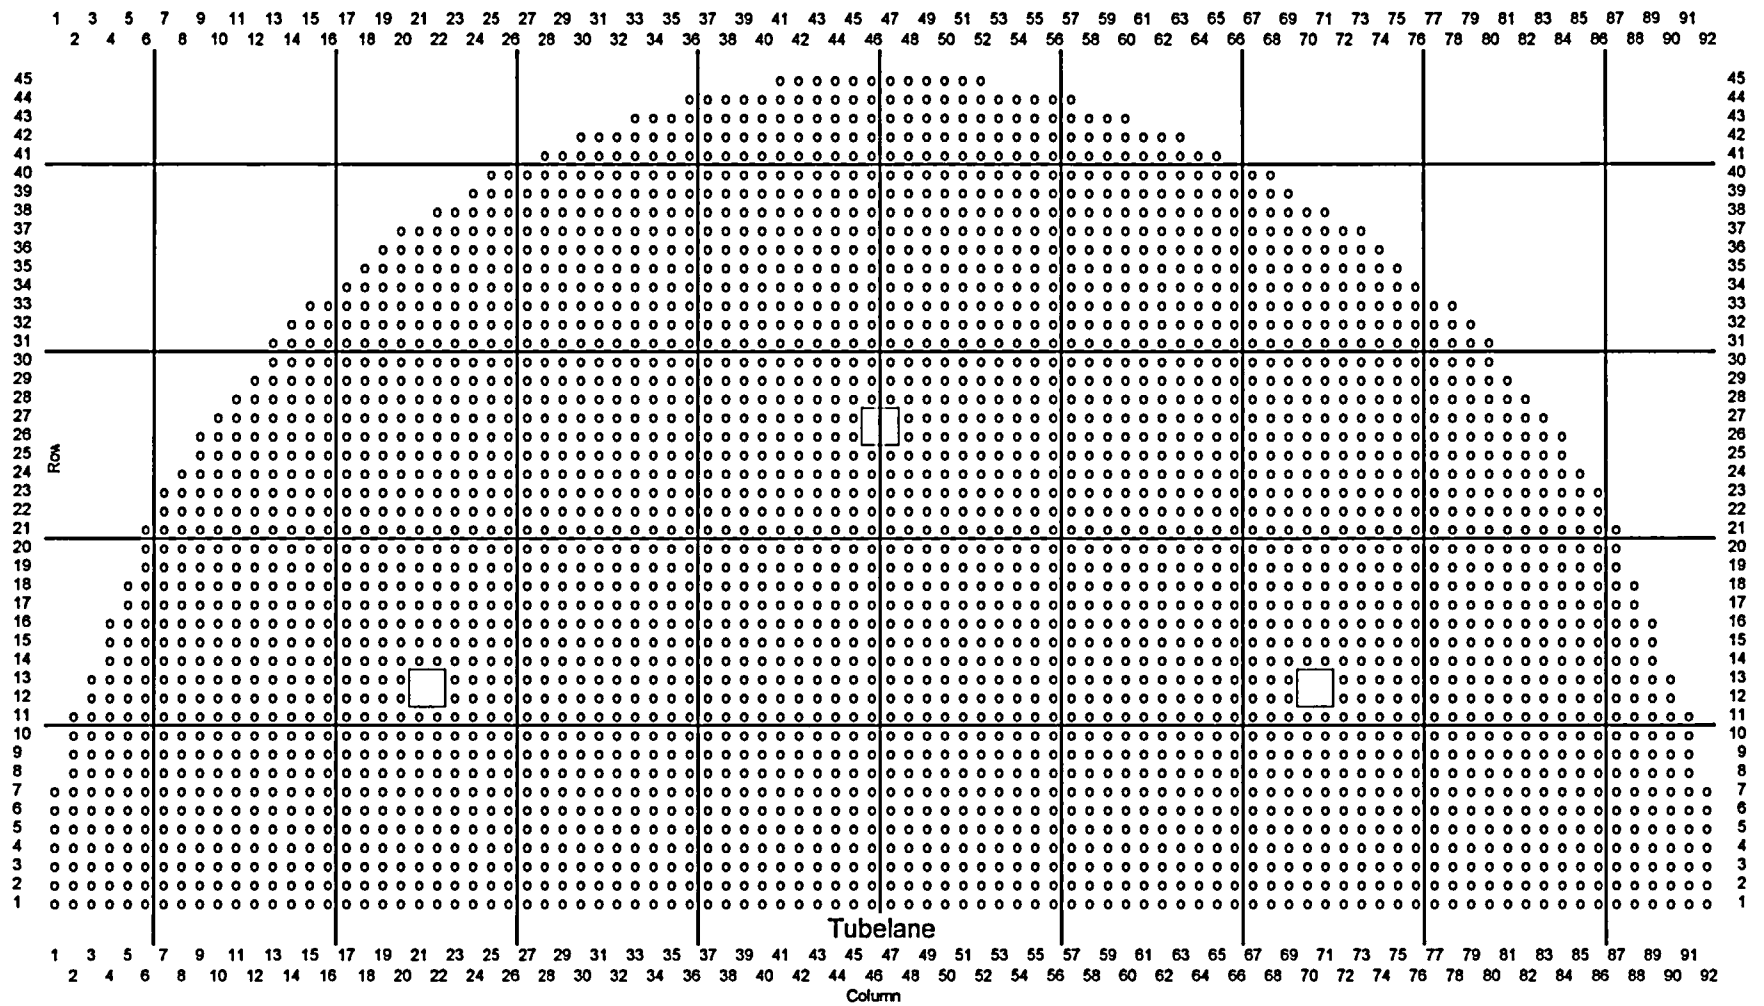
An analysis has determined that with each type of object the time required to wear a tube down to 40% through wall (assuming 20% initial tube wear) is greater than 2 operating cycles. From the eddy current inspection program it has been determined that these foreign objects did not produce any indications of tube wear. Table 1 provides a detailed list of the foreign objects that were observed. Figure 2 provides the SG Tubesheet Map (one leg).

Steam Generator Tubesheet Map (one leg)  
 Westinghouse Model 44F (Indian Point 2)  
 Column 1 is the nozzle side of SG
