February 5, 2004 NOC-AE-04001674 10CFR50.73

South Texas Project Unit 2 Docket No. STN 50-499 Licensee Event Report 2-03-004 Standby Diesel Generator 22 Failure

1. FACILITY NAM	ЛЕ							2. DOC	CKET NUME	ER			3. P	AGE		
South Texa	is Unit?	2							050	<u>)0(</u>) 499			1	OF	7
4. TITLE			-							-						
Standby Diesel Generator 22 Failure

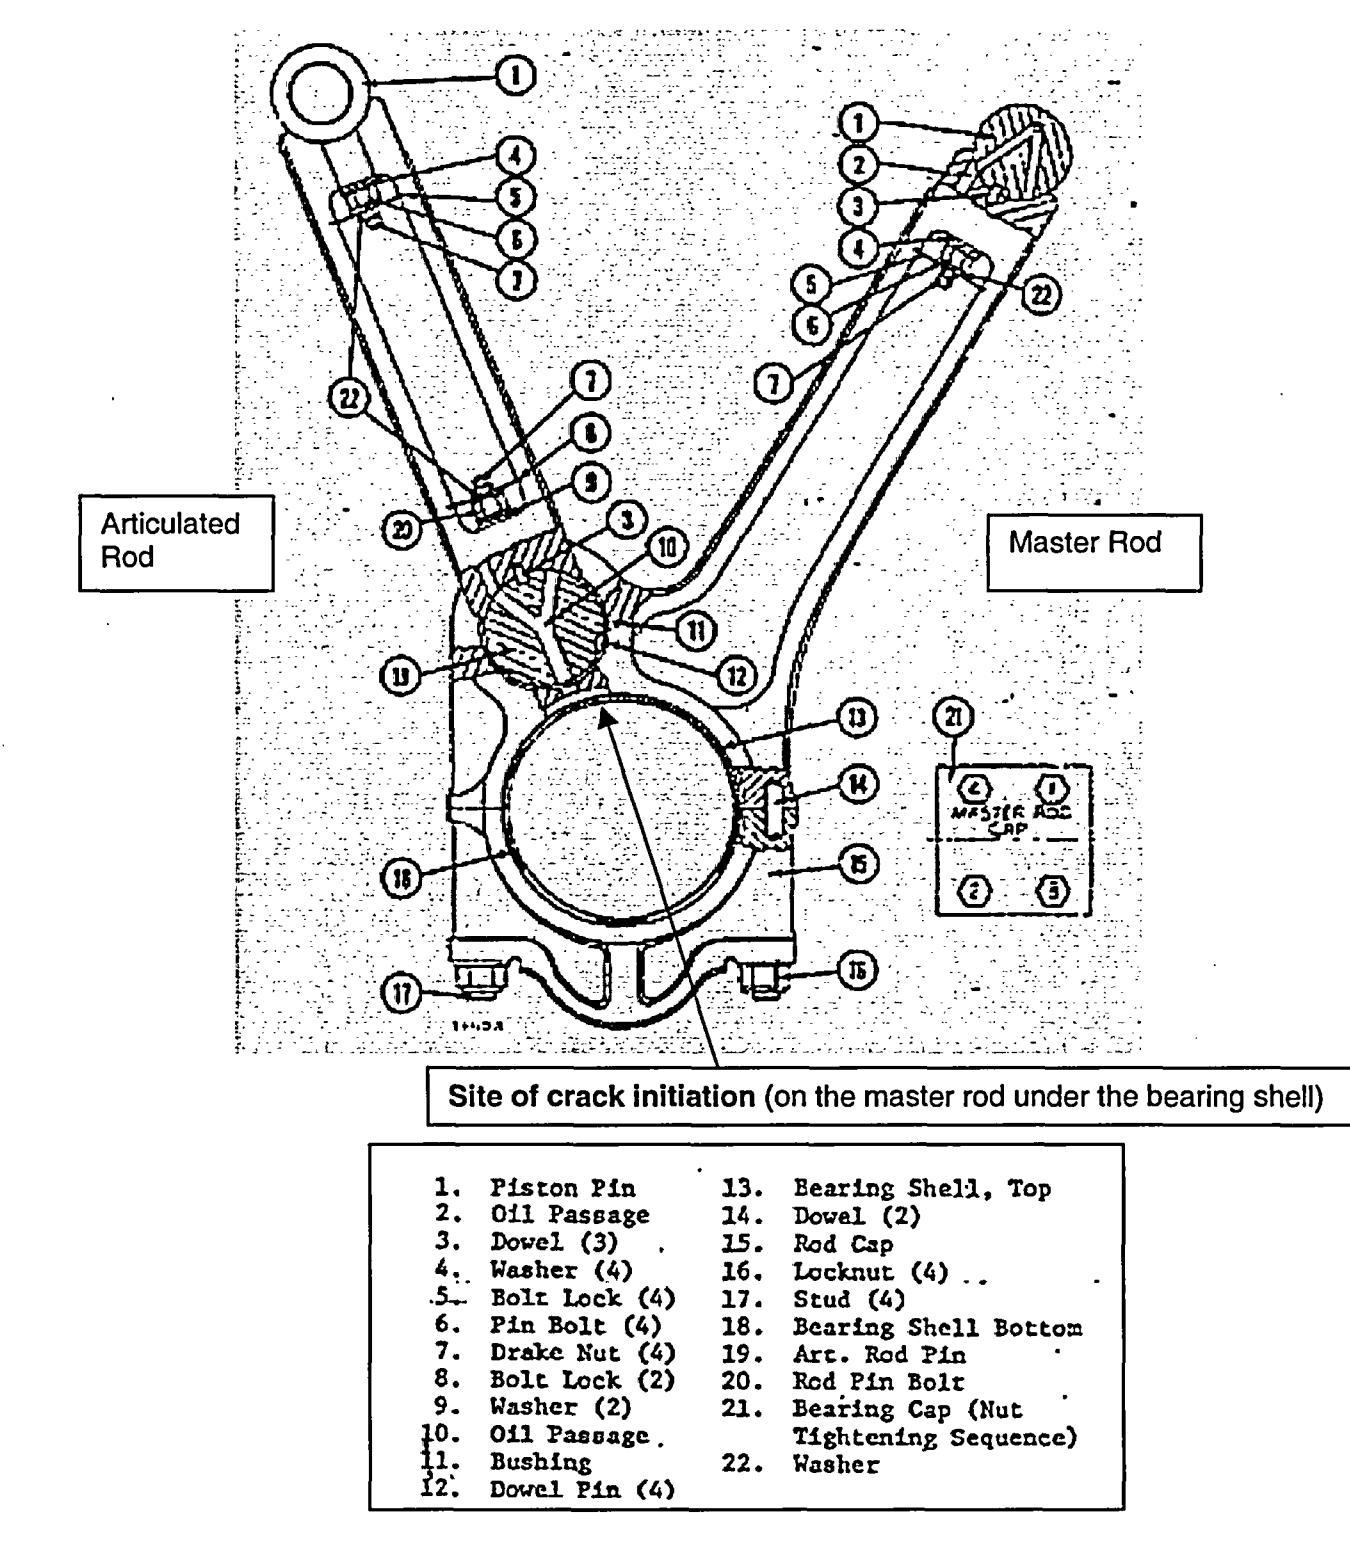
Attachment 1 Diagram of Connecting Rods

The root cause of the failure is microcracks that developed on the position 9 Master Connecting Rod during the manufacturing process. The microcracks later propagated due to high cycle fatigue until the master connecting rod failed.

See Attachment 1 for a diagram	showing the n	naster and	articulated	rods.			
I	Damage Assessment and Inves	tigation						
 	Following the incident, the Star was controlled to protect the ir Pictures were taken of the dan anything being moved or touc incident were interviewed and d	ndby Diesel G ntegrity of frac naged diesel a hed. All Ope ata collected b	enerator 2 tured surf and the ejections perations period efore the content	2 room was aces for fut ected compo ersonnel on end of shift.	s cordone ure metal onents on duty and	d off Ilurgic the fi d invo	and ac al ana loor pri lved ir	ces lysis or t า th
1 (1 1	initial examination of the engi cylinders and corresponding major components were ejecte included:	ne revealed c oving parts. F d out of the rig	lestruction Portions of ght (east)	of the 9-F the engine side of the	light (9R) center fra engine.	and ame v The ej	9-Left vith se ected j	(91 vera part
