No. I-04-004

February 11, 2004

SEARCH UNDER WAY FOR RADIOACTIVE SOURCES MISSING FROM N.J. SITE

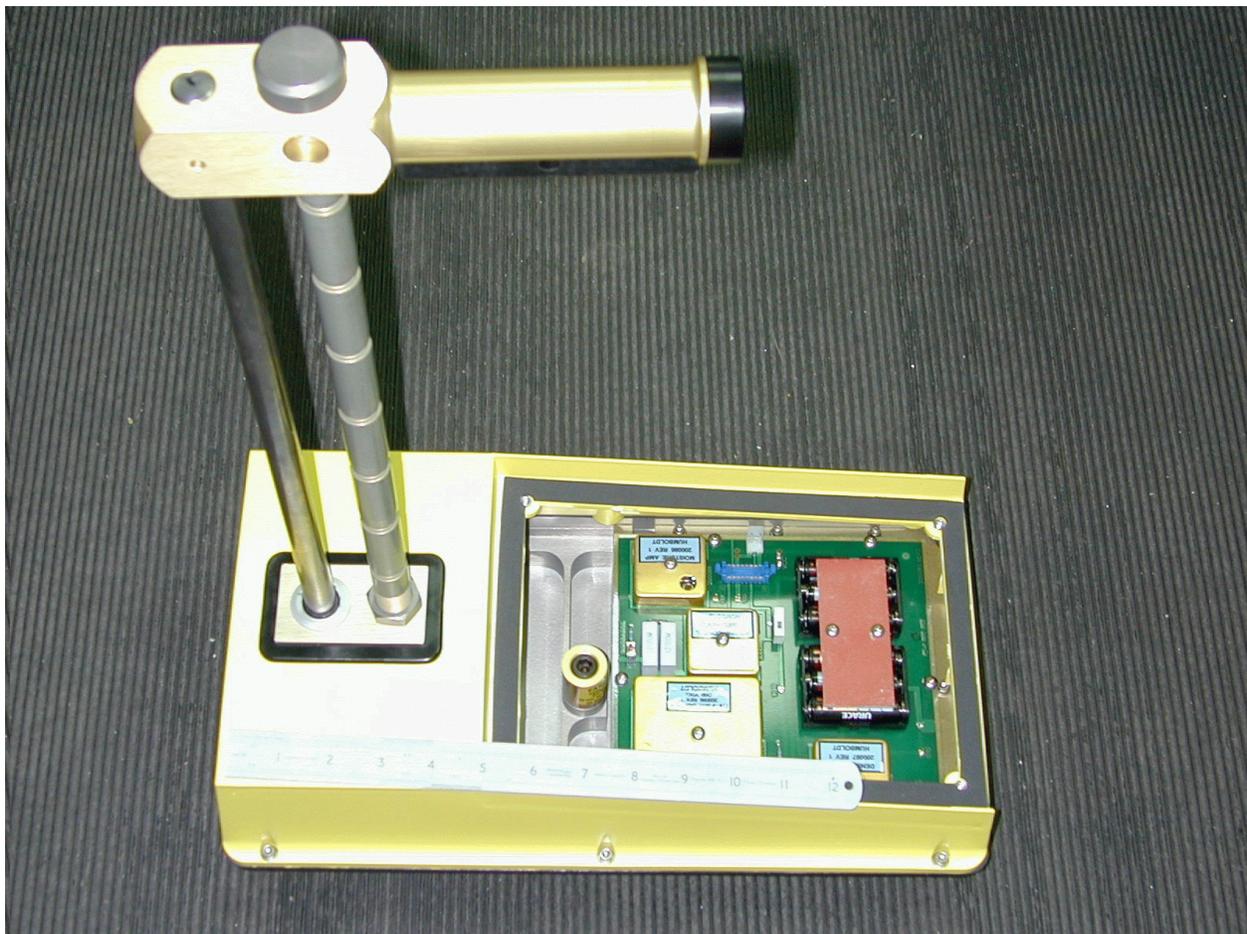
Shown above is the type of moisture density gauge involved, with its lid removed. One of the sources would be at the bottom of the long handle at far left, while the other source would look like the small cylindrical component found in the center of the device.
