SECTION 6

FRACTOGRAPHY AND OTHER EXAMINATIONS

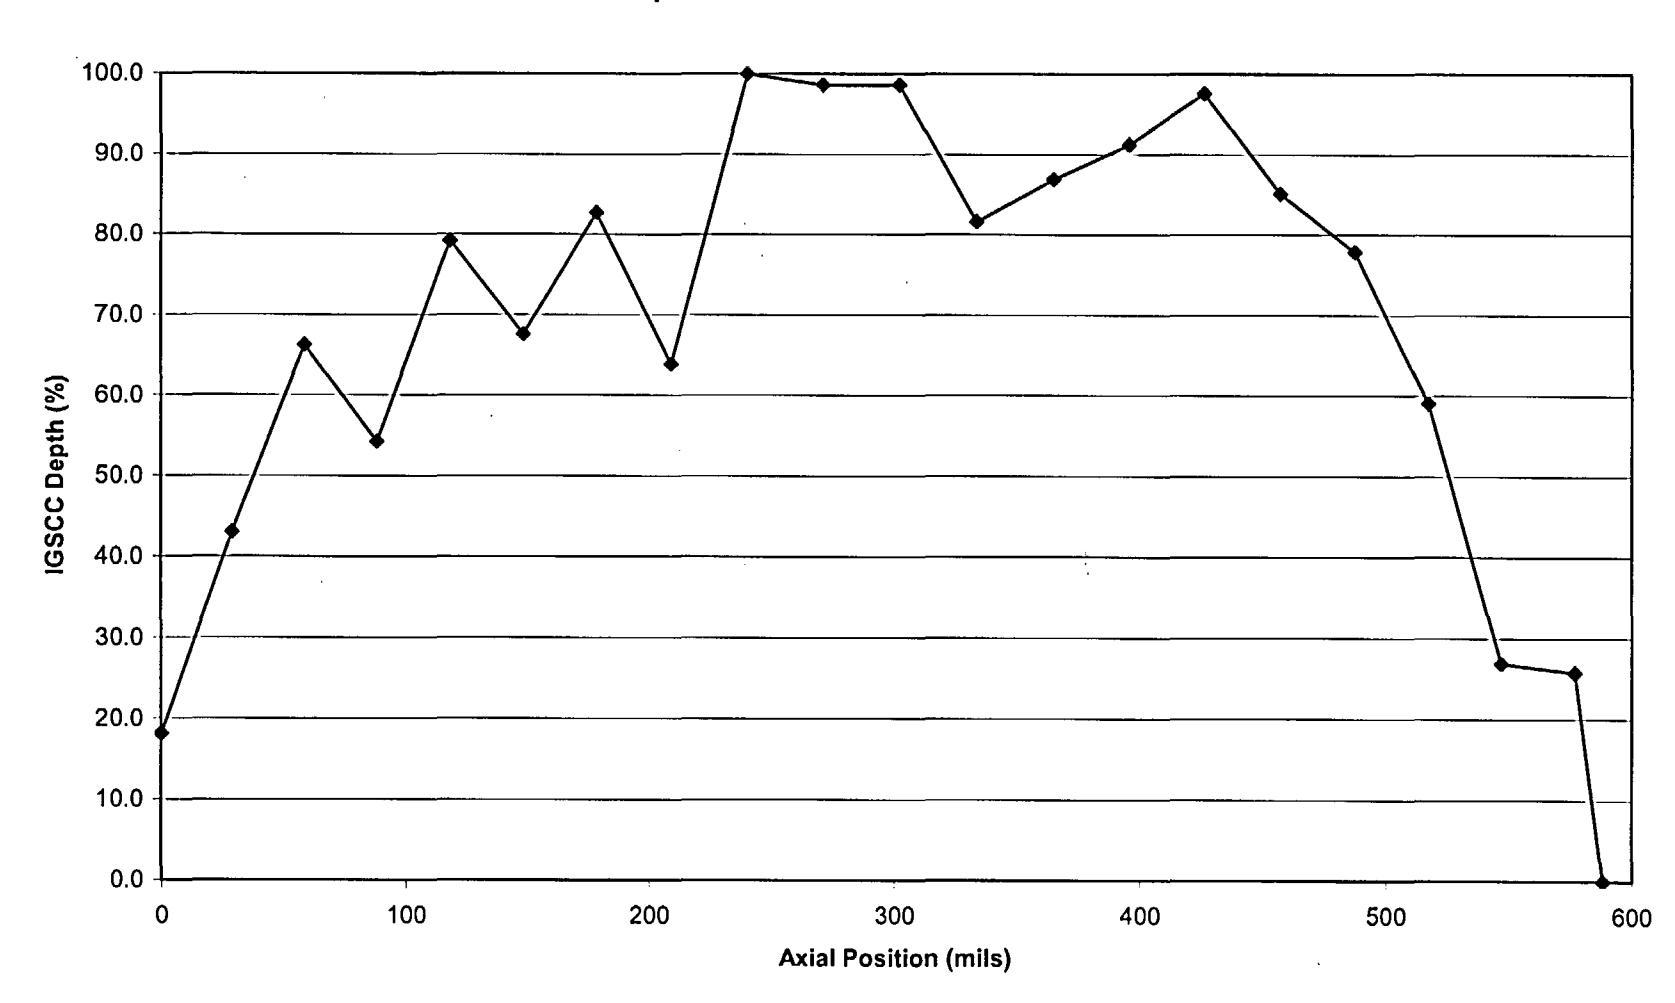
Figure 6-2 R10C39 - Piece 3B - Section 3B2A - Burst Fracture IGSCC Depth Profile Associated with H02 Plate

The H02 plate intersection of the R10C39 HL tube was identified to contain an SAI by both field and laboratory eddy current inspections. Following completion of the leak and burst testing, the burst specimen from the H02 plate was sectioned to allow fractography of the burst opening, as well as the area adjacent to the burst. The azimuthal location of the burst opening was 90°. A 1.125-inch long piece containing the burst opening was cut from the burst specimen. A longitudinal section containing the burst fracture was removed to facilitate the examination of the burst plane. The burst face contained both intergranular and ductile fracture features. The length of the axial cracking was approximately 0.6 inch and did not extend outside of the tube to plate intersection. A montage showing the burst fracture face is shown in Figure 6-1 while the intergranular fracture profile is shown in Figure 6-2. Examination of the fracture profile confirmed the through-wall extent of the intergranular cracking at one location. This region is shown in Figure 6-3, while areas illustrating both ductile and intergranular fracture features are shown in Figure 6-4. The average depth of the intergranular cracking over the length of the indication was 30.6 mils or 66.5% through-wall based on an original wall thickness of 46 mils in the area of the indication. The original wall thickness was determined by averaging the thickness obtained at the ends of the burst specimen at or near the azimuthal orientation of the Examination of the fracture face showed a number of ductile ligaments within the burst. intergranular regions. The dimensions of these ductile ligaments are summarized in Table 6-3. while photomicrographs illustrating the general appearance of the ligaments are provided in Figure 6-5. :

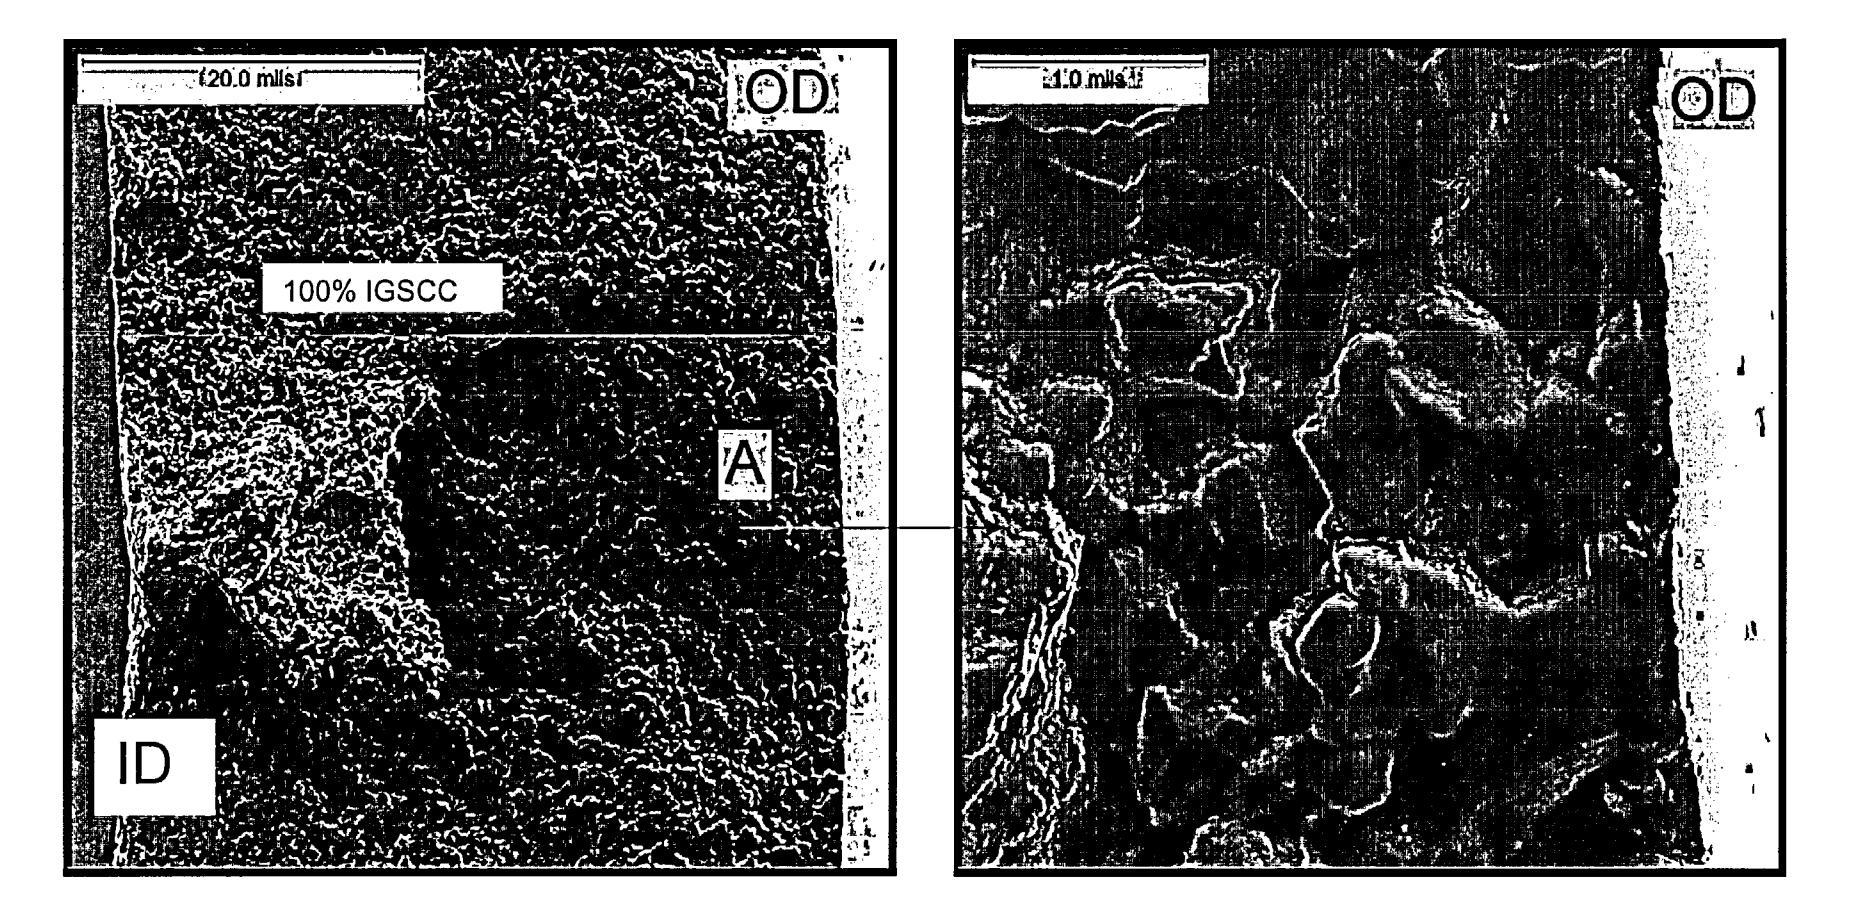
Figure 6 – 3 R10C39 – Piece 3B – Section 3B2A (H02 Plate) SEM Photographs Showing Through-Wall IGSCC Fracture Features

The fracture face contained a considerable amount of foreign debris. This is typical when a bladder, foil, and lubricant are required to perform the burst test. Nevertheless, the grain facets are defined, although somewhat rounded. This is typical of OD-initiated IGSCC. Examination of the OD surface adjacent to the burst showed no unusual features, although evidence of a shallow axial scratch was noted. The OD surface adjacent to the burst opening is shown in Figure 6-6. Based on the apparent lack of oxide deposit, the shallow scratch likely occurred during the tube removal process.

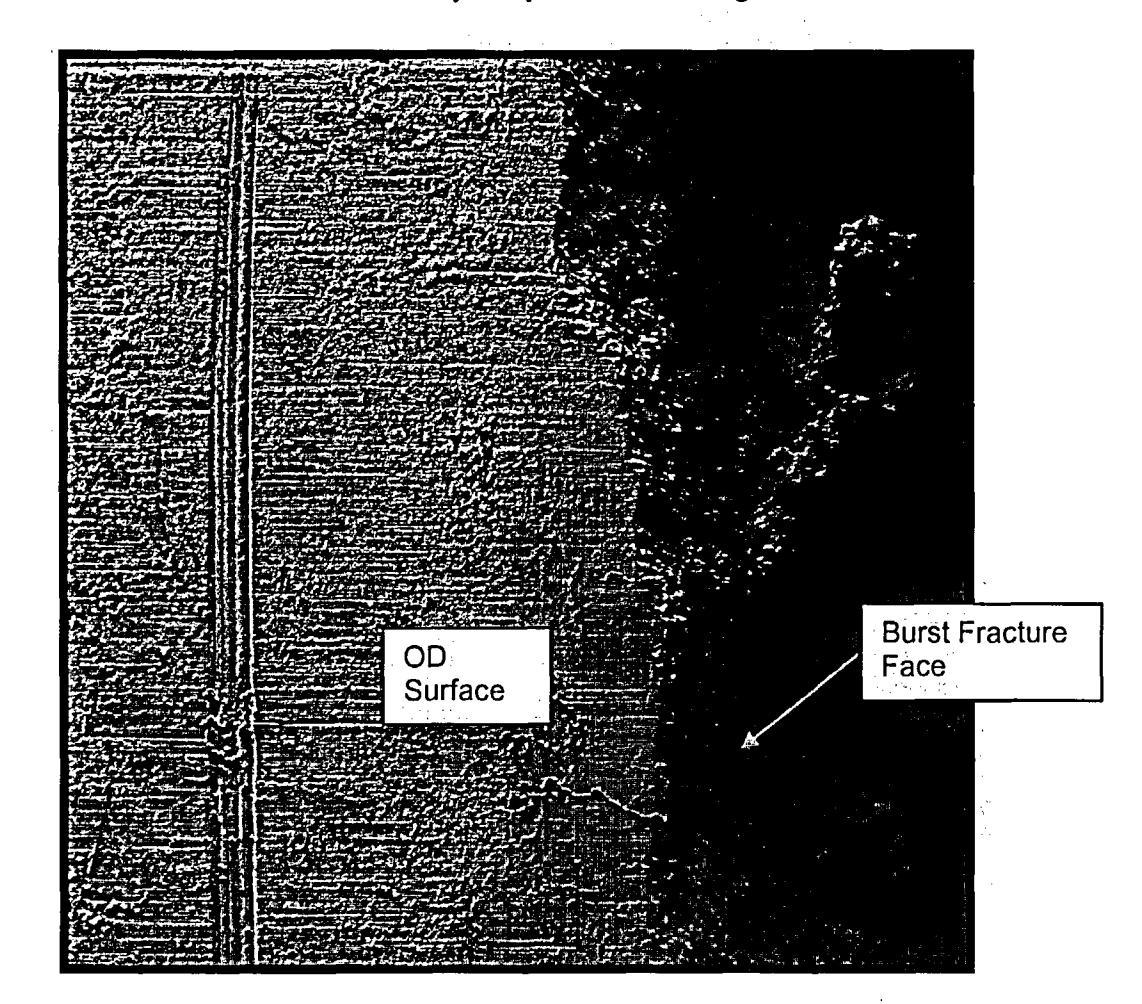
Note: Axial surface anomaly likely occurred during tube removal

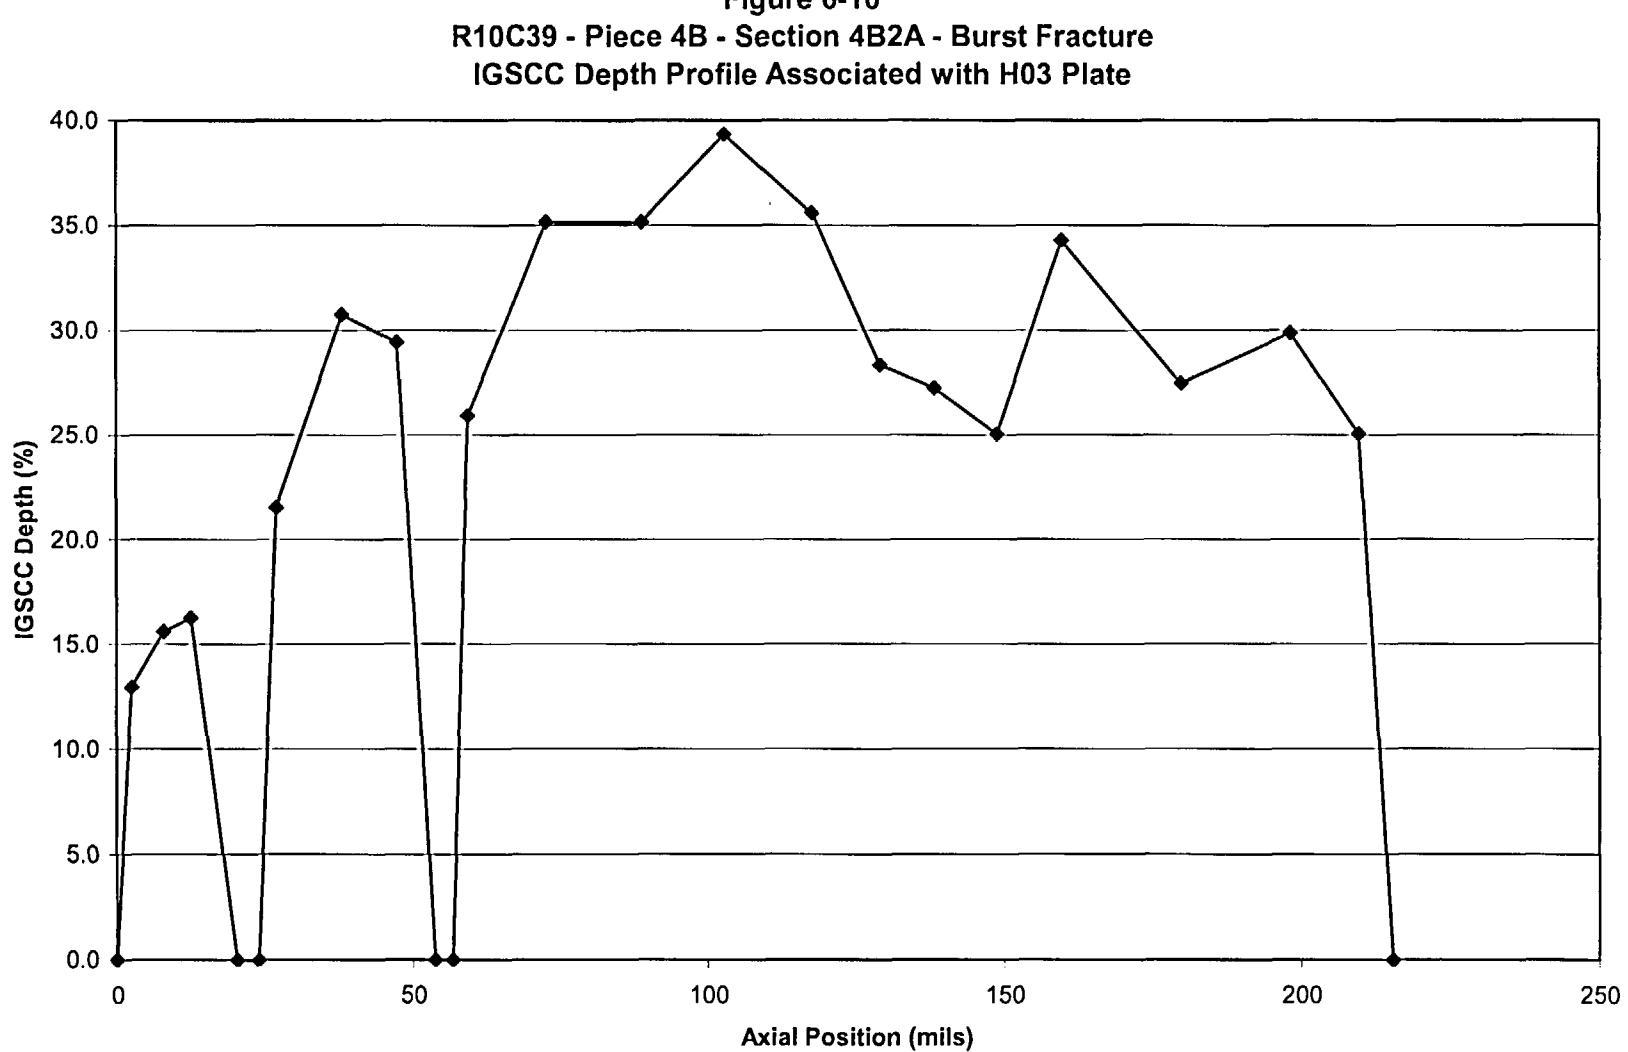
Figure 6-10

As seen in Figure 6-10, the crack profile illustrates three (3) individual cracks separated by nondegraded ligaments. Based on the appearance of crack face and the presence of ligaments exhibiting ductile fracture, the intergranular fracture face contained multiple crack fronts. Figure 6-11 presents a fractograph of the partial throughwall IGSCC observed at the H03 plate, while Figure 6-12 illustrates the OD surface adjacent to the burst. The delineation between the intergranular fracture near the OD surface and the ductile fracture near the ID surface is easily seen. The fracture face near the OD has a "rock-candy" appearance which is typical of Alloy 600 intergranular cracking. The fracture face near the ID has a "dimpled" appearance which is characteristic of ductile tearing. The region of ductile tearing was the result of non-corroded metal being torn apart by hoop tensile stresses during the burst test. This surface appearance is typical of burst-tested non-degraded Alloy 600 steam generator tubing. The somewhat rounded appearance of the grain facets seen in Figure 6-11 suggests a thick surface oxide or deposit. This appearance is typical for OD-initiated stress corrosion cracking of mill annealed Alloy 600.

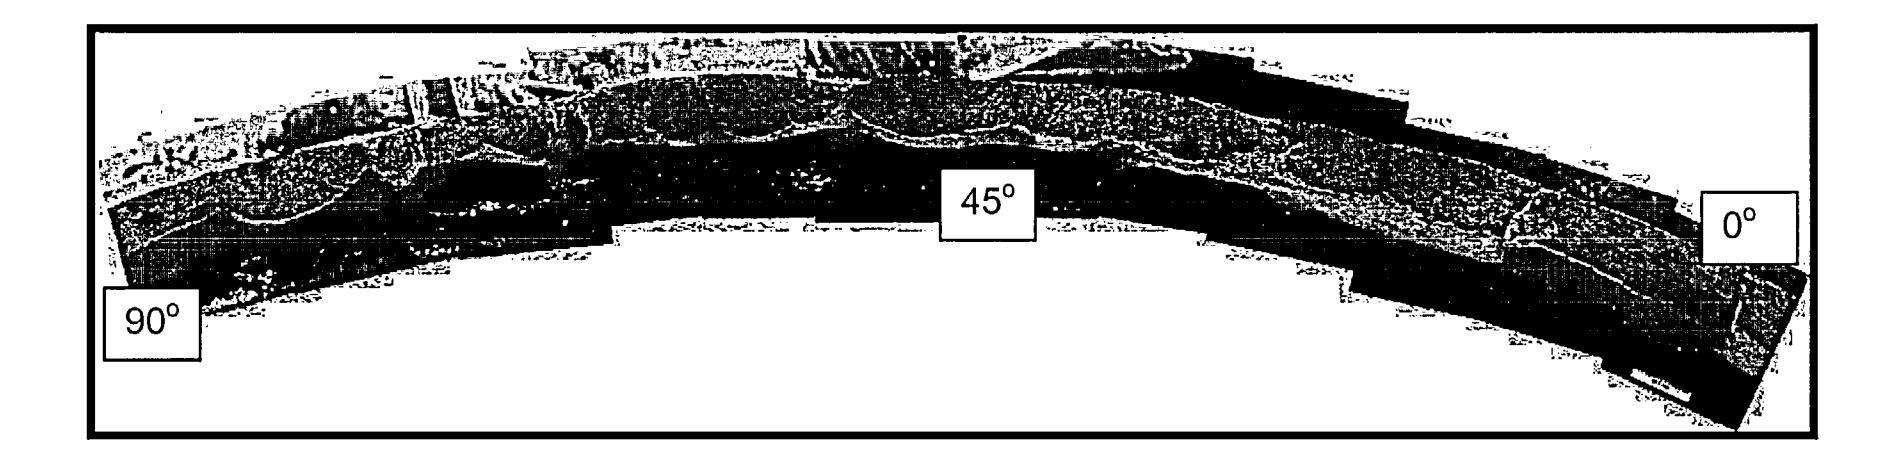
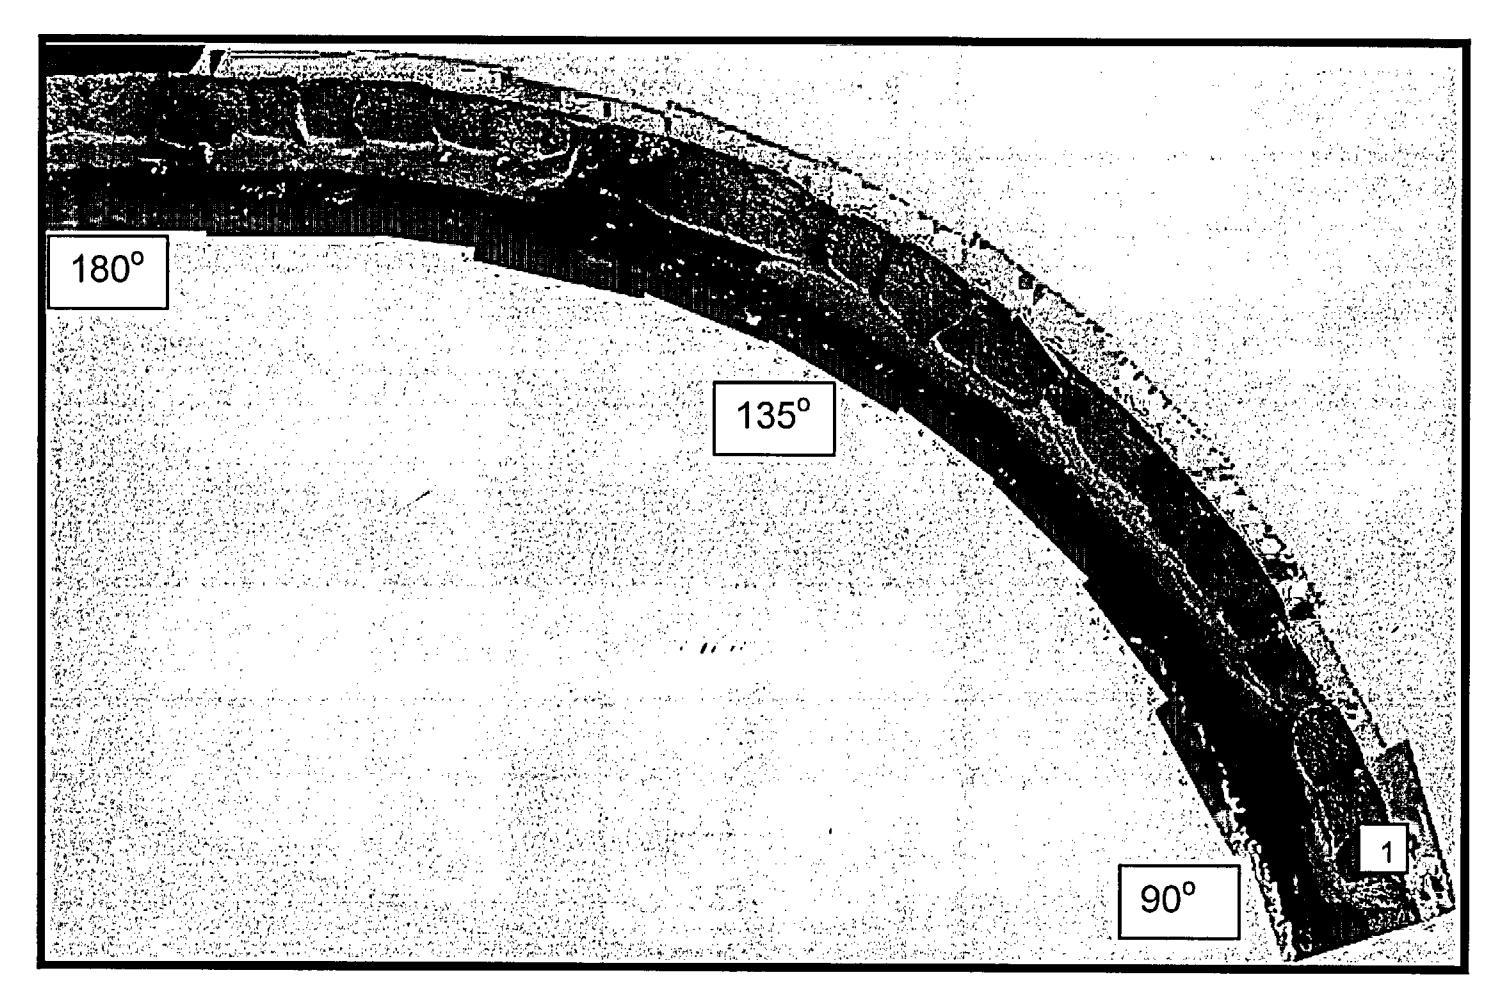
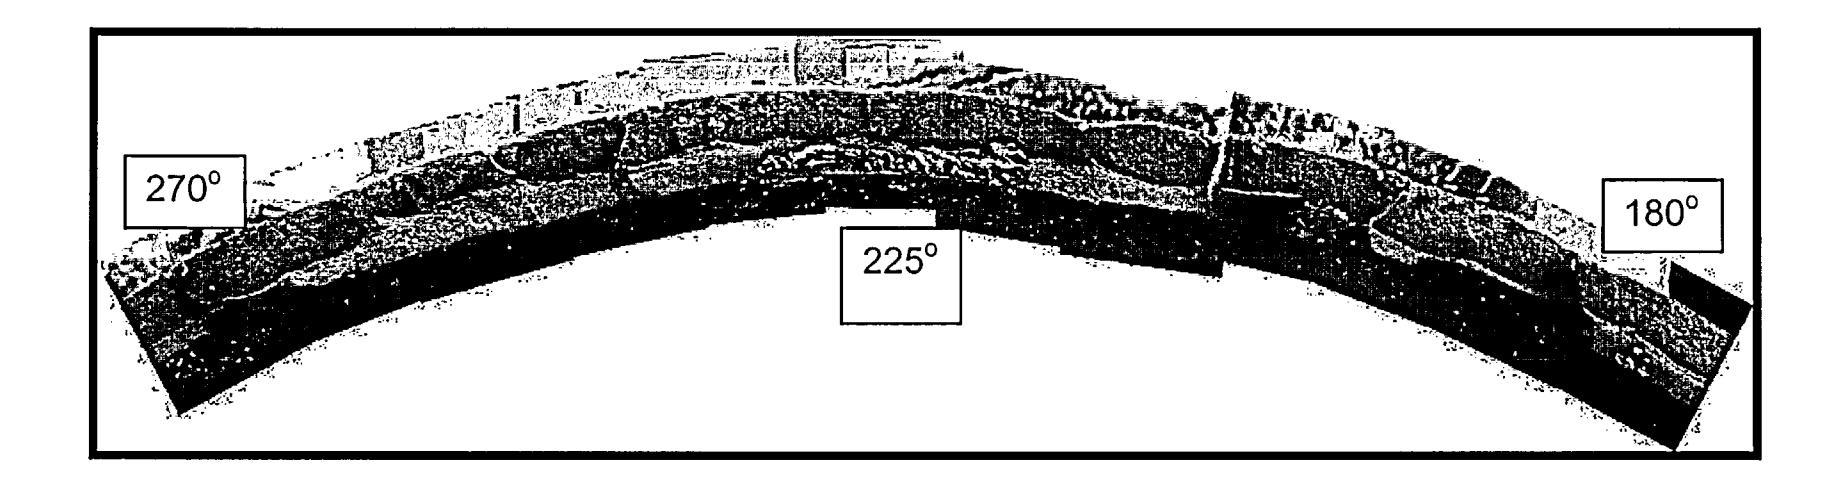
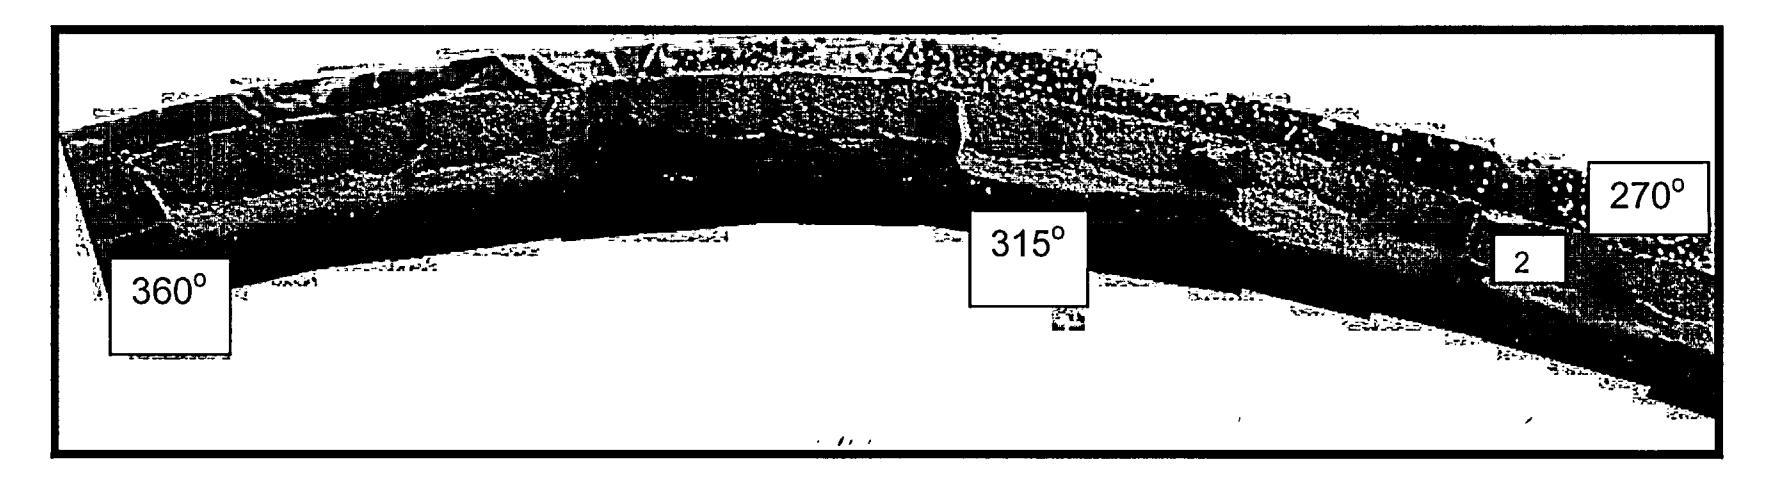
Figure 6 – 16 R11C41 – Piece 2B – Section 2B1B Fracture Face Montage (0° to 90°) of Circumferential Indication @ TTS

The SEM examination revealed the degradation to be intergranular stress corrosion cracking that initiated at the OD surface of the tube. Multiple crack planes were seen with evidence of ductile ligaments connecting the crack planes. The crack planes did not appear to extend outside the expansion transition. A series of montages showing the appearance of the fracture surface are provided in Figure 6-16. The intergranular crack depth profile measured on the fracture face is shown in Figure 6-17. Figure 6-18 are SEM photomicrographs showing the general nature of the indication. These micrographs clearly indicate the degradation originated

at the OD surface. The transition from intergranular SCC to ductile tearing is seen at higher magnification, as are ductile ligaments. The maximum depth of intergranular cracking was 28.7 mils or 61% through-wall based on a 47-mil original wall thickness. The average depth of the indication was determined to be 20.3 mils or 42.3% through-wall. As noted previously, the fracture face exhibited multiple intergranular short cracks interconnected with ductile ligaments. No effort was made to determine the area of the ductile ligaments or to perform EDS analyses of the fracture face.

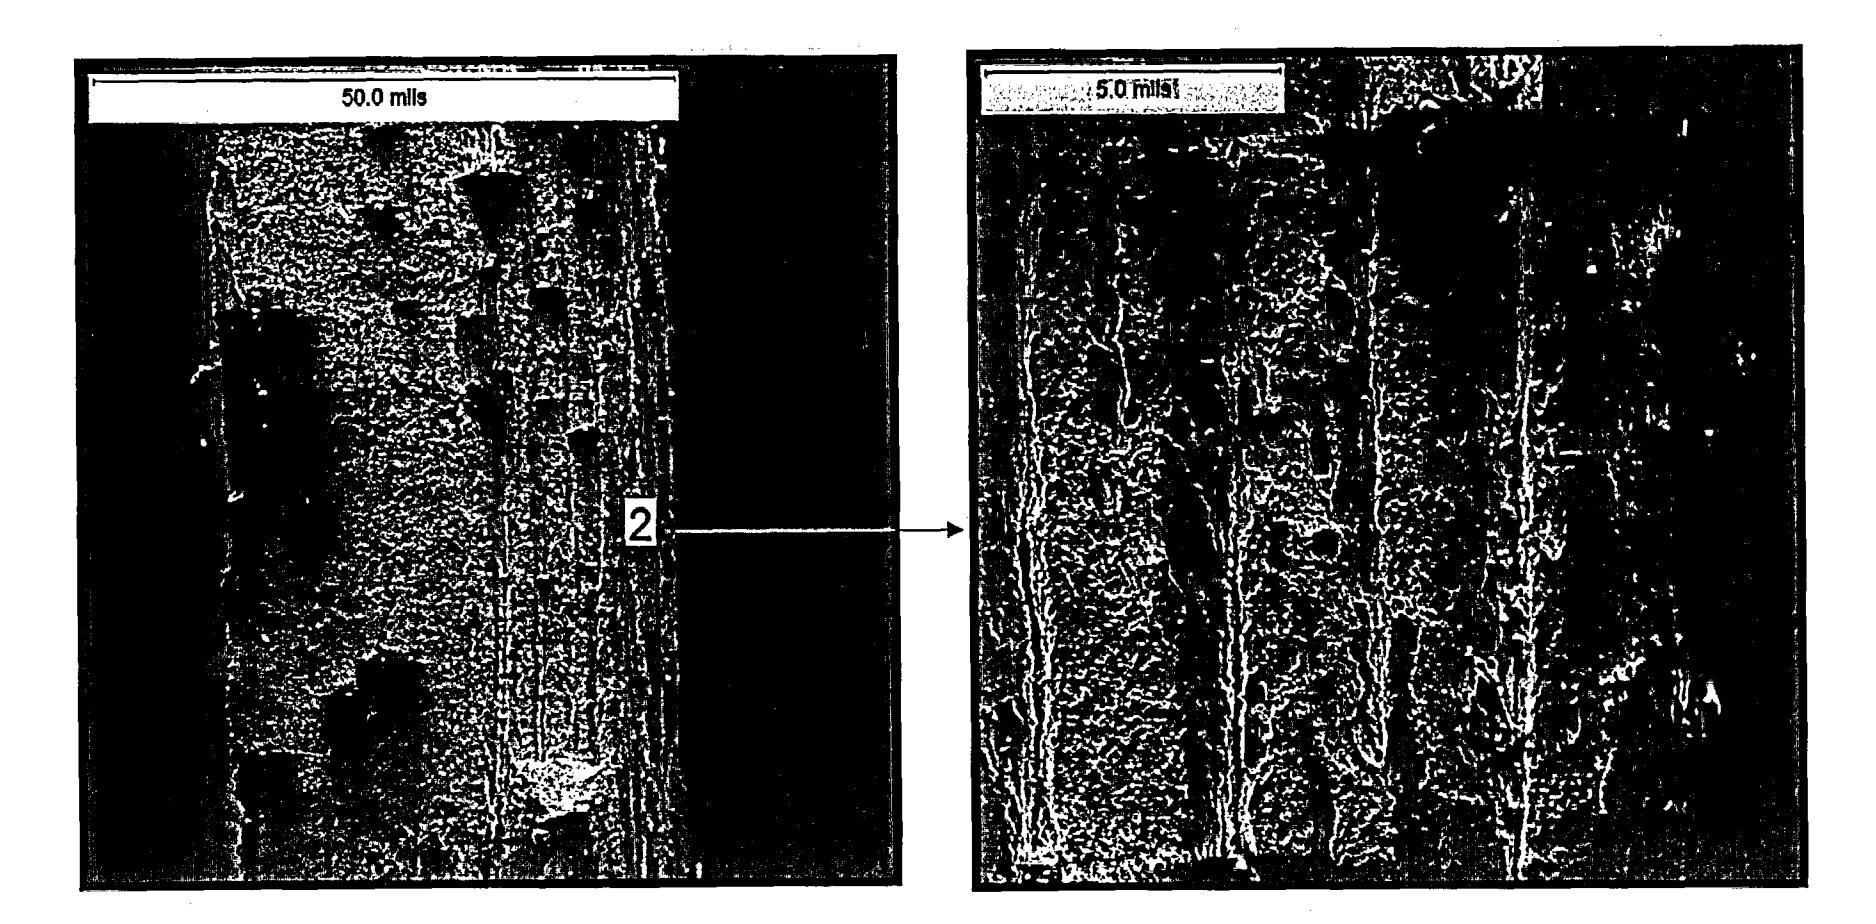
Figure 6-19 R11C41HL – Piece 2B – Section 2B2A General Appearance of Freespan Burst Fracture Face Located Above TTS

As noted above, the burst did not occur at the location of the SCI, but in the freespan above the indication. This burst pressure was 13,028 psi. This burst pressure is similar to that observed for a non-degraded freespan section. The axial burst was located approximately 1.8 inches above the TTS and had an azimuthal orientation of 300°. The burst opening measured 1.728 inches in length and 0.342 inches in width. The burst facture face was totally ductile with no evidence of corrosion. SEM photomicrographs illustrating the appearance of the fracture face are shown in Figure 6-19. EDS analyses are provided in Figure 6-20. No unusual species were noted.

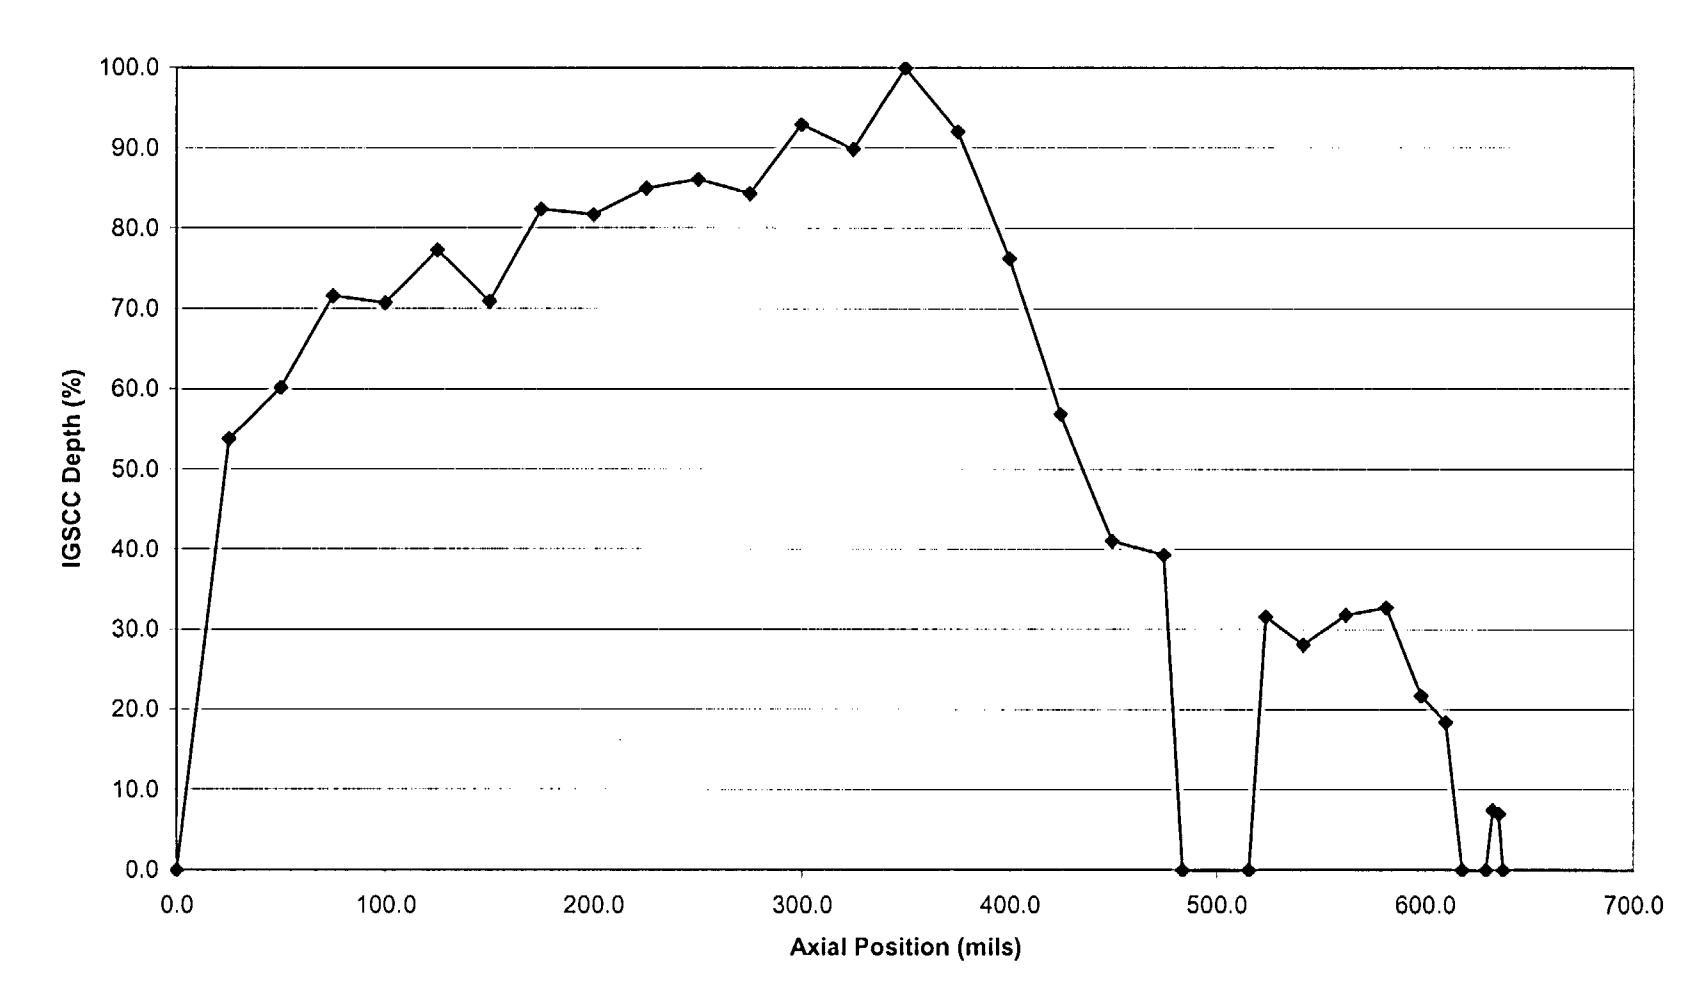
Figure 6-28 R11C41 - Piece 4B - Section 4B2A - Burst Fracture IGSCC Depth Profile Associated with H03 Plate

Examination of the fracture face showed a number of ductile ligaments within the intergranular regions. The dimensions of these ductile ligaments are summarized in Table 6-3, while photomicrographs illustrating the general appearance of the ligaments are provided in Figure 6-29. Figure 6-30 illustrations the intergranular nature of the fracture face at the region of through-wall penetration. The somewhat rounded appearance of the grain facets seen in Figure

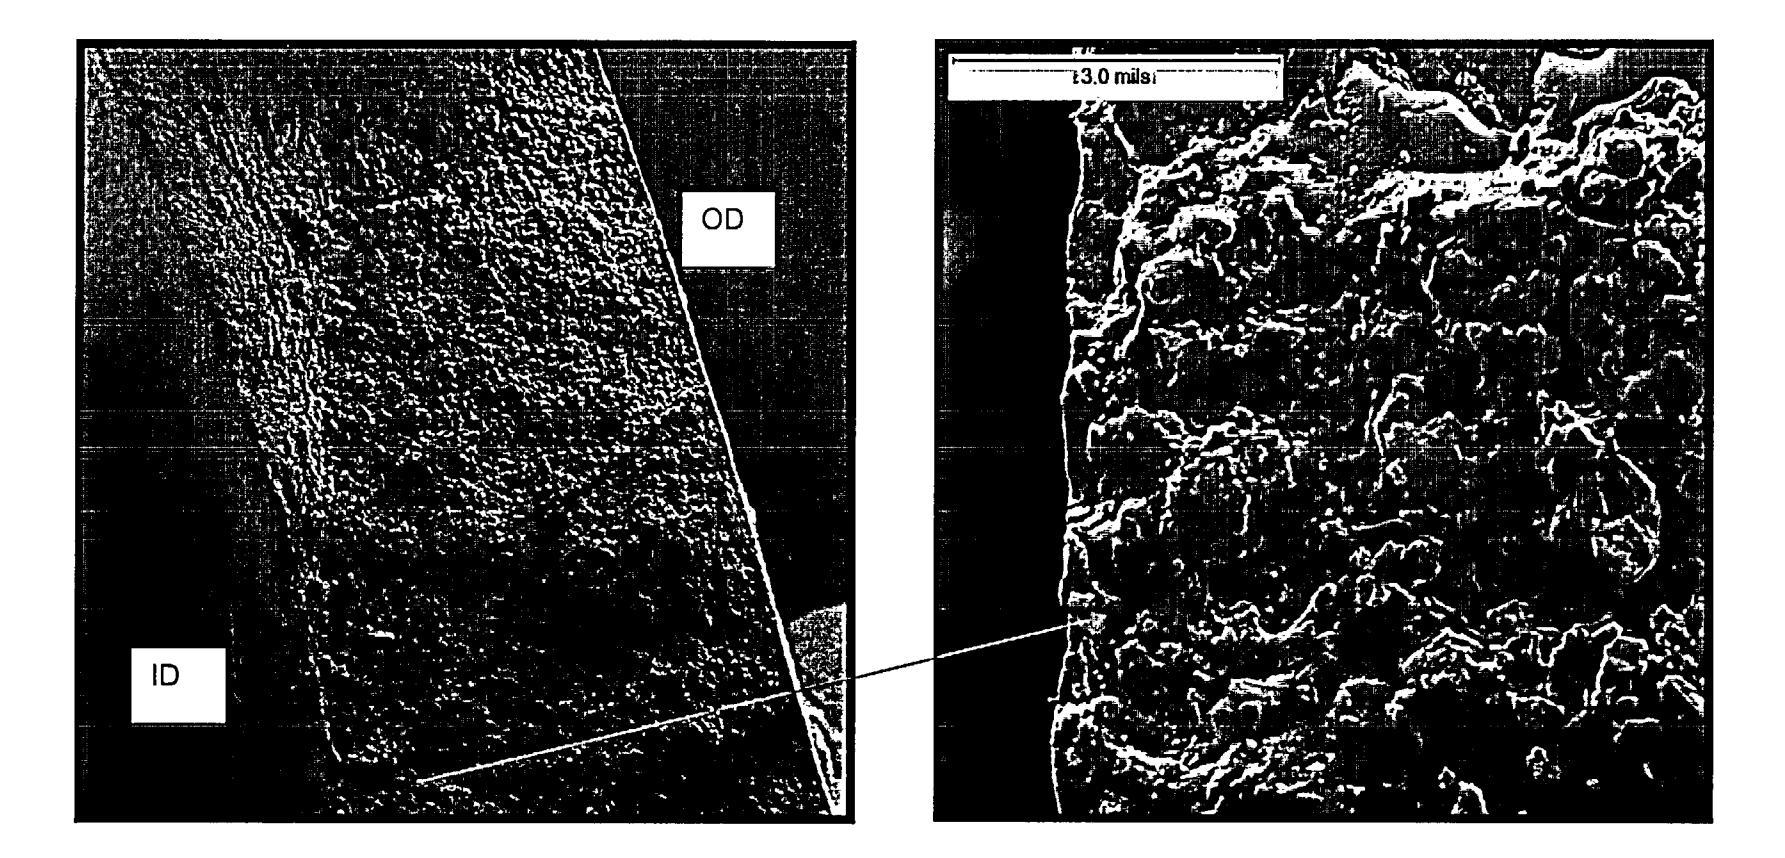
Figure 6 – 30 R11C41 – Piece 4B – Section 4B2A (H03 Plate) SEM Photographs Illustrating Intergranular Fracture Face

6-30 suggests a thick surface oxide or deposit. This appearance is typical for OD-initiated stress corrosion cracking of mill annealed Alloy 600.

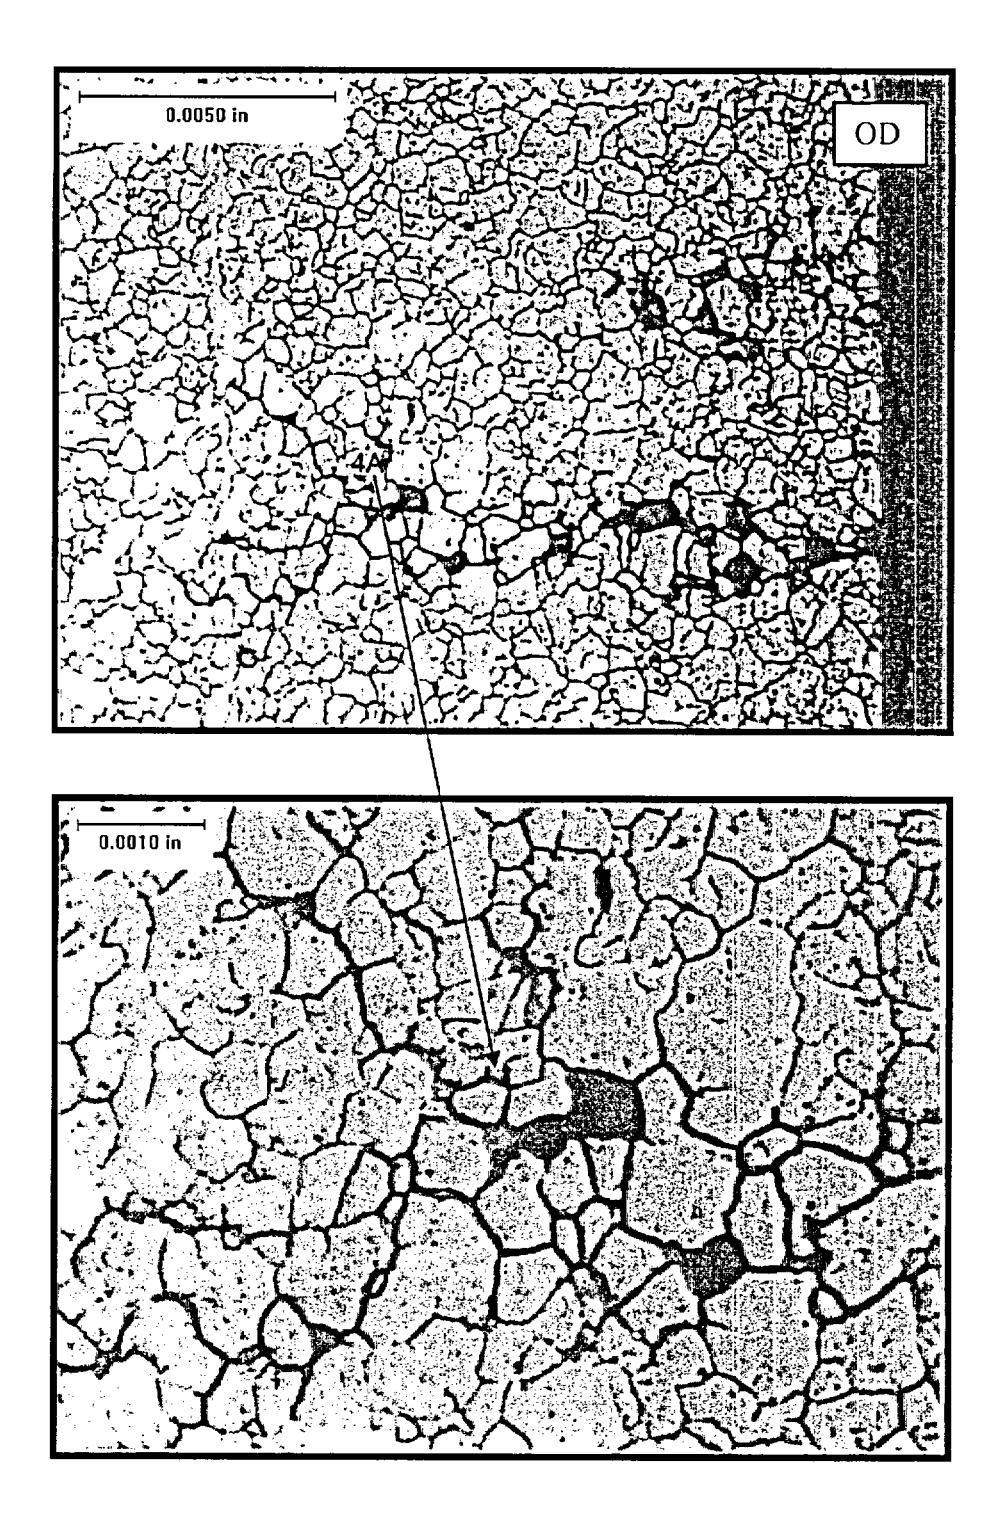
Figure 7-4 R10C39 HL- Piece 3B (H02 Plate) – Specimen 3B2B2 Transverse Section Showing IGSCC Away From Burst Face

The orientation, extent, and morphology of the ODSCC reported at the H02 tube support plate of R10C39 HL were explored by examining a transverse metallographic specimen taken through the center of the axial burst. It should be noted that this region exhibited 100% through-wall IGSCC as determined by examination of the burst fracture face. The area examined is shown in Figure 7-1, while etched photomicrographs representing the ODSCC identified are shown in Figures 7-2 through 7-4. A total of four (4) OD locations were identified with IGSCC. The position 1 shown on Figure 7-1 corresponds to the burst fracture face. It should be noted that the condition shown in these figures is after the area has been pressurized to 4,931 psi. No attempt was made to find the deepest secondary crack. As seen in Figure 7-1, the observed cracking was limited to the quadrant of the tube that was likely in contact with the TSP and thereby promoted the buildup of deposits and the subsequent of secondary side chemicals. Figures 7-2 and 7-3 show the deepest crack seen on this specimen. Minimal evidence of branching or cellular corrosion was observed. Figure 7-4 illustrates the only additional region where IGSCC was seen on this specimen. Once again, minimal cellular corrosion or IGA was noted. The approximate depth of the IGSCC shown in Figure 7-4 was 0.014 inch.

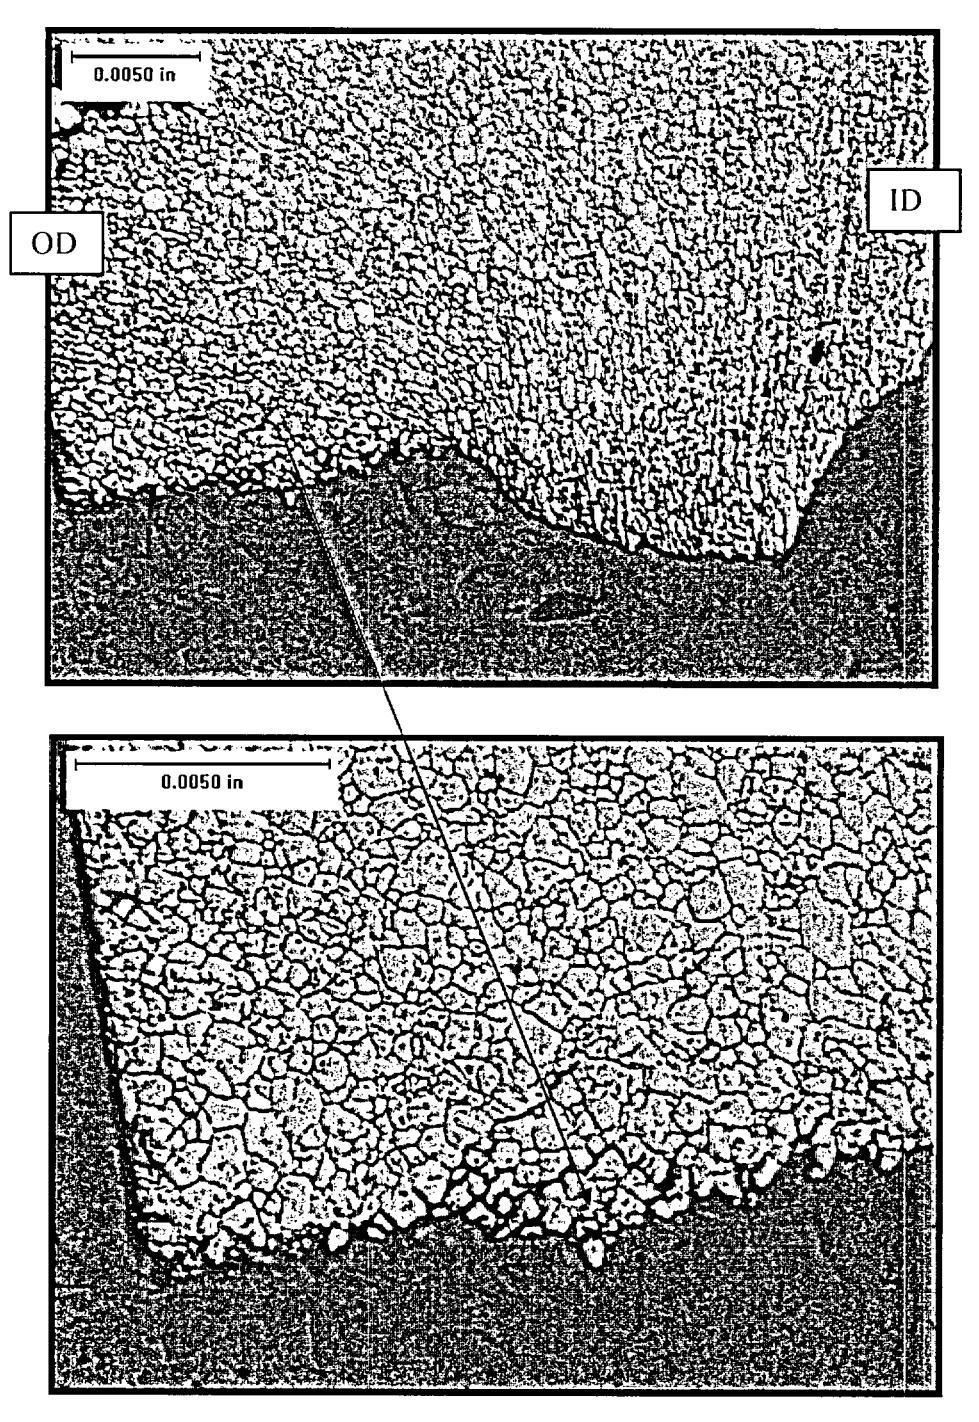
fracture area and an area near the burst face. Figure 7-6 shows that the IGSCC associated with the burst fracture face had none to minimal evidence of branching cracks or cellular corrosion. As is seen in Figure 7-6, the burst face is characterized by both intergranular and ductile fracture features. The only other evidence of IGSCC seen on this specimen was two (2) shallow indications seen near the burst fracture, Figure 7-7. The indications are intergranular in nature, with minimal evidence of cellular corrosion. The indications are blunted due to burst test pressurization. Once again, no appreciable evidence of intergranular penetration was noted on the OD surface.

R10C39 HL- Piece 4B (H03 Plate) – Specimen 4B2B2 – Position 1 Transverse Section Showing IGSCC on Burst Fracture Face
