SECTION 6

FRACTOGRAPHY AND OTHER EXAMINATIONS

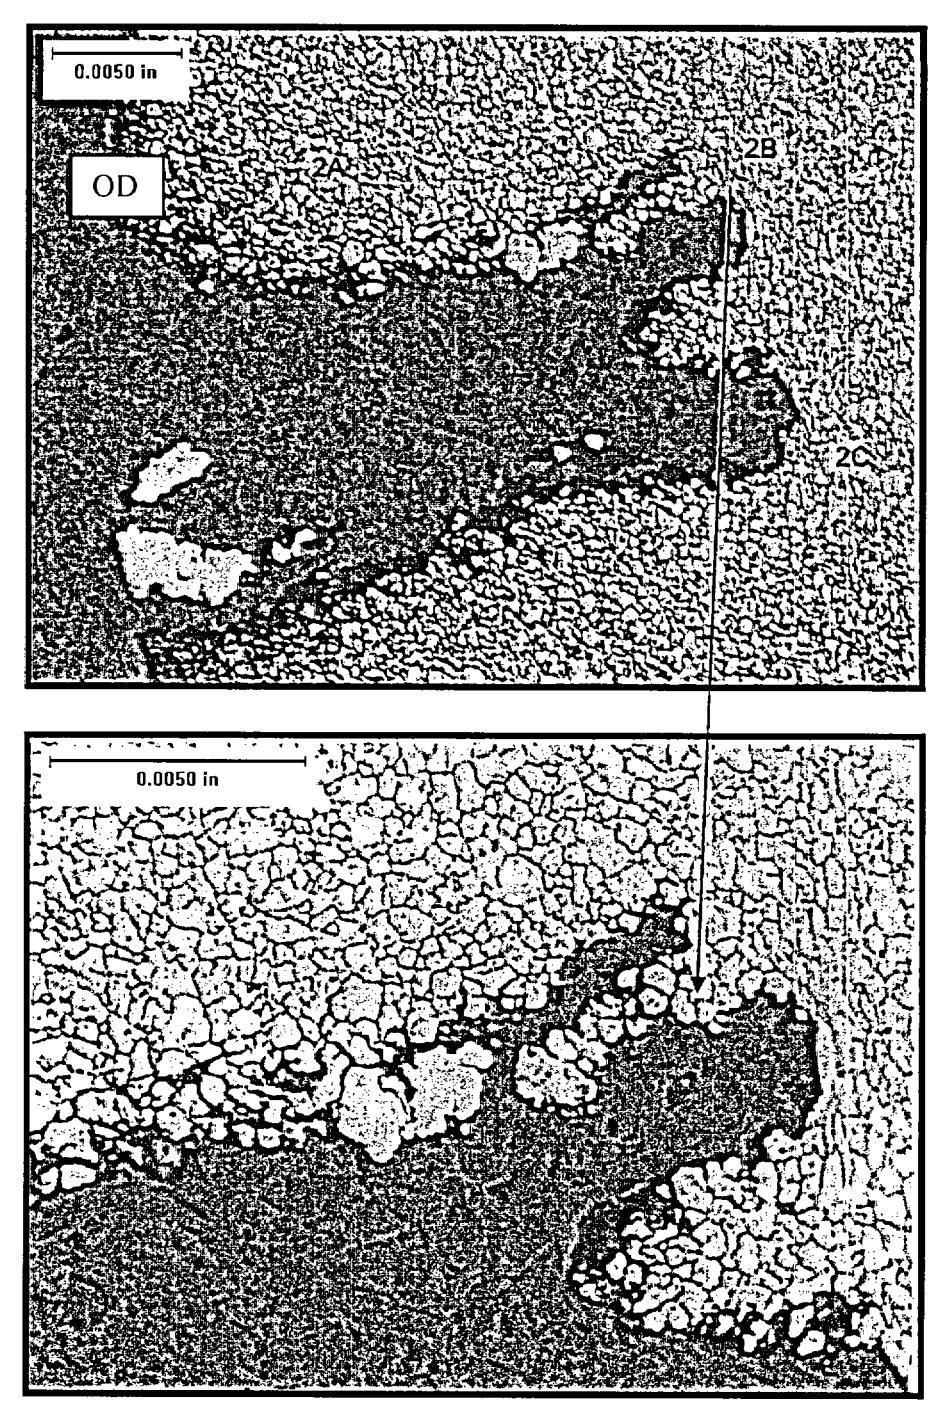
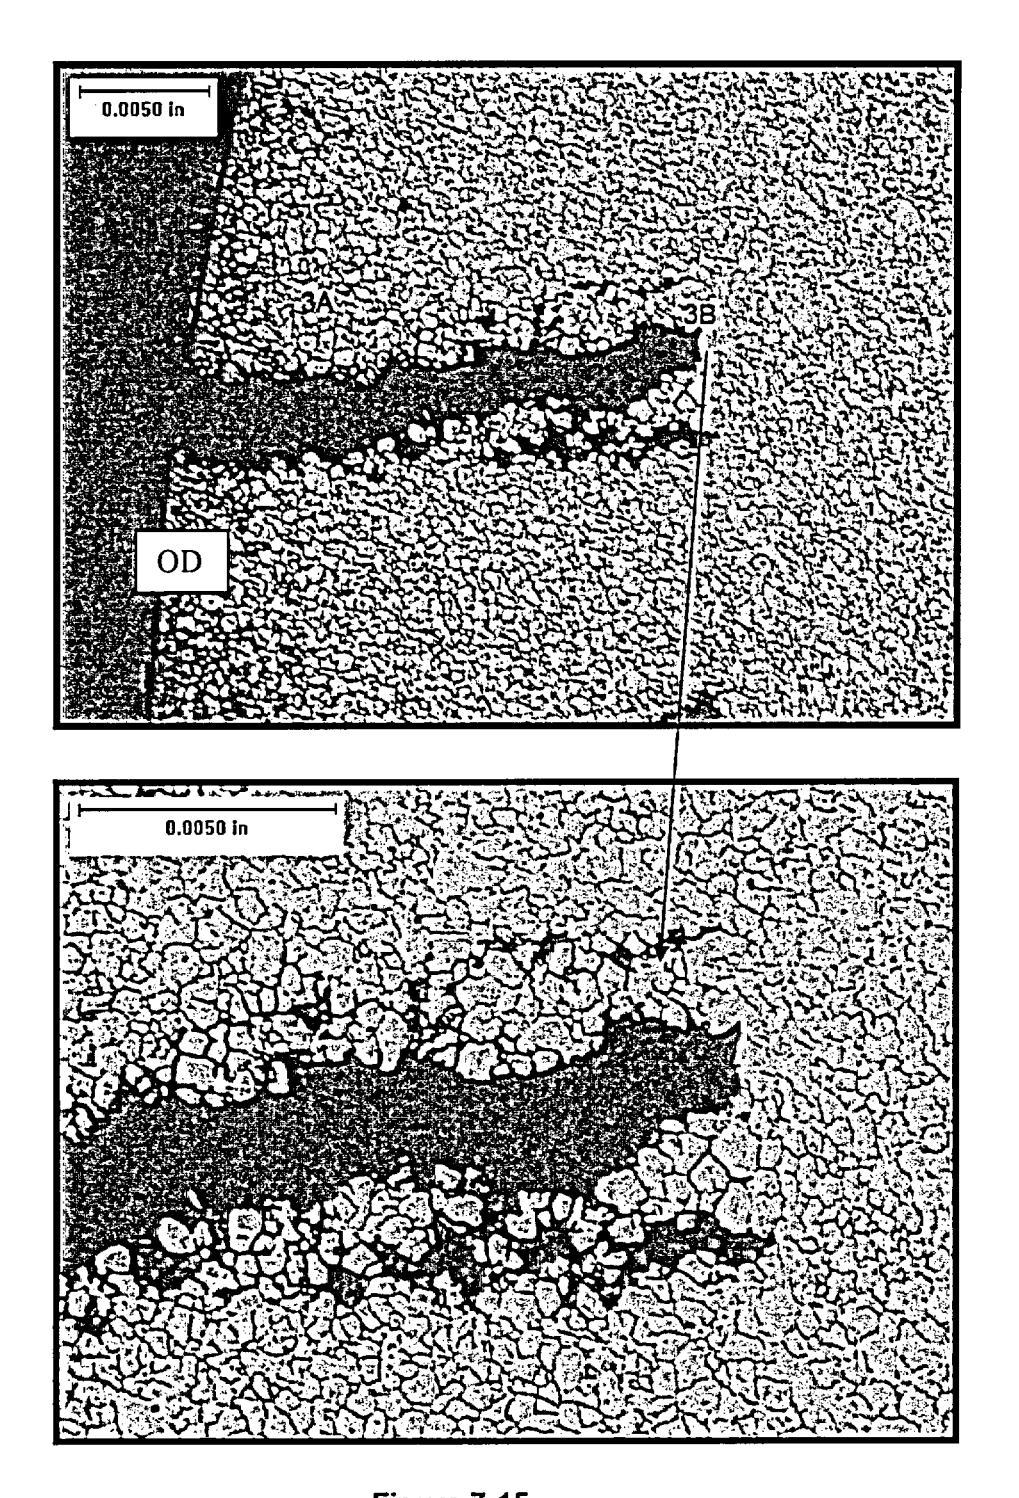
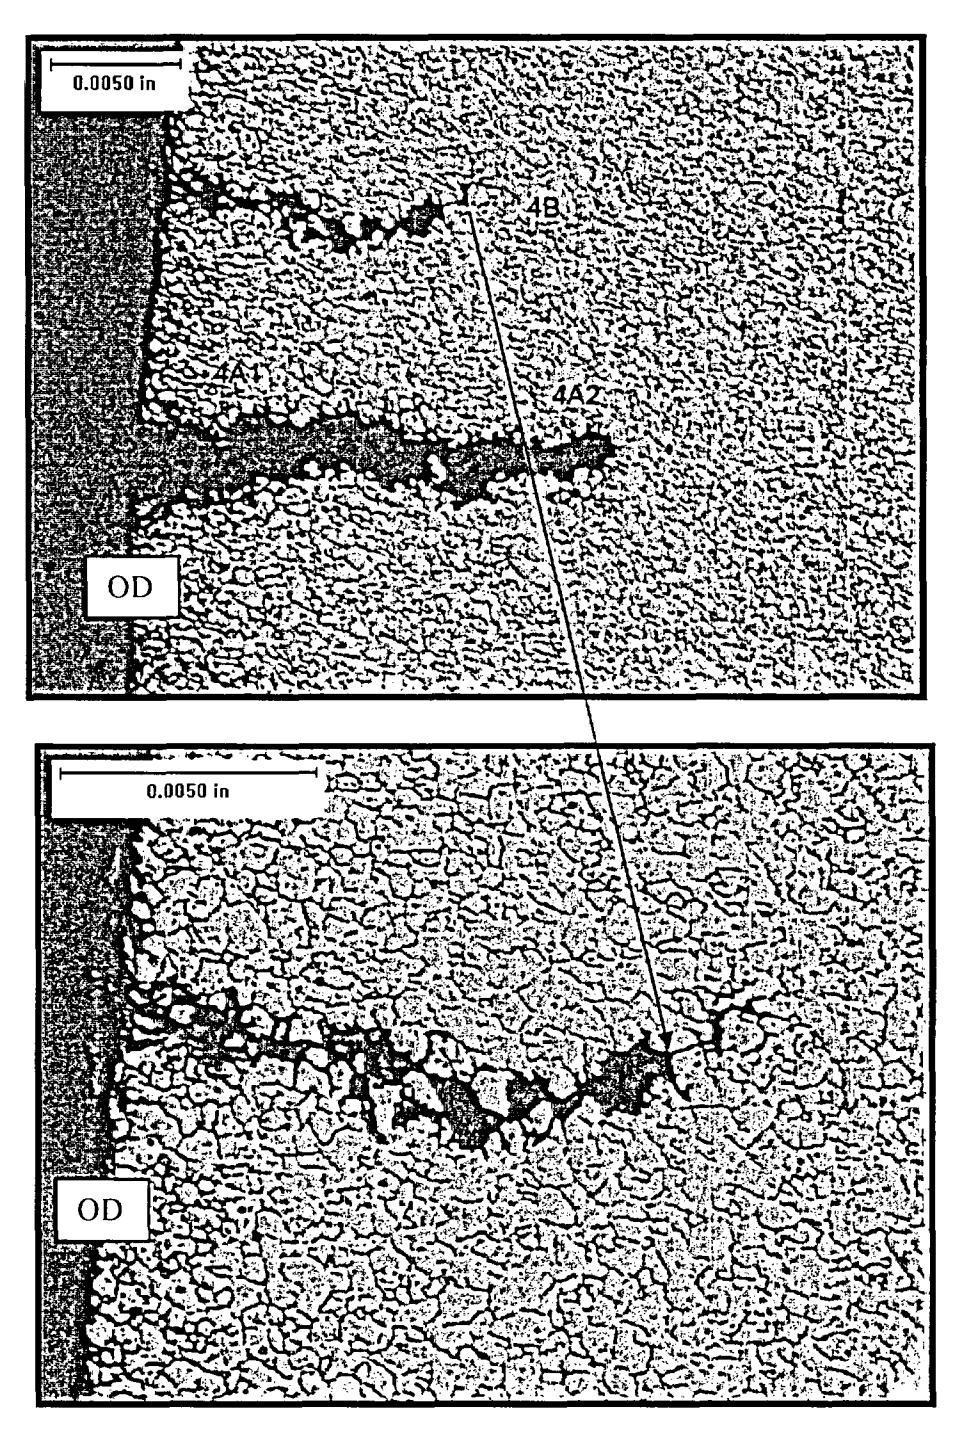
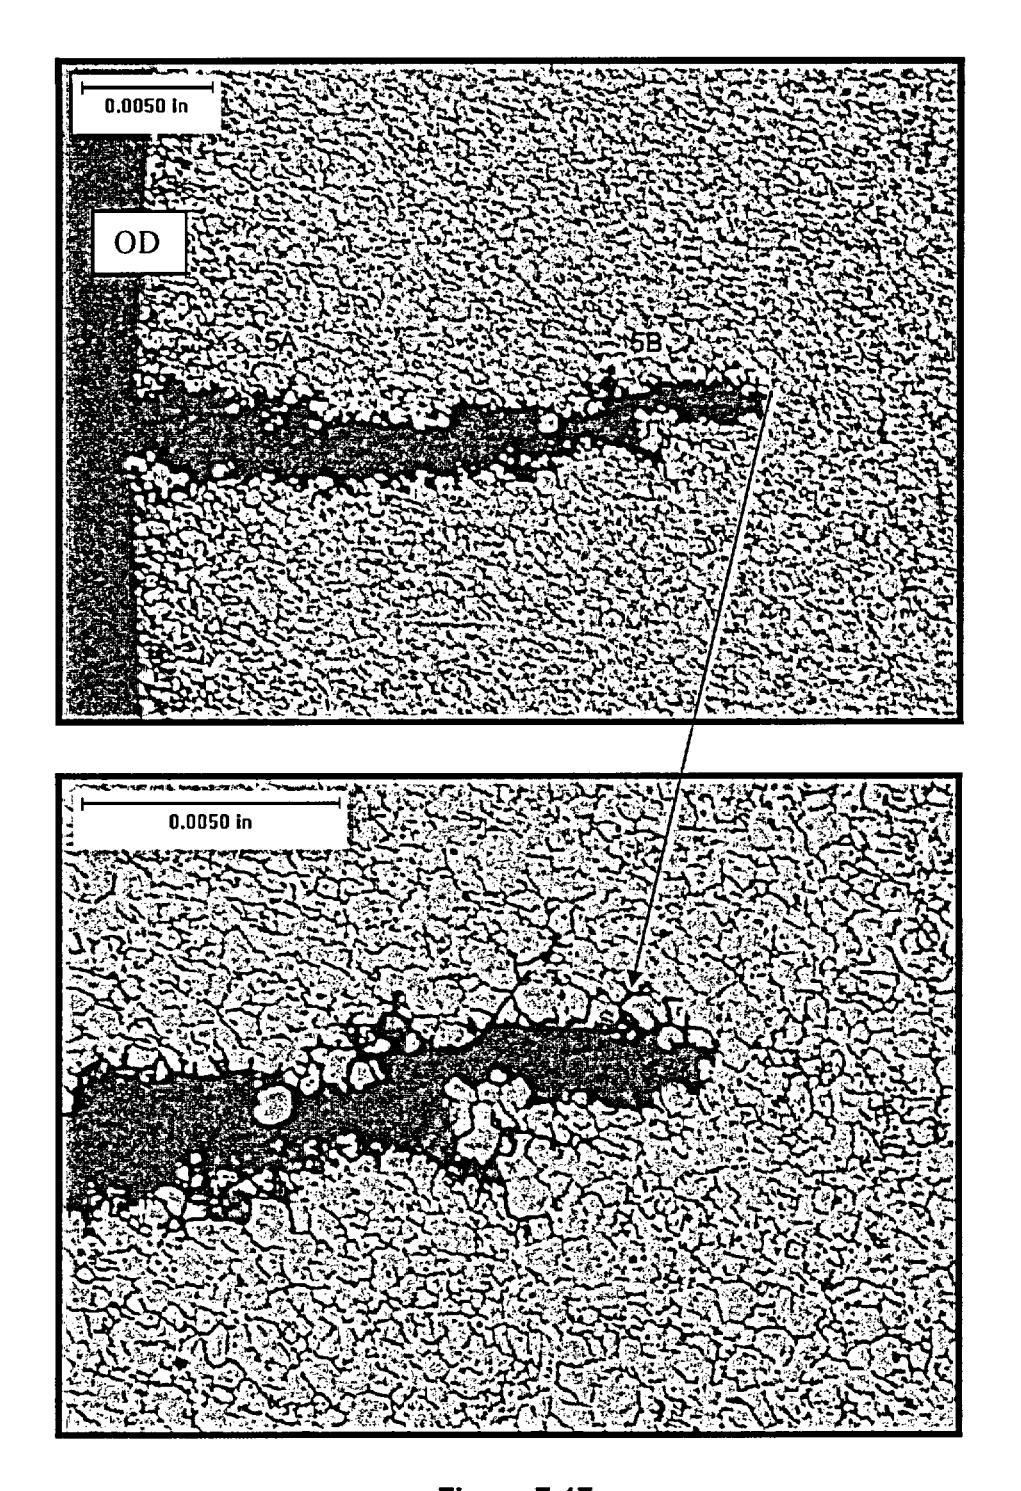
through-wall IGSCC. The remaining areas exhibiting OD-initiated IGSCC are shown in Figures 7-14 through 7-17. In all cases the indications are relatively shallow and exhibit a blunt tip due to the burst pressurization. The IGSCC cracks had no or few branches and minimal cellular corrosion. Once again, no appreciable evidence of intergranular penetration was noted on the OD surface.

R11C41HL- Piece 4B (H03 Plate) – Specimen 4B2B2 – Position 2 Etched Micrographs Showing Observed ODSCC Adjacent to Burst Fracture

Figure 7-15 R11C41HL- Piece 4B (H03 Plate) – Specimen 4B2B2 – Position 3 Etched Micrographs Showing Observed ODSCC

R11C41HL- Piece 4B (H03 Plate) – Specimen 4B2B2 – Position 4 Etched Micrographs Showing Observed ODSCC

Figure 7-17 R11C41HL- Piece 4B (Ho3 Plate) – Specimen 4B2B2 – Position 5 Etched Micrographs Showing Observed ODSCC
