Examination of Diablo Canyon Unit 1 Steam Generator Tube No. R20C54

51-5046570-01 Final Report, August 2004

Prepared for Pacific Gas & Electric Company

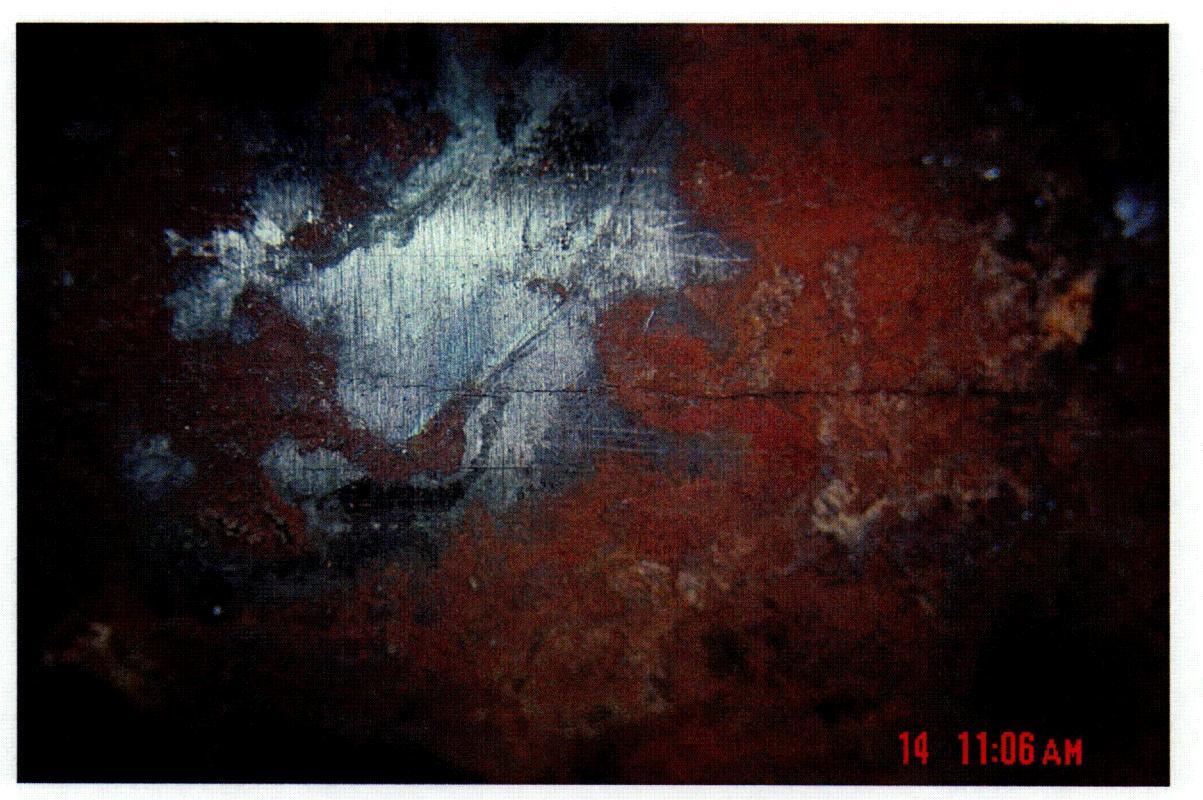
Figure 7. Post oxidation photograph of axial crack at ~19° in 1H TSP intersection of tube section no. R20C54-3. The bottom (in SG) of the tube section is to the left. (7.6X)

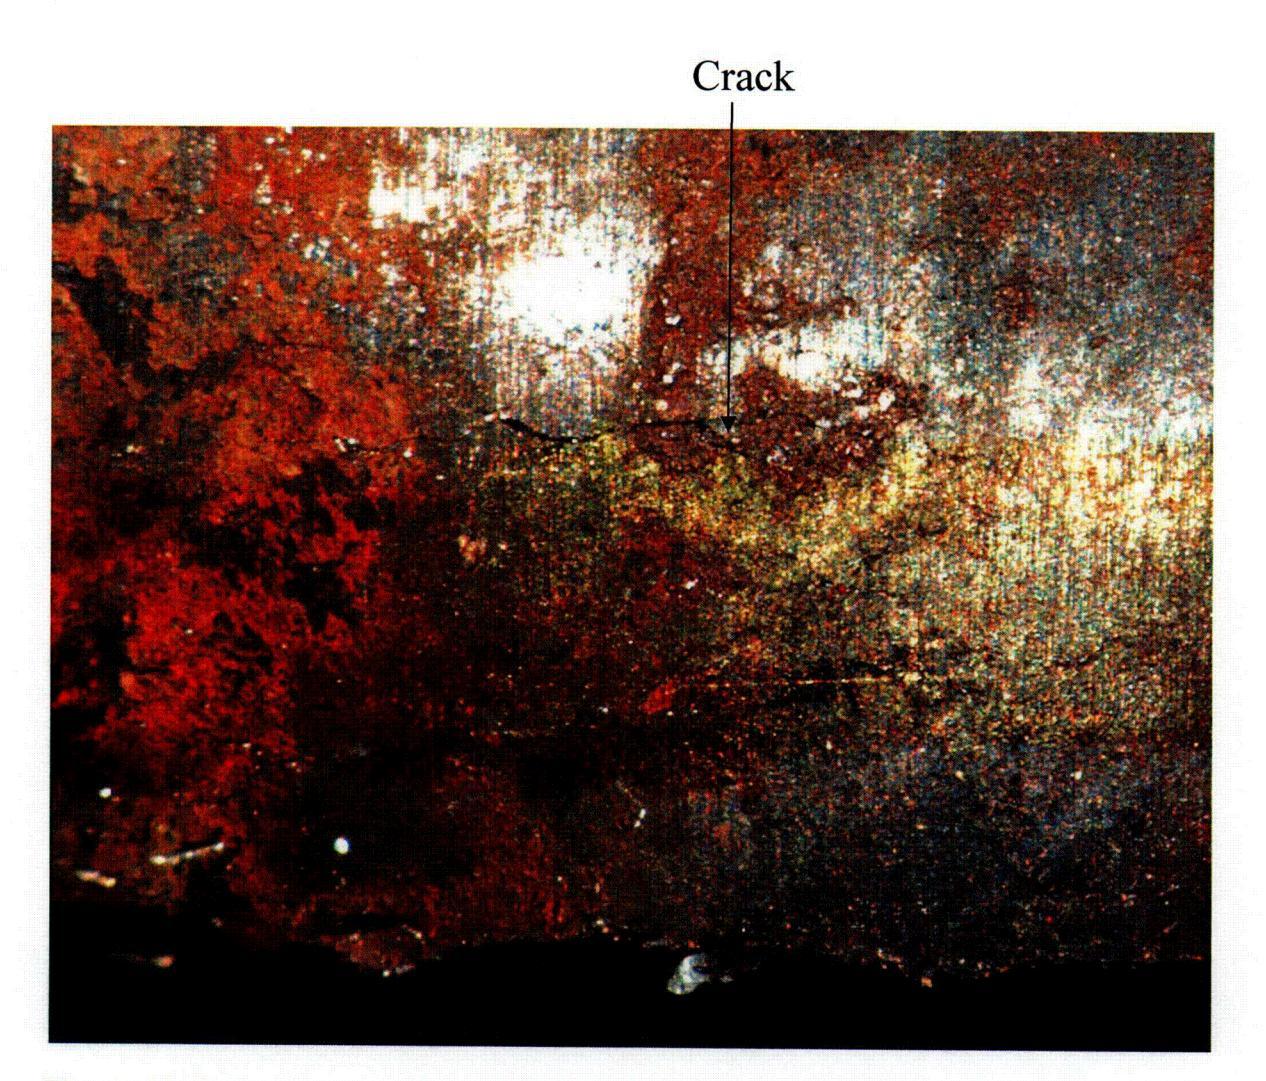
Figure 43: Secondary crack near 350° in 1H TSP, extending from ~0.1 inches to ~0.2 inches from the bottom of the TSP region. 16.6X

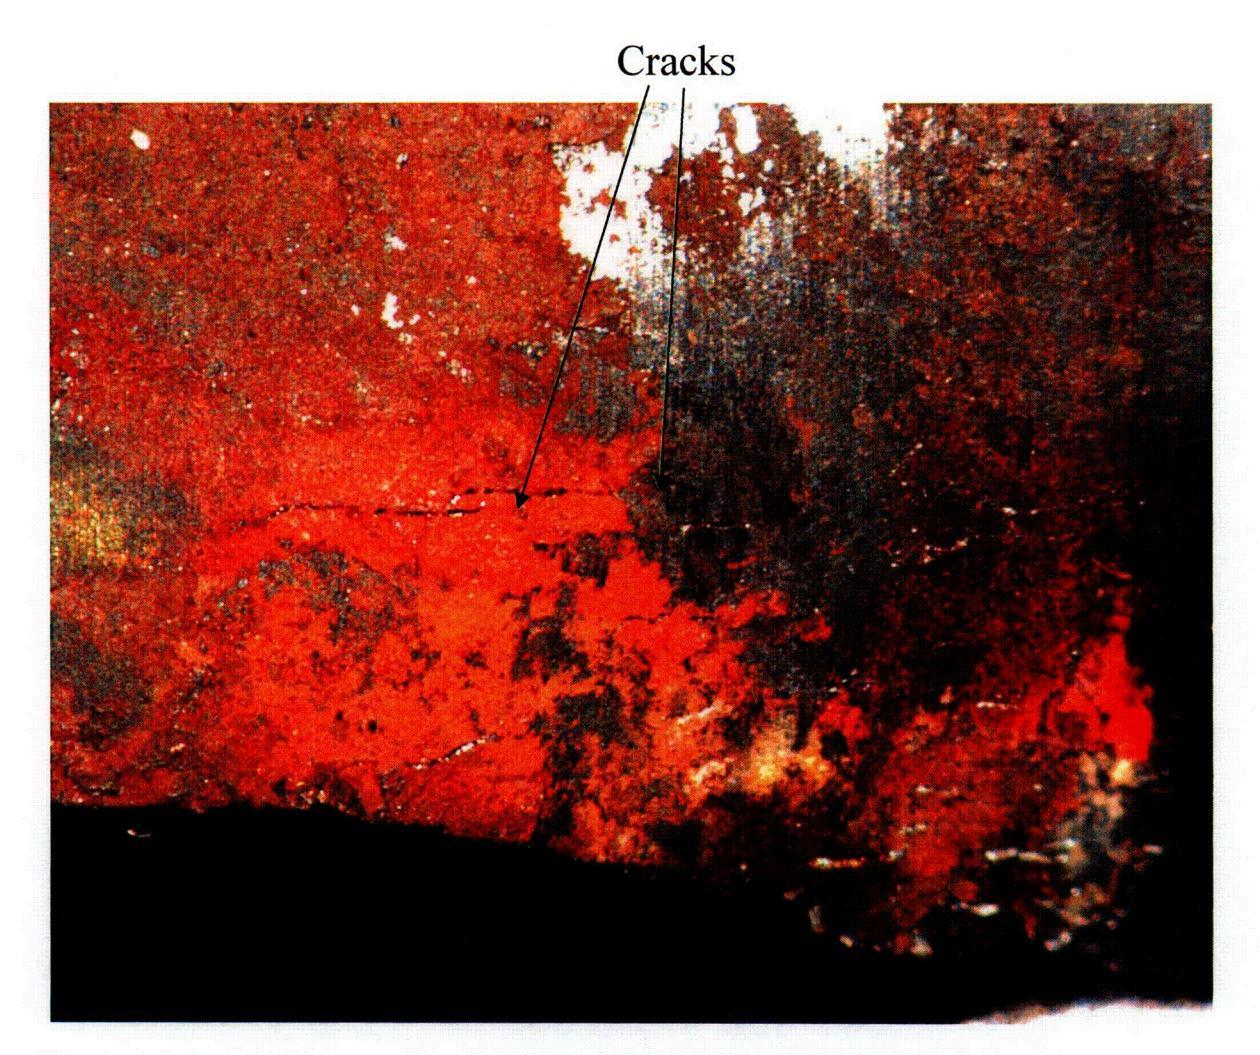
Figure 44: Secondary cracks near 355° in 1H TSP, extending from ~0.5 inches to ~0.7 inches From the bottom of the TSP region. 16.6X

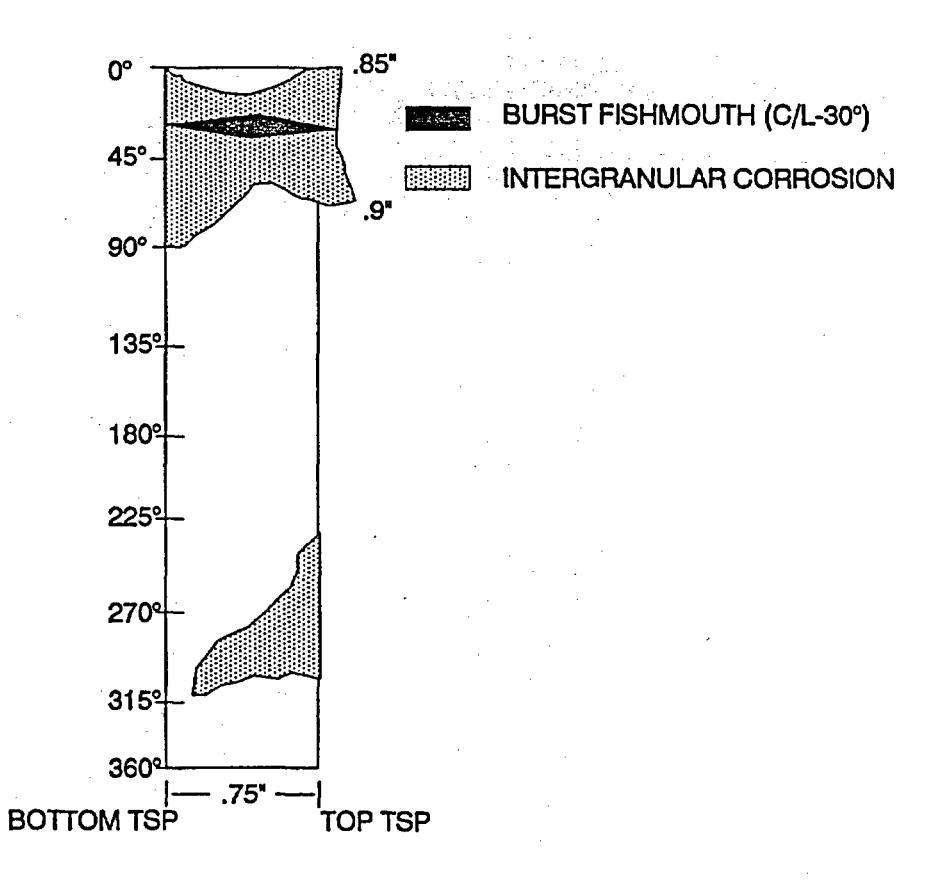
The burst pressure for the 2H TSP section was 10,428 psi. Post-burst inspection revealed two patches of intergranular corrosion that had not been detected during eddy current inspection prior to tube pull. These patches exhibited grid-like patterns of axial and circumferential cracks, dubbed by the industry as "cellular corrosion" by virtue of its appearance. Cellular corrosion is generally shallow and transitions to predominantly axial cracks as the cracking progresses. This behavior was confirmed in this examination by grinding radially through the two patches of corrosion. The maximum depth of the corrosion in the 2H burst region was found to be less than 48% through wall. A review of the eddy current data records confirmed that the corrosion was not detected by either the bobbin or rotating eddy current probes during the field inspection. On review, a small, single volumetric indication (SVI) was found in the post-pull rotating coil data.

Figure 59: Areas of intergranular (cellular) corrosion in 2H TSP

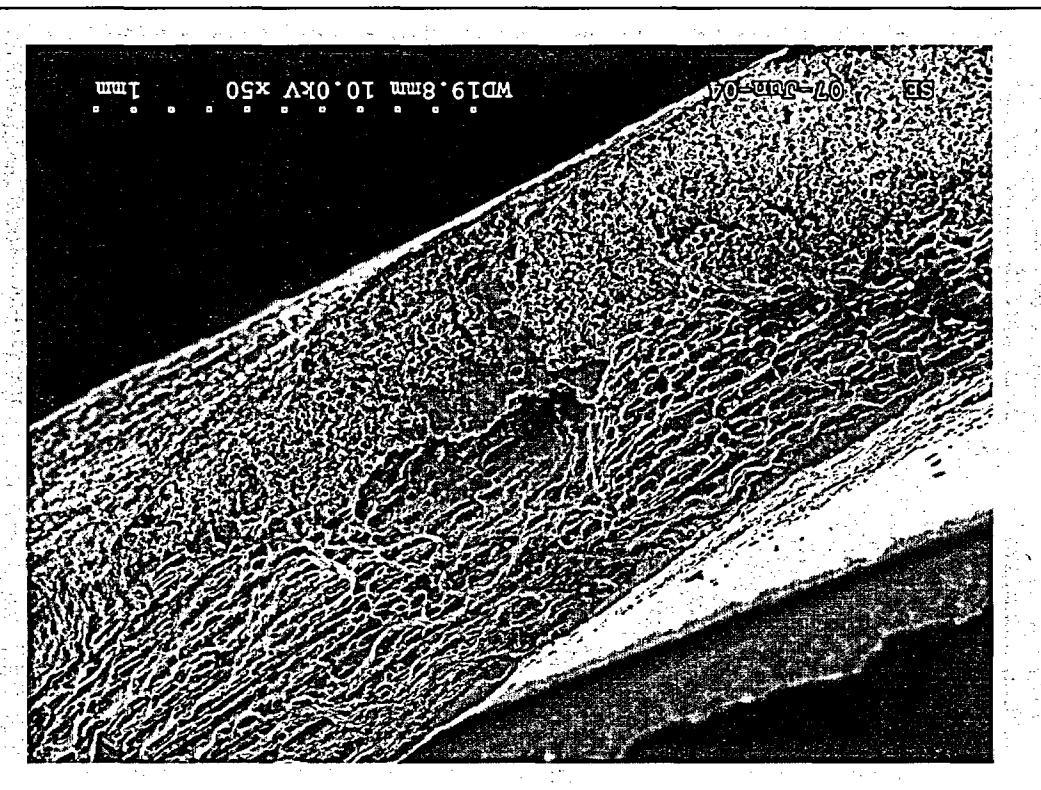
Figure 61: SE image of bottom edge of IGSCC on burst rupture surface of 1H TSP. 50X

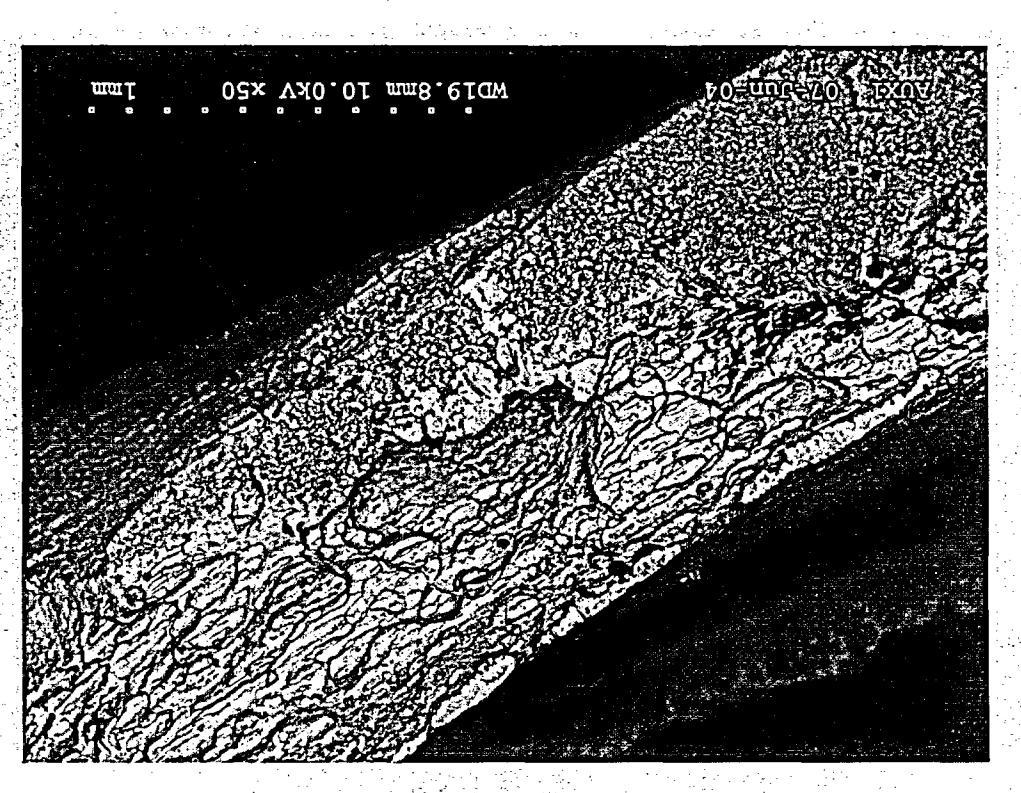
Figure 62: BSE image of bottom edge of IGSCC on burst rupture surface of 1H TSP. 50X

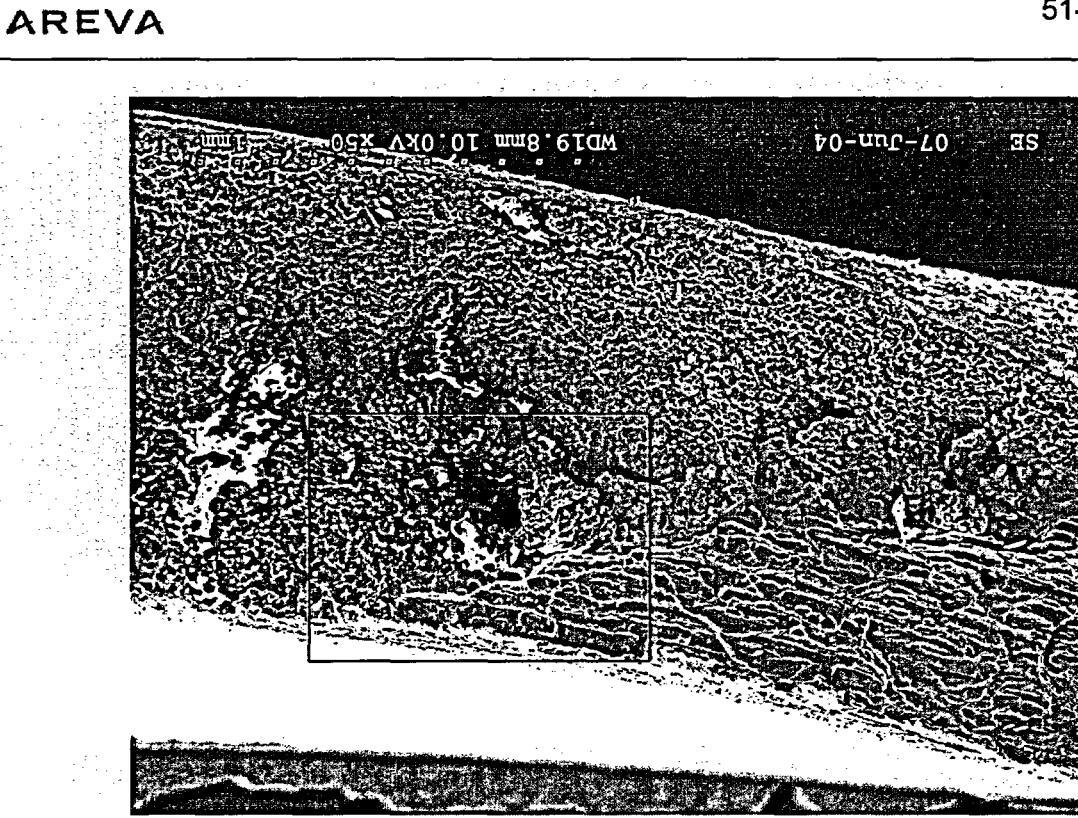
Figure 63: SE image showing transition to 100% TW IGSCC on burst rupture surface of 1H TSP. 50X

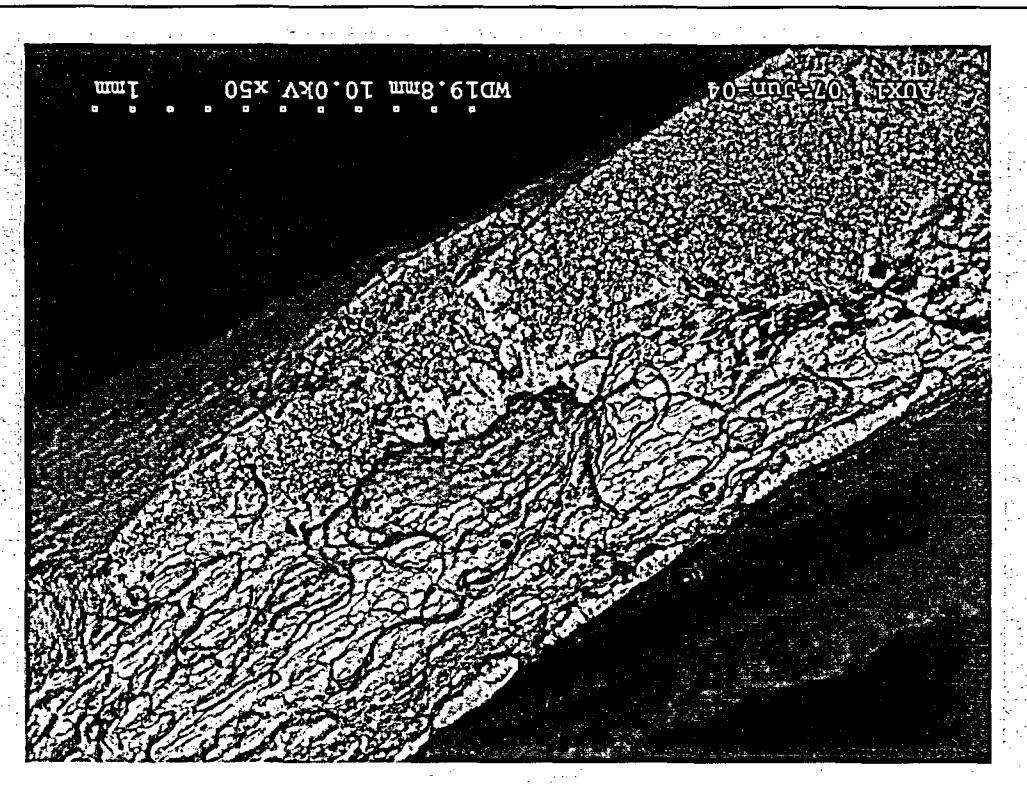
Figure 65: BSE image of transition area to 100% IGSCC on burst rupture surface of 1H TSP. 50X

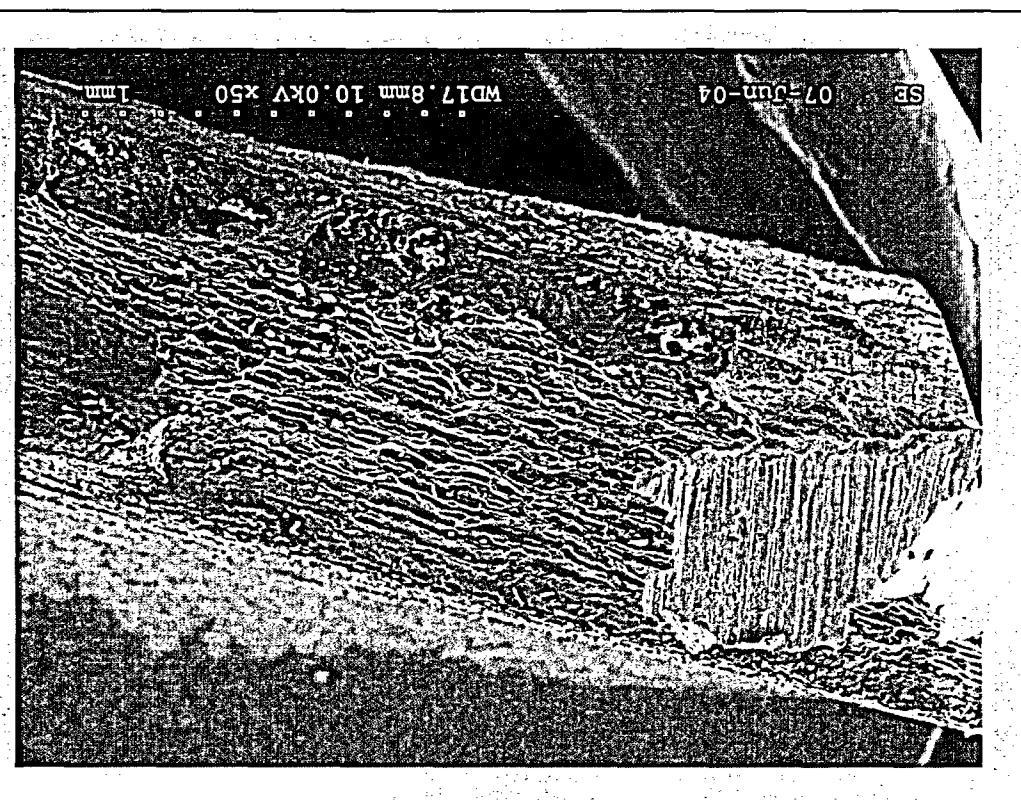
Figure 66: SE image of top edge of IGSCC on burst rupture surface of 1H TSP. 50X

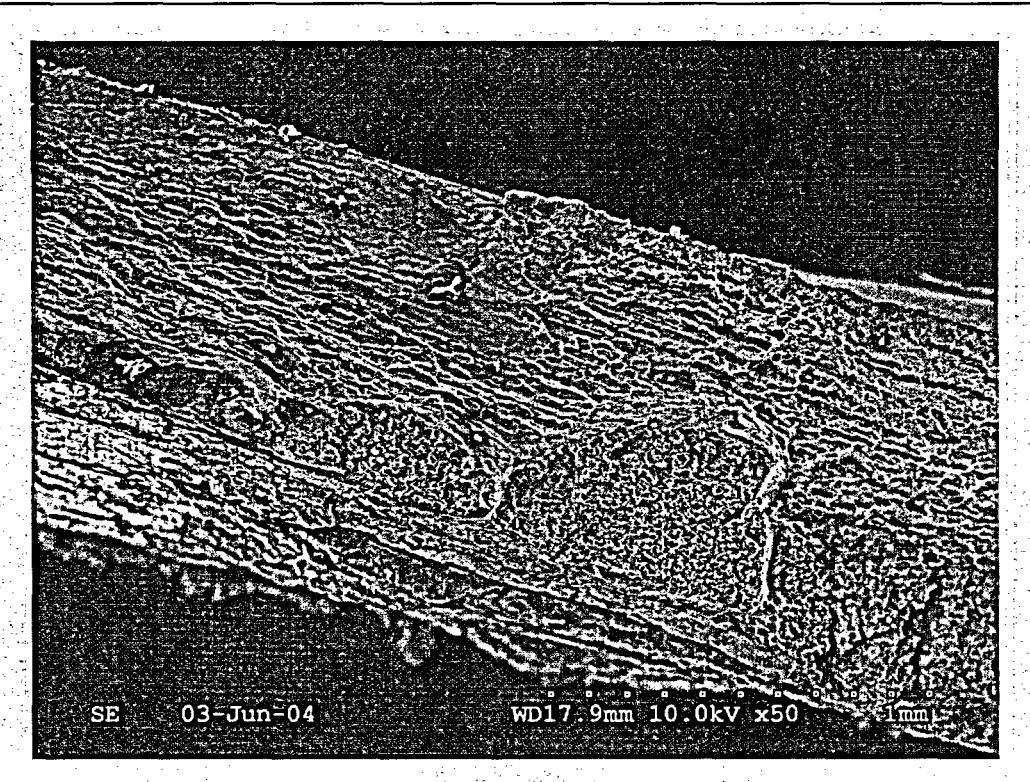
Figure 70: SE image of bottom edge of IGSCC on burst rupture surface of 2H TSP. 50X

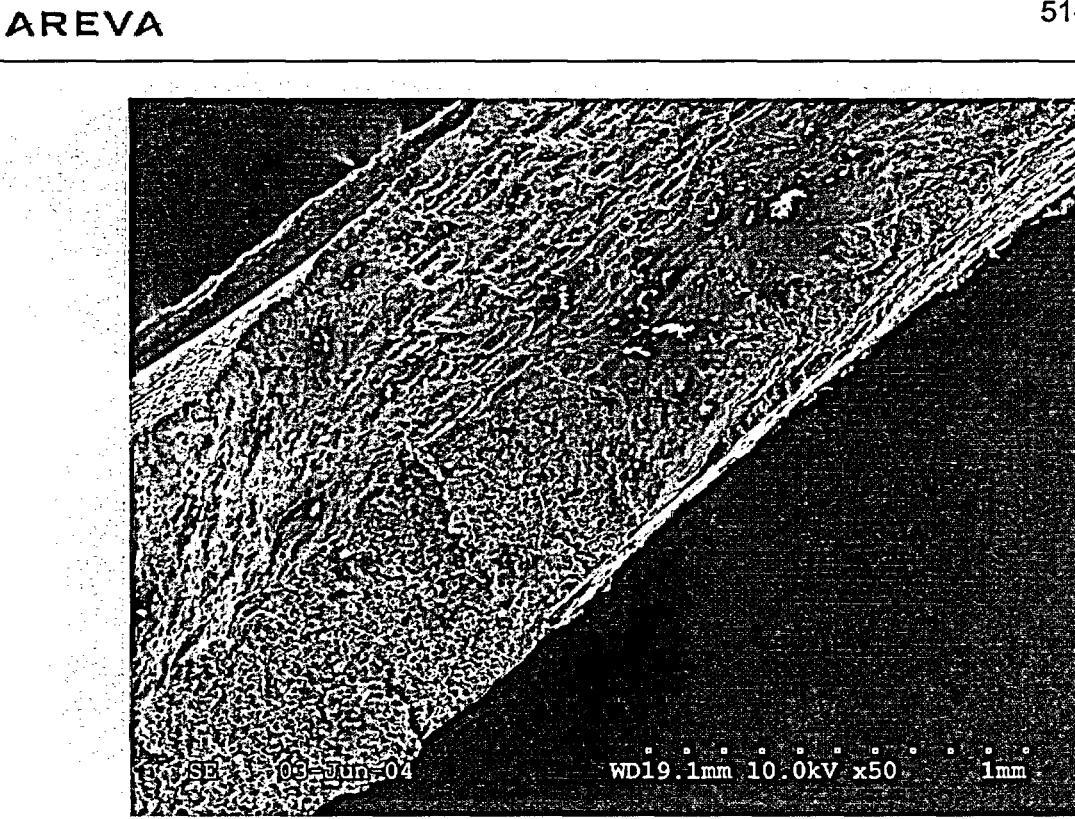
Figure 74: SE image of top edge of IGSCC on burst rupture surface of 2H TSP. 50X

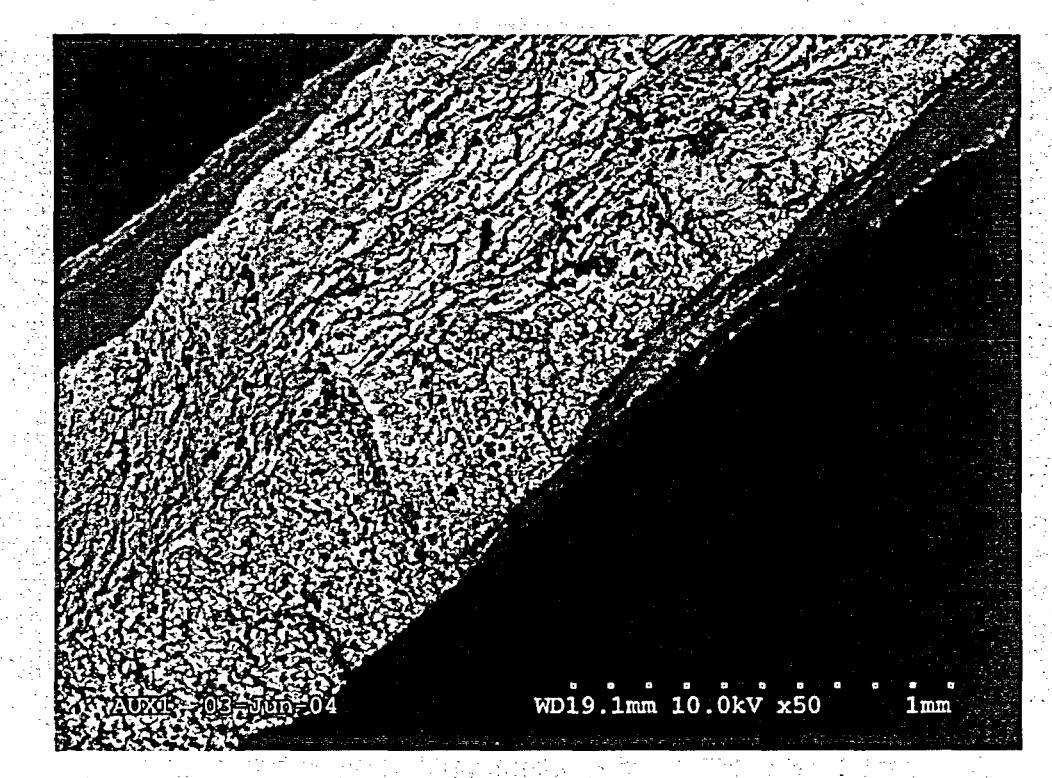
Figure 75: BSE image of top edge of IGSCC on burst rupture surface of 2H TSP. 50X

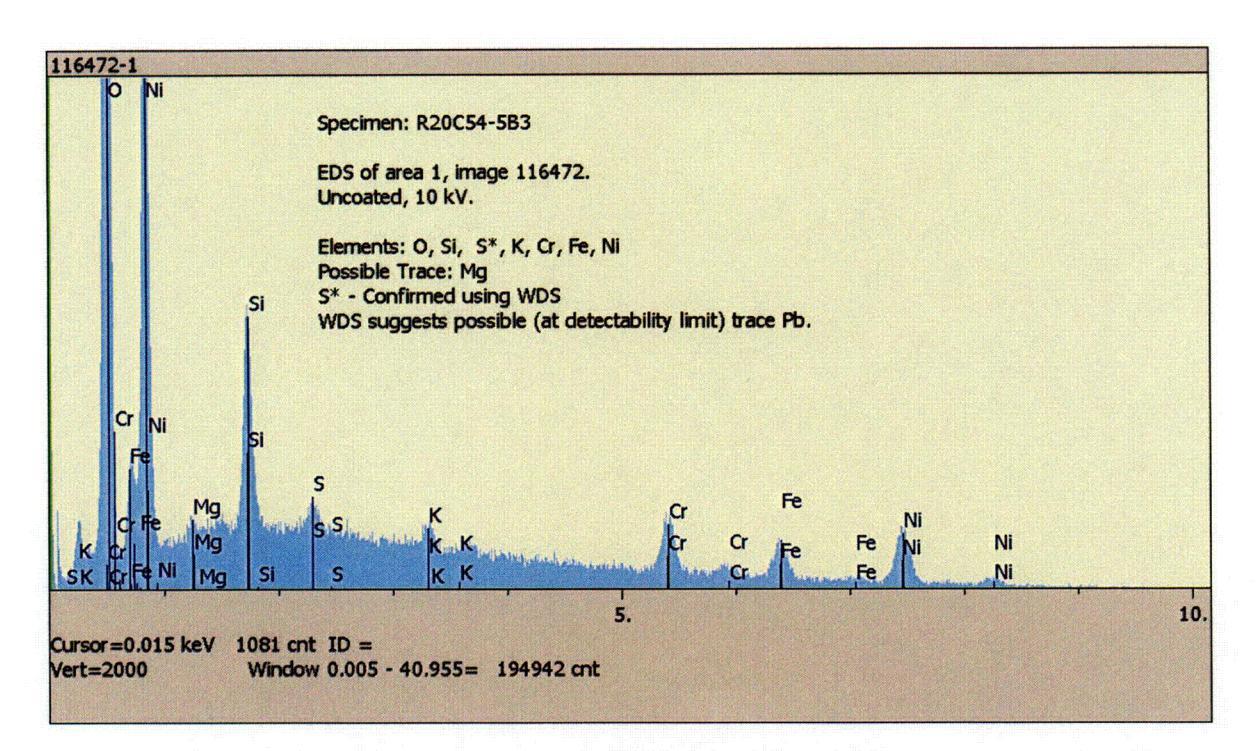
SEM/EDS/WDS analysis revealed the presence of sulfur on the 2H burst rupture surface. Sulfur is known to be detrimental to Alloy 600 and has been previously implicated in intergranular corrosion.

Figure 79: EDS analysis of area on 2H burst rupture surface.

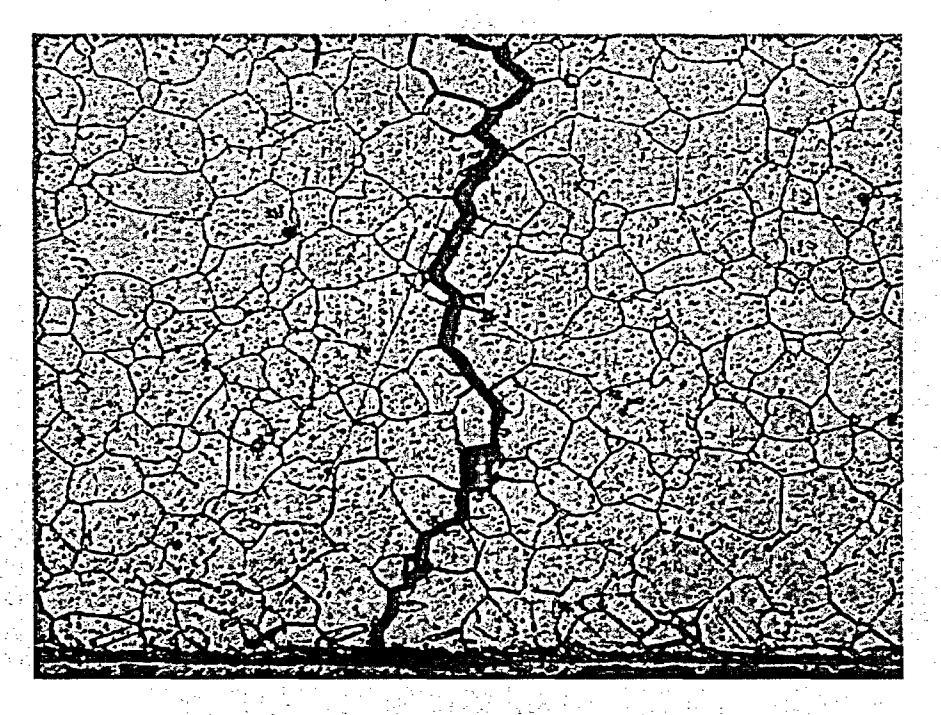
Figure 83: Etched microstructure of crack shown in Figure 82. 480X

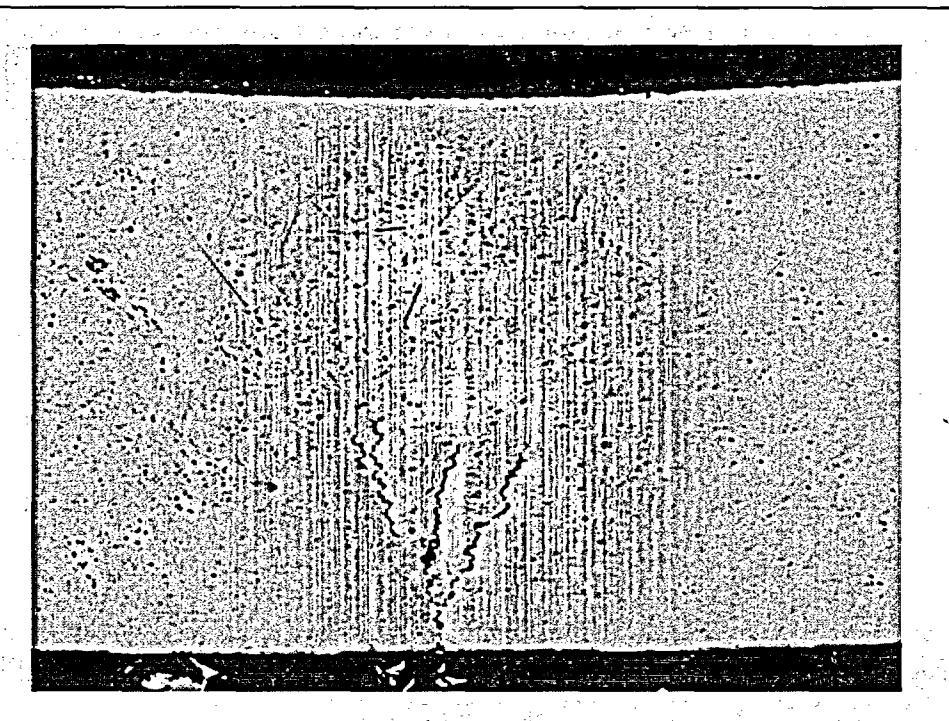
Figure 84: 40% TW indication near 330° at centerline +0.1 inches of 1H TSP, corresponding to approximate location of secondary eddy current indication. 59X

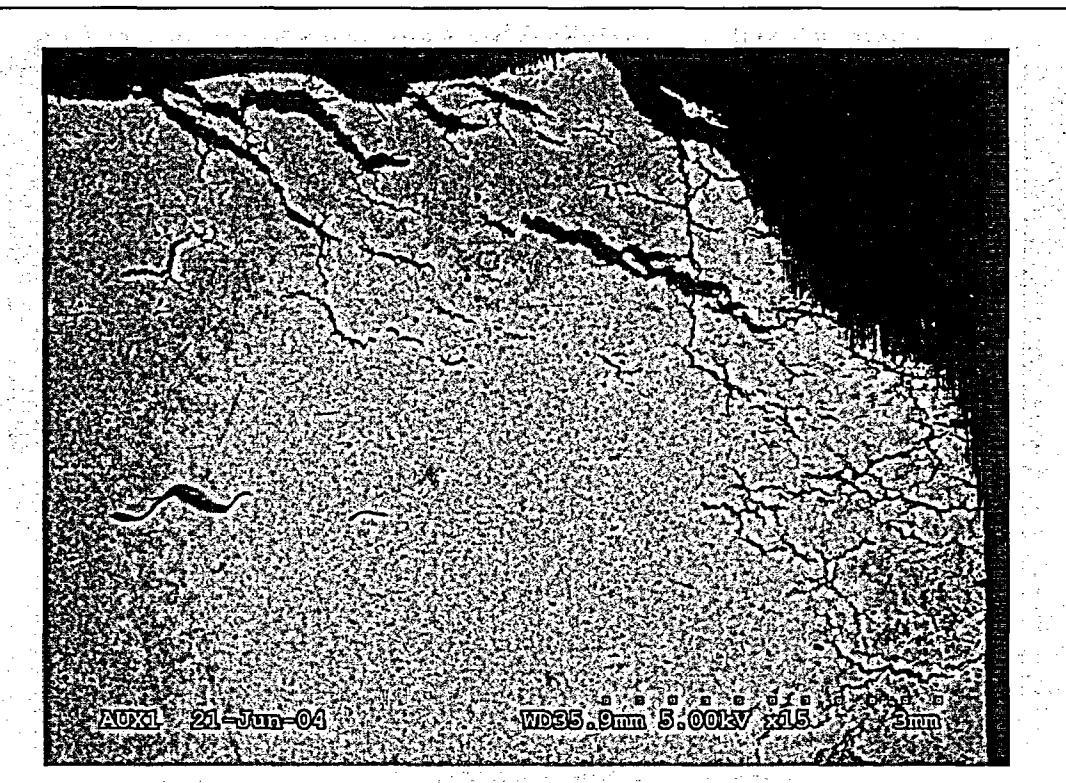
Figure 100: Corrosion area near top of 2H TSP in 5B3B2A (first face). 14.6X

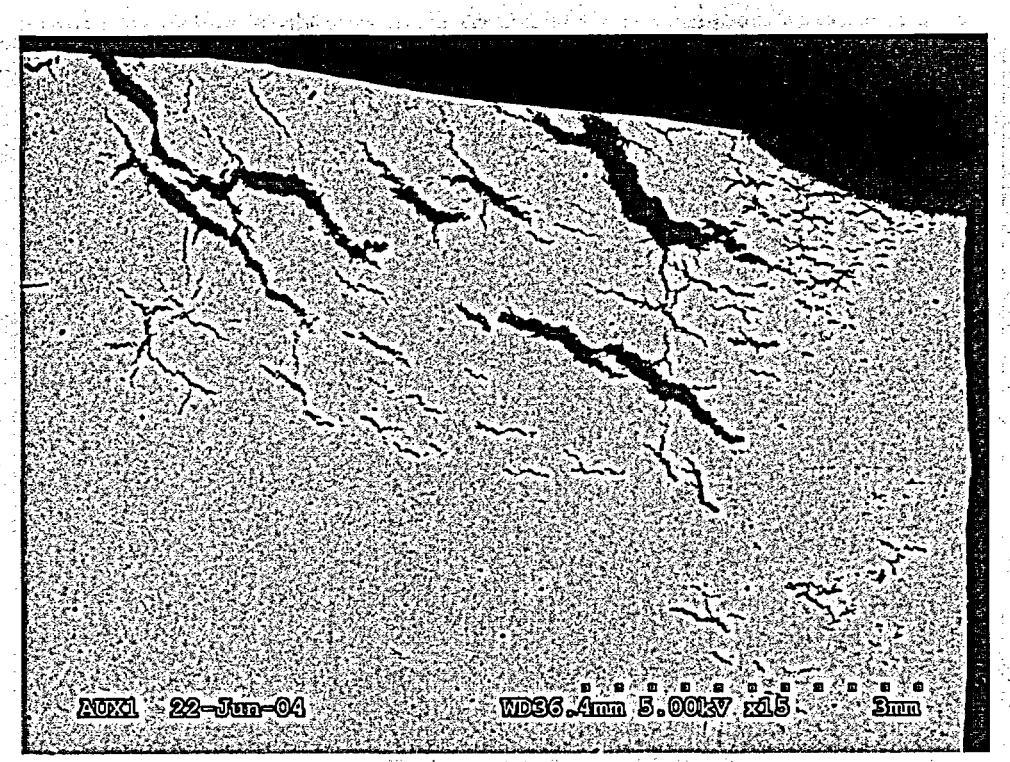
Figure 104: Corrosion area near top of 2H TSP in 5B3B2A (second face). 14.6X

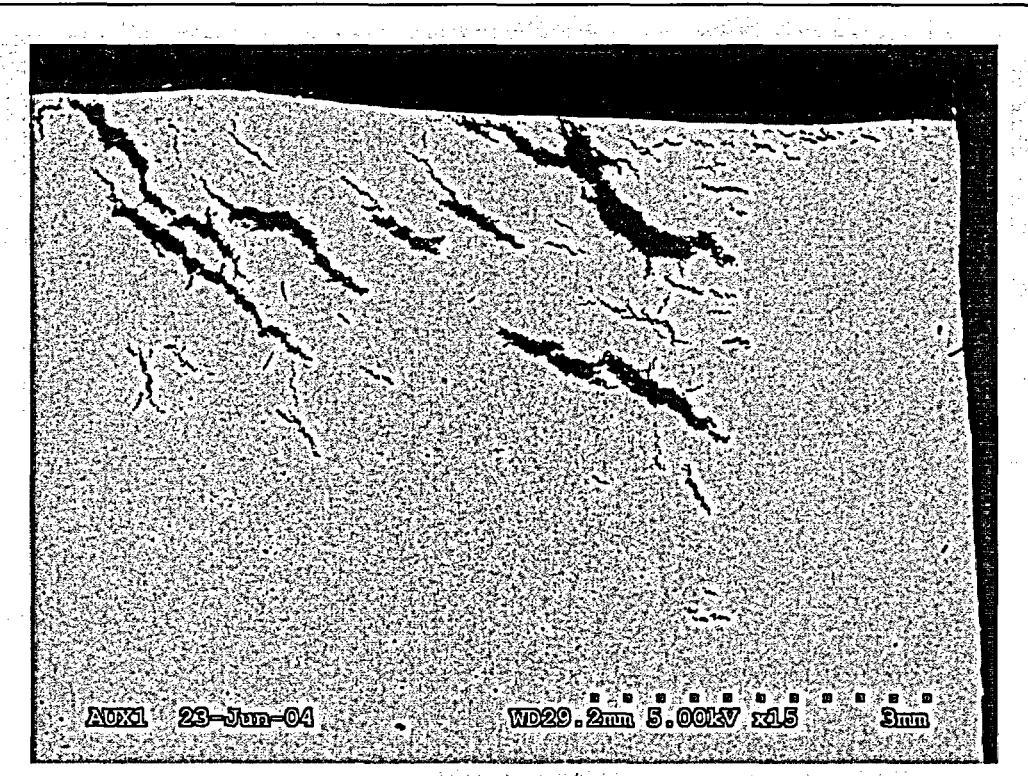
Figure 108: Corrosion area near top of 2H TSP in 5B3B2A (third face). 14.6X

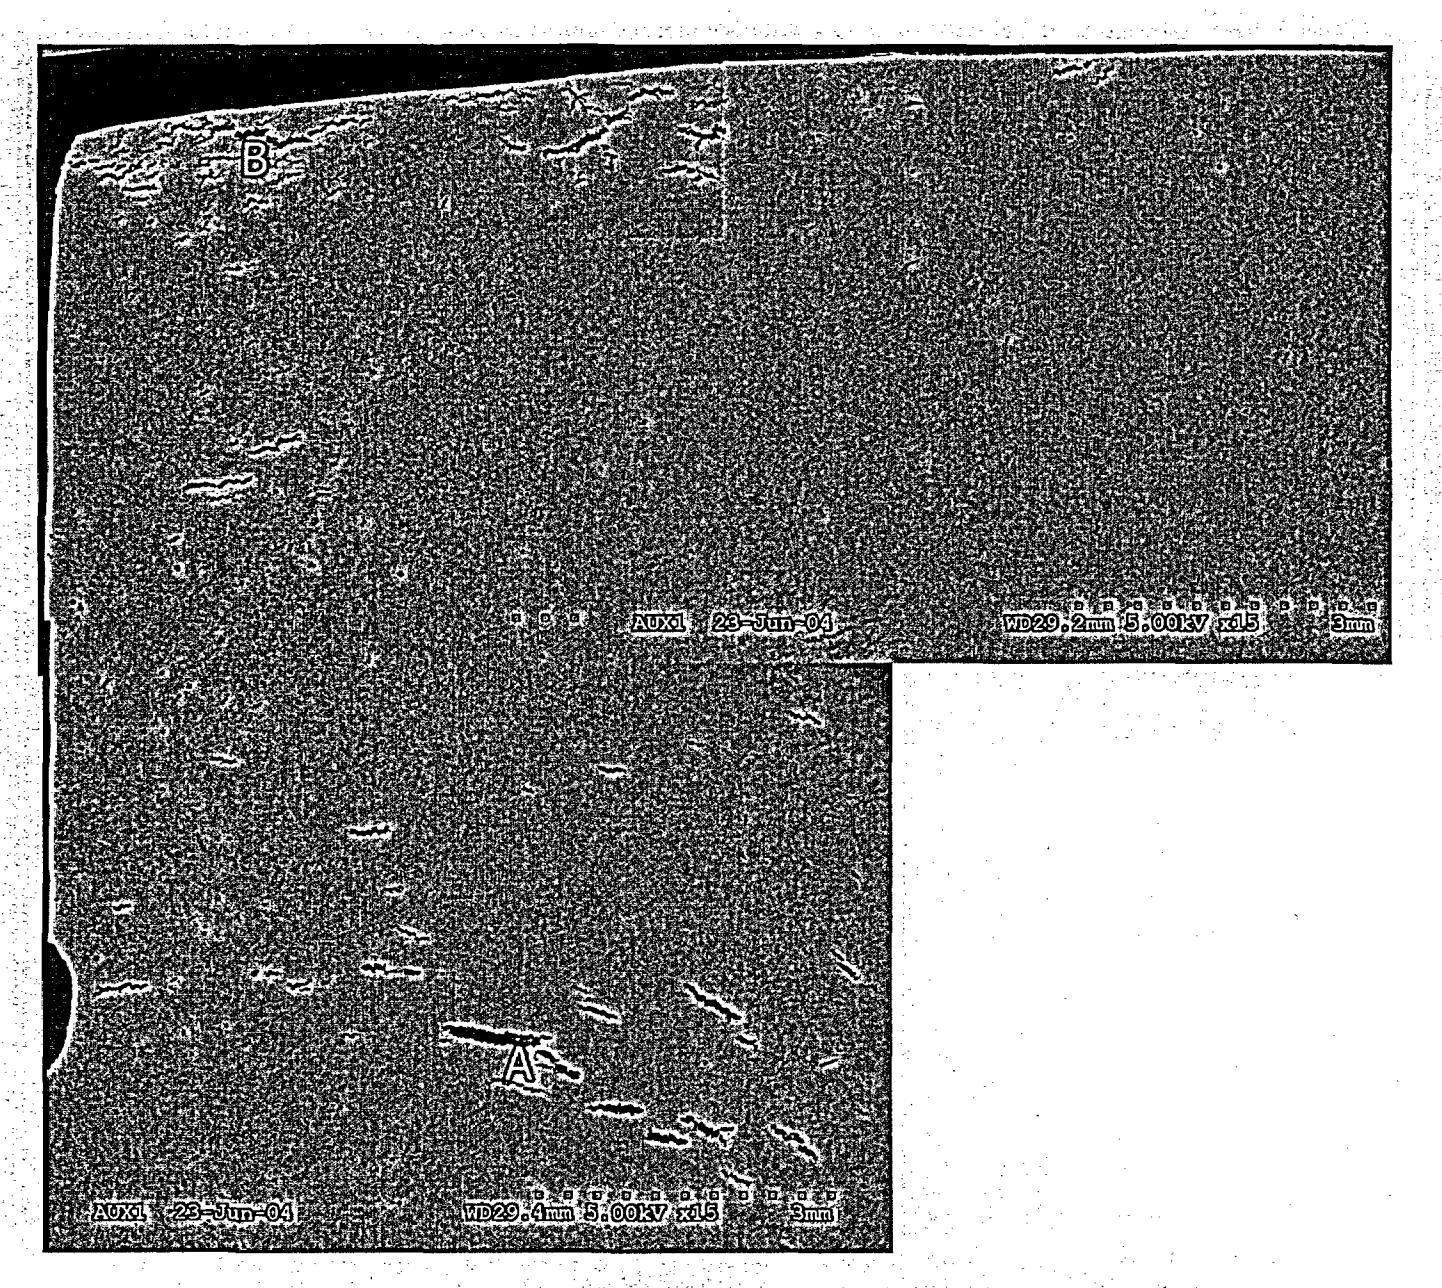
Figure 109: Overall mosaic of corrosion near bottom end of 2H TSP in 5B3B2A (third face). 12.8X

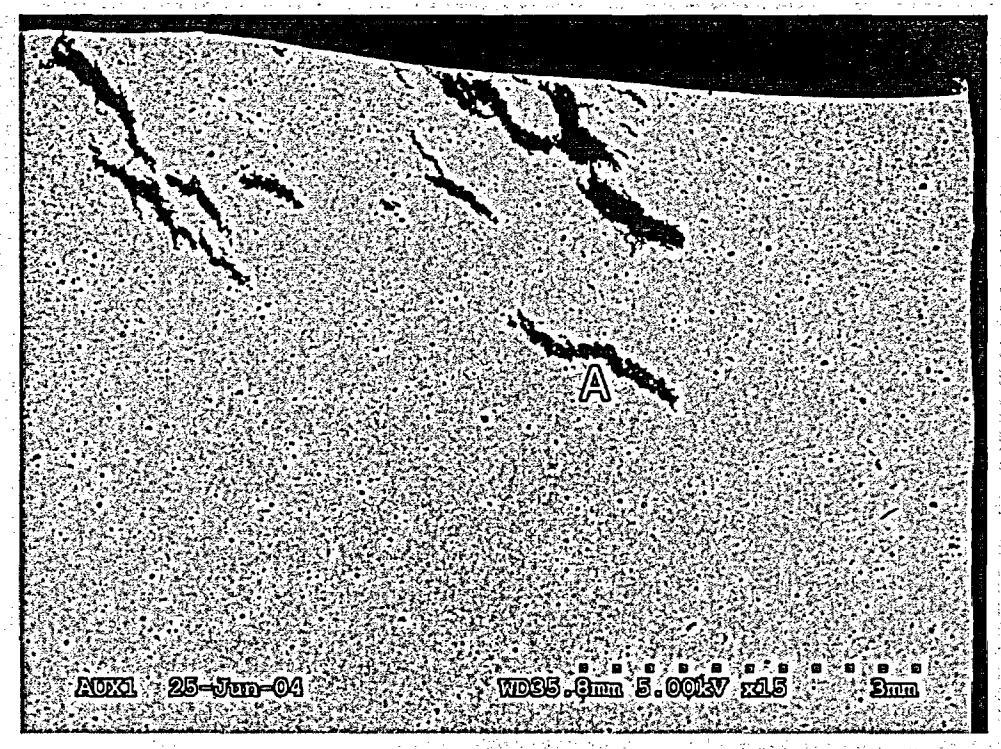
Figure 112: Corrosion area near top of 2H TSP IN 5B3B2A (fourth face). 14.6X

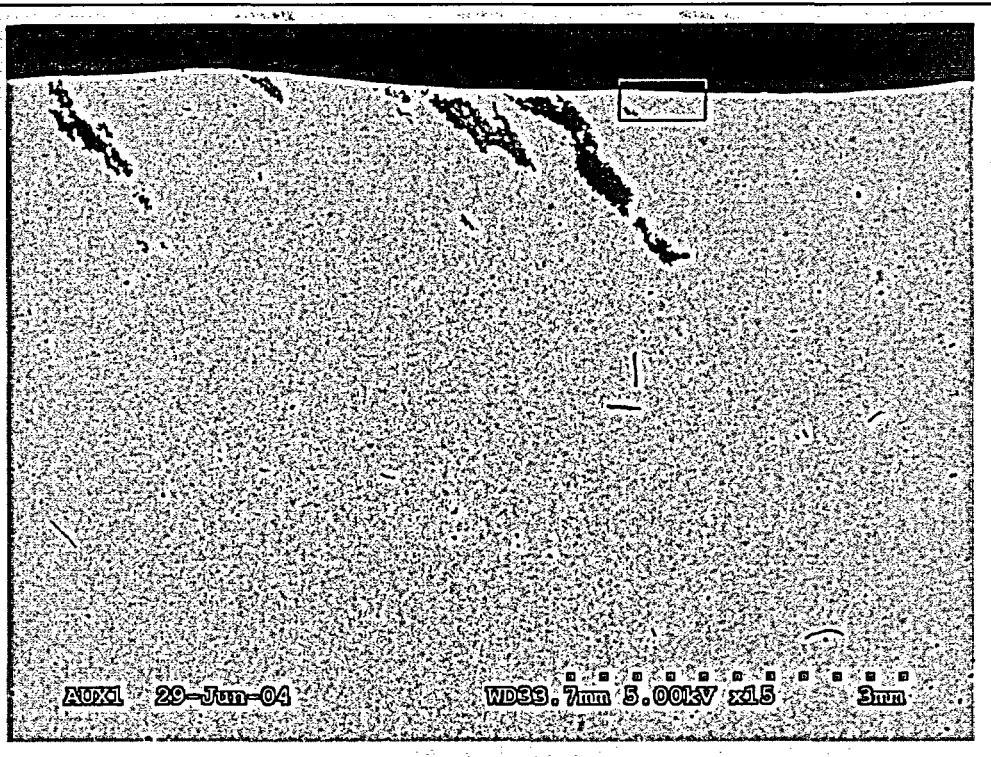
Figure 116: Corrosion area near top of 2H TSP in 5B3B2A (fifth face). 14.6X

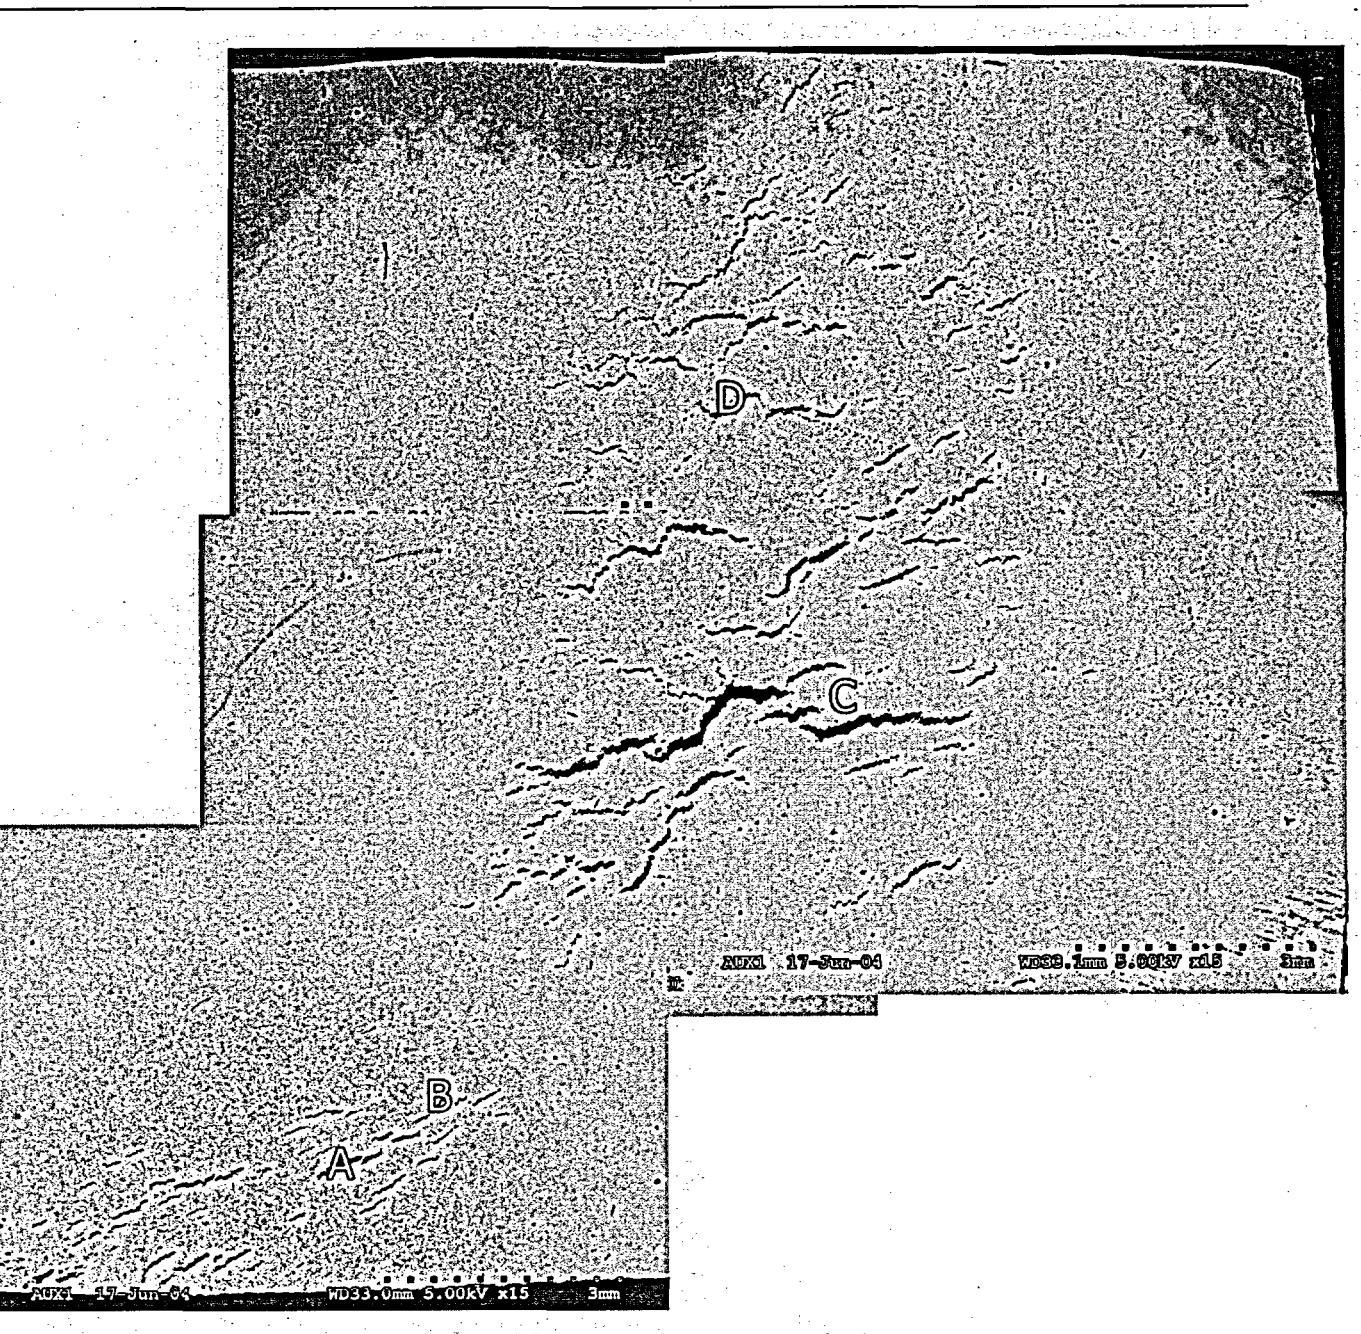
Figure 120: Overall mosaic of corrosion on 5B3B2C (first face). 10.0X
