Examination of Diablo Canyon Unit 1 Steam Generator Tube No. R20C54

51-5046570-01 Final Report, August 2004

Prepared for Pacific Gas & Electric Company

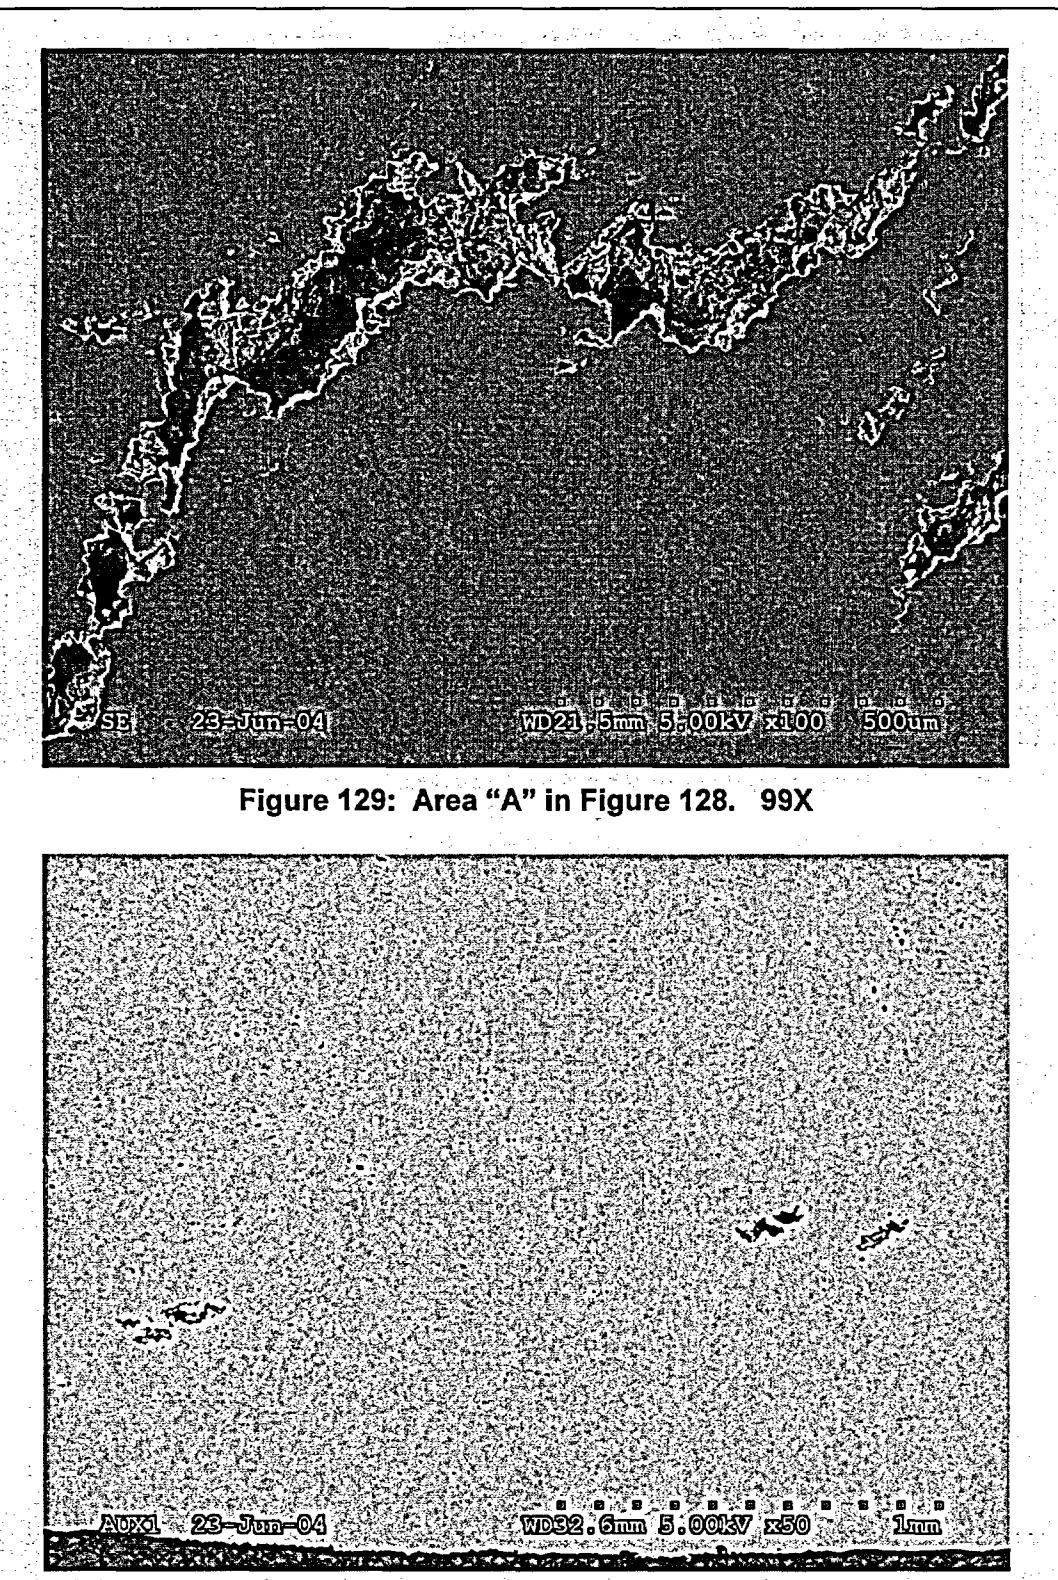
Figure 130: Last remnants of corrosion shown previously in lower left of Figure 125 (third face now). 49.6X

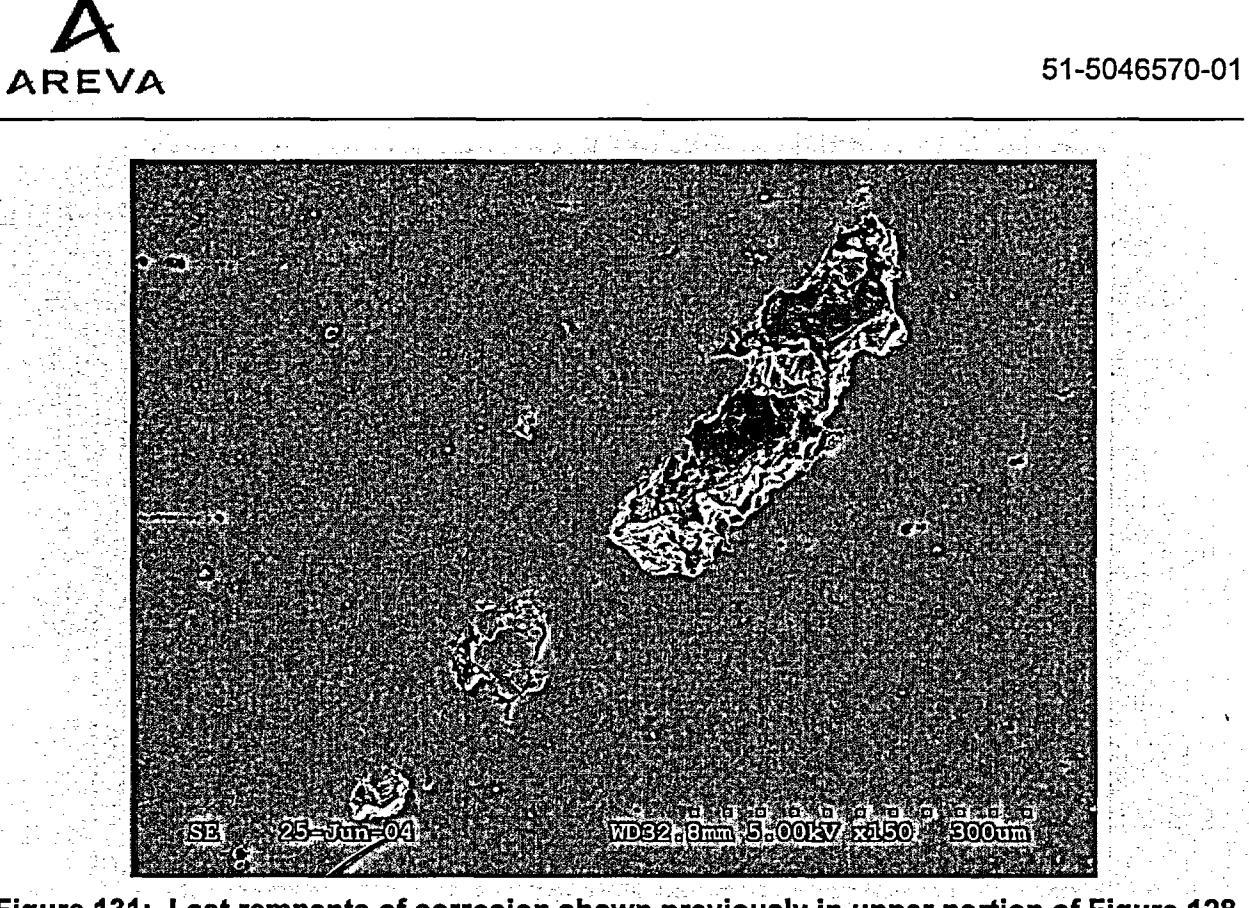
Figure 131: Last remnants of corrosion shown previously in upper portion of Figure 128 (fourth face now). 146X
