**H-1-BB-MEE-1878**

**Hope Creek 'B' Recirculation Pump**  
**Vibration Analysis**

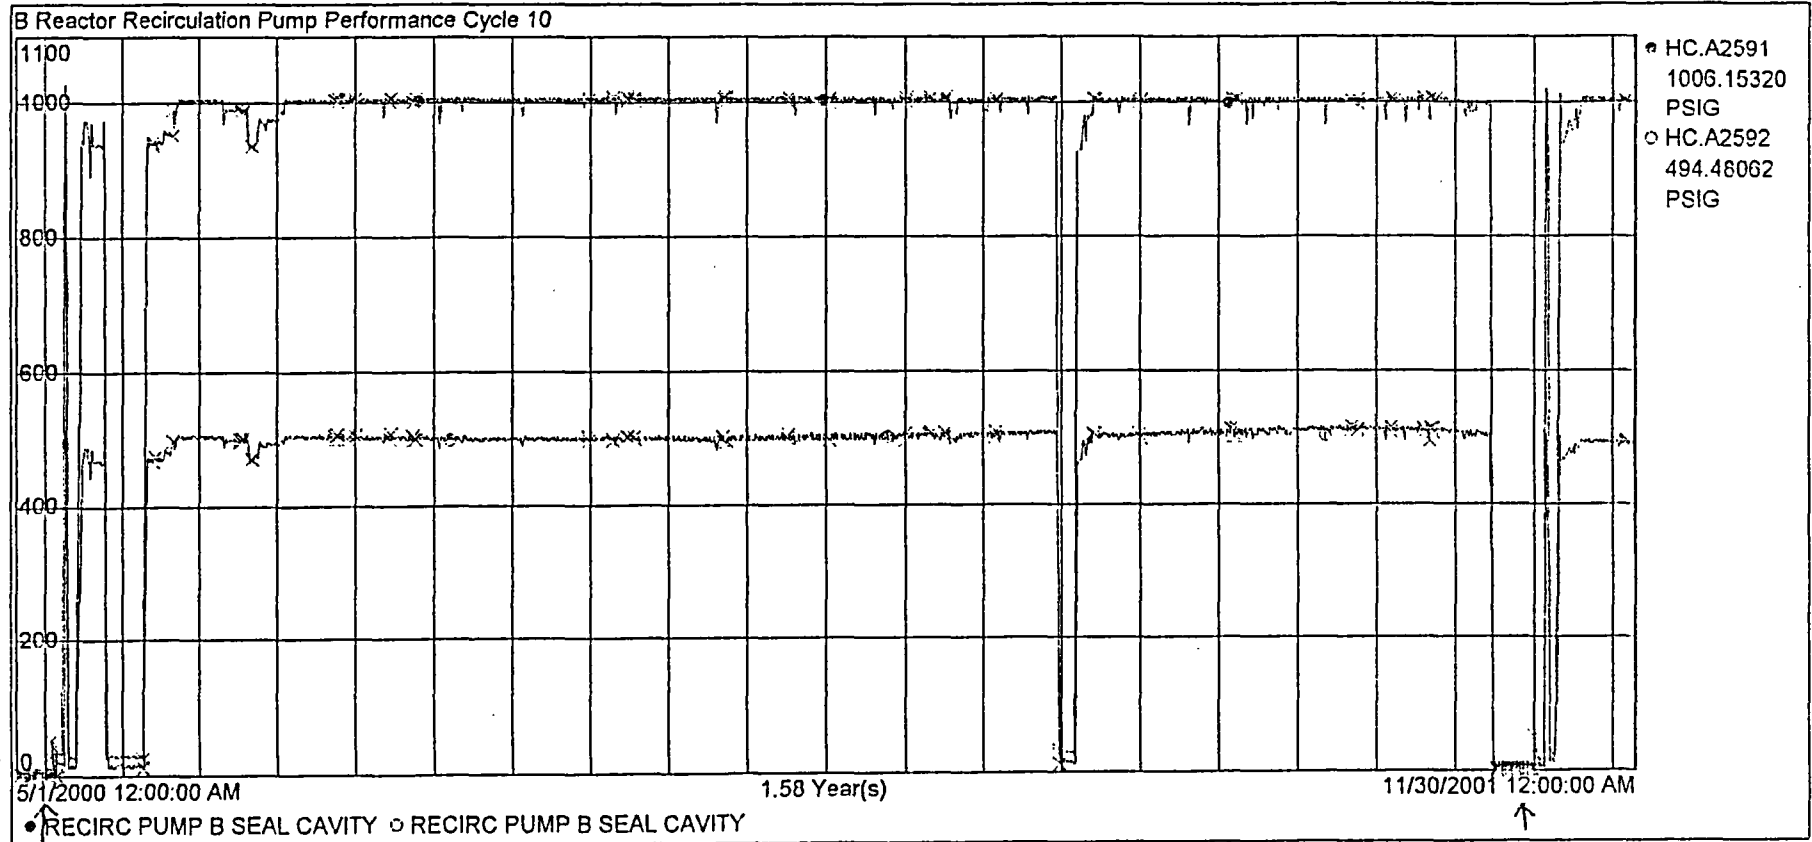
RF09  
Replace Mech  
Seal

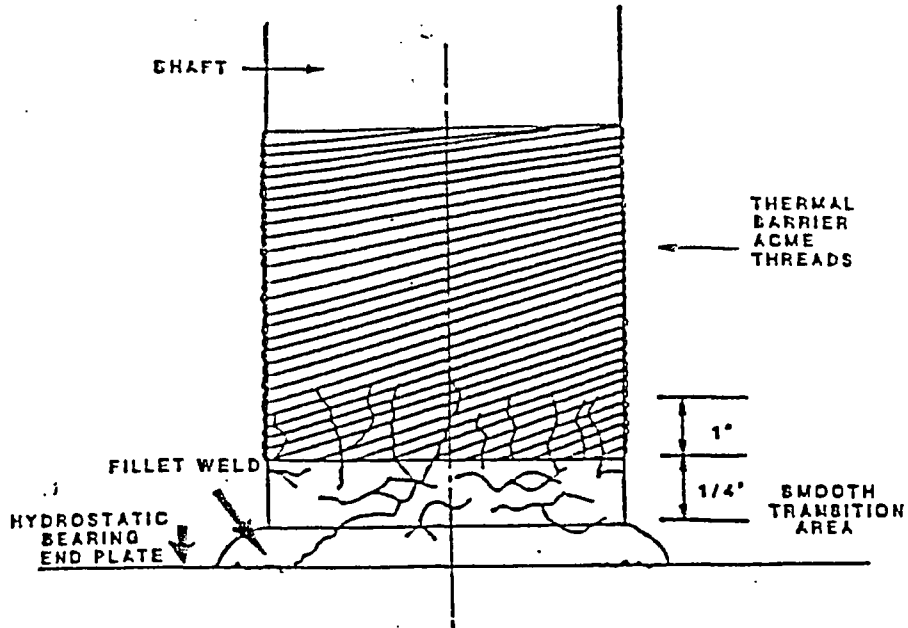
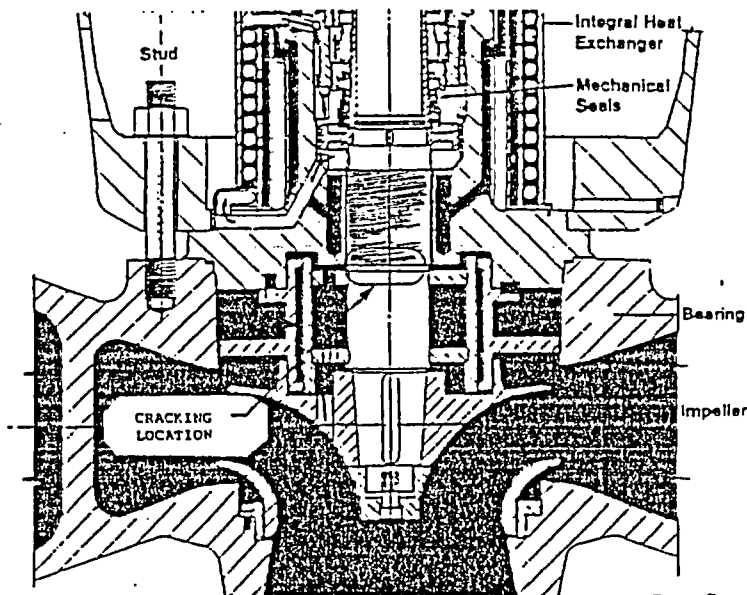
#### Location of Reactor Recirculation Pump Shaft Cracks
