H-1-BB-MEE-1878

Hope Creek 'B' Recirculation Pump
Vibration Analysis

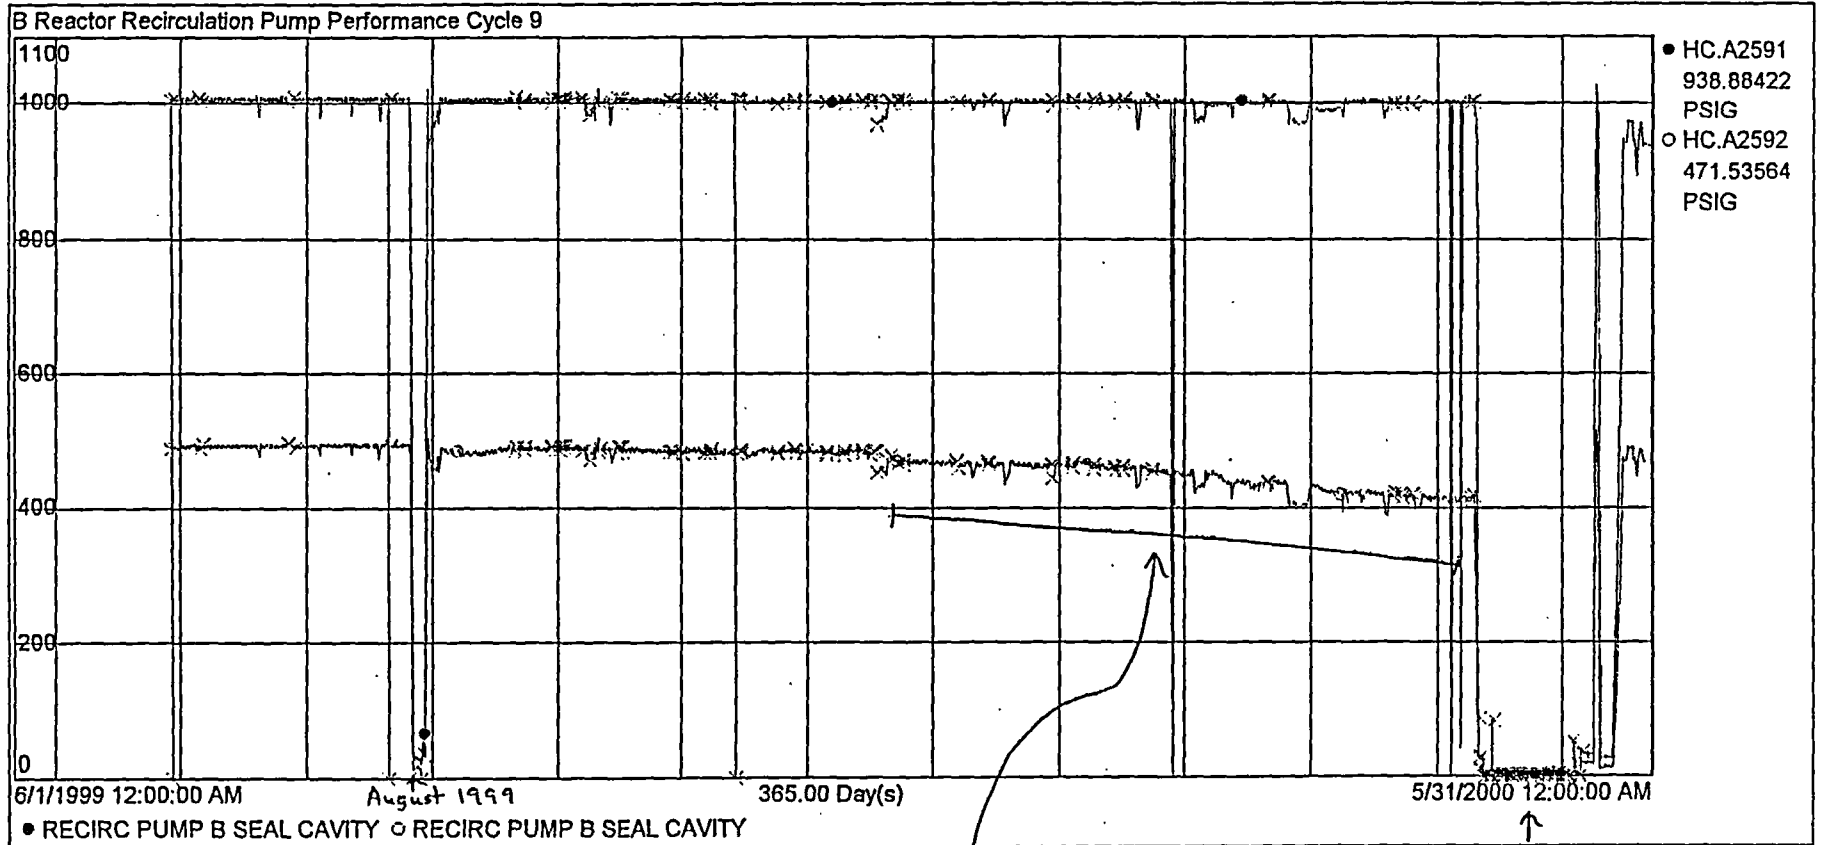
First and Second stage Mechanical Seal Pressures

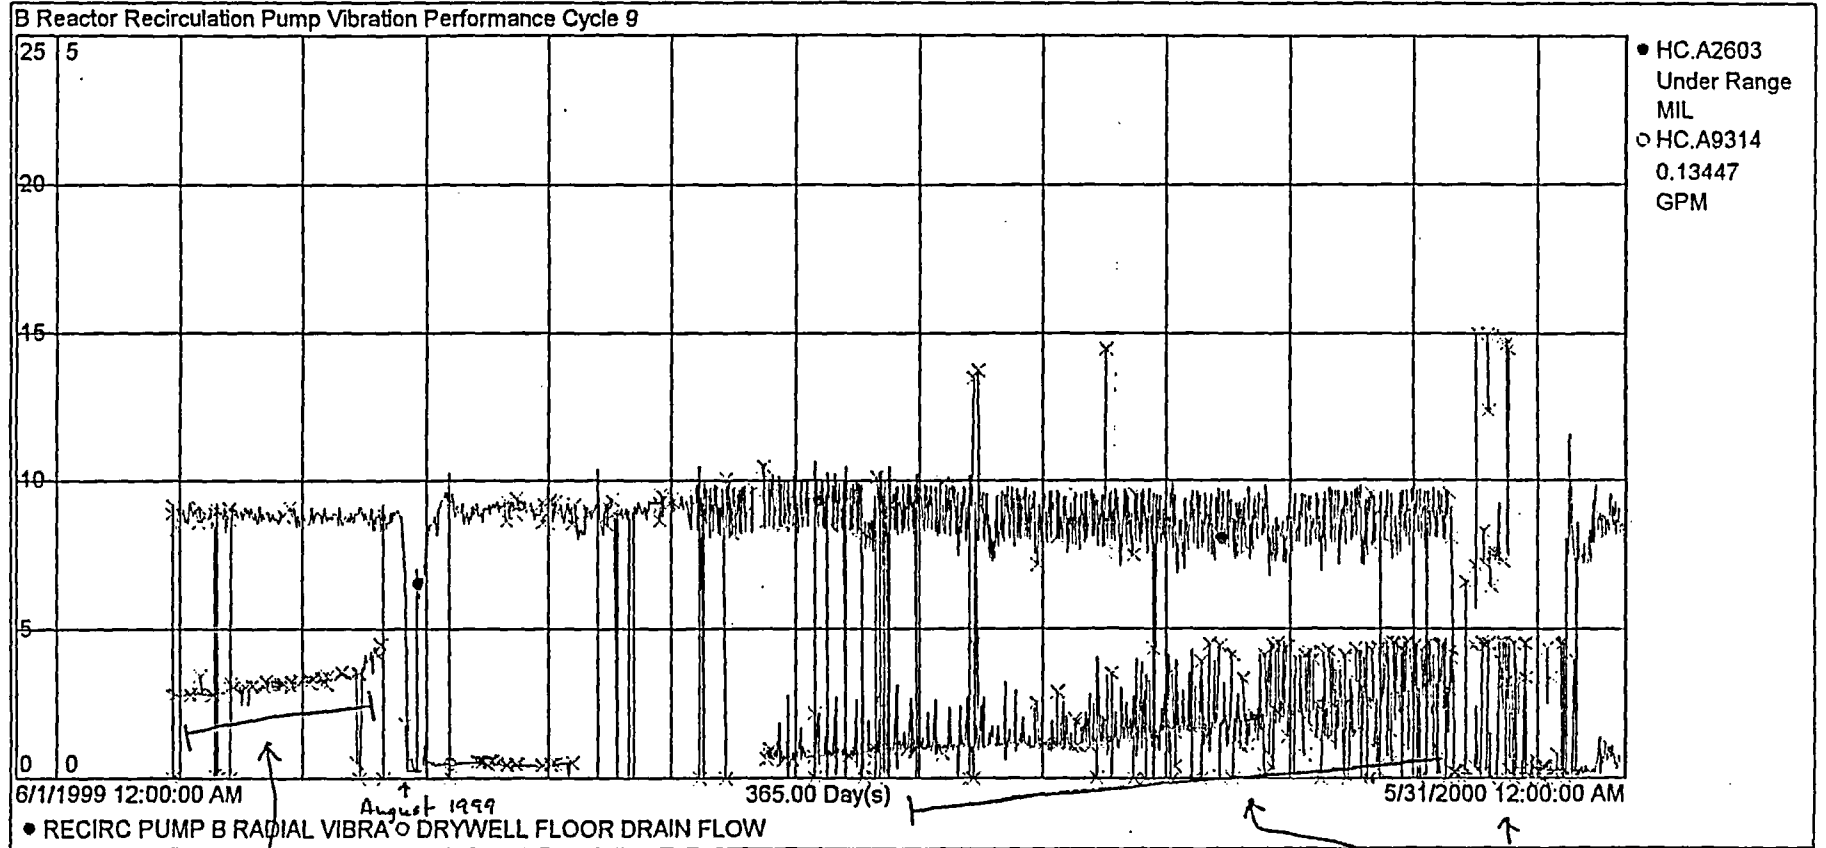
Outage
Replace Mech
Seal

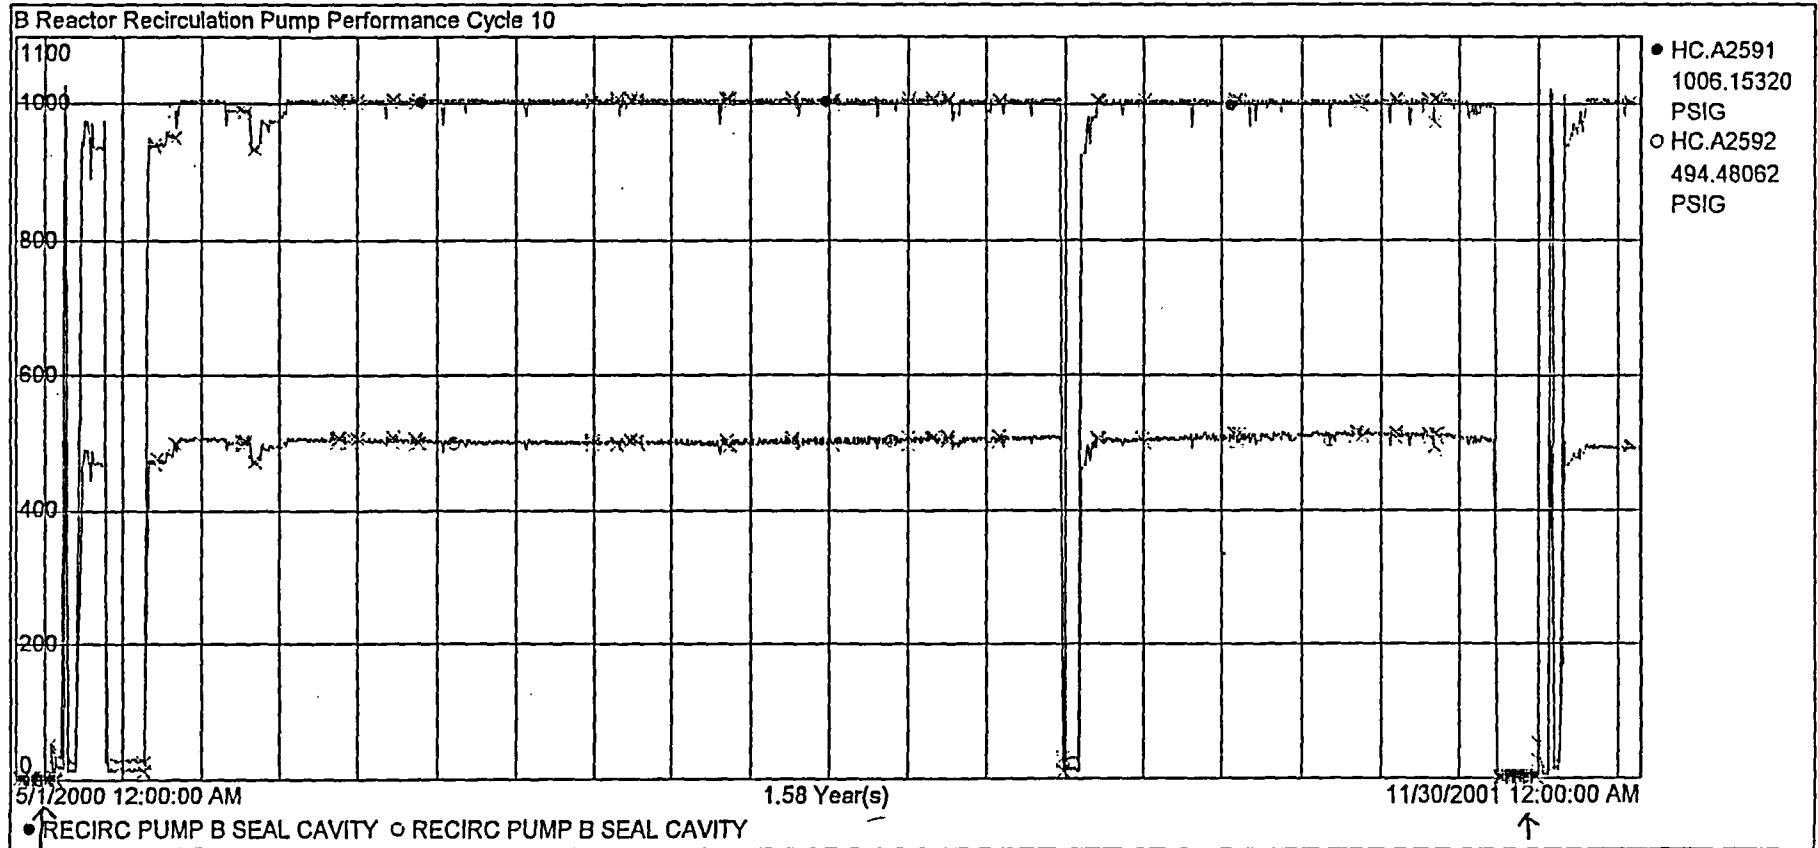
RF09
Replace Mech
Seal

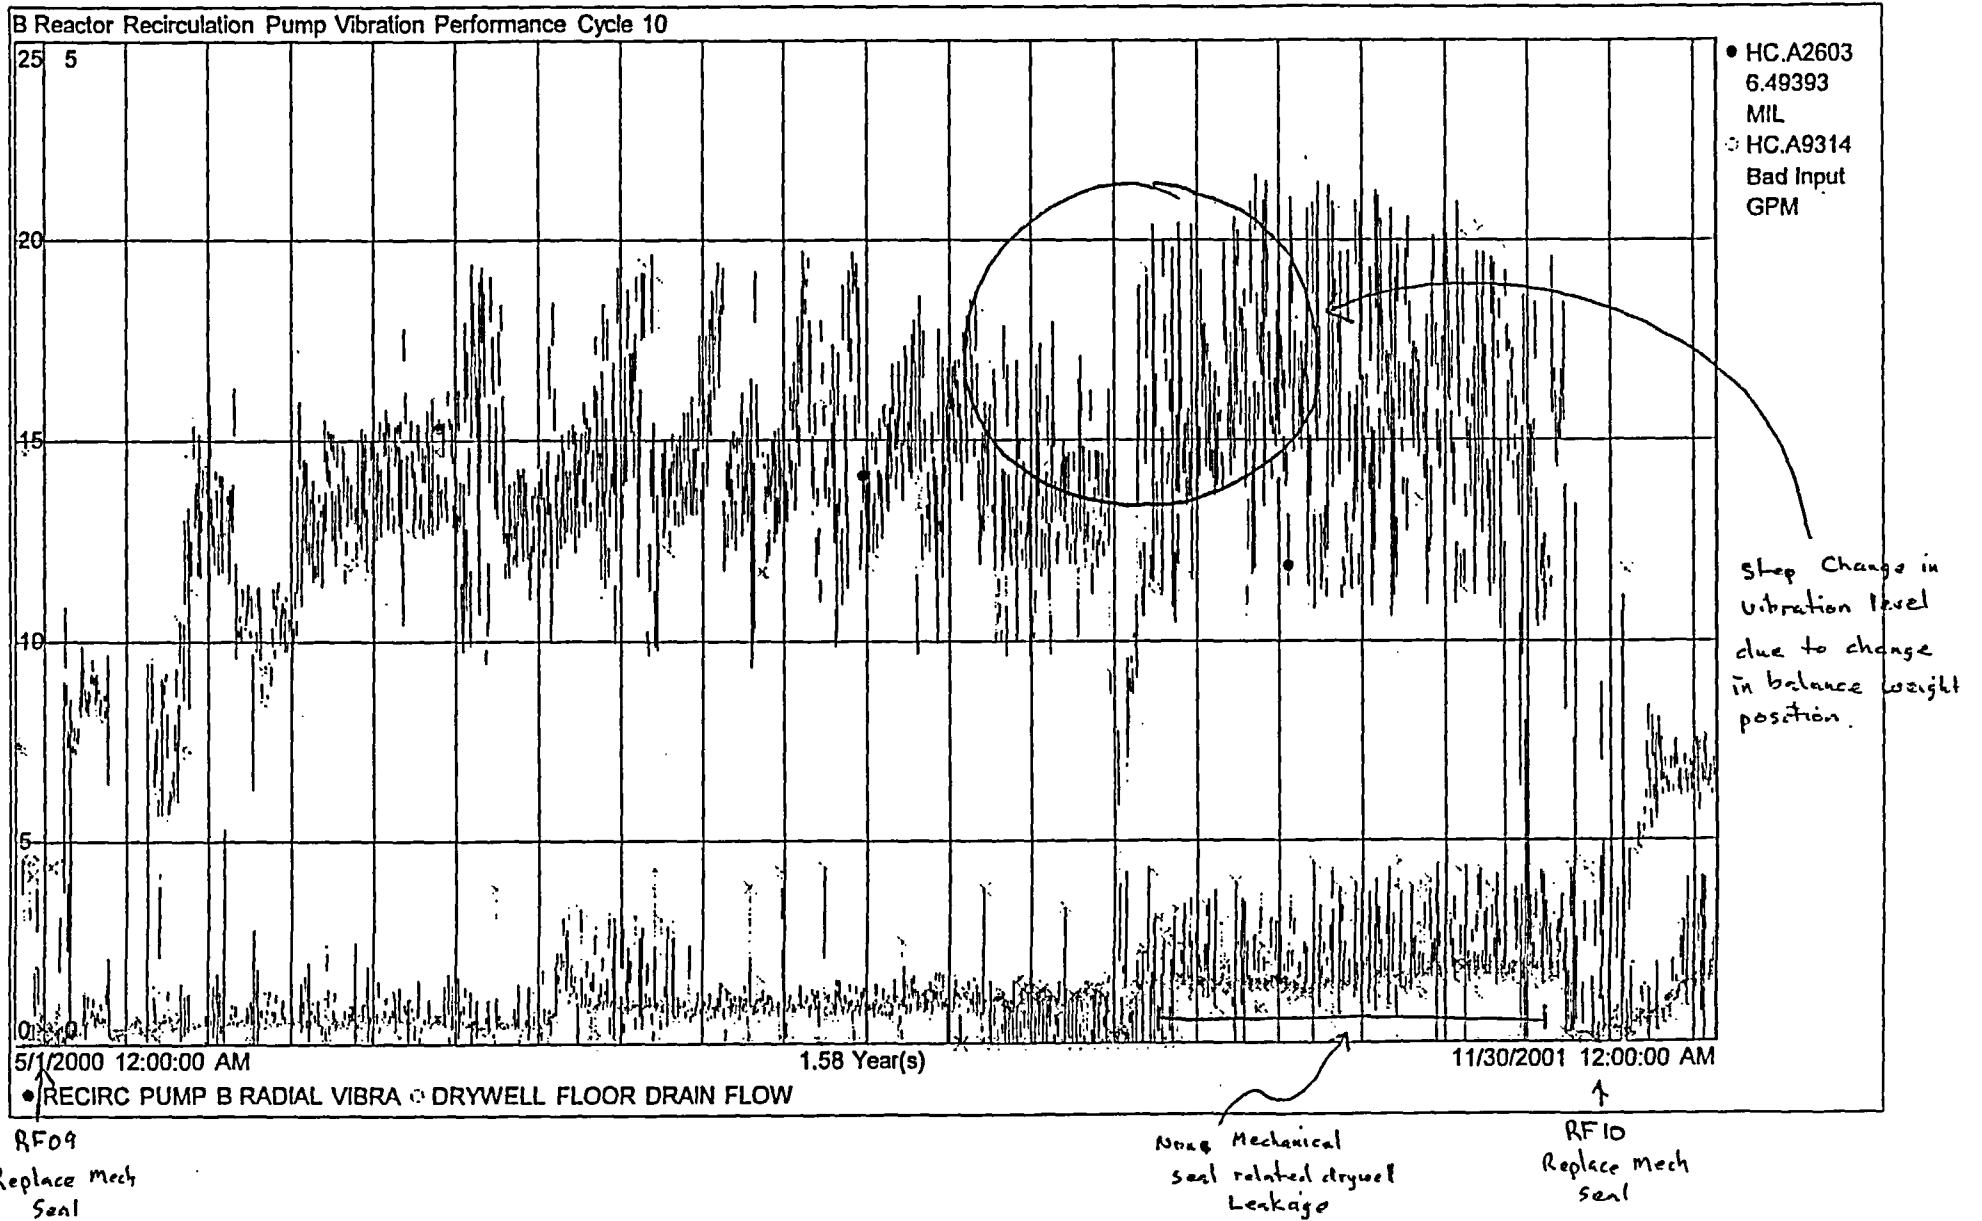
Elevated vibrations throughout the Cycle due to the balance weight installed during RF09 and moved in April 2001.

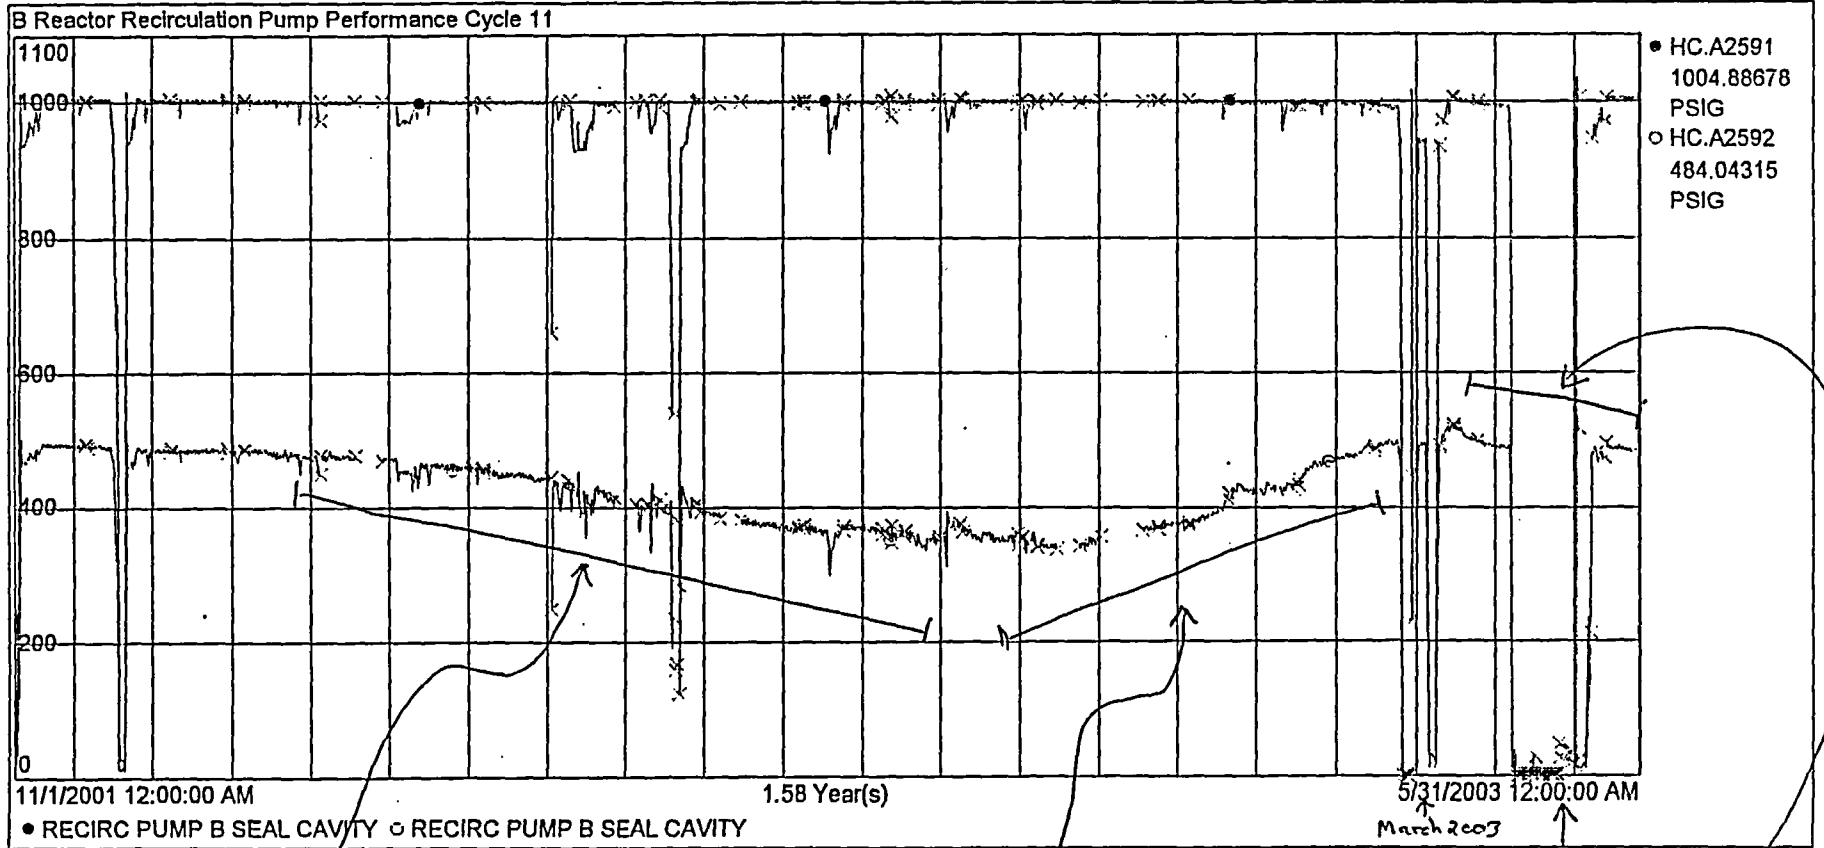
Second stage Seal leaking
 due to scoring on
 seal faces

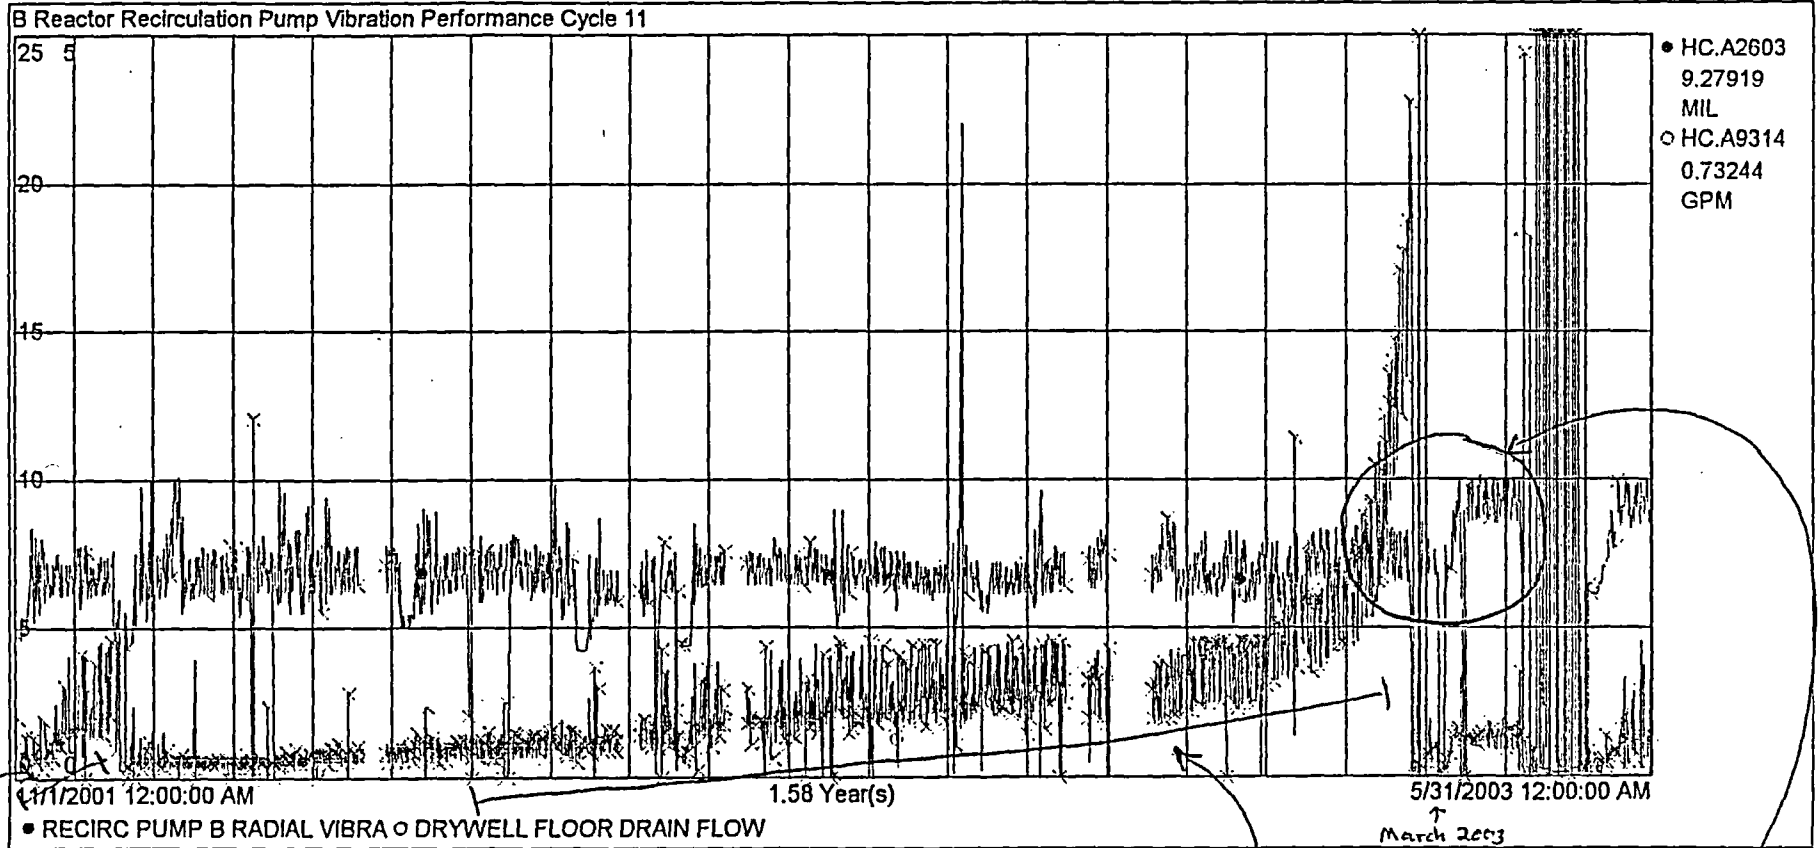
Vibrations steady (6-8mils) until March 2003 Mech Seal Replacement
 Vibrations steady (8-10mils) After March 2003 Mech Seal Replacement

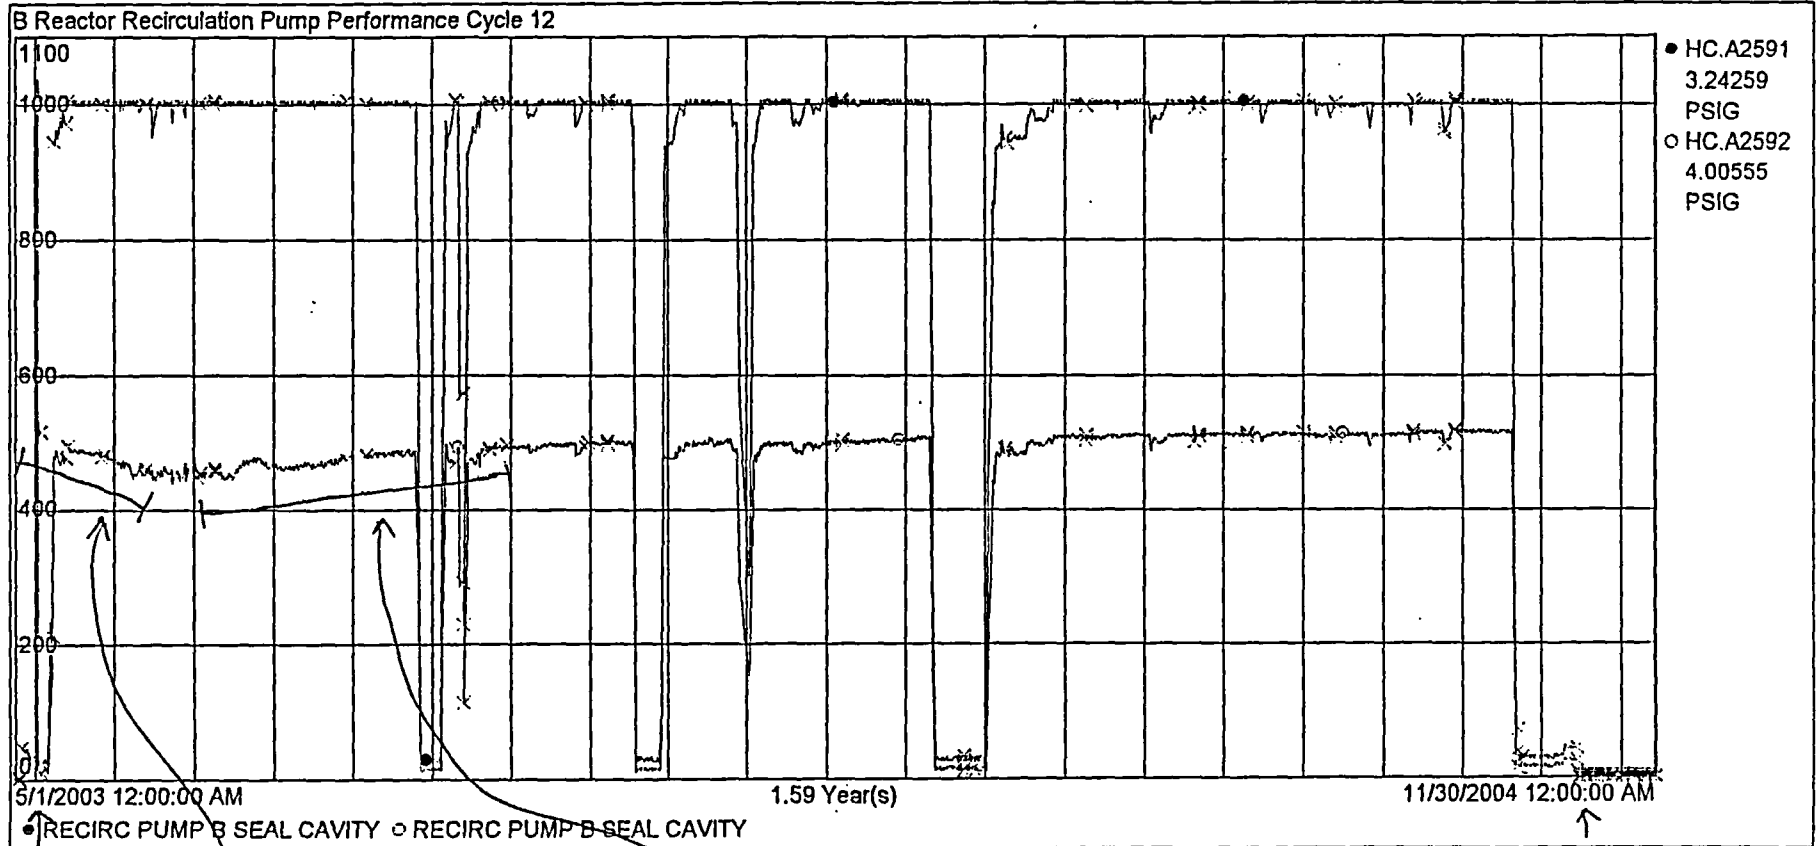
First and Second Stage Mechanical Seal Pressures

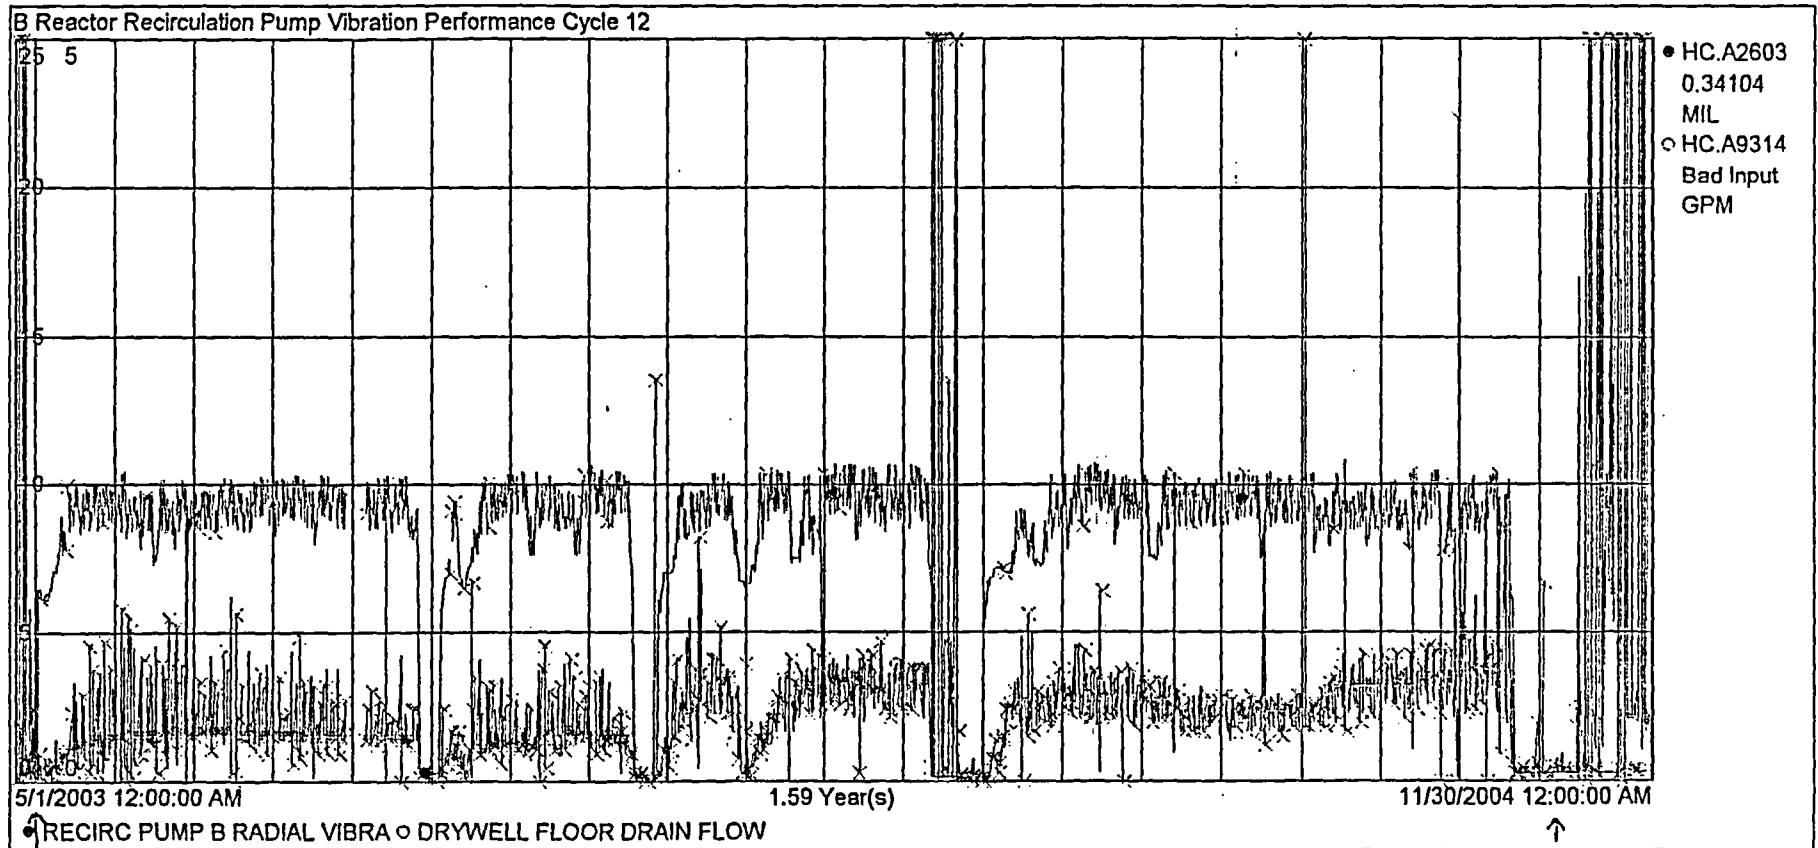
Reactor Recirculation Pump Radial Vibrations and Drywell Floor Drain Leakage

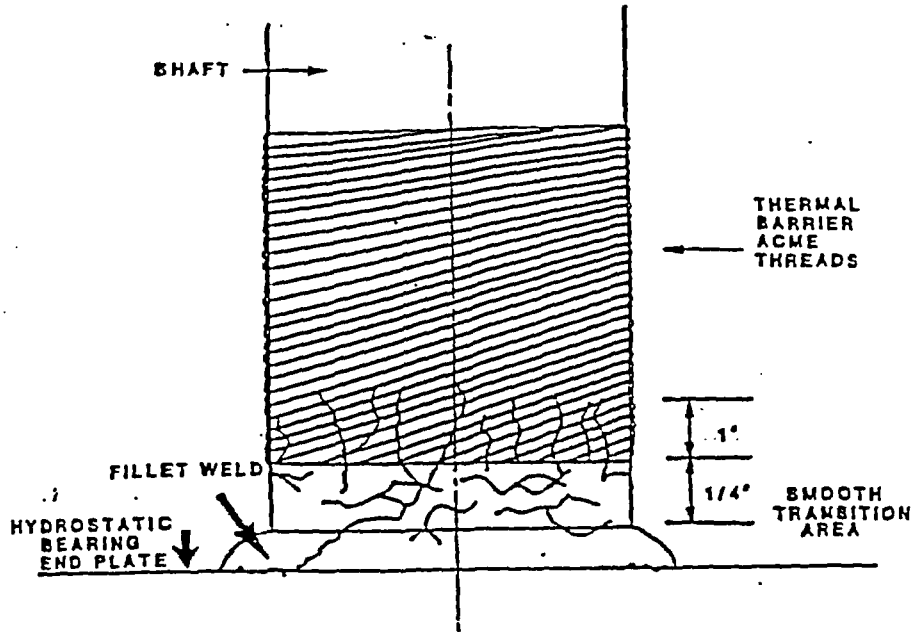
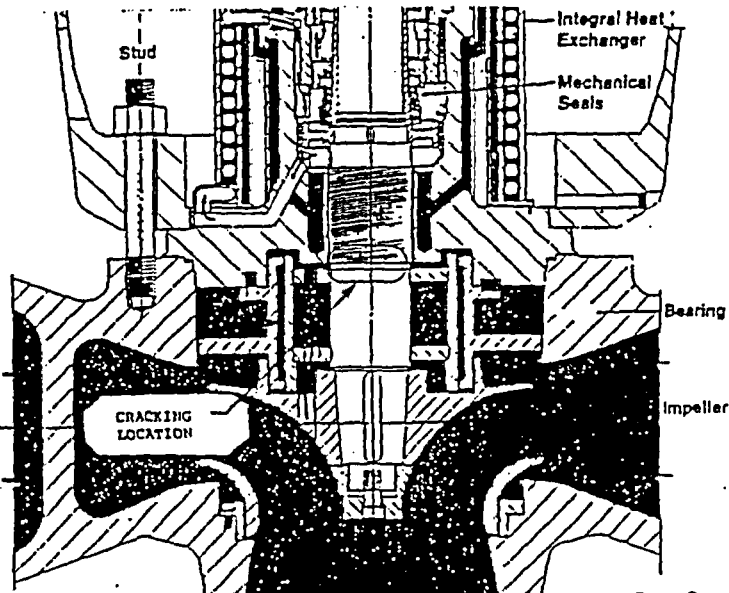
- References:
- 1) Crack Propagation in Main Coolant Pumps, S. Gopalakrishnan, BW/IP International Pump Division
 - 2) Evaluation of Main Coolant Pump Shaft Cracking, EPRI, 1992

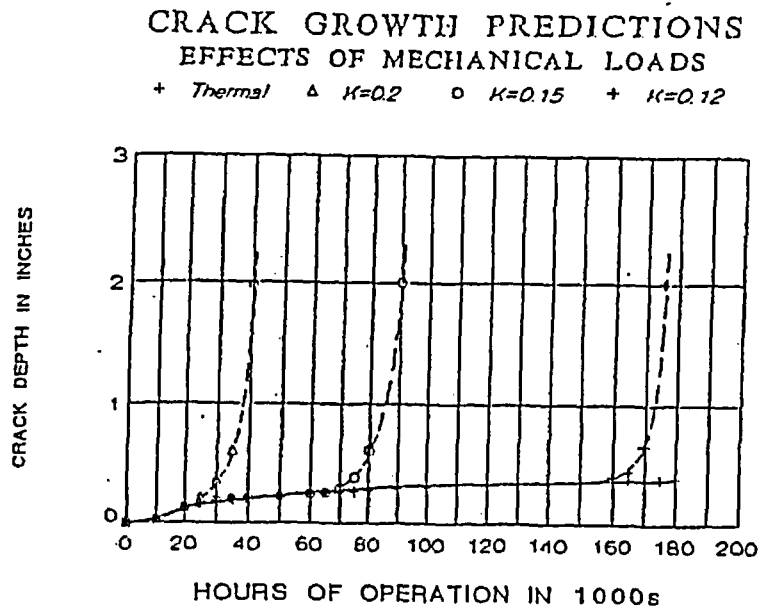
Shaft Crack Growth Prediction Graphs
