BNP - USNRC Region II Update

Neil Gannon
January 28, 2005

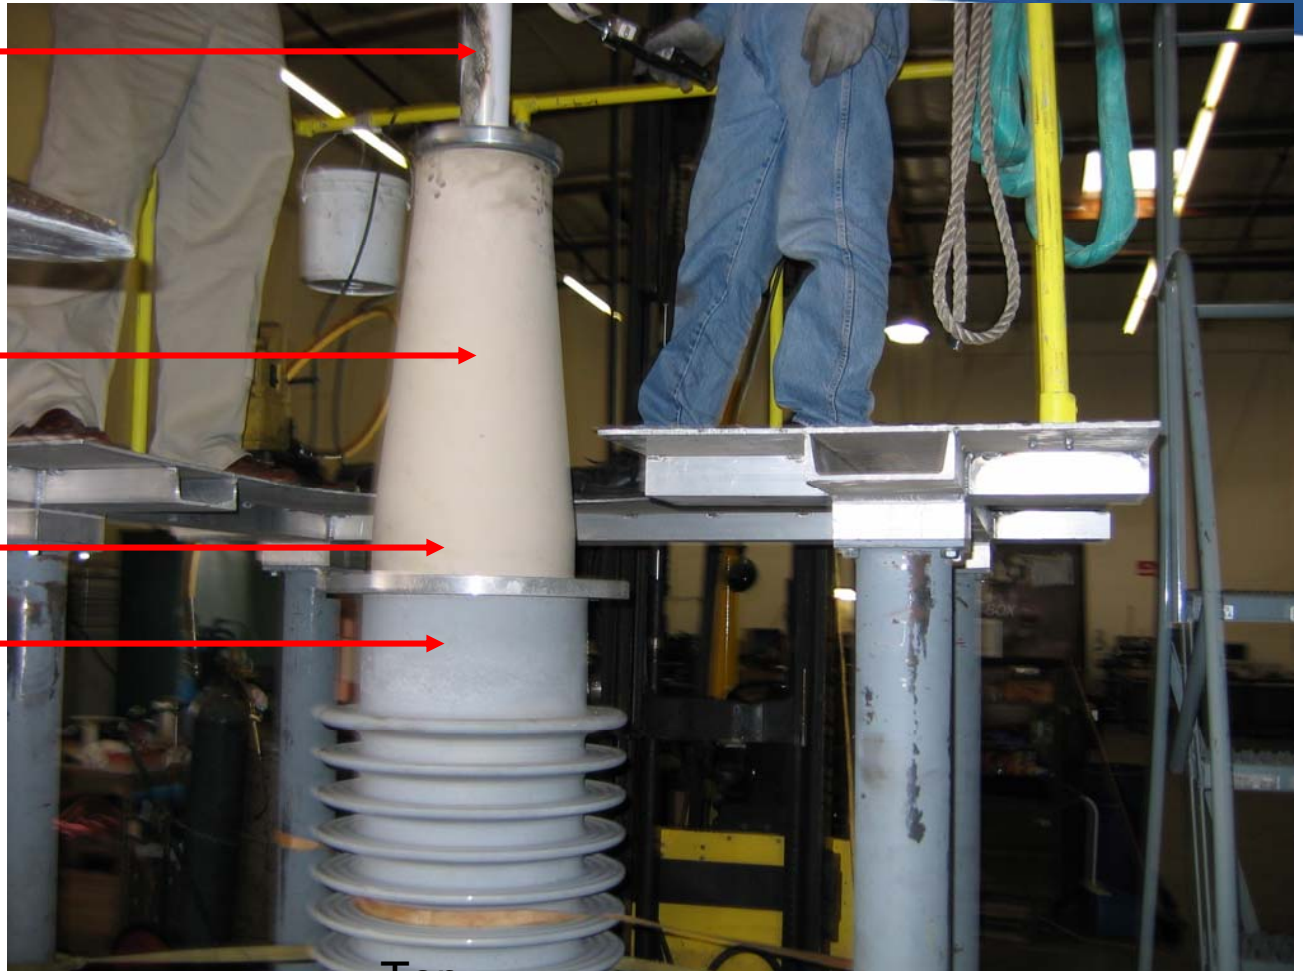
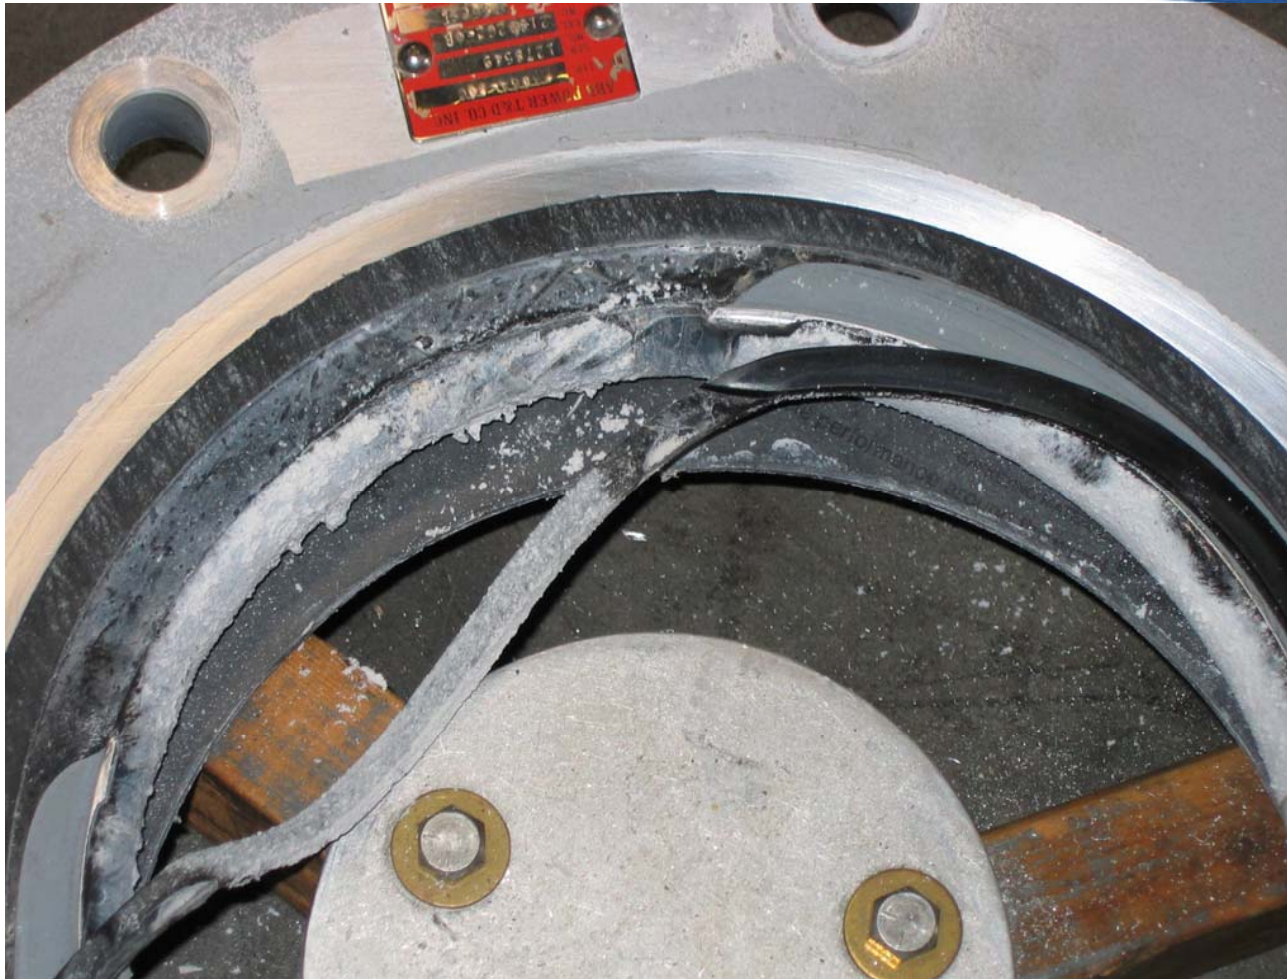
- October 2004 - PCB 24B failed again.
- Based on Visual Inspection and Vendor Input
- B Phase Bus Side Bushing Experienced Internal Fault
- Bushing Sent to ABB for Analysis
- Determined that standard pressure test had not been performed & would have identified assembly error
- Newly Installed & Recent Shipment (3) Rebuilt Bushings were pressure tested within spec.

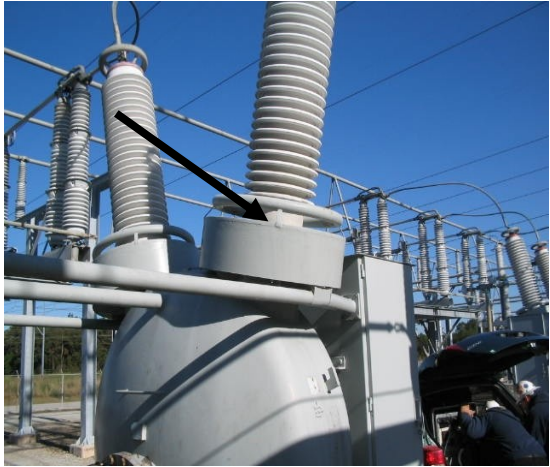
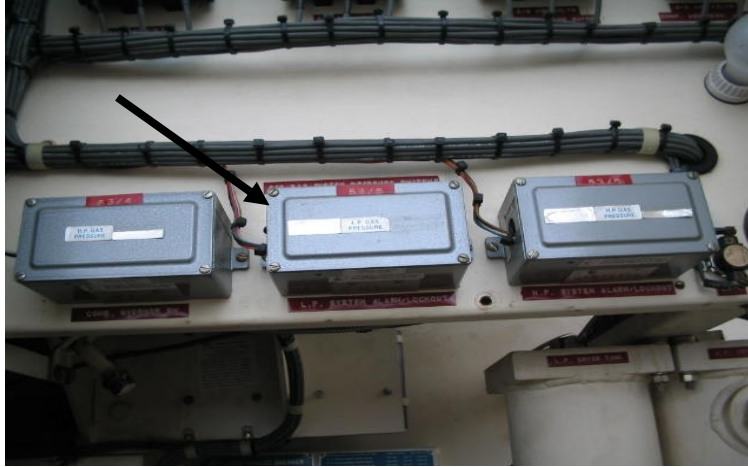
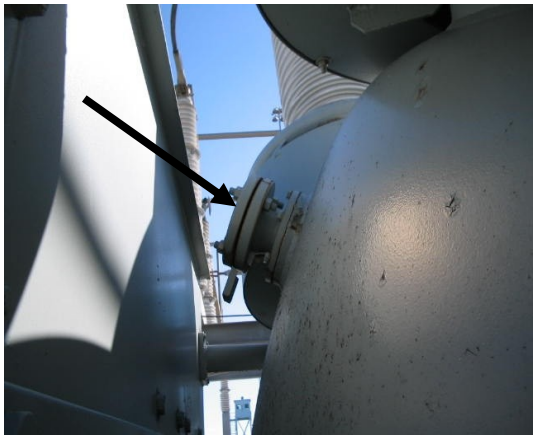
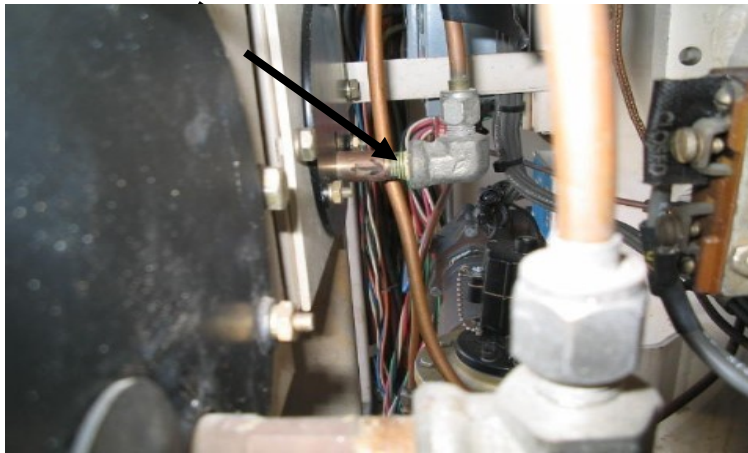
Sample Leak Locations

- Breaker returned to service following rebuild
- PNSC reviewed investigation on 12/15/04
- Identified 8 additional PCB's requiring maintenance due to minor leaks
- PCB 24B determined to be highest priority
- PCB 24 B removed from service for leak repair on January 4, 2005
- Bushings replaced from stock obtained from ABB rebuild facility

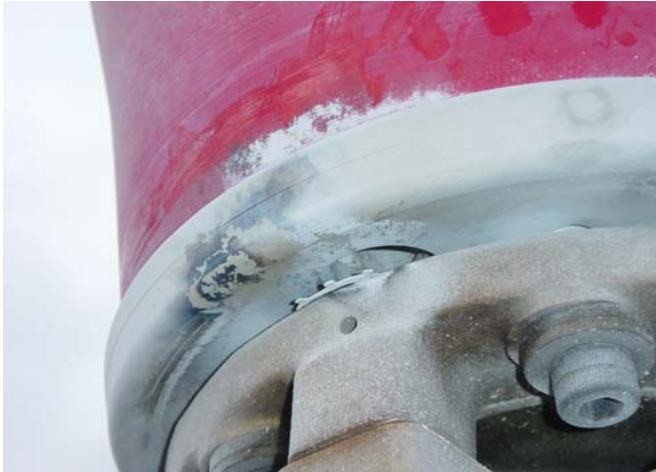
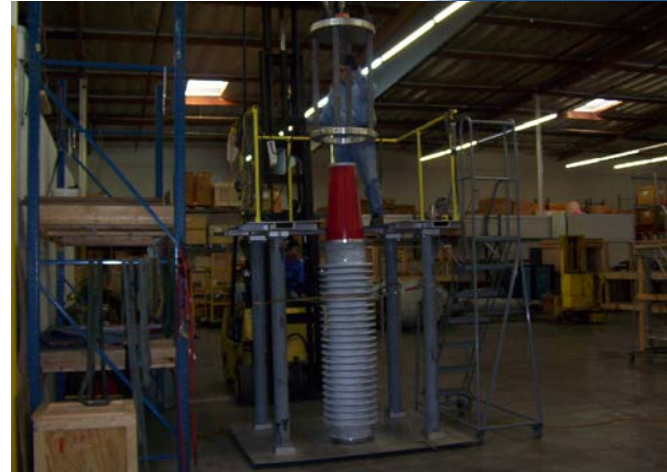
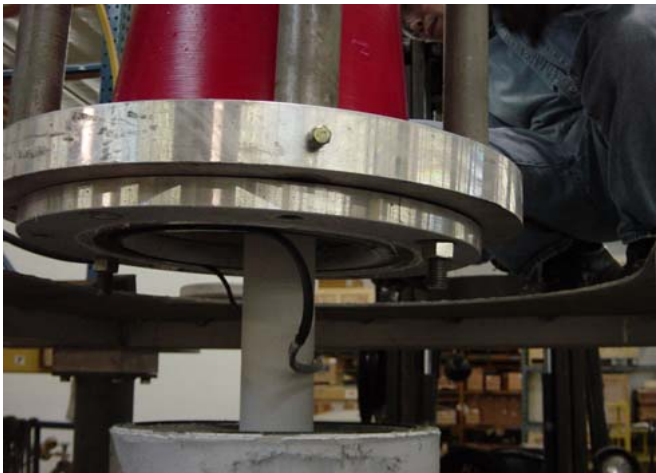
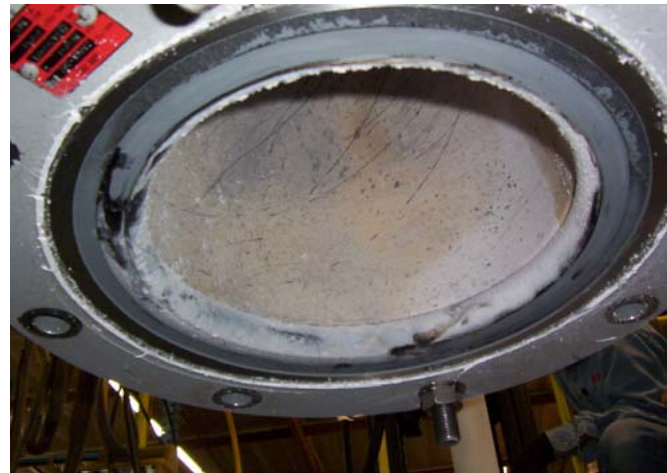
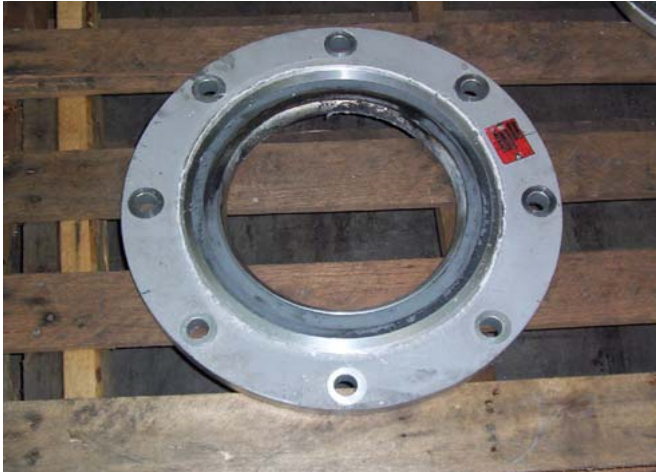
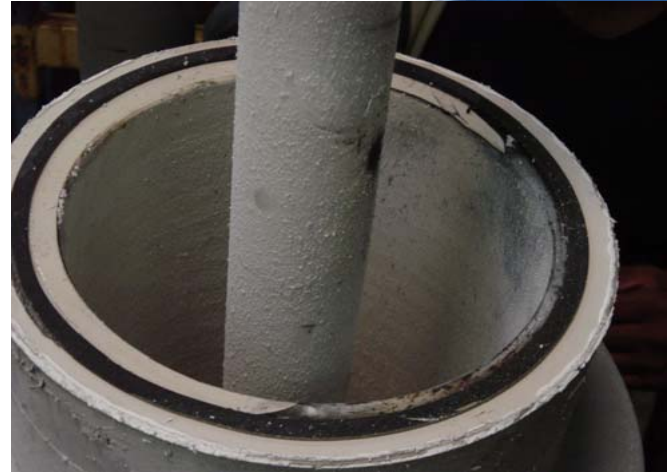
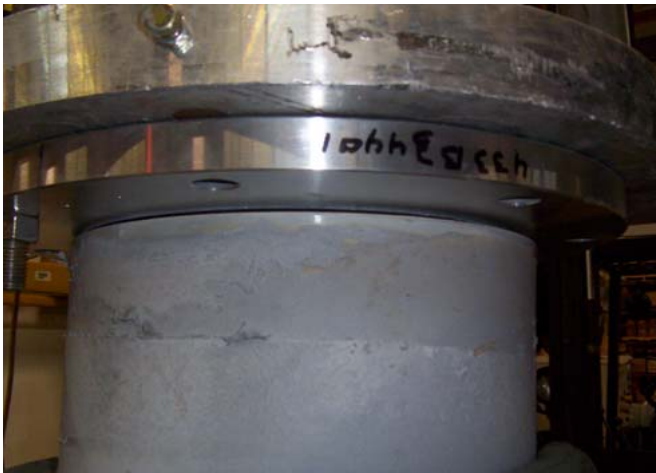
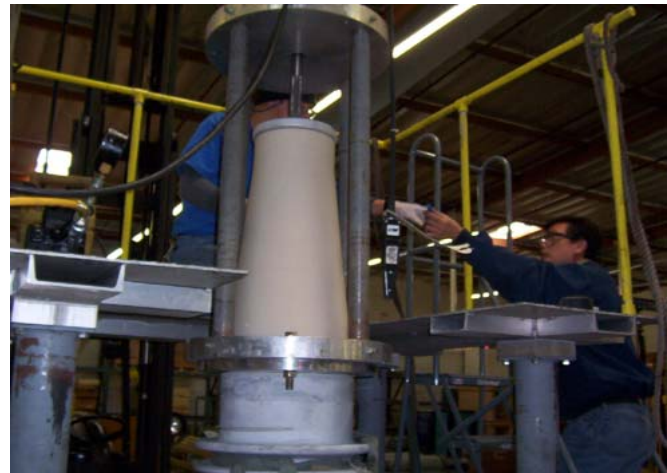
24B PCB Photos

- 1/7/05 - Bushing Failed During Restoration
 - ◆ PCB Was Open
- Shipped to ABB 1/9/05
- Observations - Teardown in Carson, CA
 - ◆ Personnel Not Using Checklist
 - ◆ Adhesive was Inadequate
 - ◆ Personnel Training was Inadequate
 - ◆ Chain Hoist was used vs. Cable Hoist

- ABB Review With Station Management
- Continue with Leak Repairs on Low Risk Leaks (PCB in Service)
- Witness Bushing Rebuilds to Gain Confidence
- Return PCB 24B Back to Service
- Determine if correlation between as-found leak rates and time to failure
- Present Plan for Repairing Leaking PCB's
- Evaluate Possible Compensatory Measures until leaking PCBs can be repaired

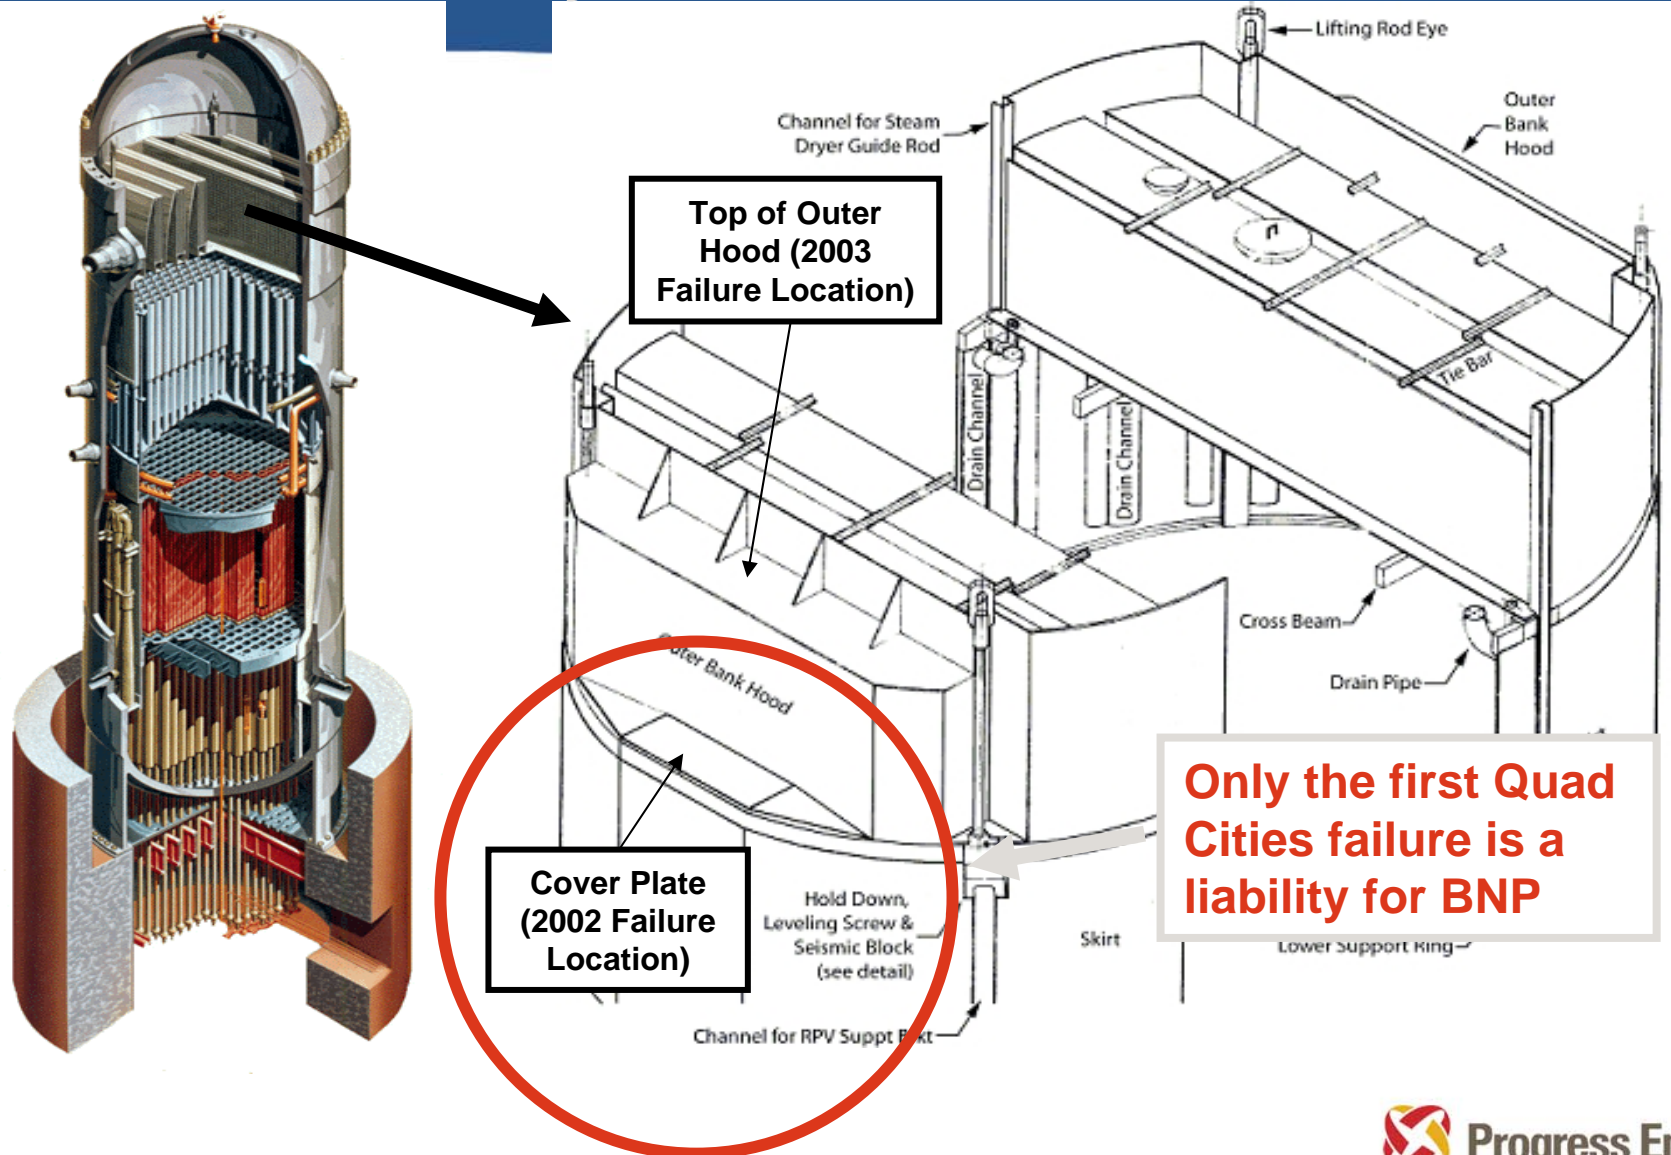
Quad Cities Dryer Failures

- Prompted by Quad Cities failures
- GE recommended design changes
 - ◆ BNP has a less susceptible design
 - ◆ Based on very conservative load calculations
- Design changes
 - ◆ Increases weld size to strengthen vulnerable areas
 - ◆ Adds Gussets for additional support
 - ◆ Significantly improves design margin

- **Scope**
- Modify welds (increase bead size) on the steam dryer cover plate (including manway).
- Install gusset plates to the Outer Bank Hood @ 90 and 270 degrees.
- Replace all ten tie bars on the top of the steam dryer.
