102-05247-CDM/SAB/RJR April 14, 2005

Subject: Palo Verde Nuclear Generating Station (PVNGS) Unit 2 Docket No. STN 50-529 Response to Request for Information Related to Relief Request 31.

Subject: Hot Leg Alloy 600 Small Borehole Fatigue Crack Growth

Your ref: Our ref: LTR-CI-05-16, Rev. 1

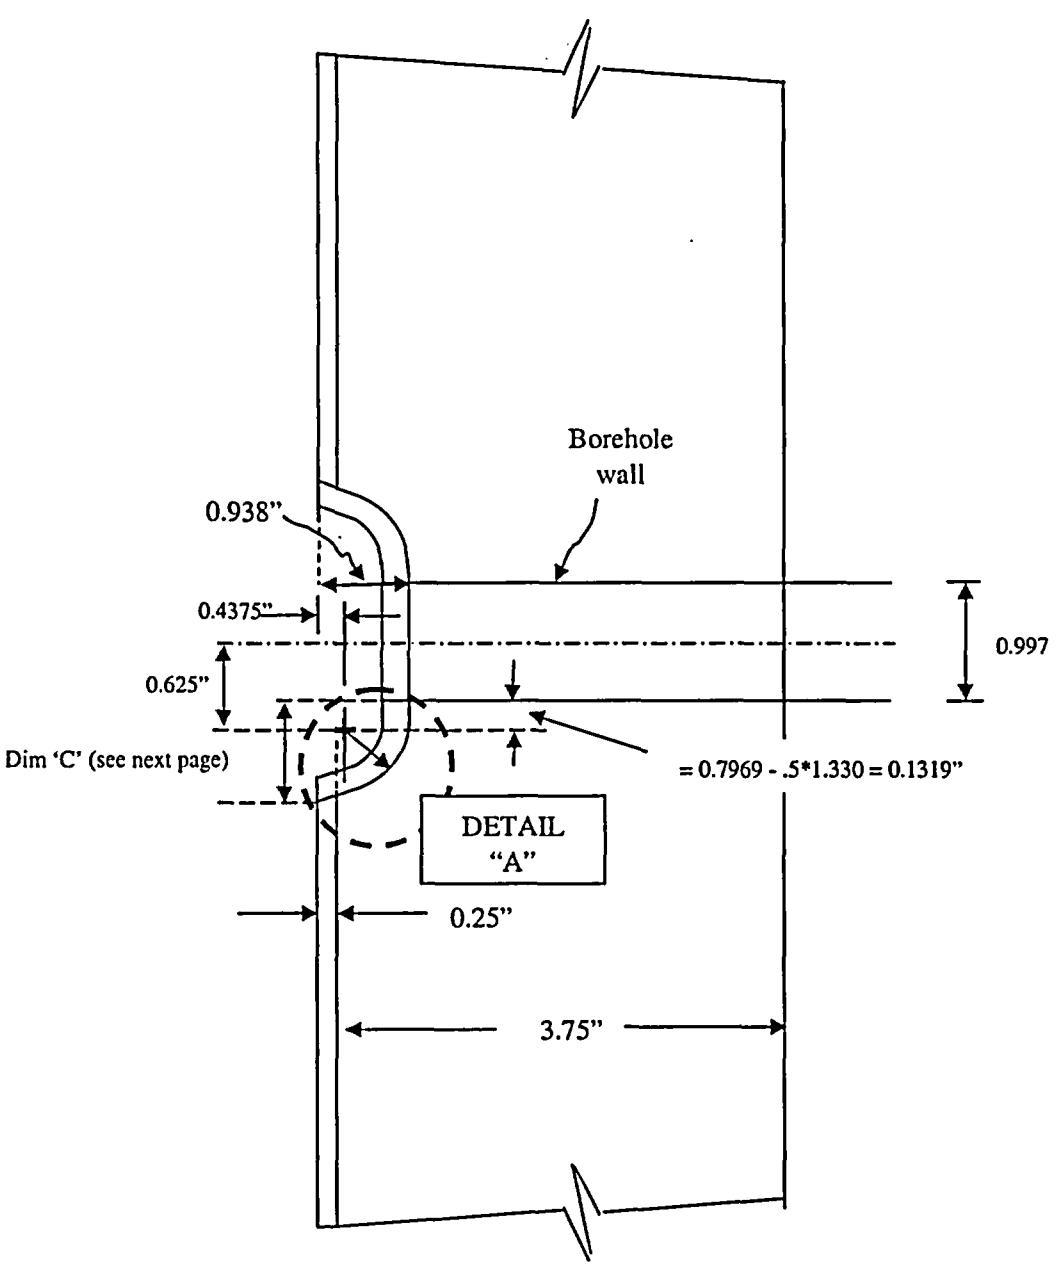
Figure 1: Small Bore Nozzle Bounding Plant Geometry a) Hot Leg Piping, Sheet 1 of 2 (Figure 6-1 from Ref.1) .

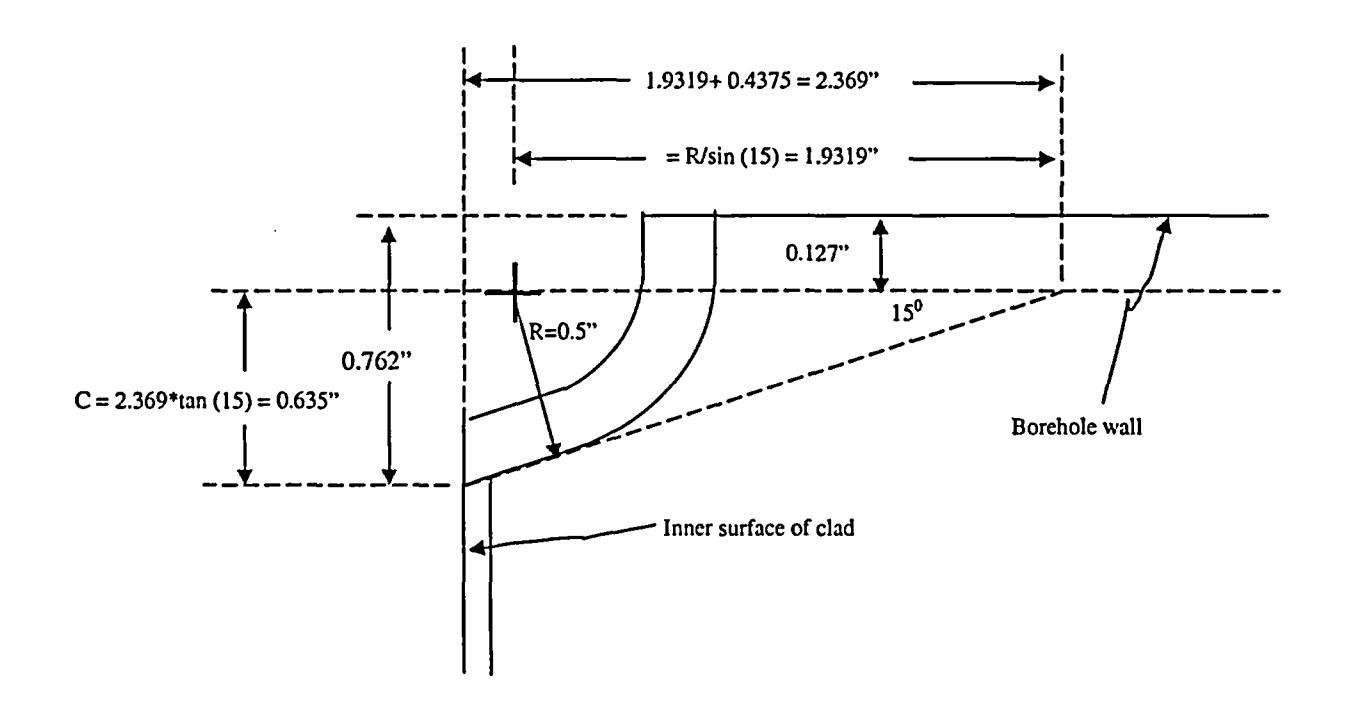
Figure 1: Small Bore Nozzle Bounding Plant Geometry b) Hot Leg Piping, Sheet 2 of 2 (Figure 6-1 from Ref.1)

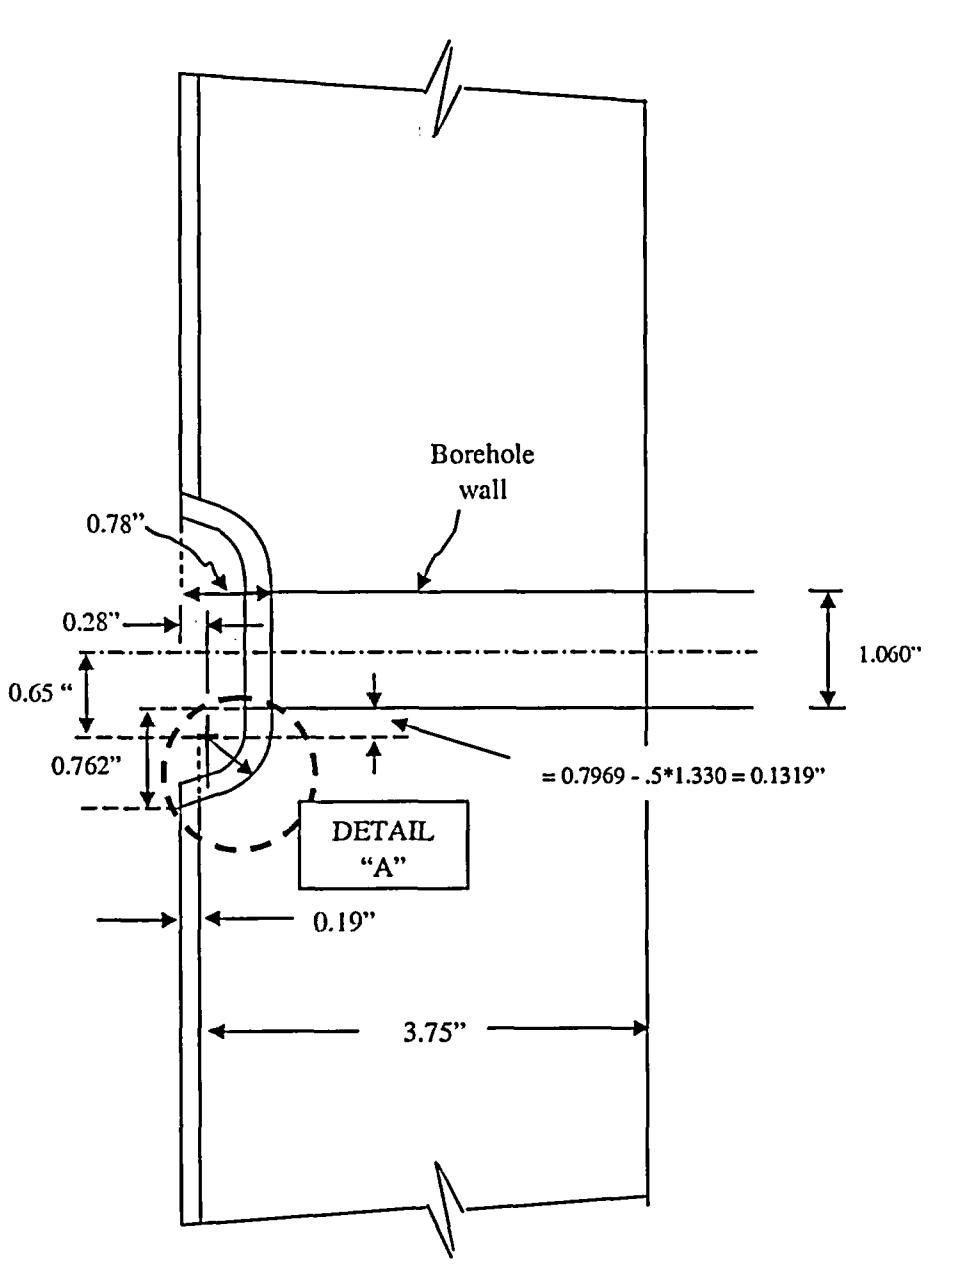
Figure 2: ANPP Hot Leg Piping Small Bore Nozzle Geometry, Cut E In Reference 2

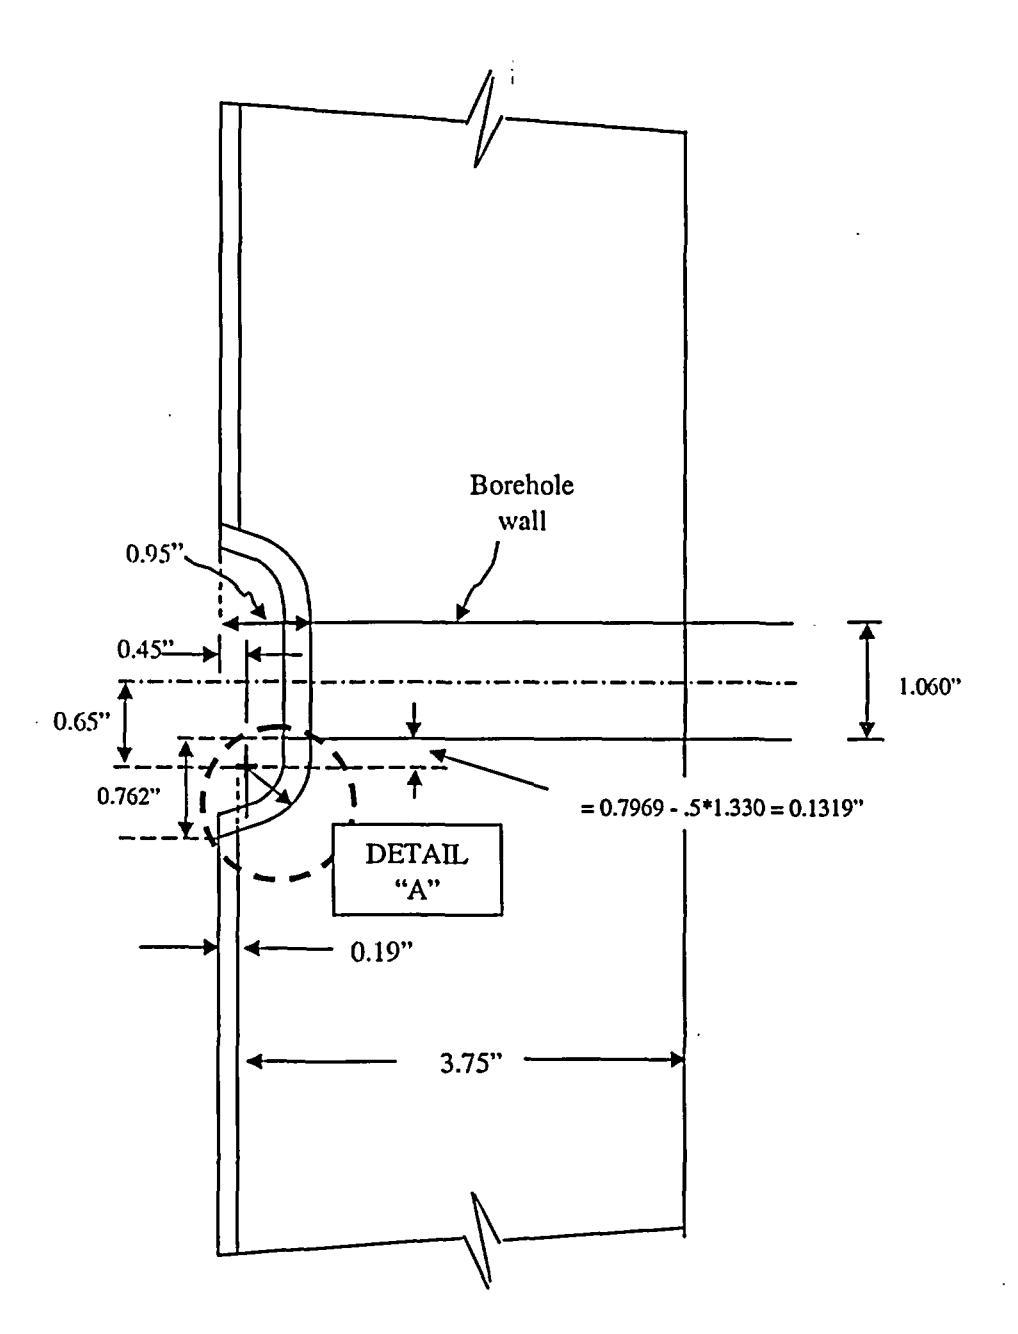
Figure 3: ANPP Hot Leg Piping Small Bore Nozzle Geometry, Cut F in Reference 2

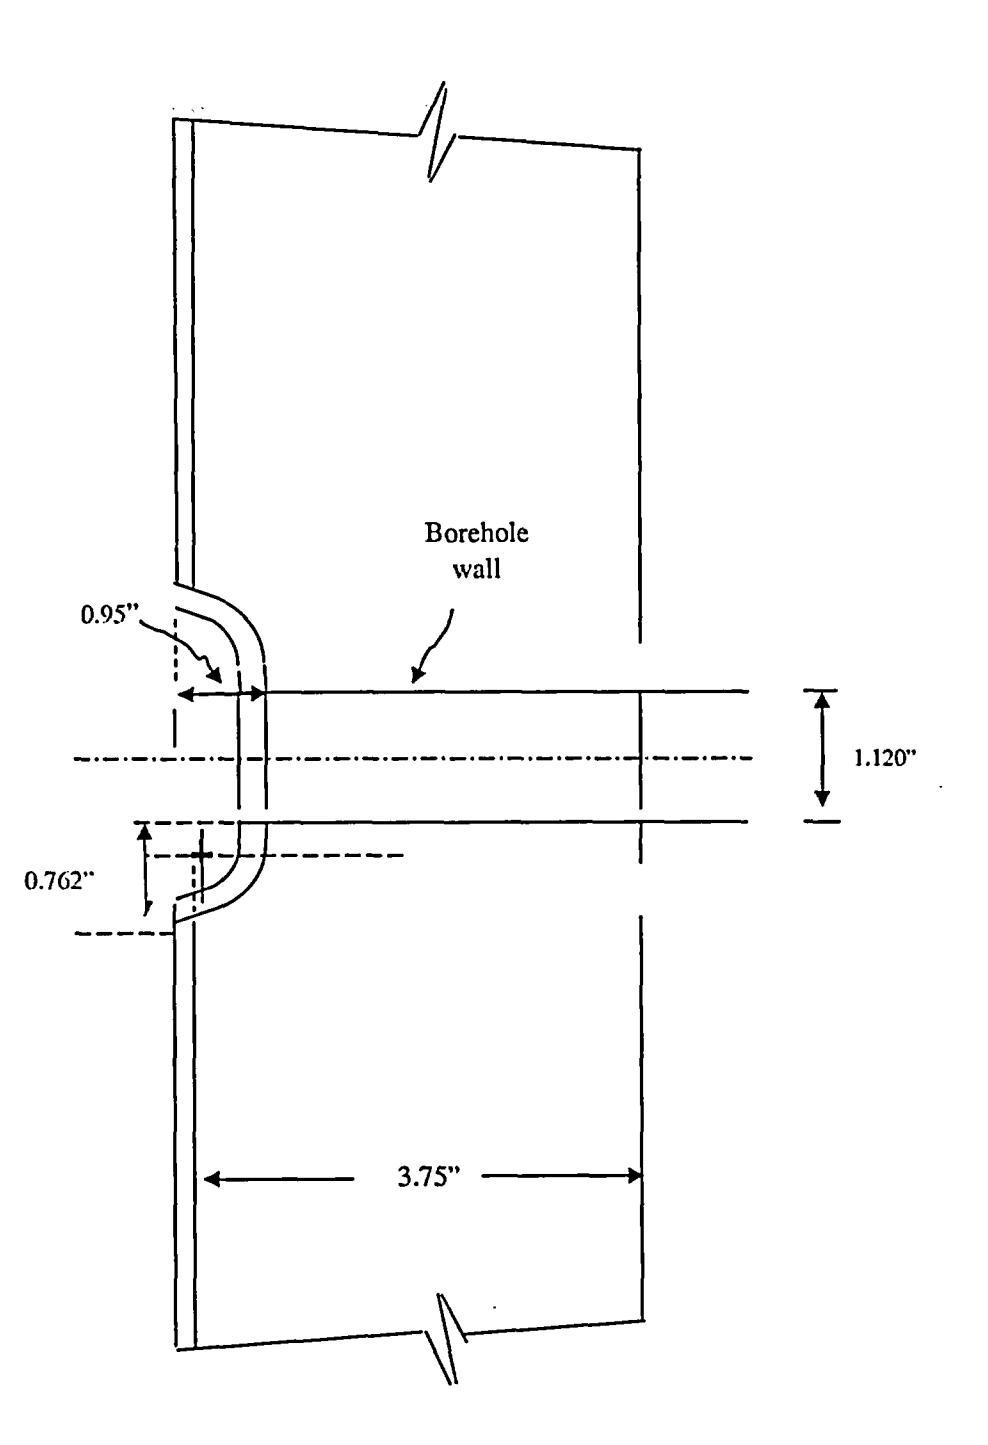
Figure 4: ANPP Hot Leg Piping Small Bore Nozzle Geometry per Reference 3
