Subject: 30-Day Written Follow-up Report to NRC Event Number #41857 Reported 7/20/2005 to NRC Operations Center. Docket No. 04003392, License No. SUB-526

Metropolis Works, Metropolis, Illinois (Uranium Conversion Facility) is reporting a failure to follow procedure related to the installation of valves in UF_6 cylinders.

10 CFR 21.21 (d) (4) Written 30-day follow-up report required:

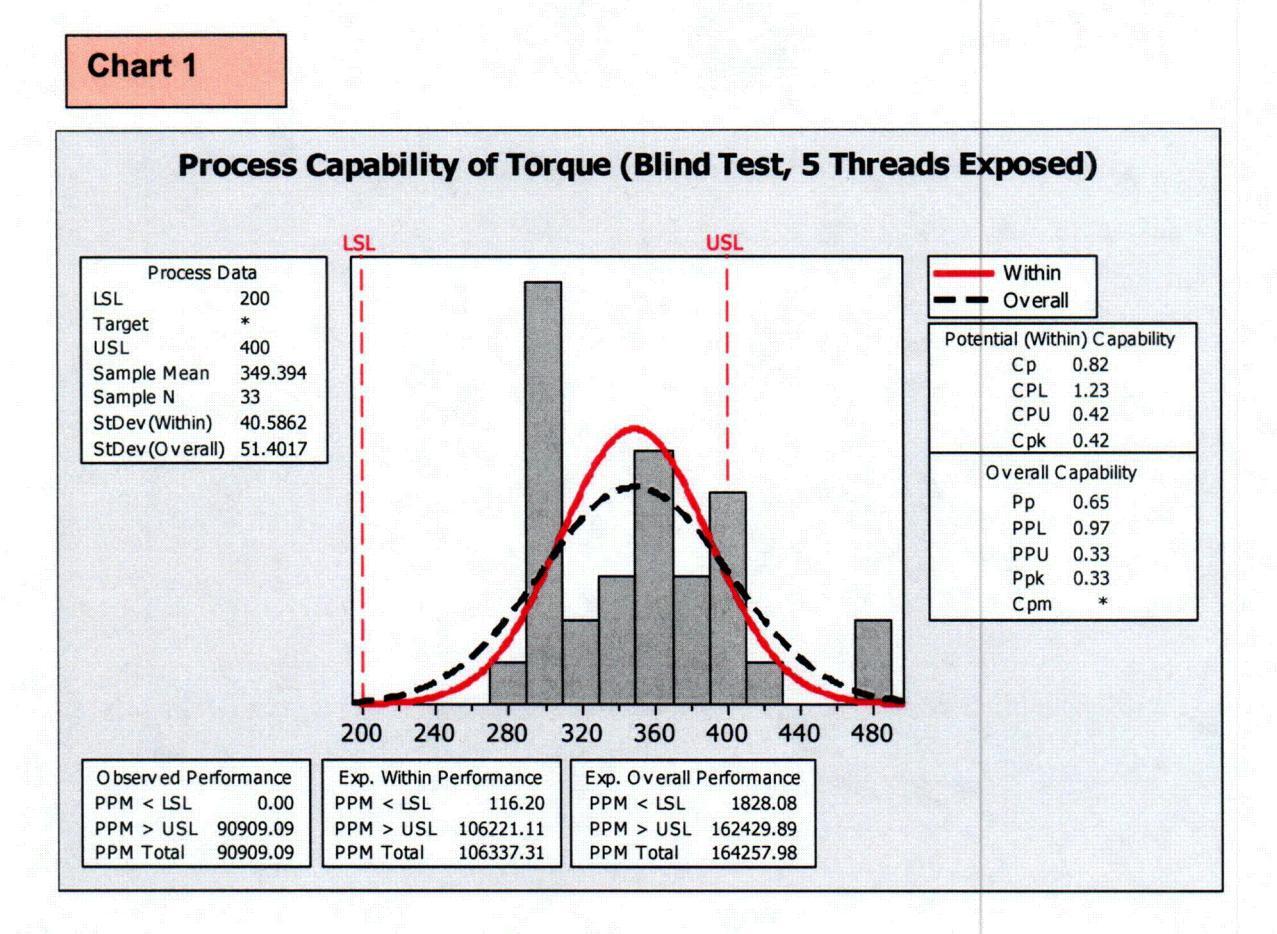
Chart 1 below shows the Process Capability while Chart 2 is a bar chart summarizing the torque values obtained in the blind study.

Three of the thirty-three test cylinders had more than 400 ft-lbs of torque applied to insert their valve up to the point where 9 threads were engaged. If a normal distribution is assumed, 16.2% of the cylinders are likely to have greater than 400 ft-lbs of torque applied and 0.18% are likely to have less than 200 ft-lbs of torque applied. It is possible that no cylinder in the population would have less than 200 ft-lbs of torque applied due to the test procedure and experience of the personnel installing the valves.

There is a large spike in the distribution at 300 ft-lbs and another small spike at 475 (2 data points); otherwise the distribution looks normal.

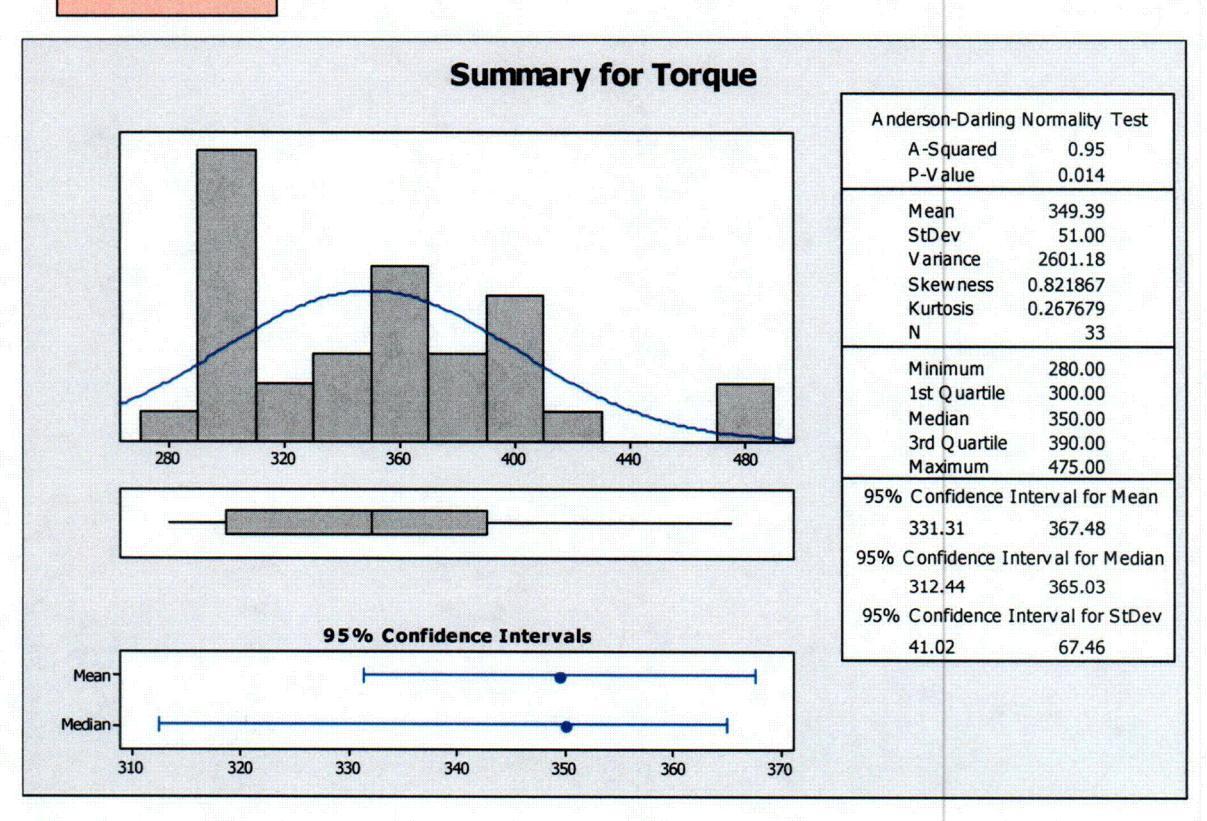
Chart 2

In achieving the proper thread engagement, the torque values ranged from 280 - 475 ft.-lbs.
