U.S. Army Corps of Engineers Mobile District

SUBJECT: Removal Action at LaGarde Park, Phase II.

- 1. LOCATION: Anniston, Alabama
- 2. CONTRACT NO.: DACA01-01-D-0007 DELIVEY ORDER NO.: 0009
- 3. PREPARED FOR: U.S. Army Corps of Engineers-Mobile District (USACE-Mobile)
- 4. ATTENDEES: Solutions To Environmental Problems, Inc. (STEP) Explosive Ordinance Disposal Technology (EODT) MHF Logistical Solutions (MHF) Damon Young, Geologist, USACE-Mobile District

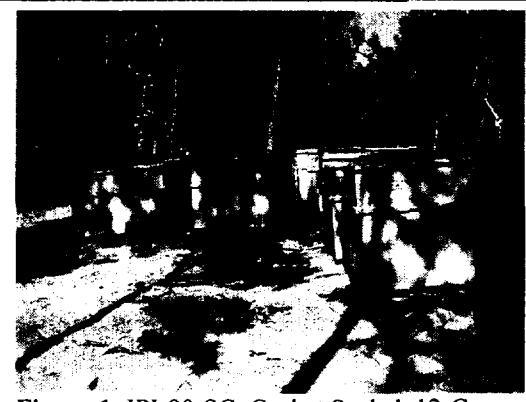
Figure 1: IPI-90-SC, Gasket Sealed, 12-Gauge Carbon Steel, 90 ft³.
