Appendix D3

ESEM and SEM/EDS Data for Test-2 Day-30 Drain Collar Fiberglass

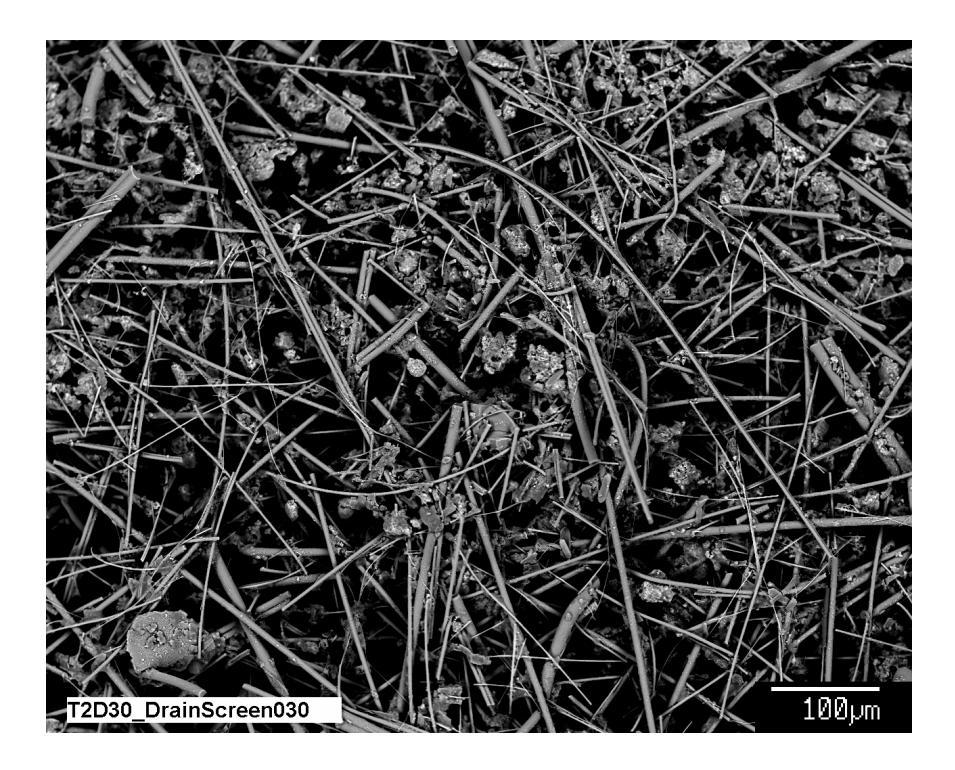
Figure D3-2. Backscattered SEM image for a Test-2 Day-30 fiberglass sample on the drain collar next to the drain screen, illustrating that deposits have a similar atomic number to fiberglass (T2D30_DrainScreen030).

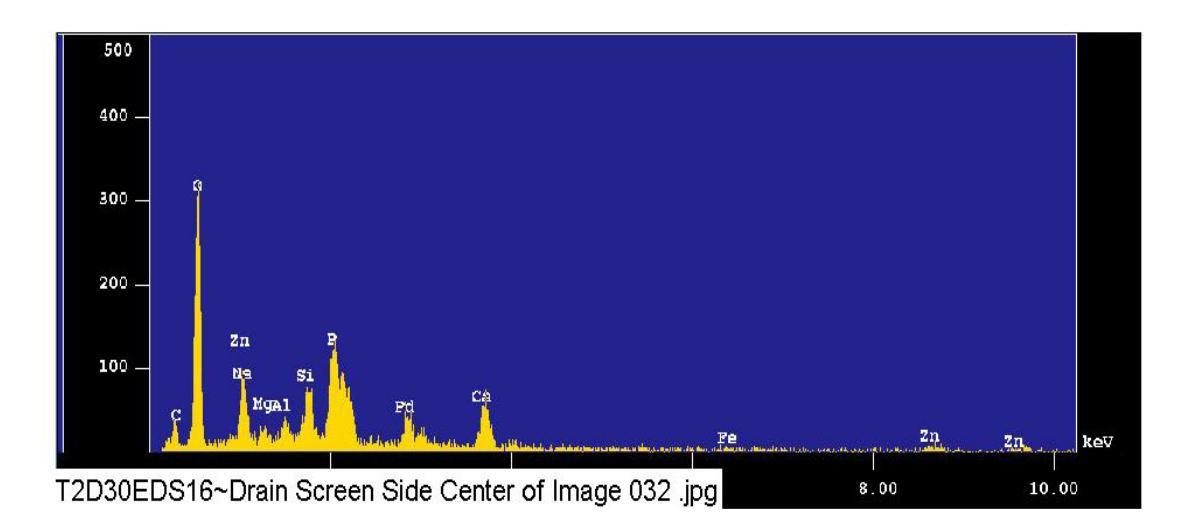
Figure D3-5. EDS counting spectrum for the center of the image shown in Figure D3-4 (T2D30EDS16~Drain Screen Side Center of Image 032).

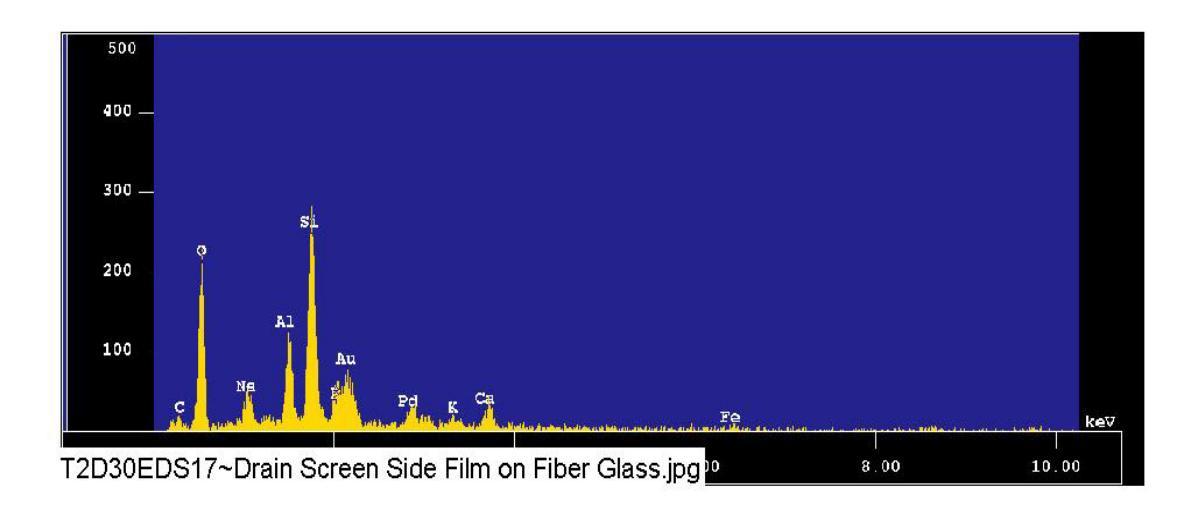
Figure D3-6. EDS counting spectrum for the film between fibers shown in Figure D3-4. The film is rich in Si, O, Al, Na, and Ca (T2D30EDS17~Drain Screen Side Film on Fiber Glass).

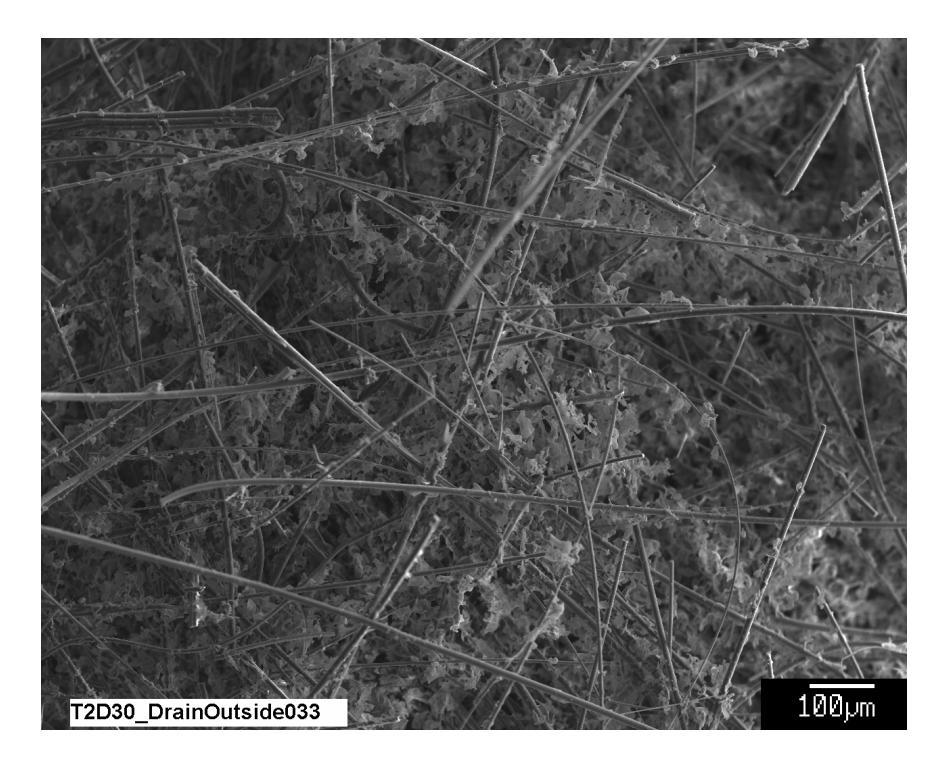
Figure D3-7. SEM image for a Test-2 Day-30 exterior fiberglass sample on the drain collar (away from the drain screen) showing deposits or growth on fiberglass (T2D30_DrainOutside033).

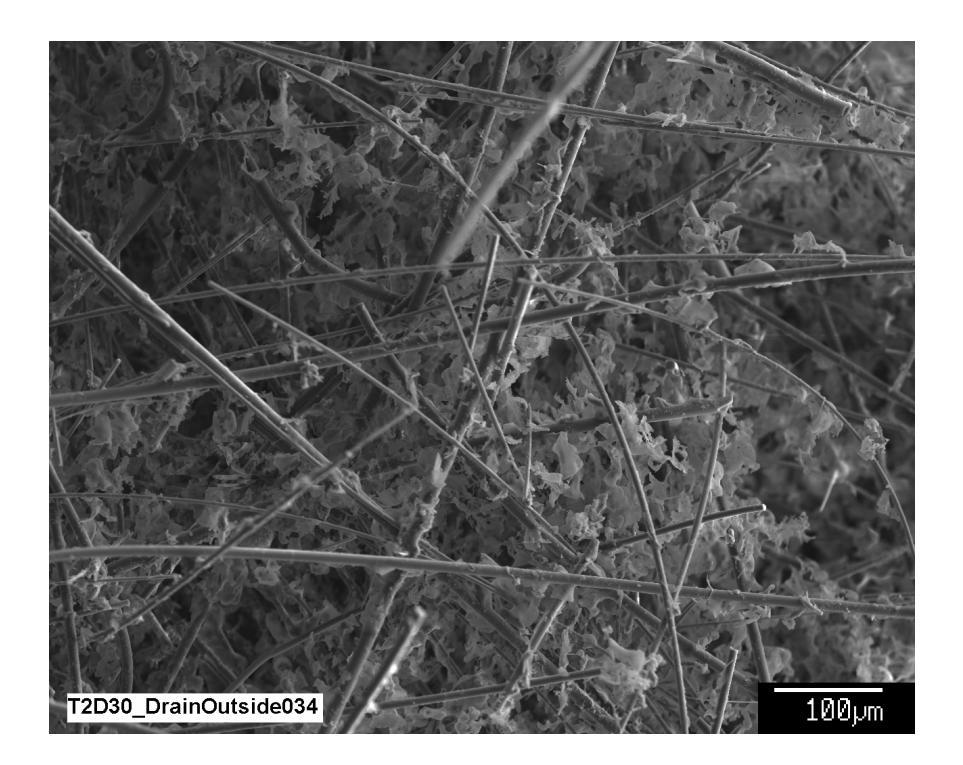
Figure D3-8. SEM image for a Test-2 Day-30 exterior fiberglass sample on the drain collar showing deposits or growth on fiberglass (T2D30_DrainOutside034).

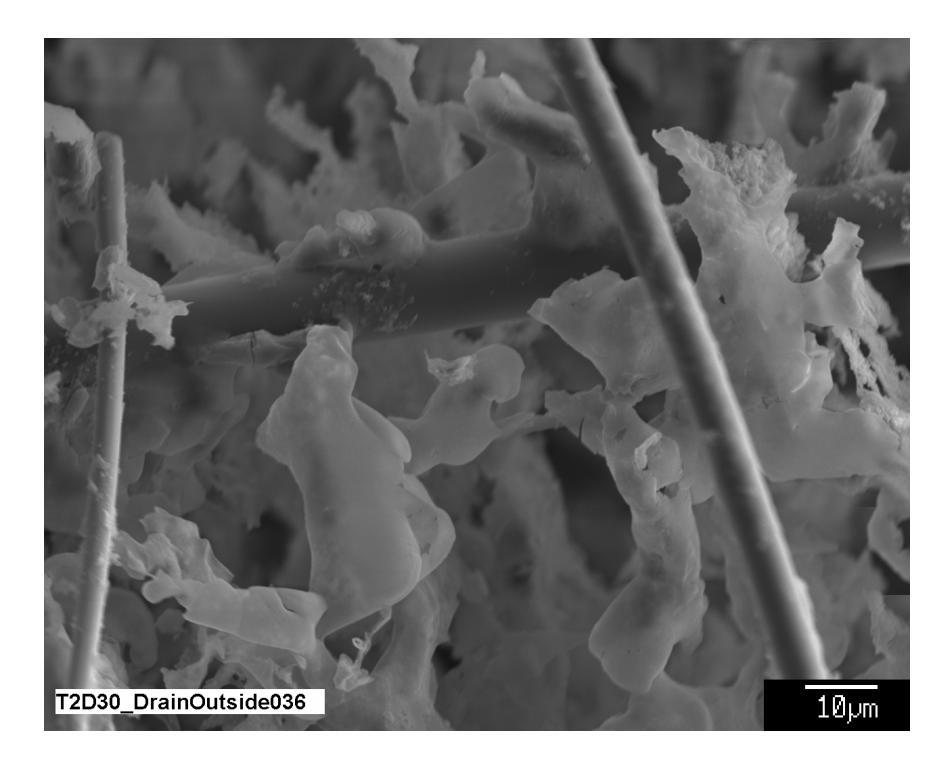
Figure D3-10. SEM image at a higher magnification for a Test-2 Day-30 exterior fiberglass sample on the drain collar showing deposits or growth on fiberglass (T2D30_DrainOutside036).

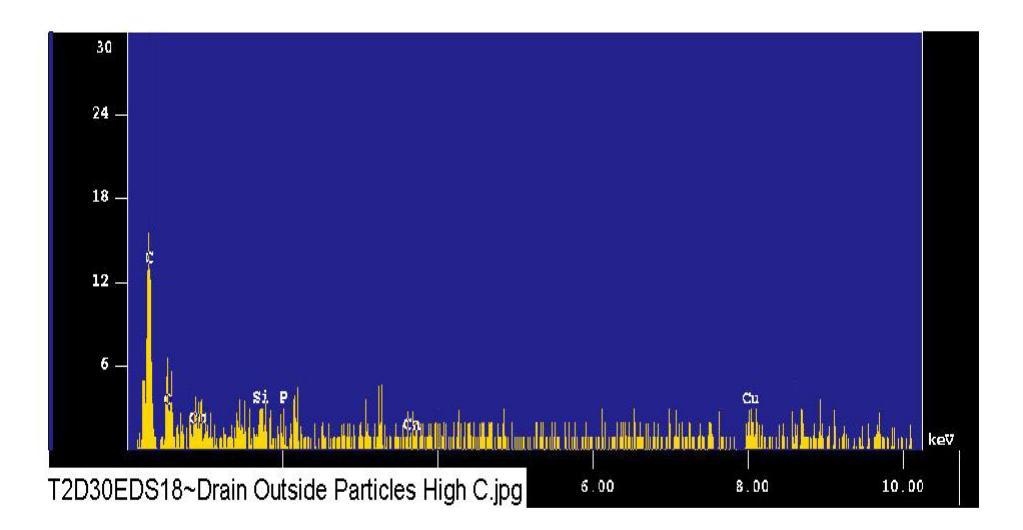
Note: *Very difficult to get EDS spectrum of particles. The particles are very thin and react under the beam. EDS18 and EDS19 are simply replicates at slightly different sample locations.

Figure D3-11. EDS counting spectrum for deposits or growth on fiberglass. The deposits contain a significant amount of C (T2D30EDS18~Drain Outside Particles High C).

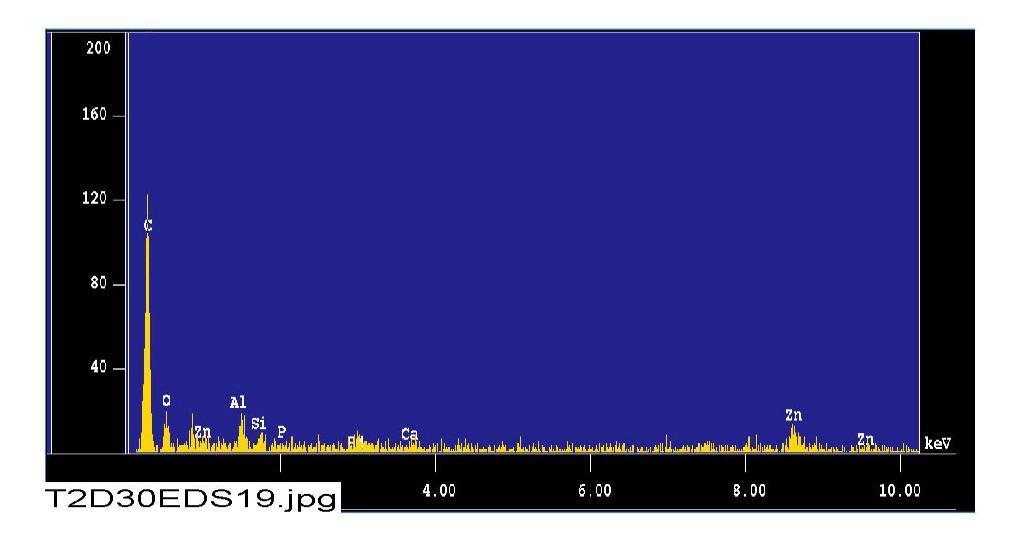
Figure D3-12. EDS counting spectrum for a deposit or growth on fiberglass. The deposit contains a significant amount of C (T2D30EDS19).

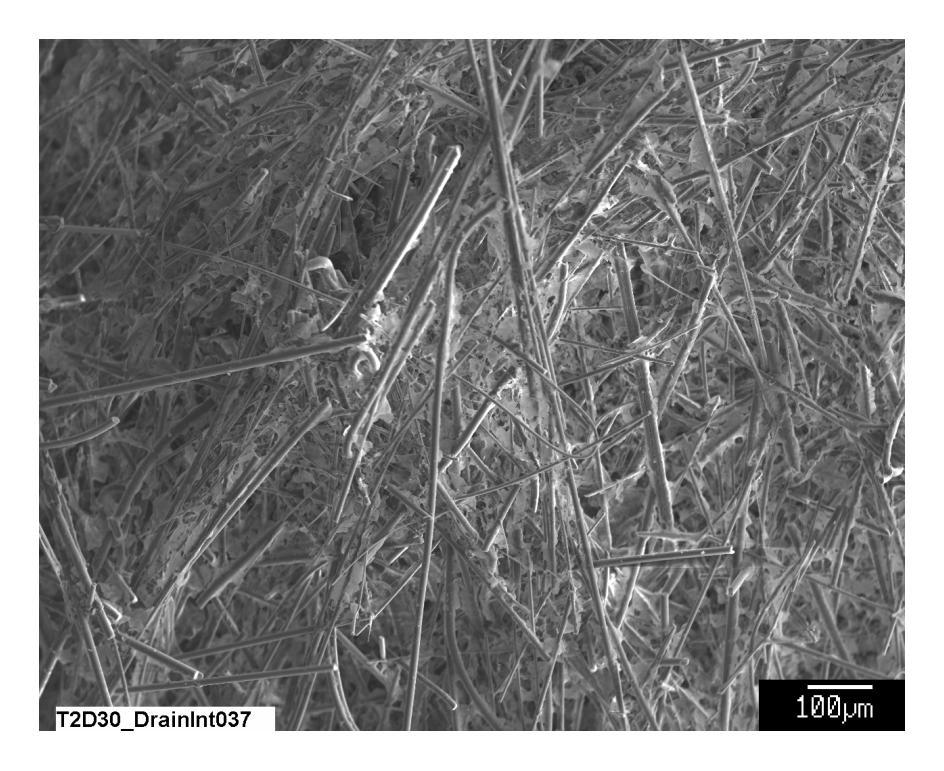
Figure D3-13. SEM image for a Test-2 Day-30 interior fiberglass sample on the drain collar. Image shows deposits or growth on fiberglass (T2D30_DrainInt037).

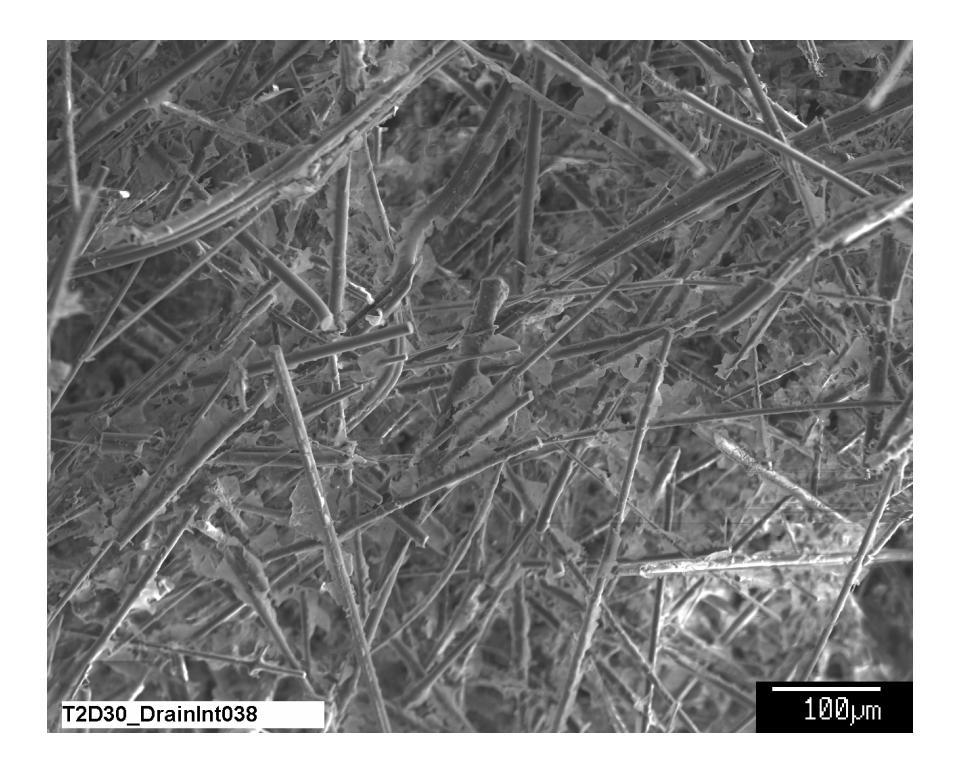
Figure D3-14. SEM image for a Test-2 Day-30 interior fiberglass sample on the drain collar. Image shows deposits or growth on fiberglass (T2D30_DrainInt038).

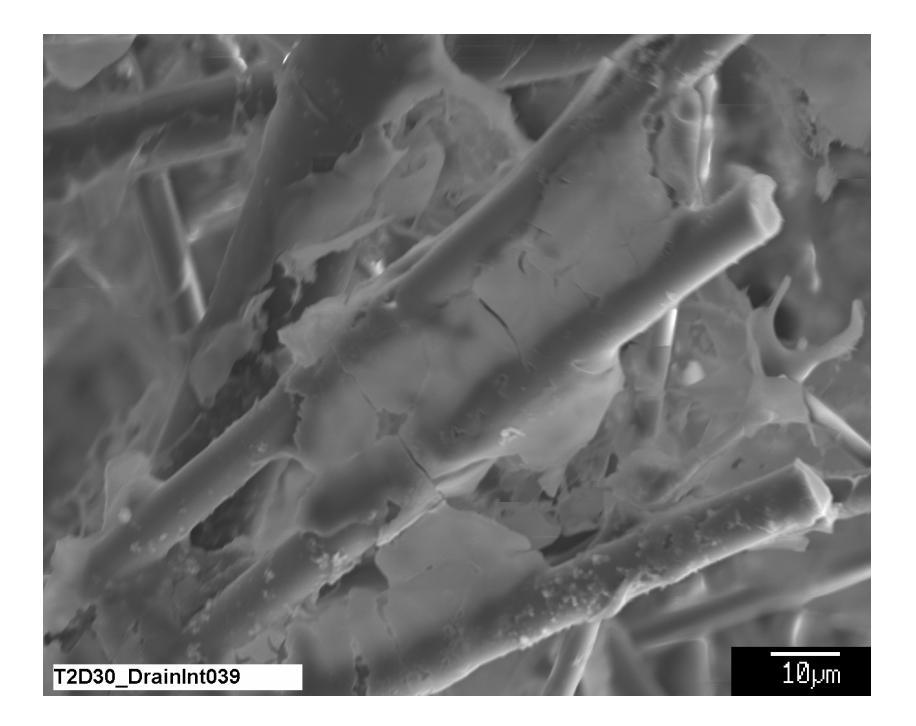
Figure D3-15. SEM image of a higher magnification for a Test-2 Day-30 interior fiberglass sample on the drain collar. Image shows deposits or growth on fiberglass (T2D30_DrainInt039).

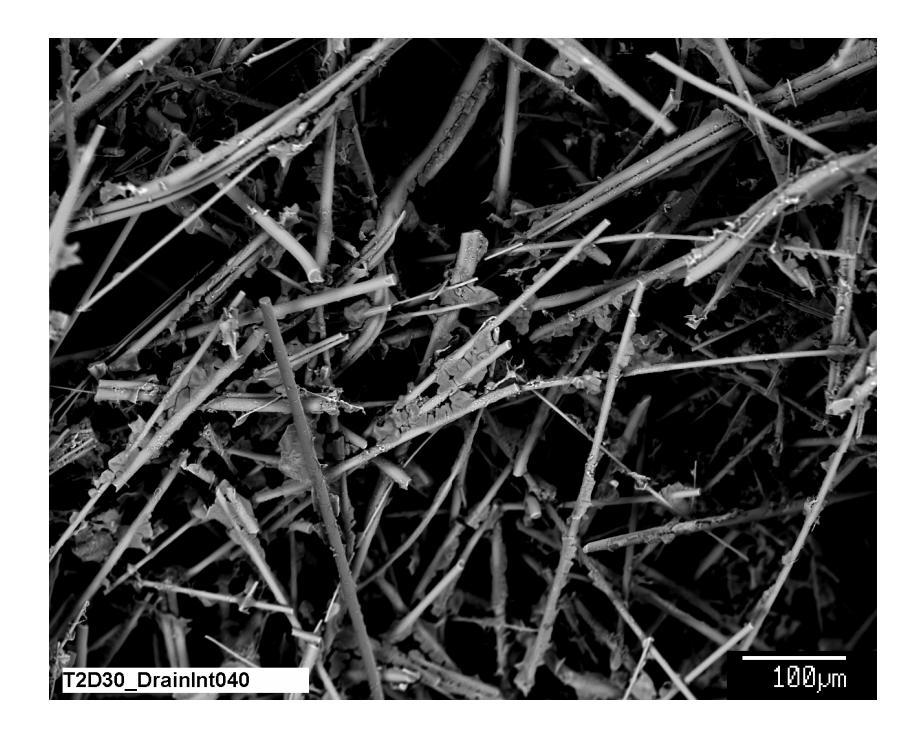
Figure D3-16. Backscattered SEM image for a Test-2 Day-30 interior fiberglass sample on the drain collar. Deposits appear to have a similar or lower atomic number than fiberglass (T2D30_DrainInt040).

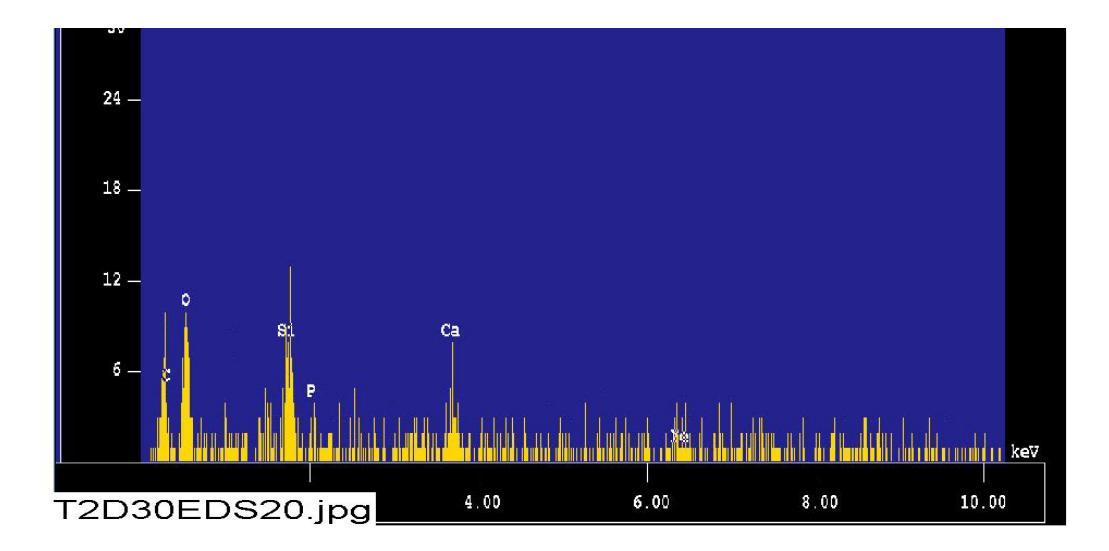
Figure D3-17. EDS counting spectrum for the deposits or growth on fiberglass. The deposits are rich in Si, C, O, and Ca. The deposits are very thin, thus it was difficult to obtain high-quality EDS spectra (T2D30EDS20).

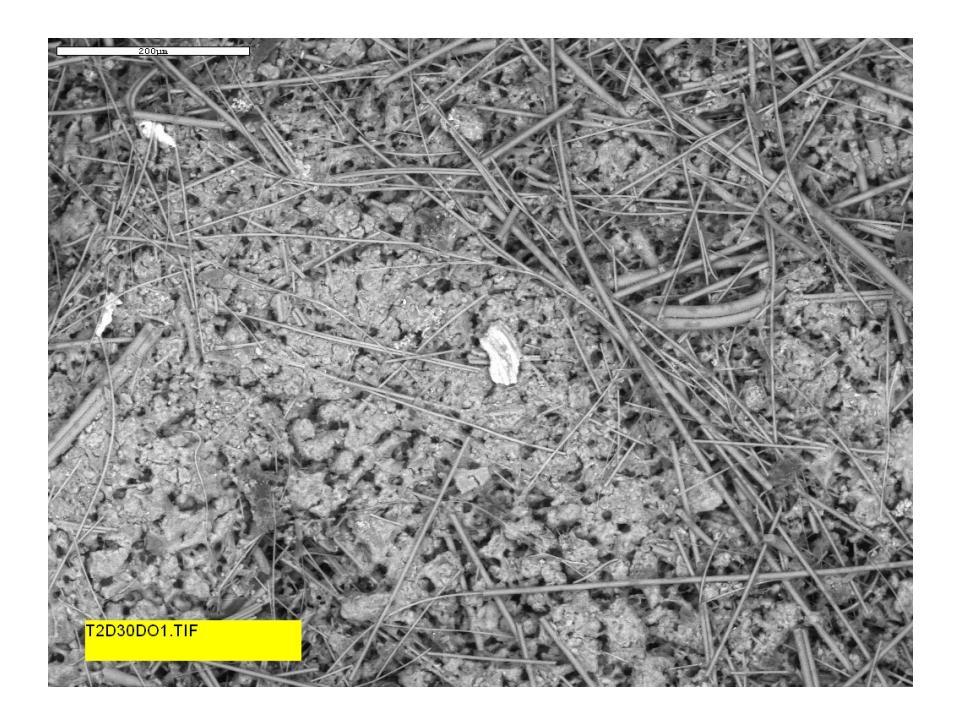
Figure D3-18. ESEM image for a Test-2 Day-30 exterior fiberglass sample on the drain collar. Image shows particulate deposits or growth on fiberglass (T2D30DO1).

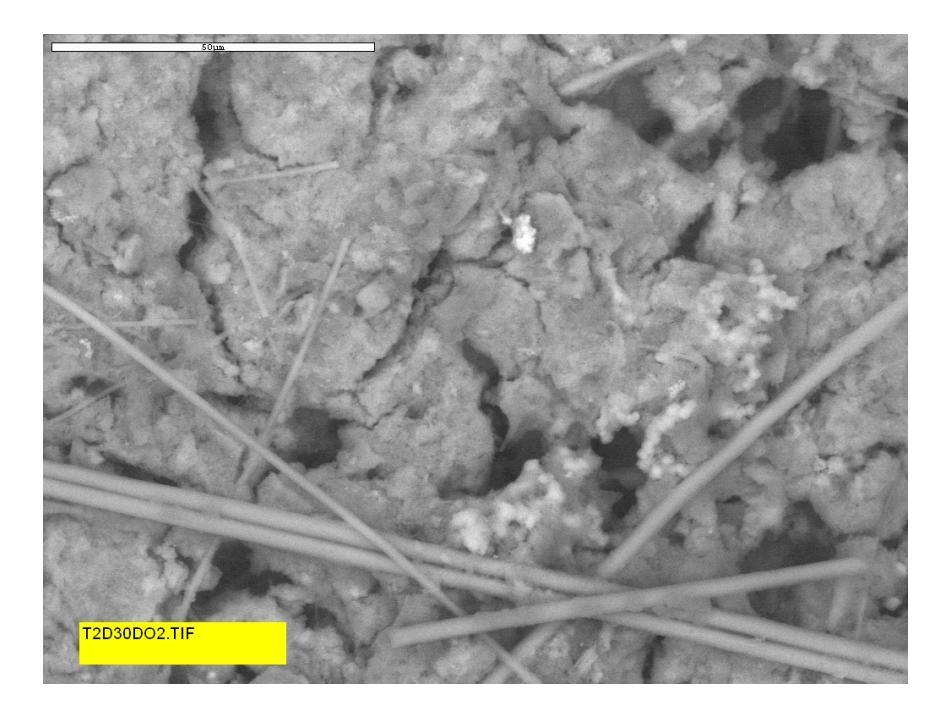
Figure D3-19. ESEM image of a higher magnification for a Test-2 Day-30 exterior fiberglass sample on the drain collar. Image shows particulate deposits or growth on fiberglass (T2D30DO2).

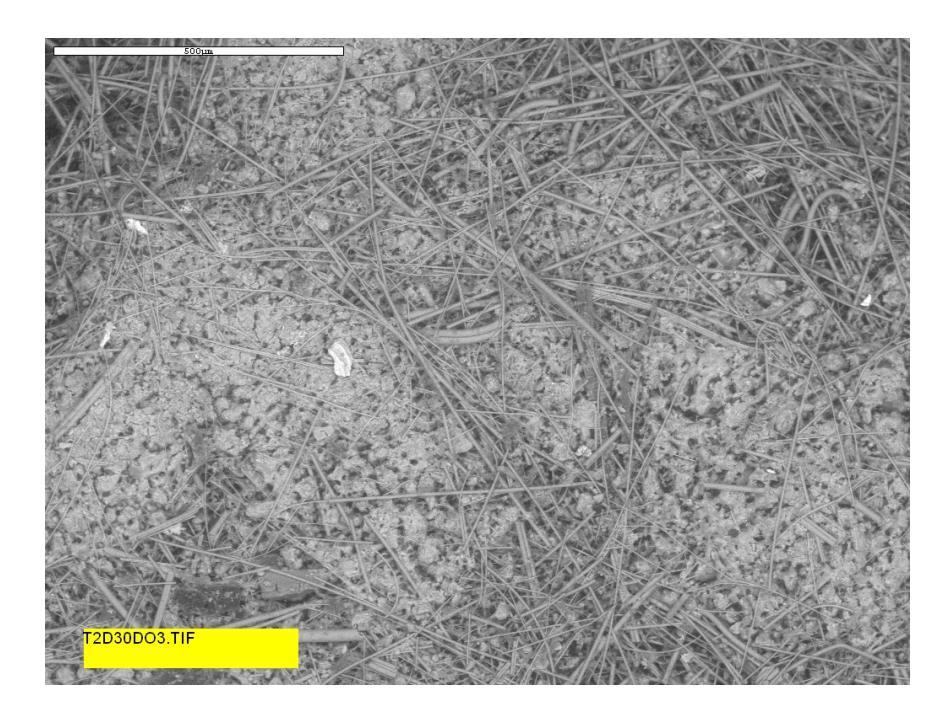
Figure D3-20. ESEM image for a Test-2 Day-30 exterior fiberglass sample on the drain collar. Image shows particulate deposits or growth on fiberglass (T2D30DO3).

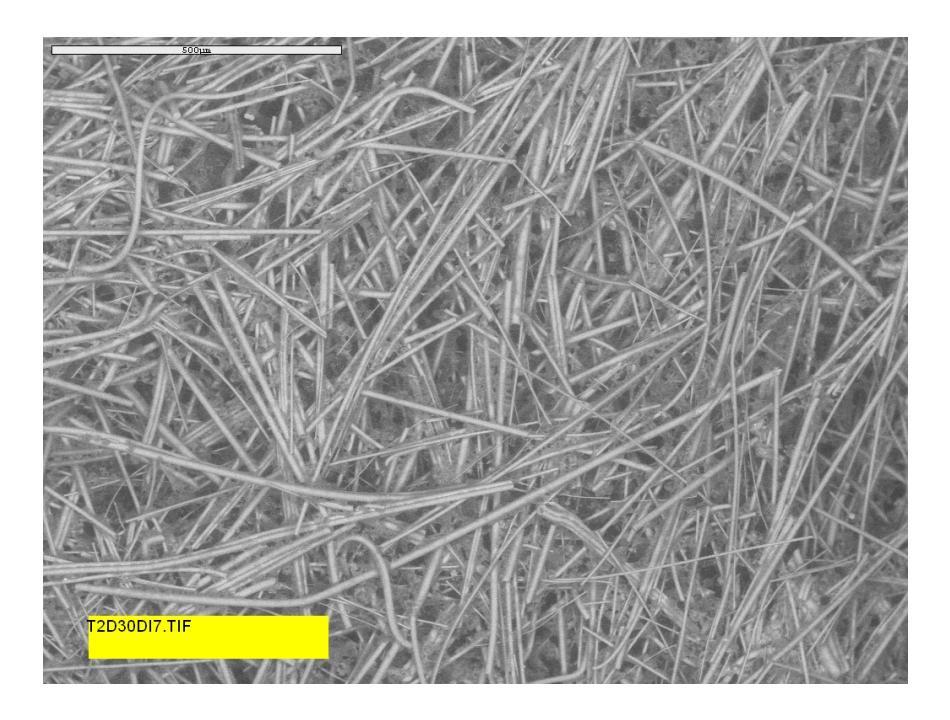
Figure D3-24. ESEM image for a Test-2 Day-30 interior fiberglass sample on the drain collar. Image suggests that interior fiberglass was relatively clean compared to exterior (T2D30DI7).

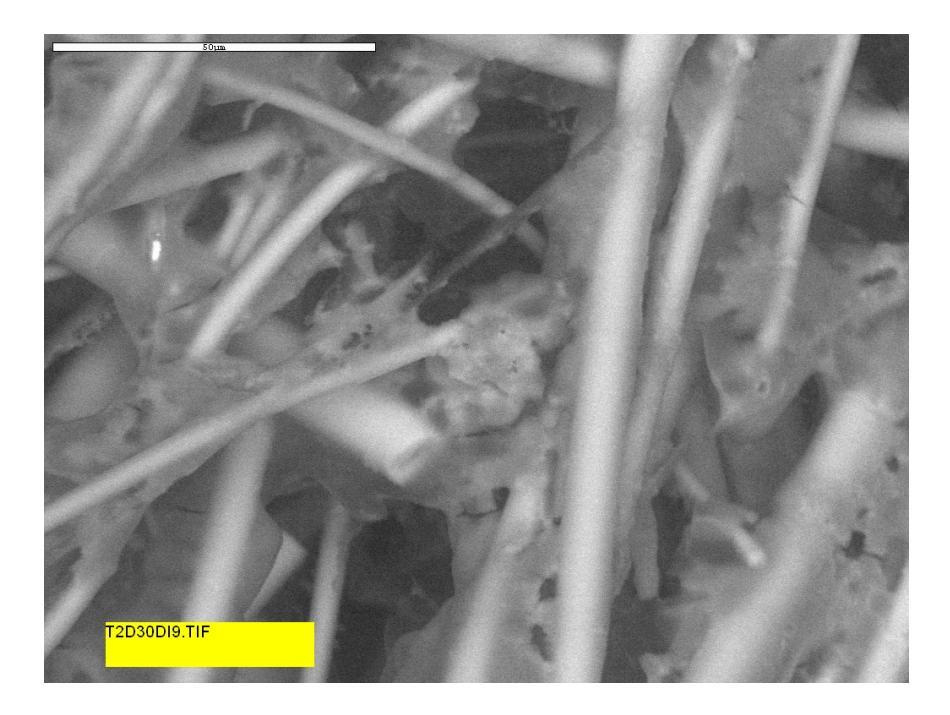
Figure D3-26. ESEM image of a higher magnification for a Test-2 Day-30 interior fiberglass sample on the drain collar. Image shows deposits or growth on the interior fiberglass, although the quantity was less than for exterior samples (T2D30DI9).
