Appendix B1

ESEM/EDS and SEM/EDS Data for Test #3 Day-15 Fiberglass in High-Flow Zones

This appendix shows the ESEM/probe SEM/EDS results for ICET Test #3 Day-15 high-flow zone fiberglass samples. Both exterior and interior locations of the fiberglass samples were examined. These fiberglass samples were obtained on April 20, 2005 (15th day of Test #3). For probe SEM examination, the fiberglass samples were air dried at room temperature and then were coated with Au/Pd. Available logbook entries for this laboratory session are included in this appendix as transcribed notes.

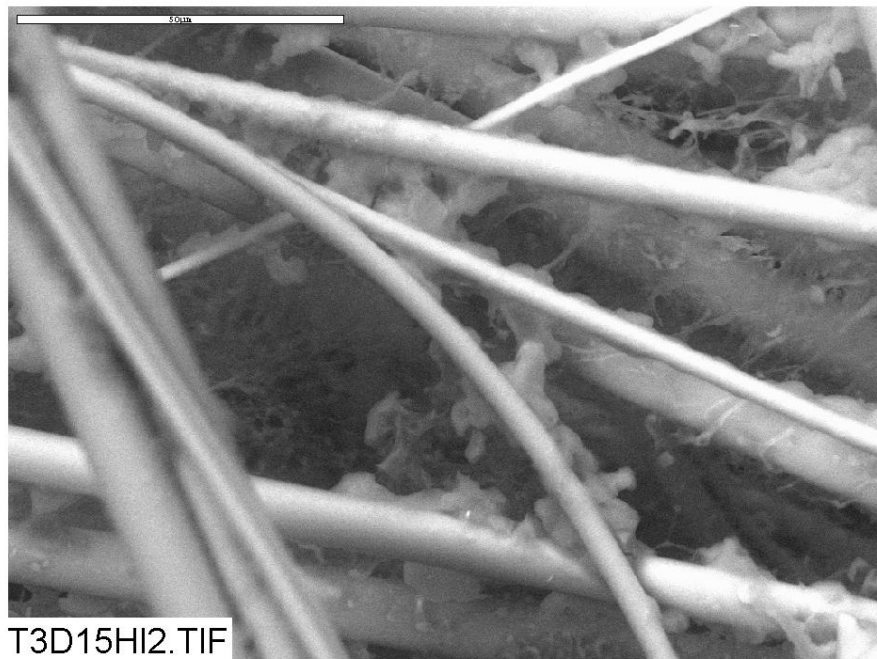
Figure B1-2: Environmental SEM image magnified 1000 times for a Test #3 Day-15 high-flow interior fiberglass sample. (T3D15HI2)

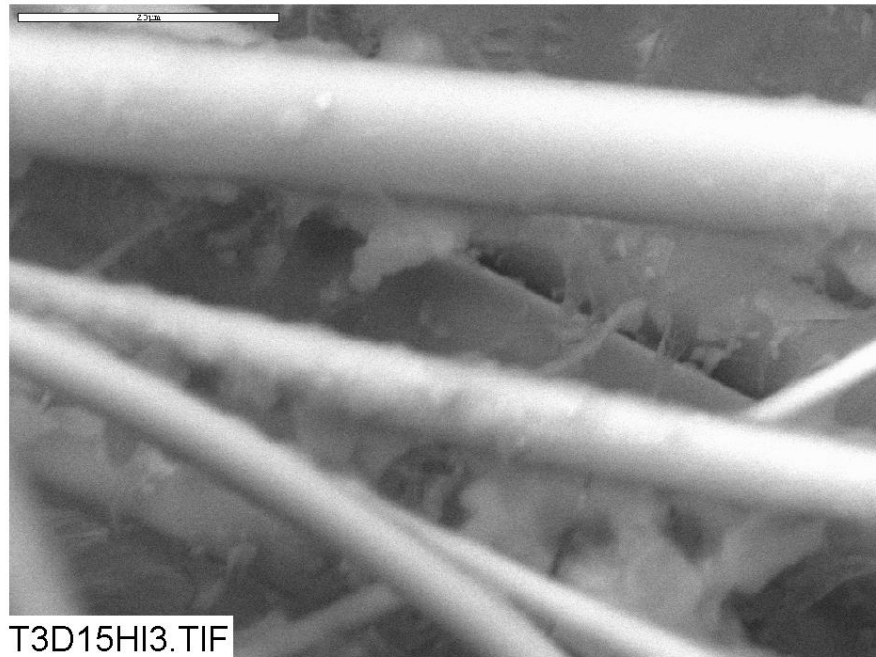
Figure B1-3: Environmental SEM image magnified 2000 times for a Test #3 Day-15 high-flow interior fiberglass sample. (T3D15HI3)

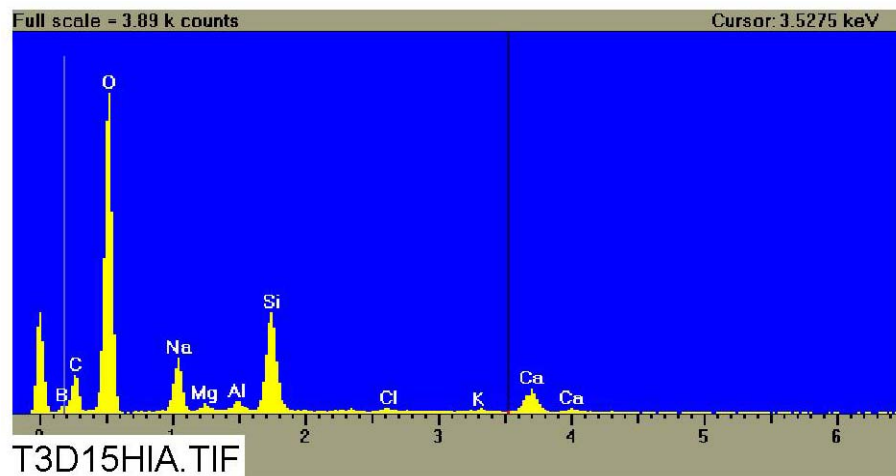
Figure B1-4: EDS counting spectrum for the flocculence deposits between the fibers on ESEM image shown in Figure B1-3. (T3D15HIA)

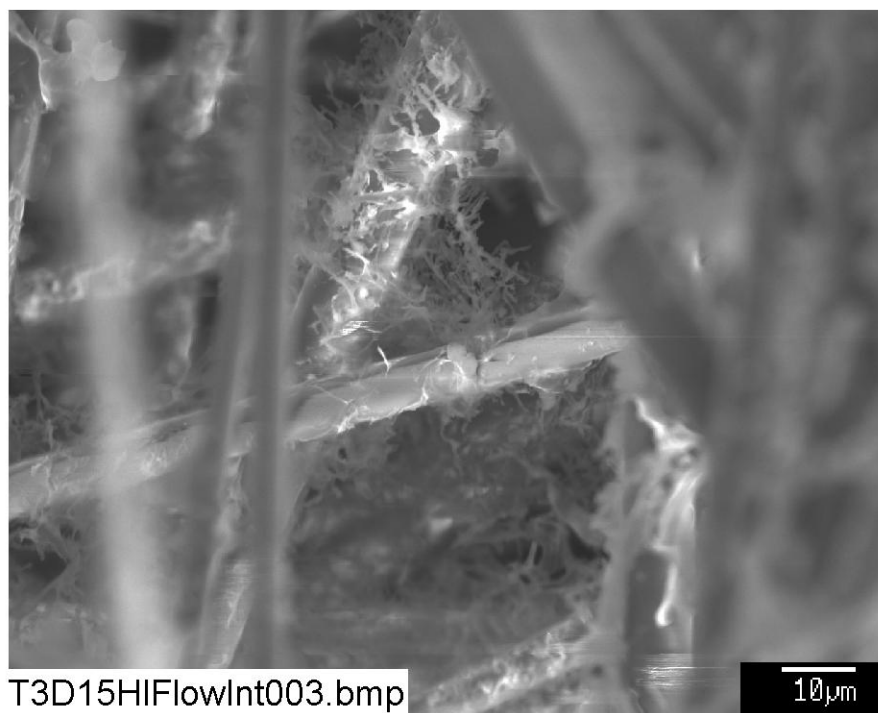
Figure B1-9: SEM image magnified 1000 times for a Test #3 Day-15 high-flow interior fiberglass sample. (T3D15HIFlowInt003)

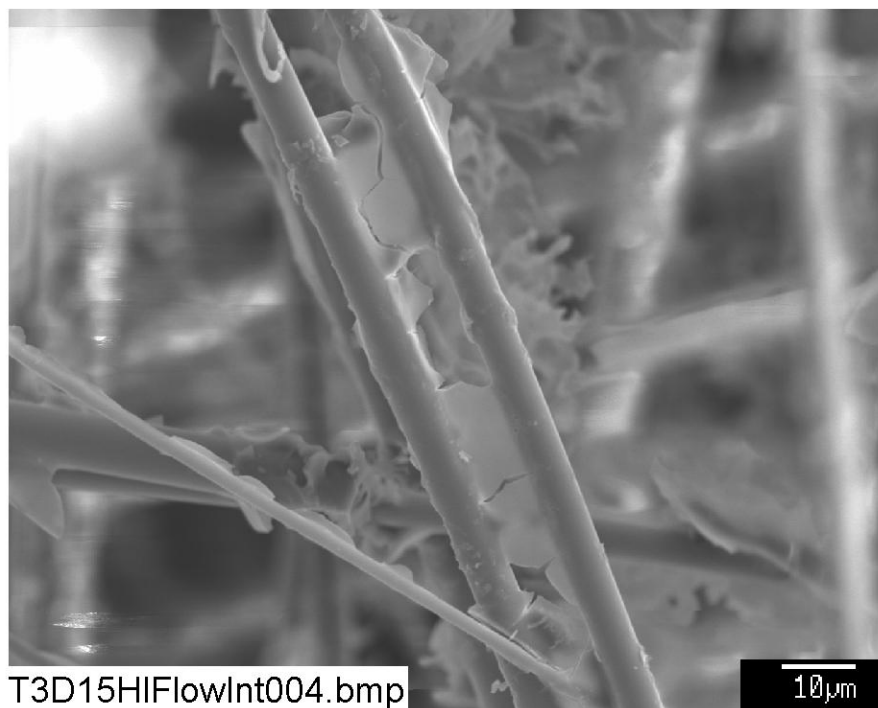
Figure B1-10: SEM image magnified 1000 times for a Test #3 Day-15 high-flow interior fiberglass sample. (T3D15HIFlowInt004)
