Westinghouse Electric Corporation Westinghouse Building Gateway Center Pittsburgh Pennsylvania15222

September 23, 1991

United States Nuclear Regulatory Commission Region 1 475 Allendale Road King of Prussia, PA 19406 Attention: John D. Kinnemann

License No. SMB-1527 Docket No. 040-08976

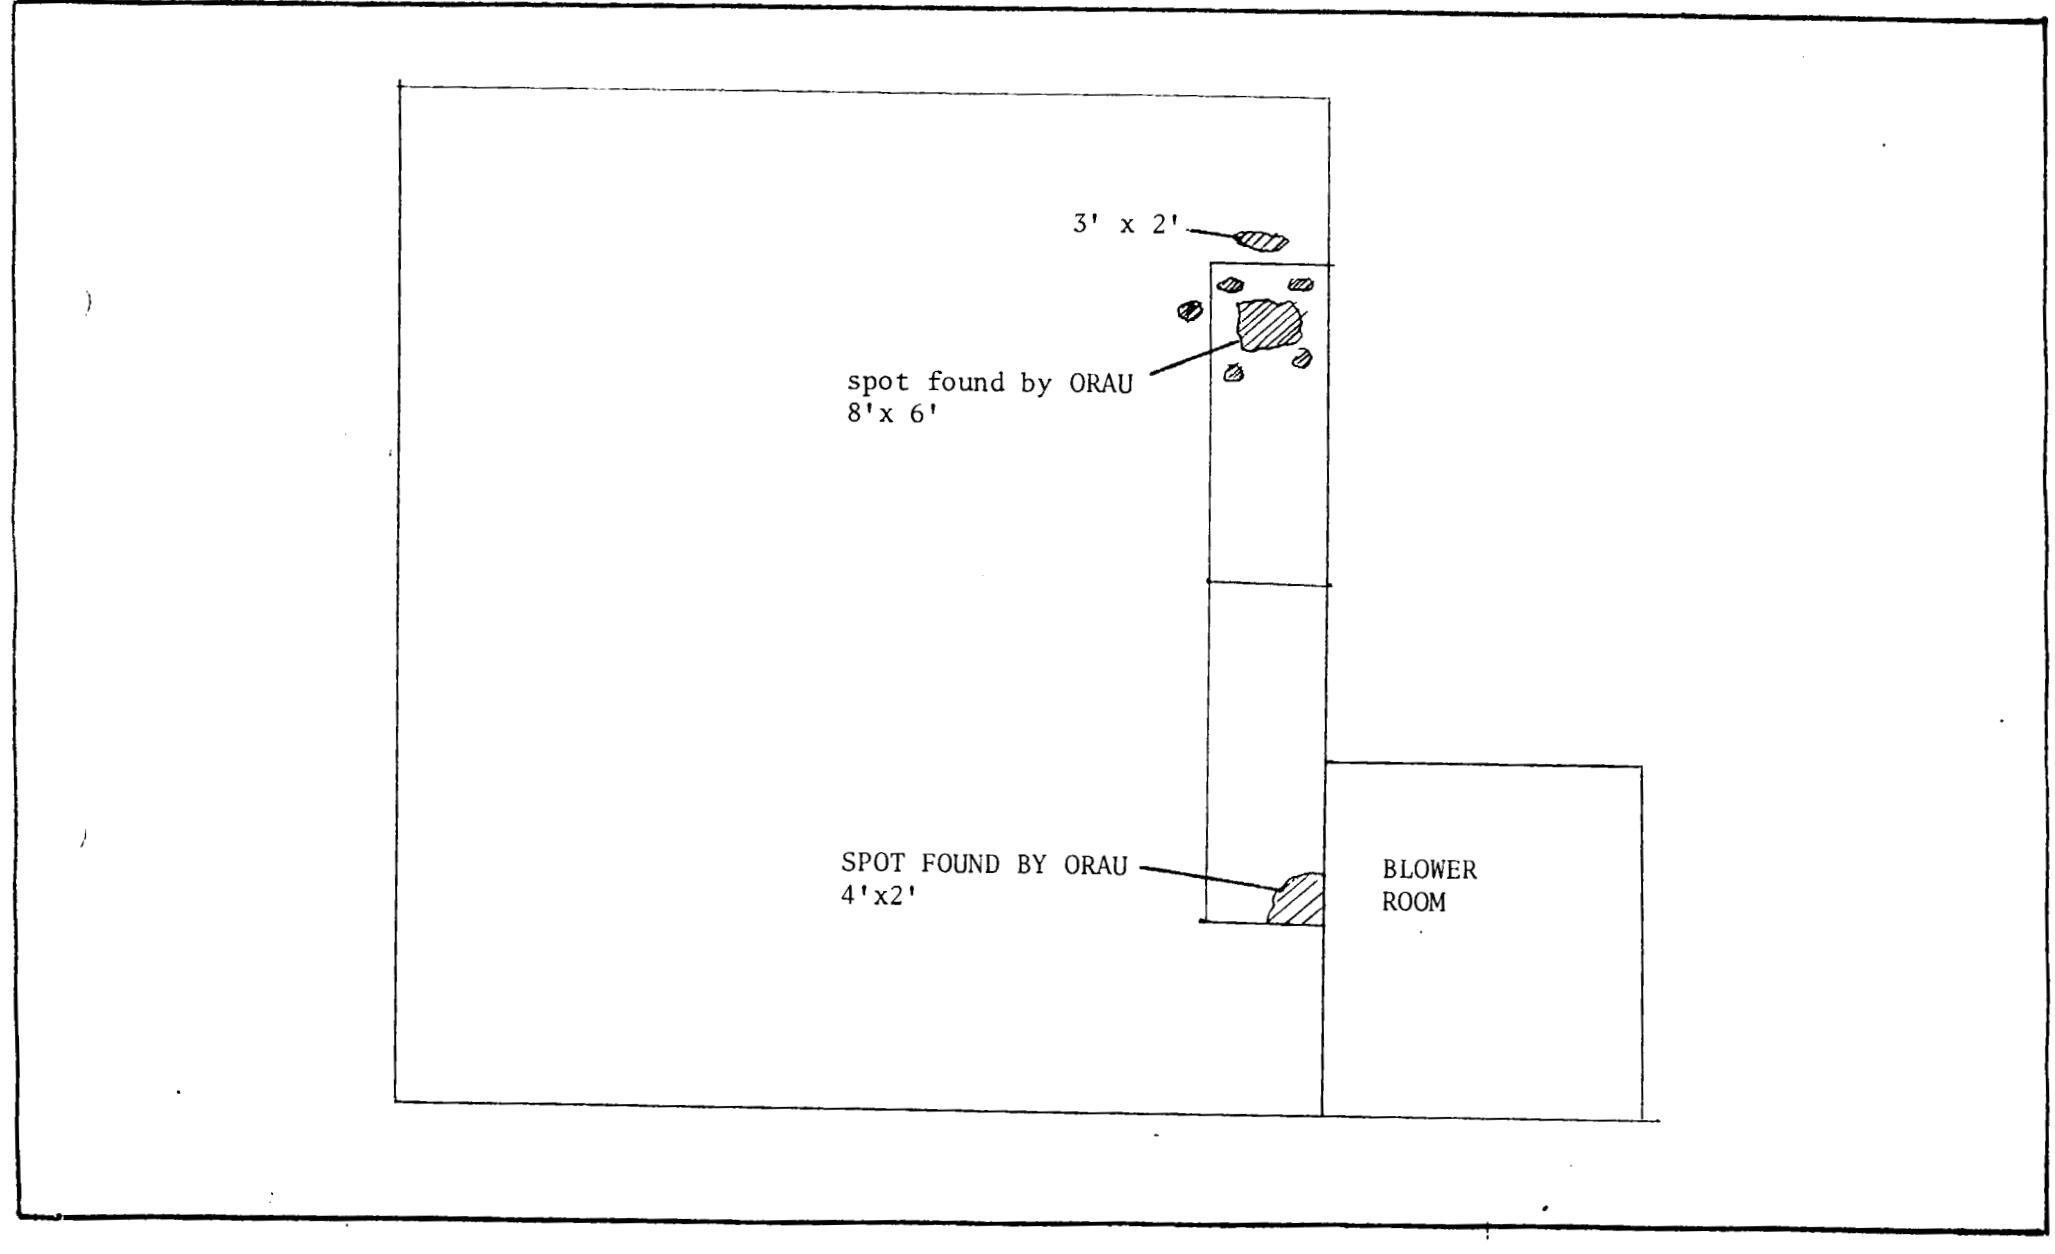
Location	BUILDING	2	1st	FLOOR

Six small, isolated spots were found to contain Ra-226 exceeding release criteria (no removable contamination found). The total contaminated area was less than 20 square feet. Follow-up surveys identified an additional area of

SPOTS CLEANED AND RELEASED Comments ISOLATED SPOTS ON FLOOR Ra-226 1000 pCi

200 square feet requiring remediation. All areas have been cleaned and cleared for release.

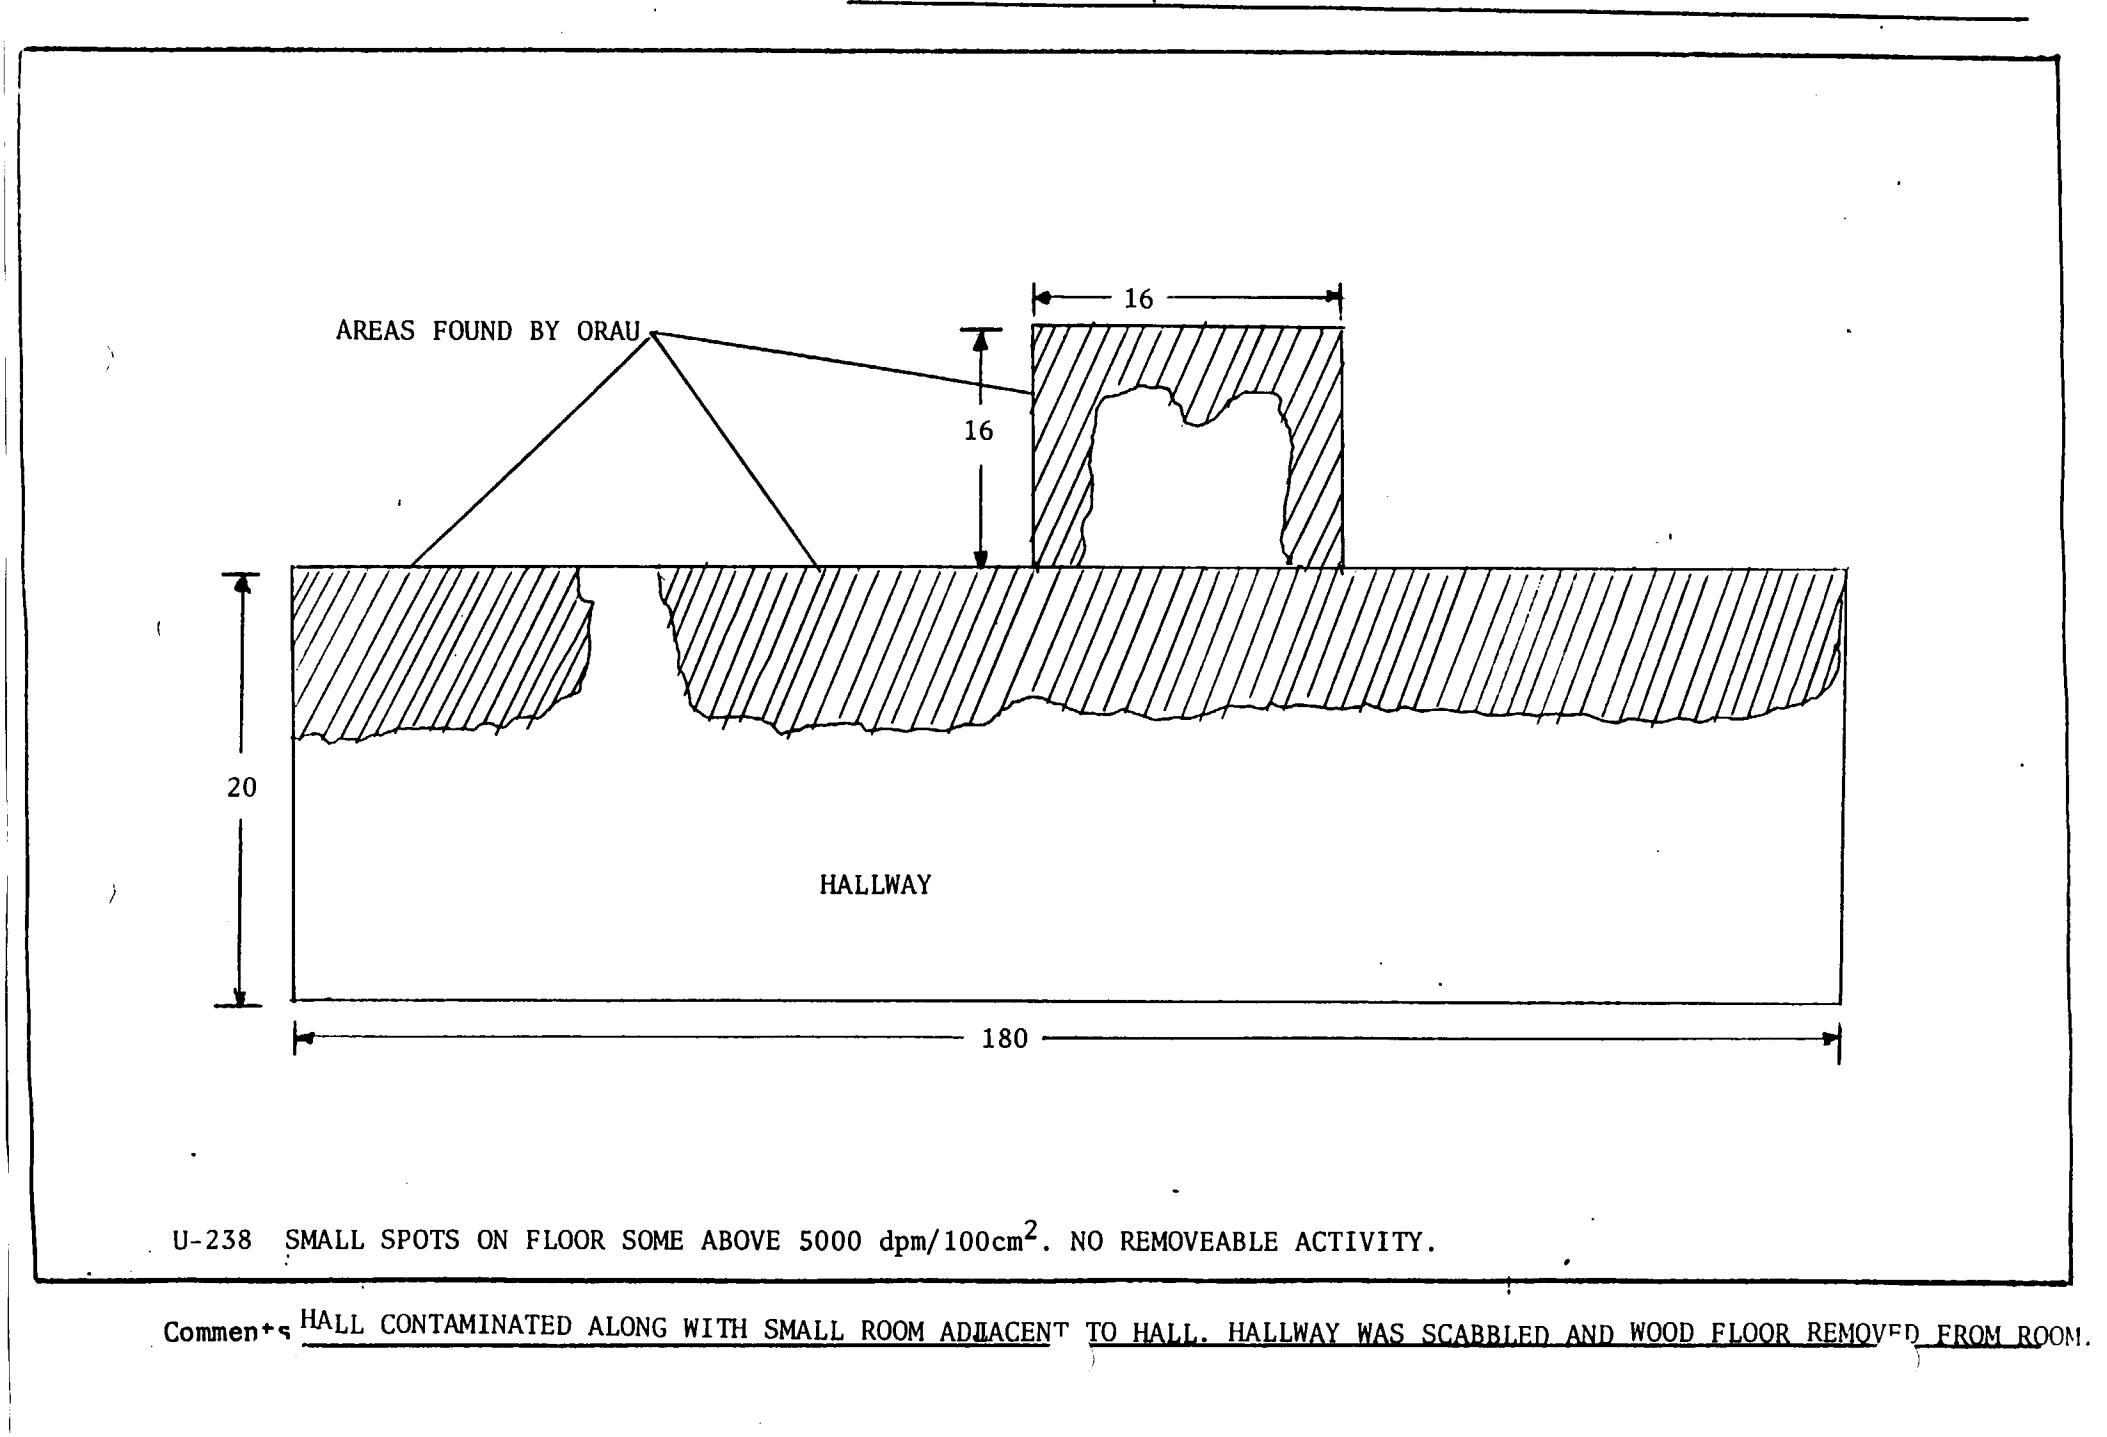
Location BUILDING #3 1st FLOOR	HALLWAY AND ROOM	. ·

A corridor approximately 150 feet long was determined to contain uranium contamination. Verification measurements showed that while levels were generally elevated, actual readings exceeding criteria were very spotty and randomly distributed. Since it was more expeditious to perform large area surface removal than to locate and clean specific spots, the surface of the entire corridor was removed. A survey to confirm decontamination identified an additional 20 to 30 feet to be cleaned. The entire area was remediated and a confirmatory survey performed.

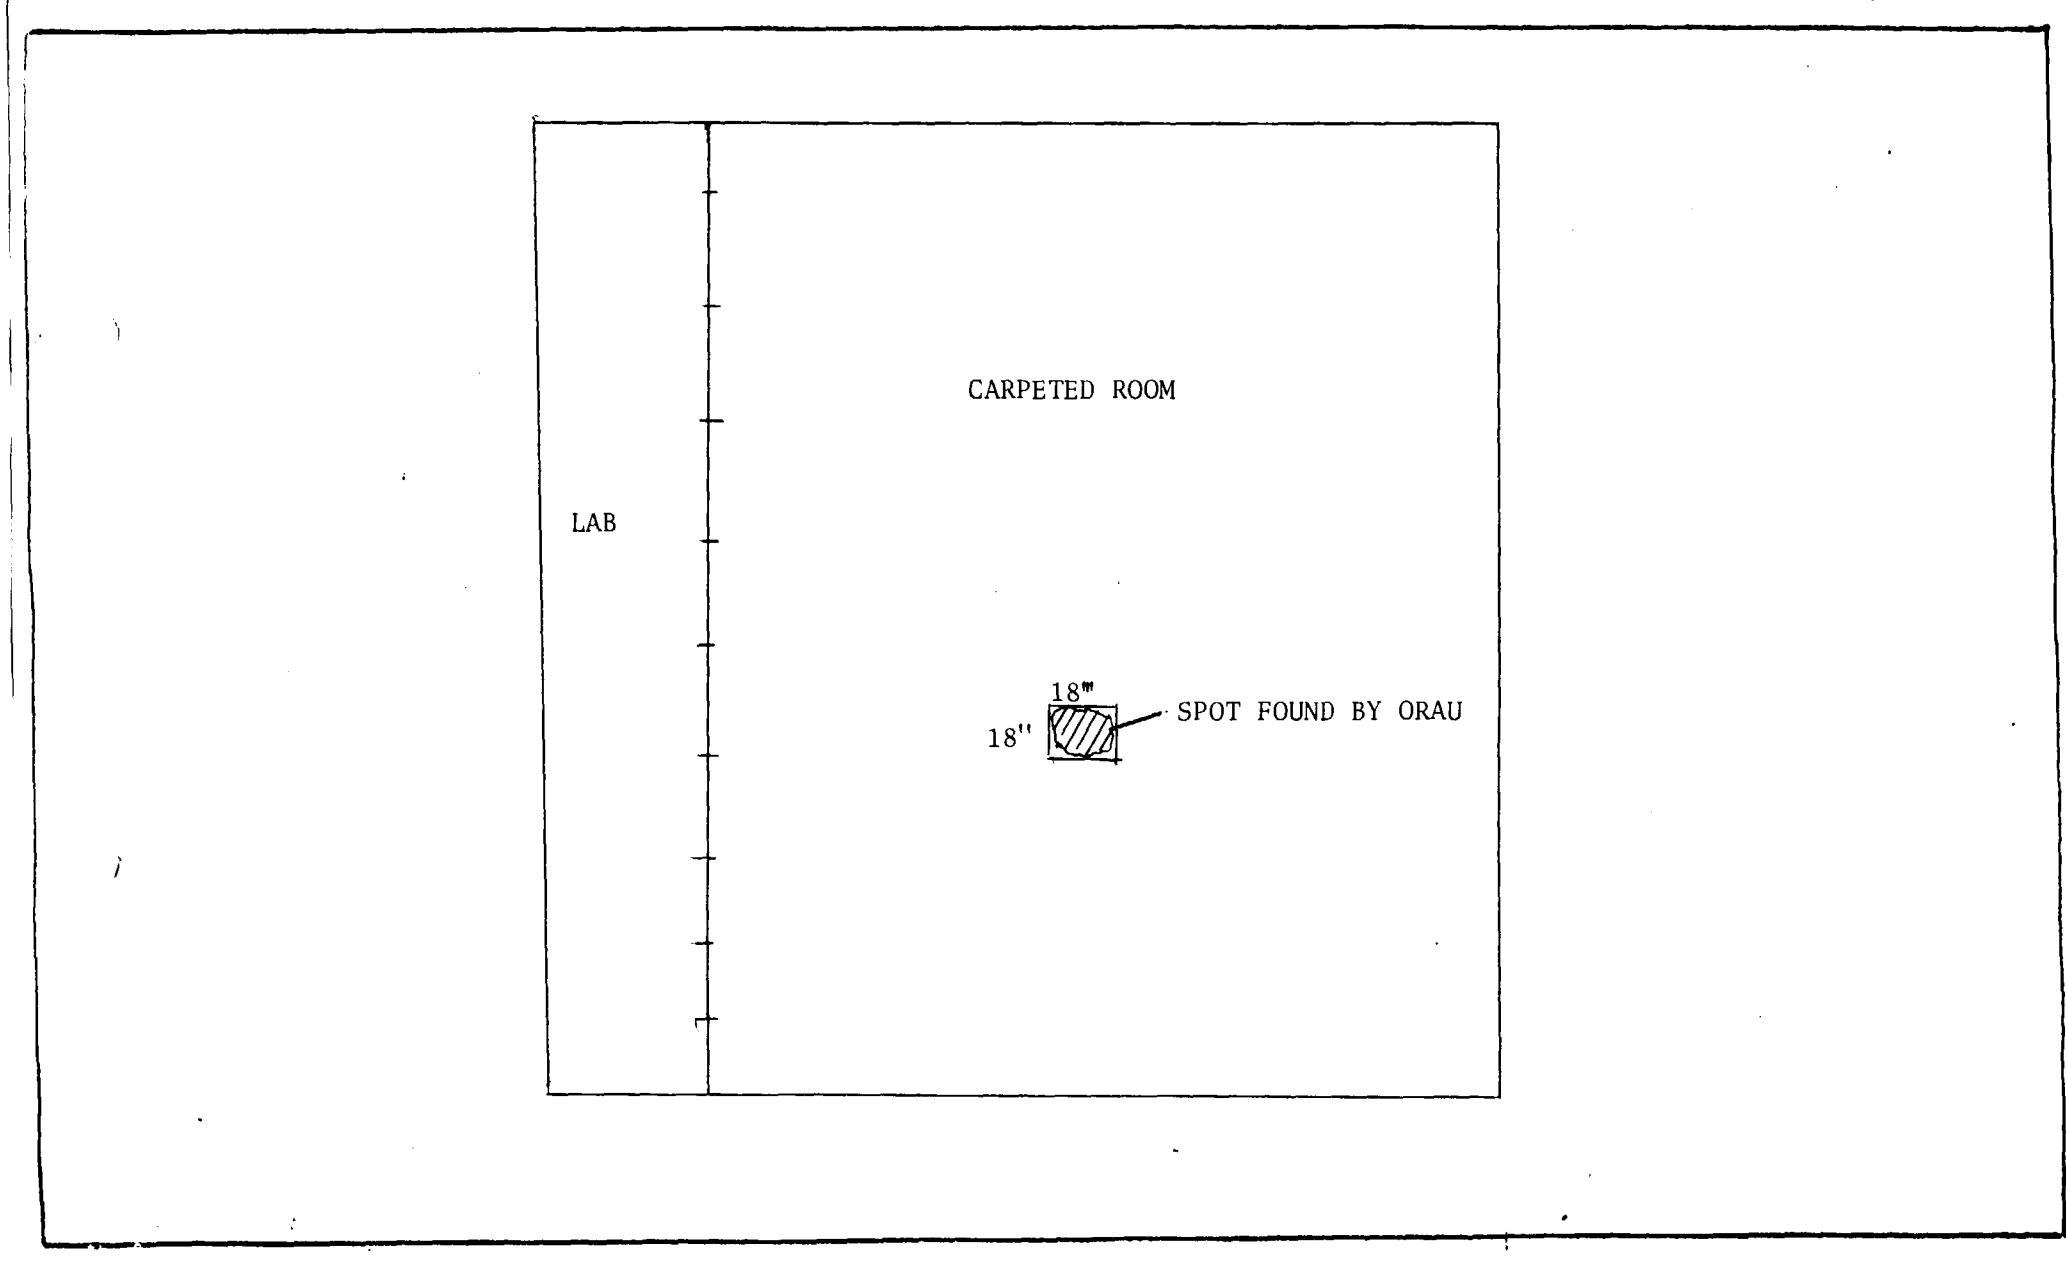
BUILING 5 SIG LEOON	Location	BUIL	ING 3	3rd	FLOOR
---------------------	----------	------	-------	-----	-------

A lab room was reported to have elevated readings throughout. Our confirmatory survey found only a single area approximately two feet by two feet, which was removed. All other readings are due to elevated background levels from wall materials containing natural radioactive materials, e.g. potassium, and do not exceed release criteria.

Comments SPOT FOUND UNDER CARPET 11-238 ACTIVITY 120 pCi/gm SPOT REMOVED AND RELEASED

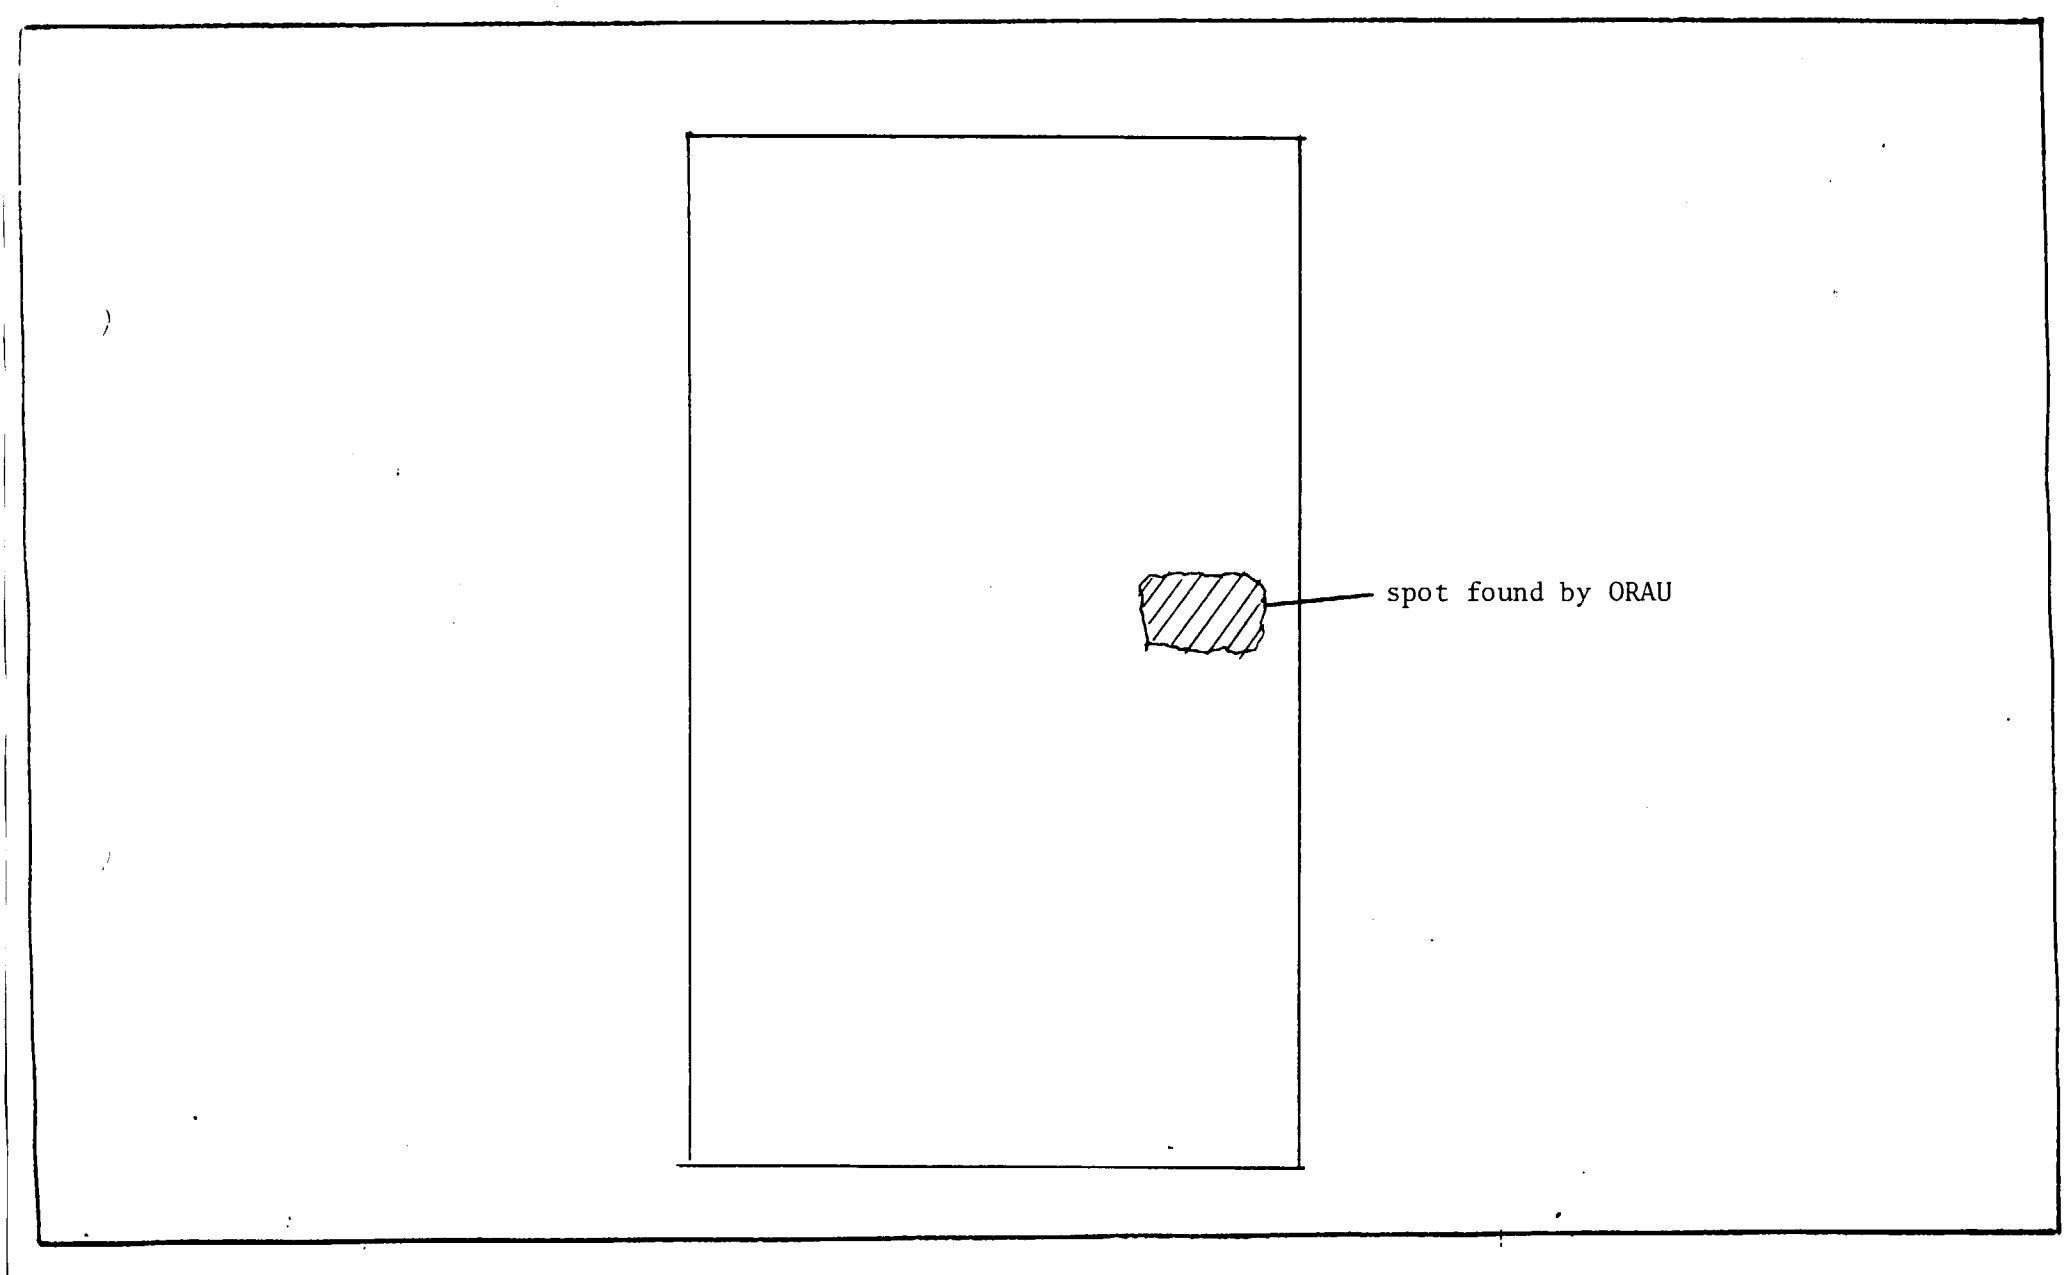
Location BUOLDING 4 1st FLOOR CARPENTRY AREA

A 36 square foot section of floor in the carpentry shop was confirmed as exceeding criteria and was removed.

WOOD FLOORING REMOVED, AREA VACUUMED Comments <u>U-238 4700 pCi</u>

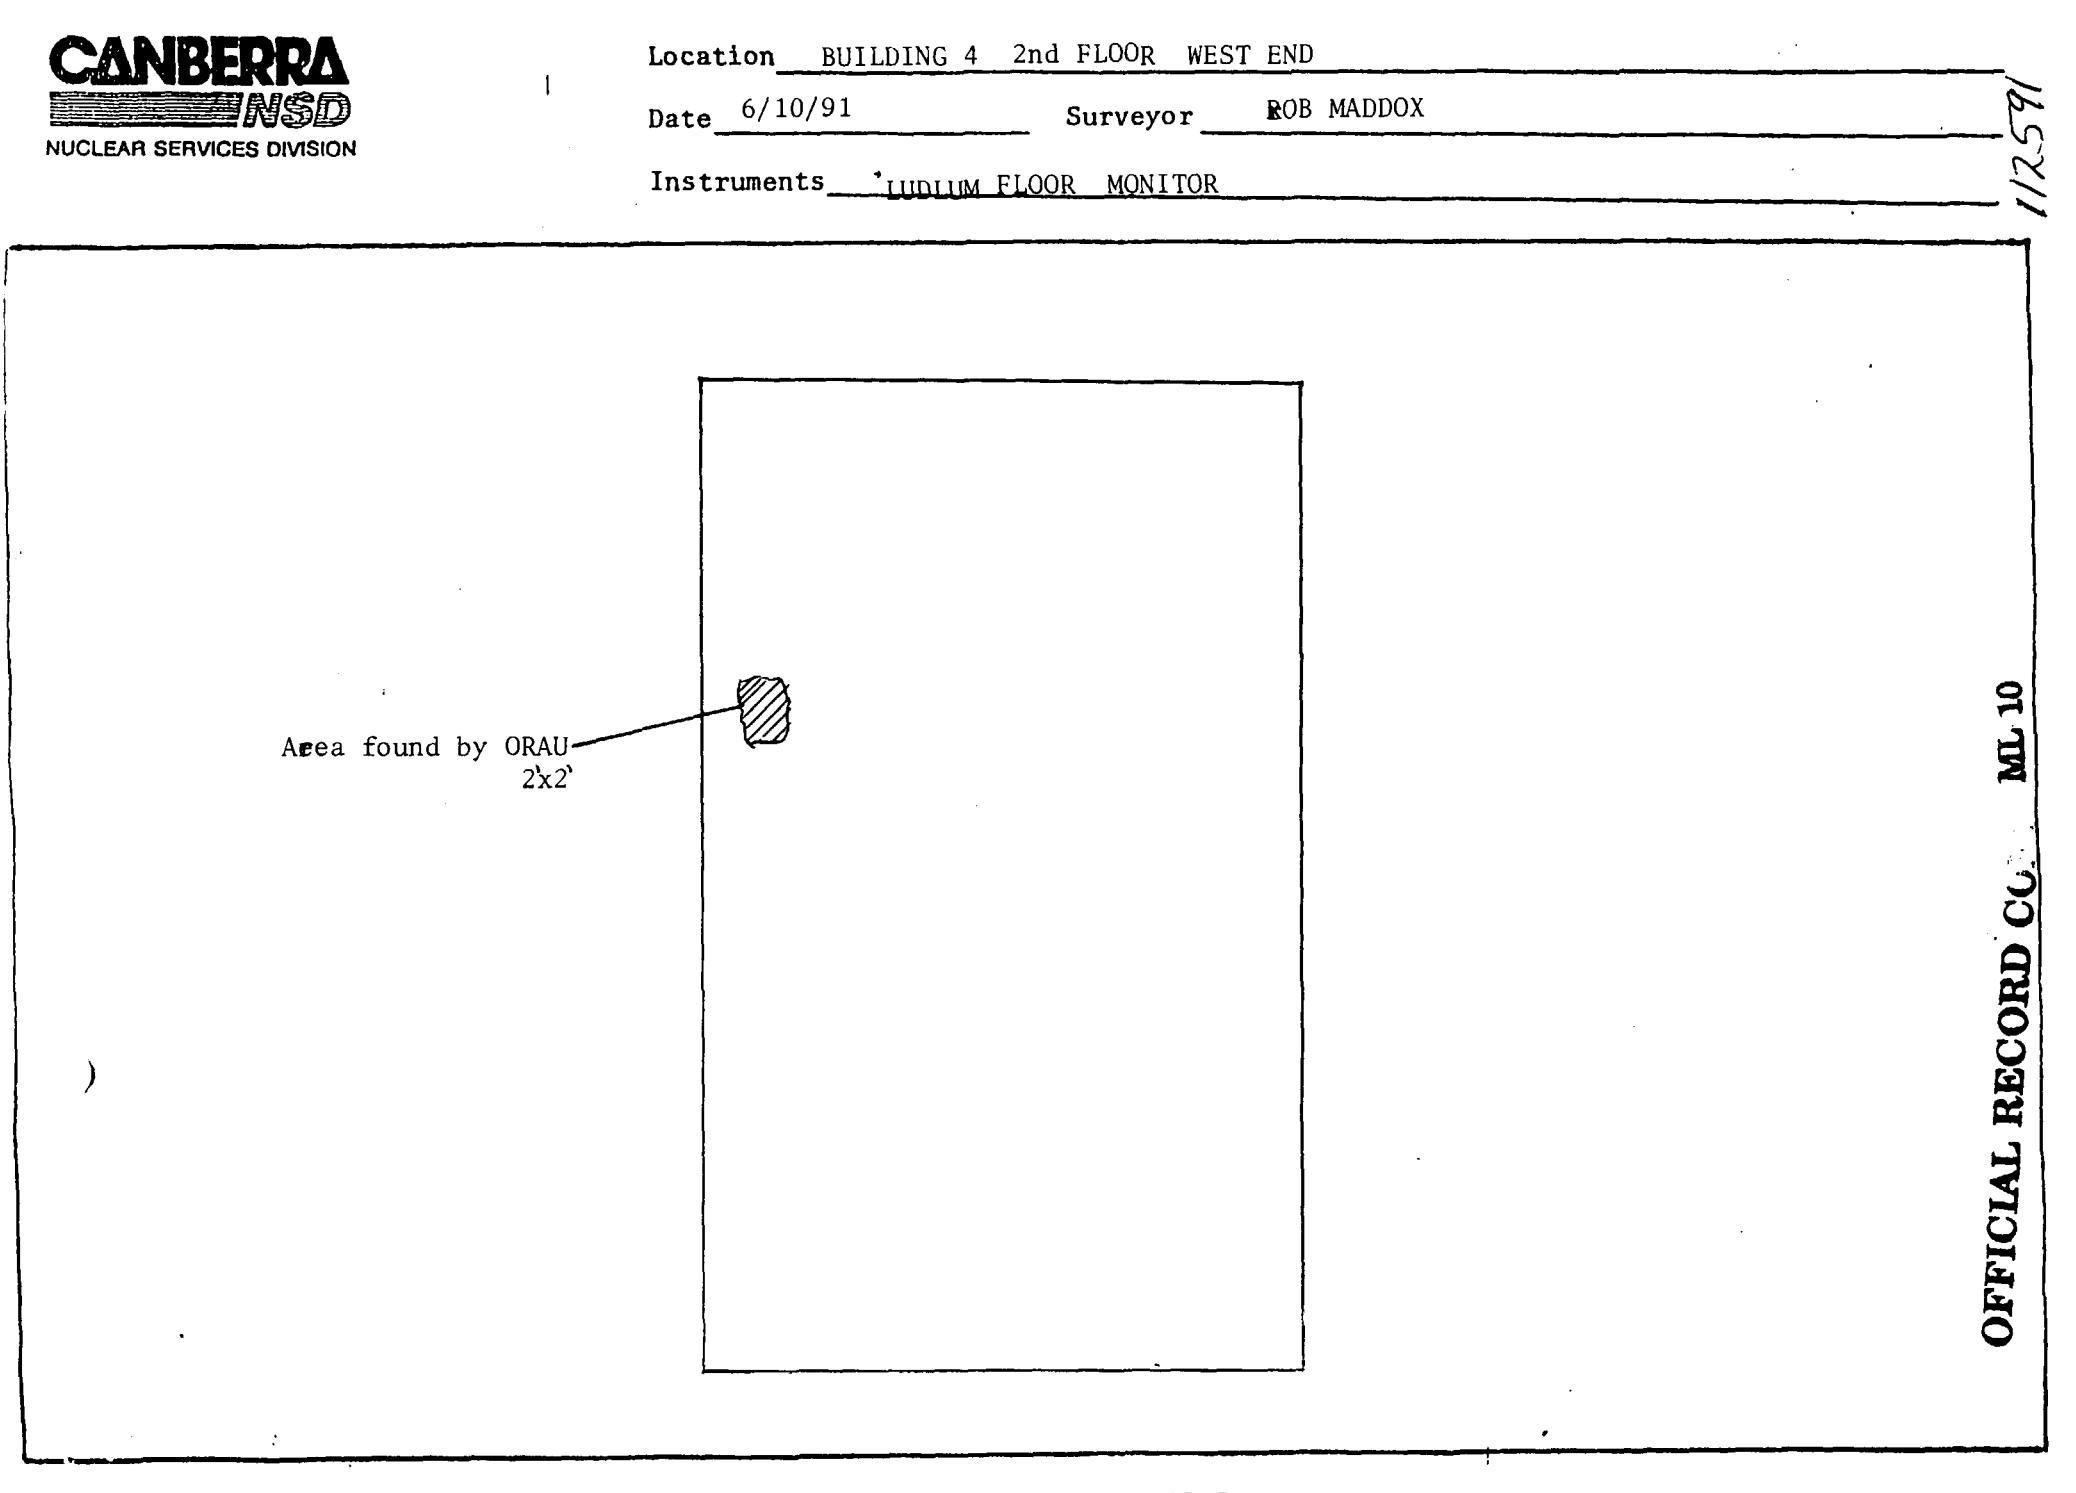
A two square foot area in the machine shop was vacuumed to remove loose contamination beneath the wood flooring.

Comments DIRT SAMPLE UNDER FLOOR BOARDS, Th-232 10,000 pCi DIRT VACUUMED AND RELEASED

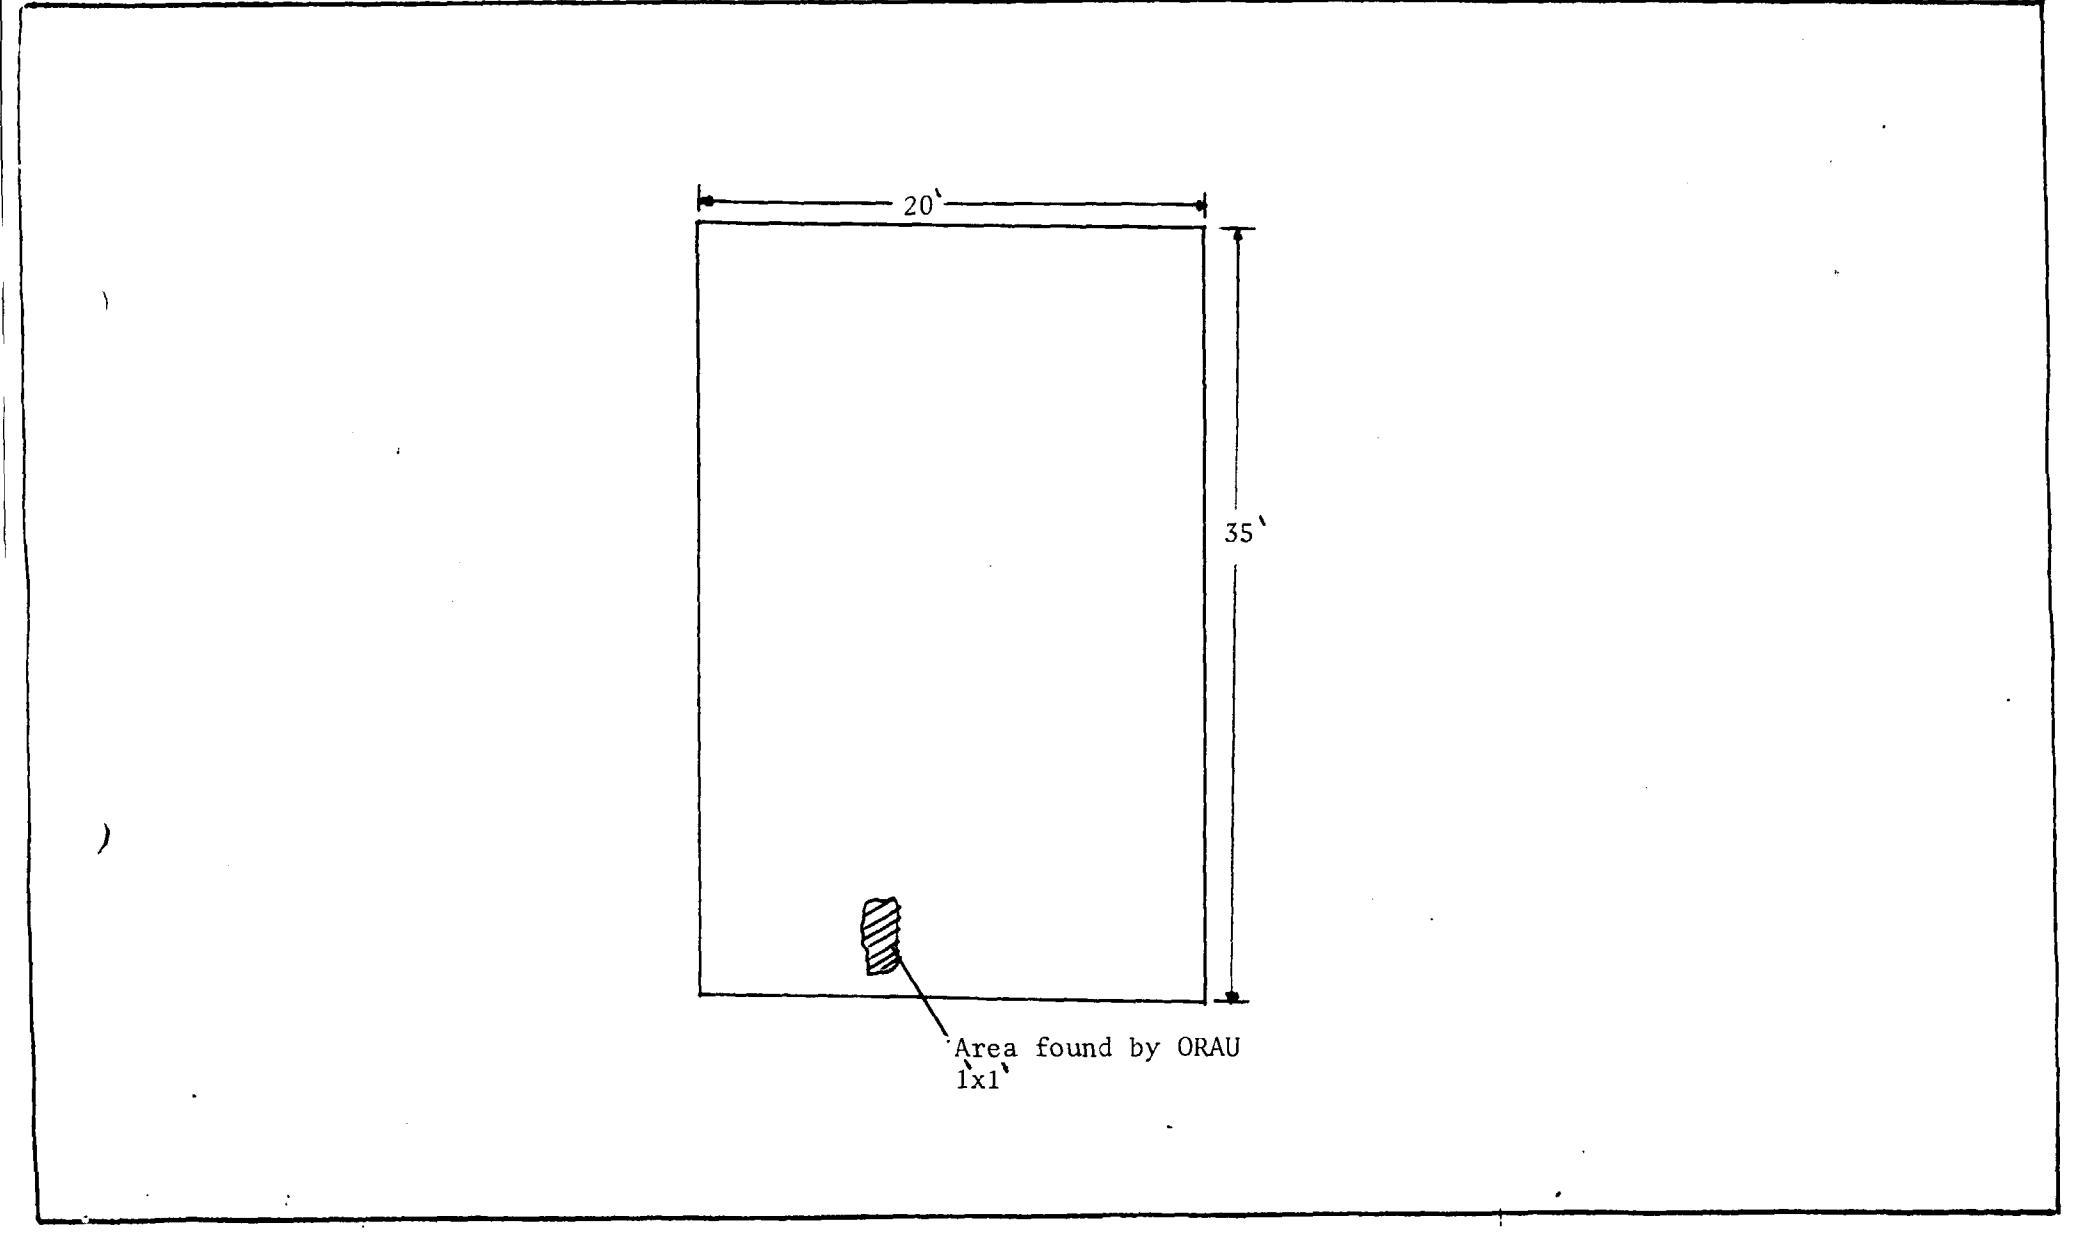
Location	_B UILDING 4	2nd	FLOOR	PLATING	ROOM

A four square foot area in the plating room was confirmed to have spots exceeding criteria. The concrete surface was chipped and vacuumed to meet release limits.

Comments _____CONCRETE_CHIPS_FROM_SMALL_AREA_SHOWED_TRACE_URANIUM_AND_THORIUM__AREA_FOUND_TO_MEET_CRITERIA

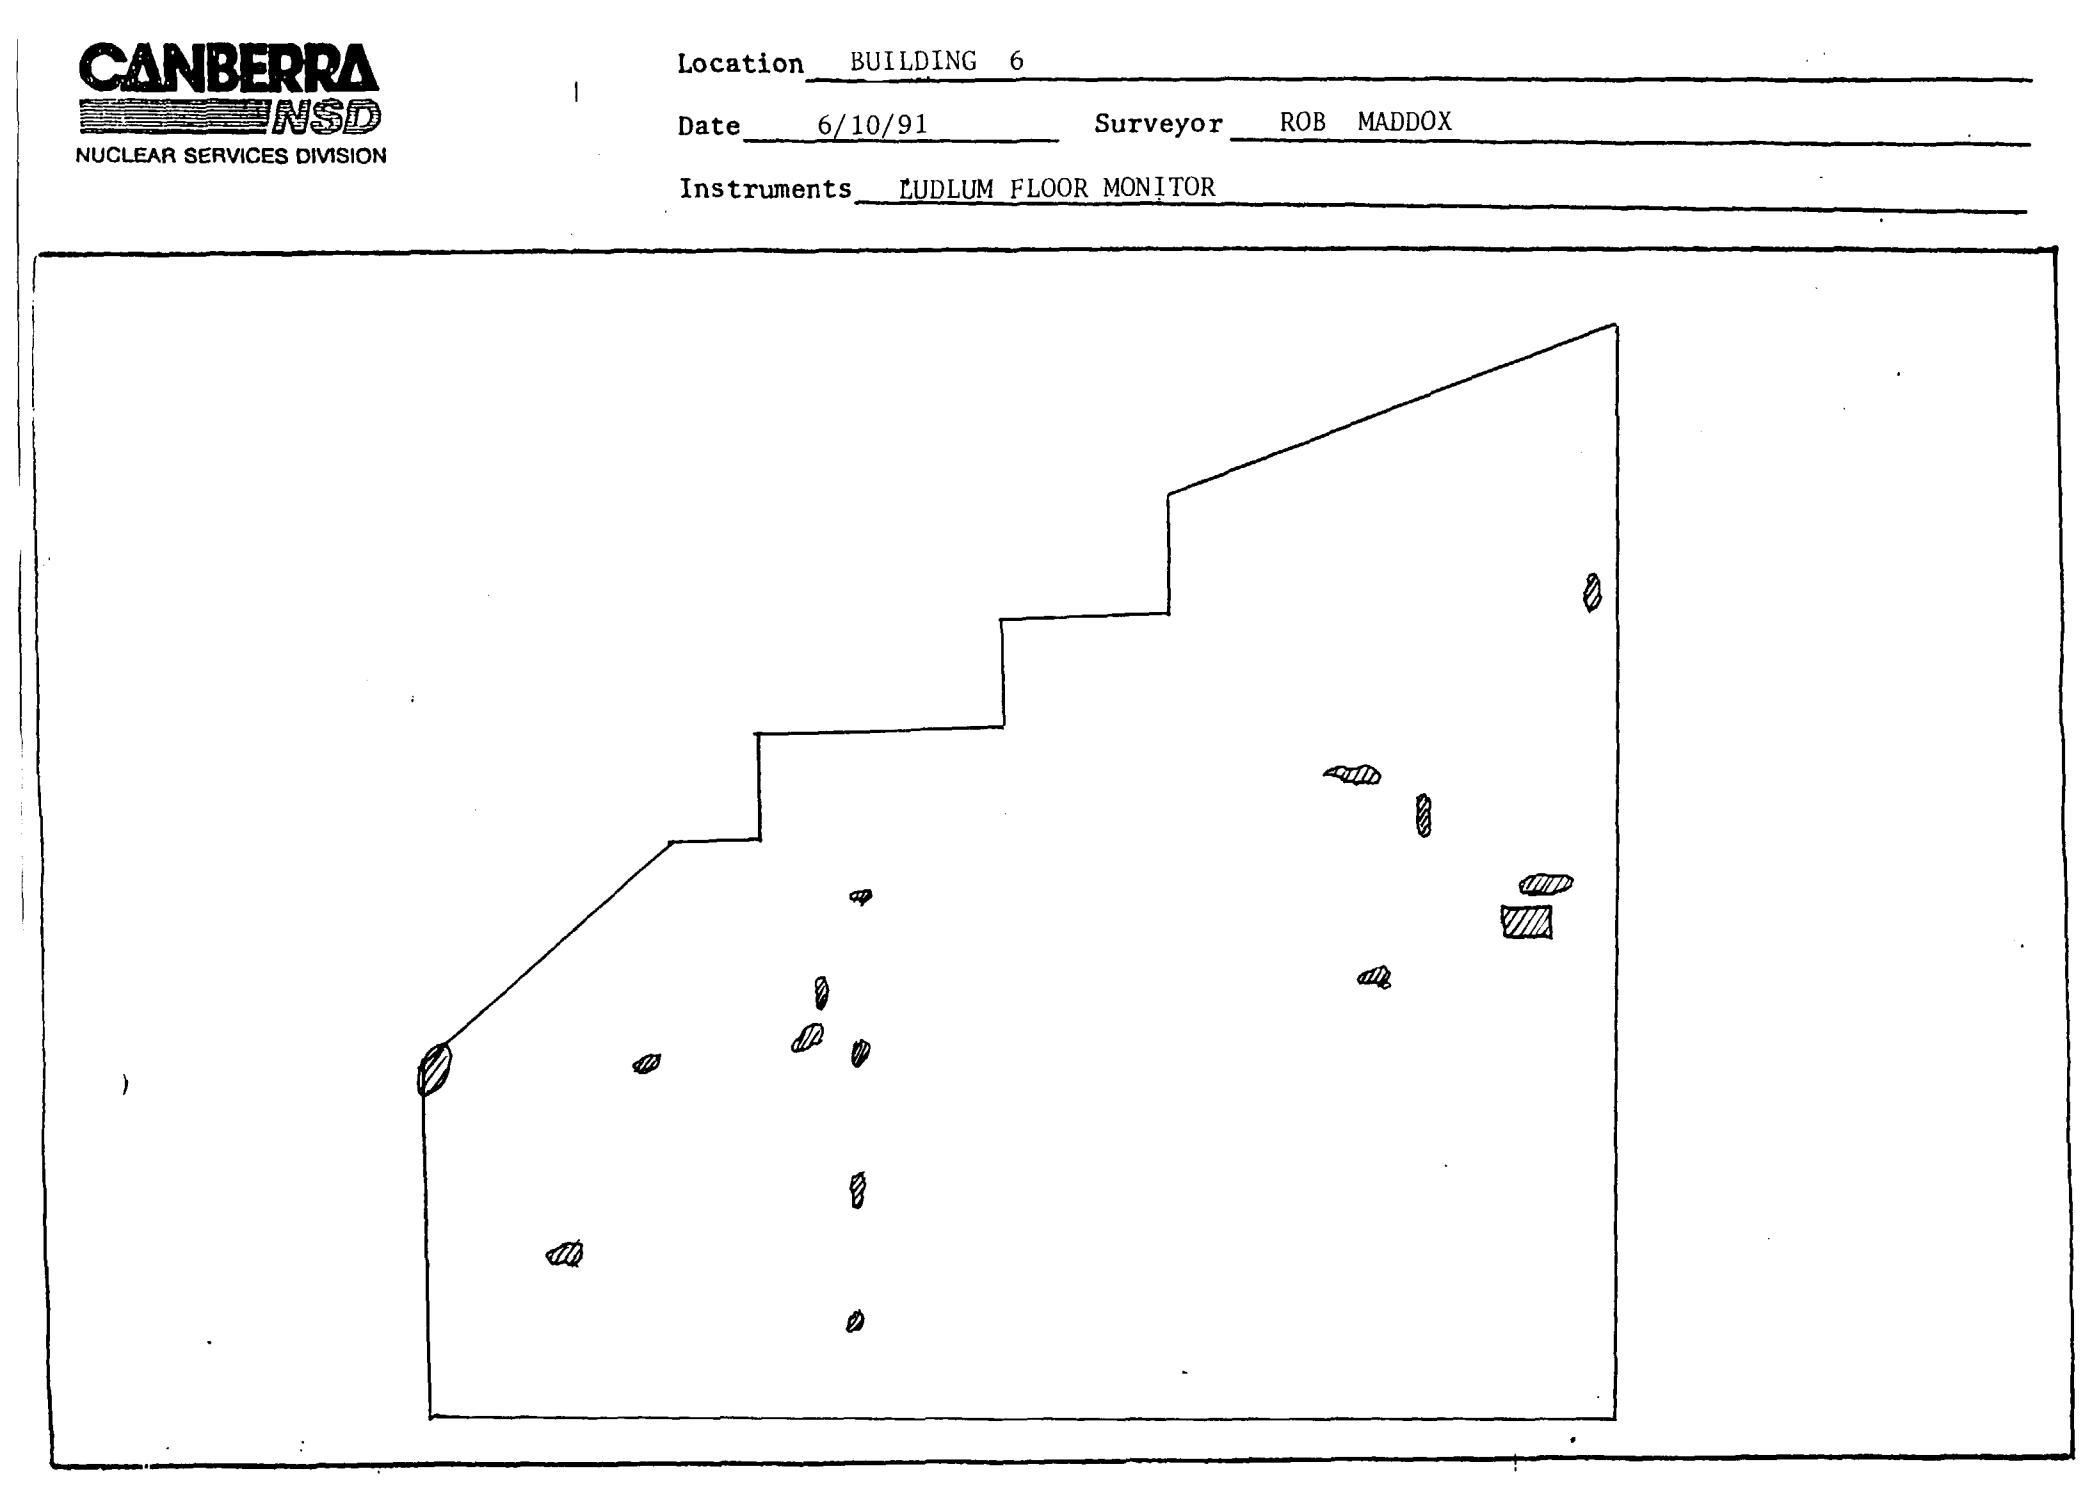
Comments _____ Th-232 activity at 8pCi/gm various small spots with surface contamination Spots removed and cleared
