RY
From: A. Randolph Blough
To: Daniel Holody; James Clifford; Tae Kim
Date: 6/14/04 1:41PM
Subject: Fwd: Salem deja vu from UCS

NUCLEAR REGULATION

Preventing Problem Plants Requires More Effective NRC Action

Salem Nuclear Generating Station, Units 1 and 2

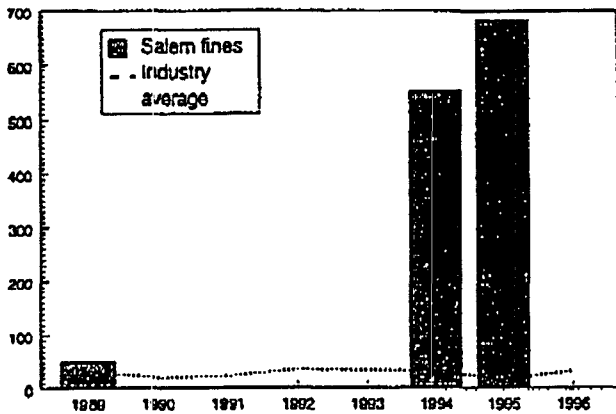
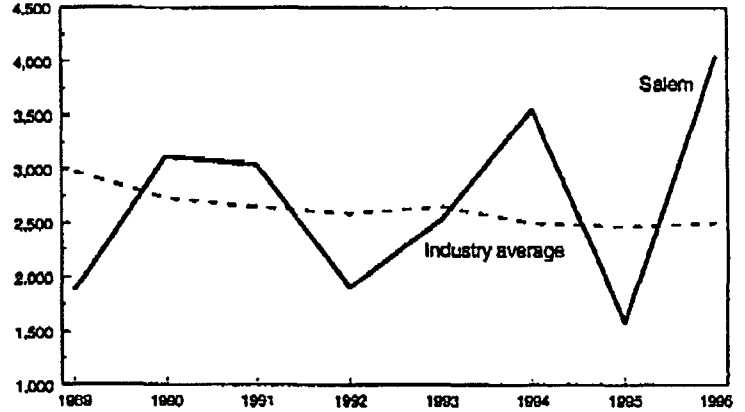
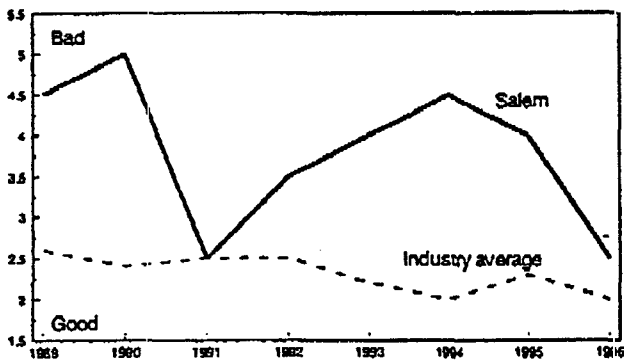
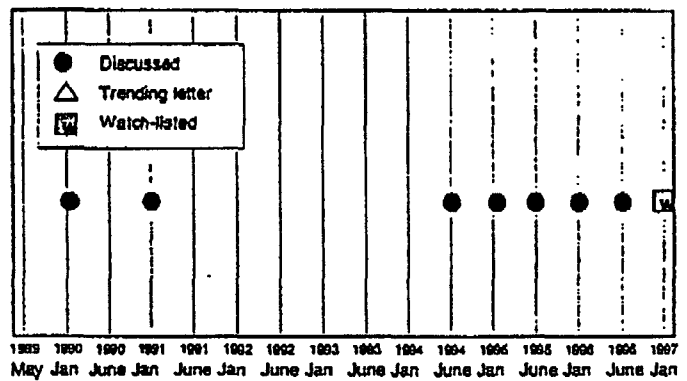
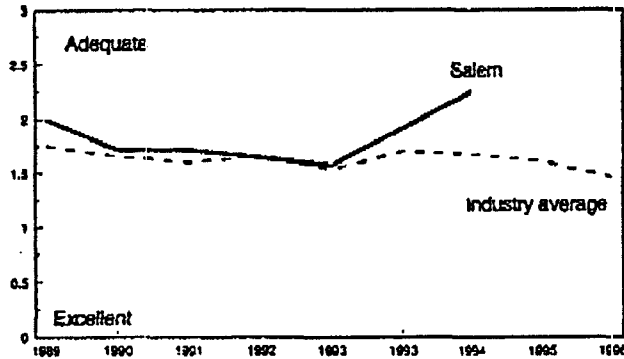
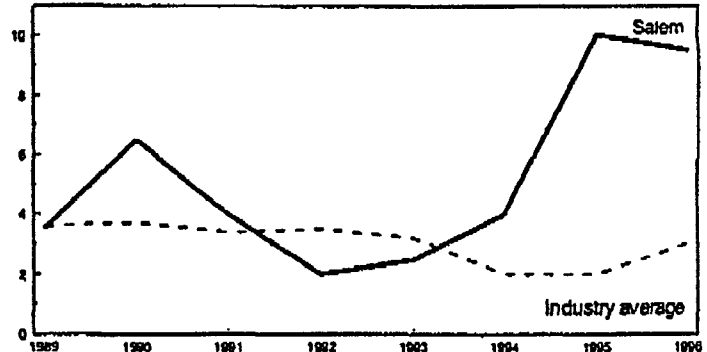
Figure II.1: Salem's Performance History Against the Industry Average

Salem's performance history compares unfavorably to the industry's average. For example, NRC heavily fined Salem on seven occasions; the fines ranged from none for several years to a high of \$680,000. The industry average annual fines assessed each plant during this period ranged from \$17,000 to \$37,000. As the number of NRC's hours of inspection of the Salem plant increased—an indication of NRC's growing concern—Salem's Systematic Assessment of Licensee Performance (SALP) scores worsened in 1993. Salem's performance indicators also worsened during this period, and NRC discussed Salem's performance every year except 1992 and 1993 at its SMMS. In addition, from 1989 through 1996 Salem units reported an average of about five safety system failures per year compared to an industry average of about three per year. Since 1989, SALP scores, performance indicators, and the number of safety system

failures, on average for the industry, have shown overall improvement, while the number of inspection hours devoted to a plant have decreased. Figure II.1 compares the performance of the Salem plant with the nuclear industry as a whole.
