**BROWNS FERRY NUCLEAR PLANT (BFN) - UNITS 1, 2, AND 3 -
LICENSE RENEWAL APPLICATION (LRA) - SUPPLEMENTAL INFORMATION
FOR OPEN ITEM 2.4-3 (TAC NOS. MC1704, MC1705, AND MC1706)**

TENNESSEE VALLEY AUTHORITY
BROWNS FERRY NUCLEAR PLANT (BFN)
UNITS 1, 2, AND 3
LICENSE RENEWAL APPLICATION (LRA)

SUPPLEMENTAL INFORMATION FOR OPEN ITEM 2.4-3

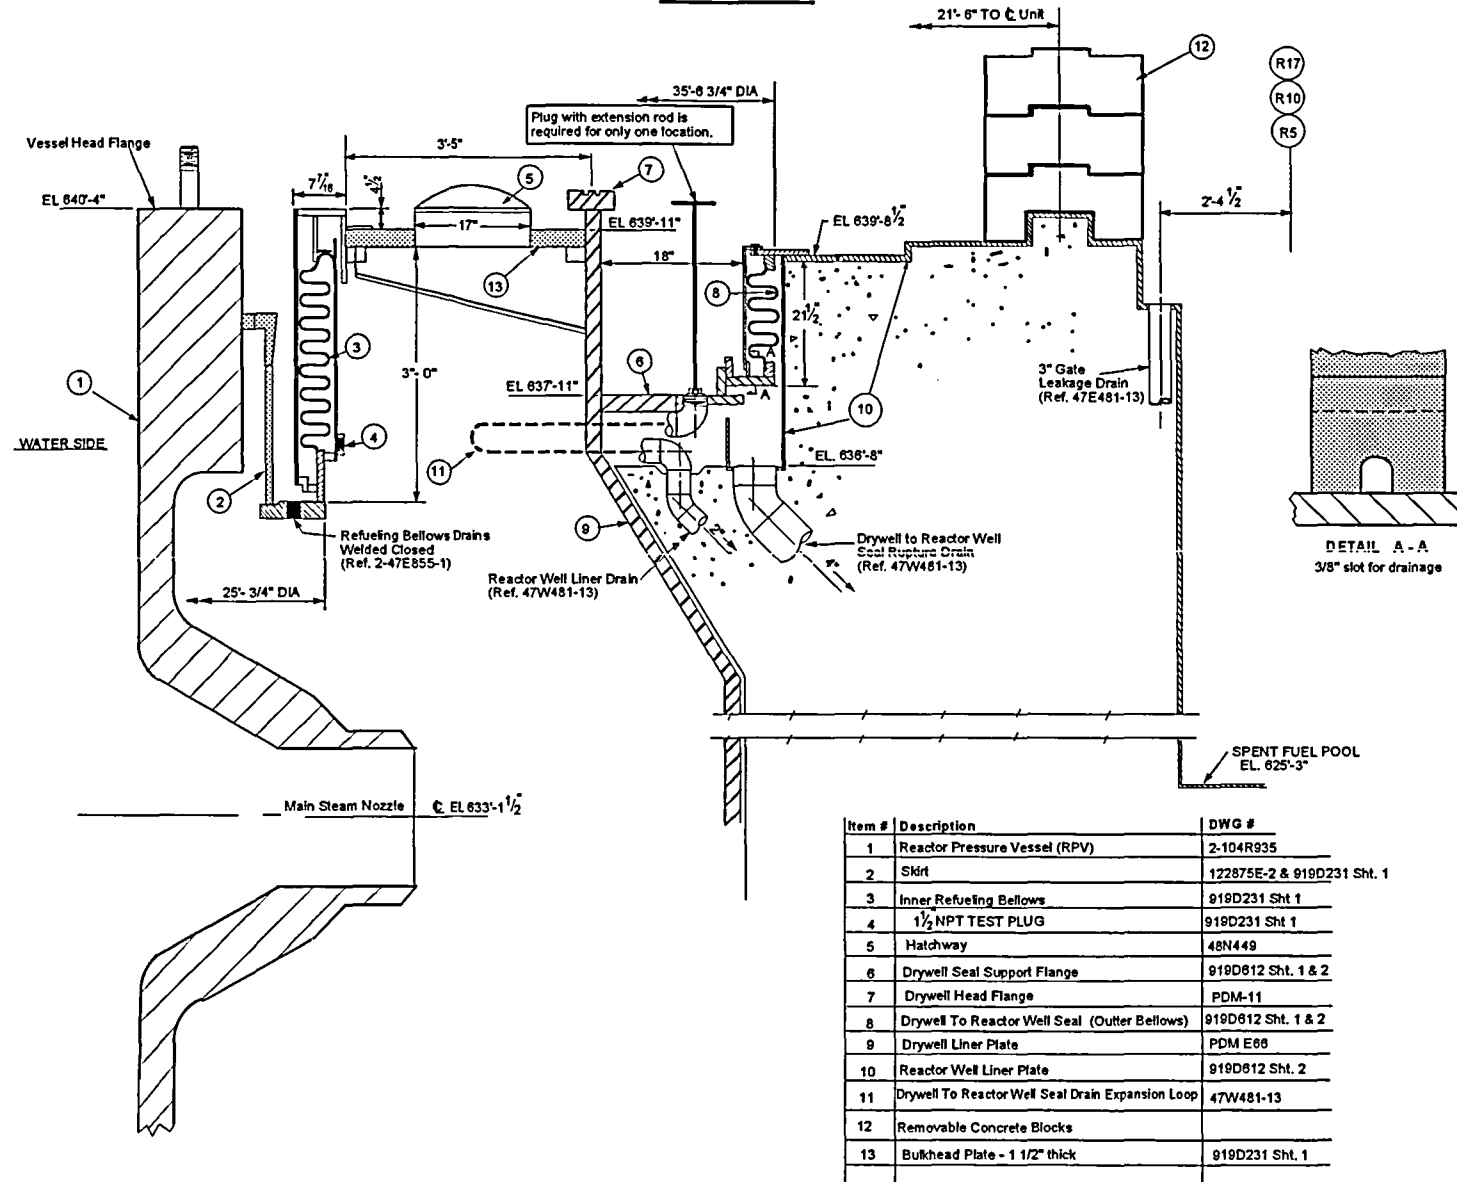
FIGURE 1

A sketch of the BFN configuration of the refueling cavity to drywell seal is provided in Figure 1 of this enclosure.

The BFN configuration was compared to the Oyster Creek drywell to cavity seal configuration which contained a 2" drain line which uses a gasket. As shown in Figure 1, the BFN configuration for the 2" drain line does not use a gasket. For BFN, this 2" drain line is welded to the plate. Using a weld connection eliminates the concern of gasket degradation which could result in water leakage during refueling operations. Also, as can be seen in Figure 1, any

leakage from the Drywell to Reactor Well Seal (Outer Bellows), which is Item 8 in the figure, will go directly to the Drywell to Reactor Well Seal Rupture Drain and not to the inaccessible area of the drywell shell.

Referring to Figure 1, the standing water was located between the outside of the Drywell Shell (Item 9) and the Outer Bellows (Item 8) above the Drywell Seal Support Flange (Item 6) at Elevation 637'-11". This area is routinely flooded for shielding and contamination control during refueling operations. After refueling operations are completed, water may be left in this refueling seal area for shielding. As stated in the May 31, 2005, letter, this area is exposed to standing water and repeated wetting and drying during

refueling operations. The area is not accessible for detailed visual examination from the outside surface.
