**BROWNS FERRY NUCLEAR PLANT (BFN) - UNITS 1, 2, AND 3 -
LICENSE RENEWAL APPLICATION (LRA) - SUPPLEMENTAL INFORMATION
FOR OPEN ITEM 2.4-3 (TAC NOS. MC1704, MC1705, AND MC1706)**

SUPPLEMENTAL INFORMATION FOR OPEN ITEM 2.4-3

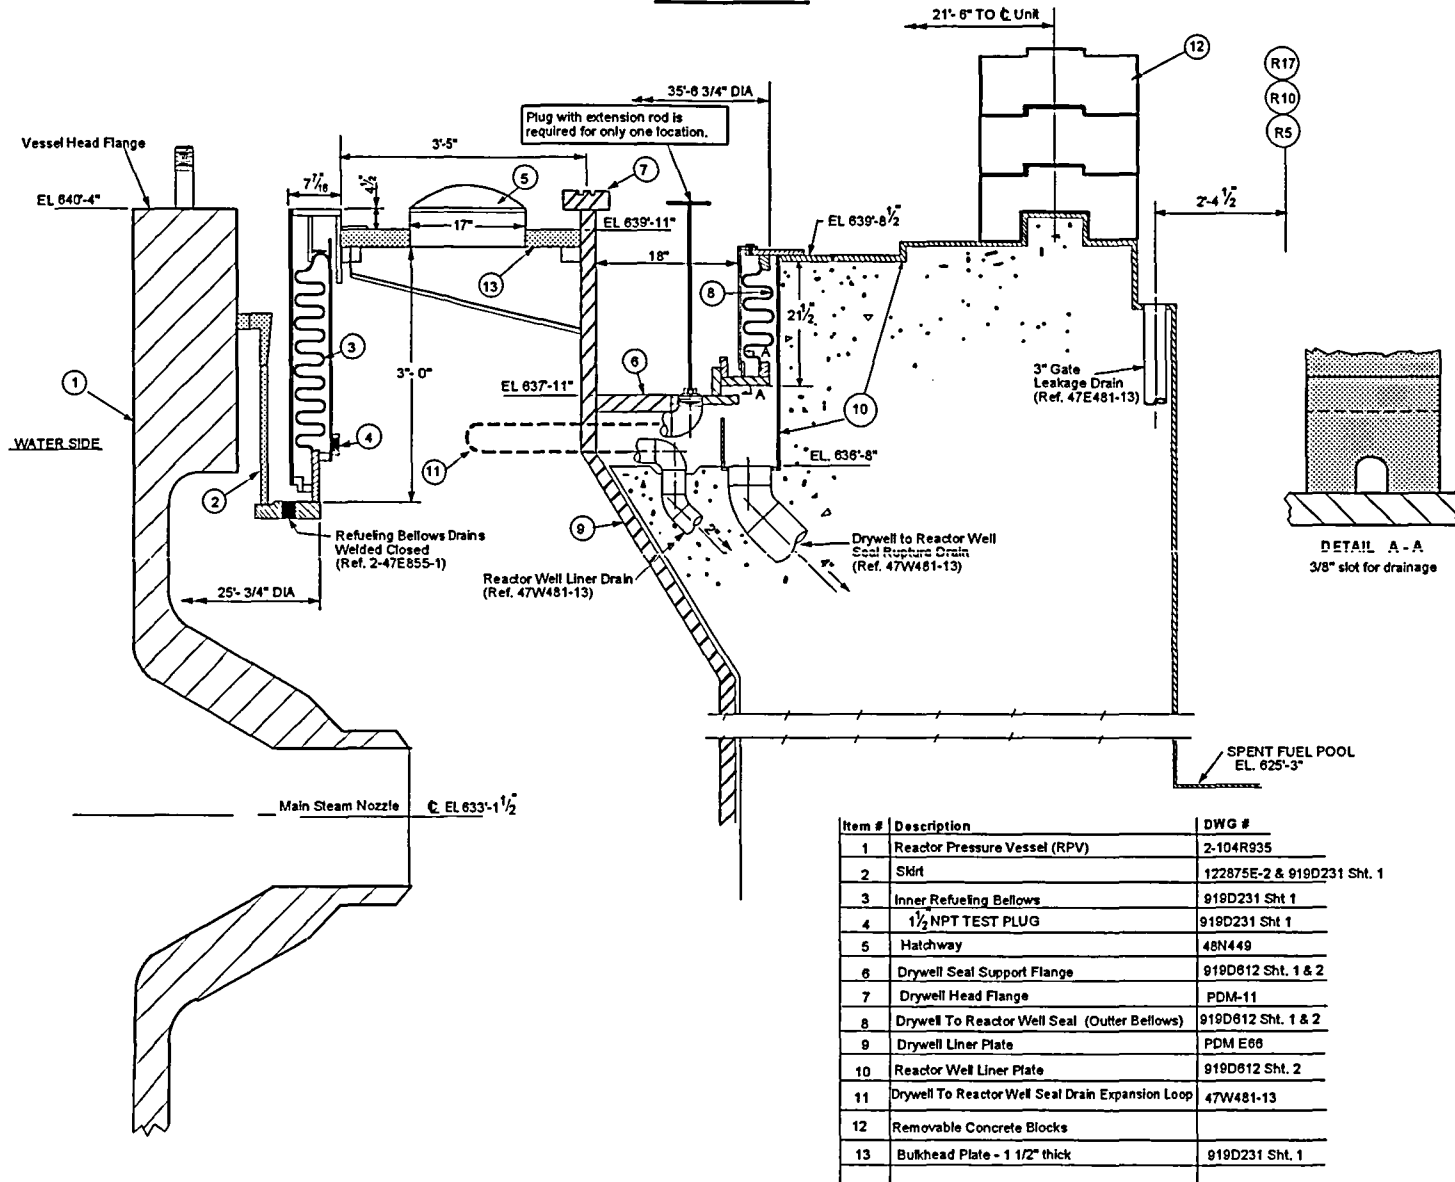
FIGURE 1

A sketch of the BFN configuration of the refueling cavity to drywell seal is provided in Figure 1 of this enclosure.

The BFN configuration was compared to the Oyster Creek drywell to cavity seal configuration which contained a 2" drain line which uses a gasket. As shown in Figure 1, the BFN configuration for the 2" drain line does not use a gasket. For BFN, this 2" drain line is welded to the plate. Using a weld connection eliminates the concern of gasket degradation which could result in water leakage during refueling operations. Also, as can be seen in Figure 1, any

leakage from the Drywell to Reactor Well Seal (Outer Bellows), which is Item 8 in the figure, will go directly to the Drywell to Reactor Well Seal Rupture Drain and not to the inaccessible area of the drywell shell.

Referring to Figure 1, the standing water was located between the outside of the Drywell Shell (Item 9) and the Outer Bellows (Item 8) above the Drywell Seal Support Flange (Item 6) at Elevation 637'-11". This area is routinely flooded for shielding and contamination control during refueling operations. After refueling operations are completed, water may be left in this refueling seal area for shielding. As stated in the May 31, 2005, letter, this area is exposed to standing water and repeated wetting and drying during

refueling operations. The area is not accessible for detailed visual examination from the outside surface.
