SUBJECT: INSPECTION NO. 070-00139/96-002

INSPECTION REPORT

070-00139/96-002

Inspection Summary: Routine, announced safety inspection of remediation activities (NRC Inspection No. 070-00139/96-002).

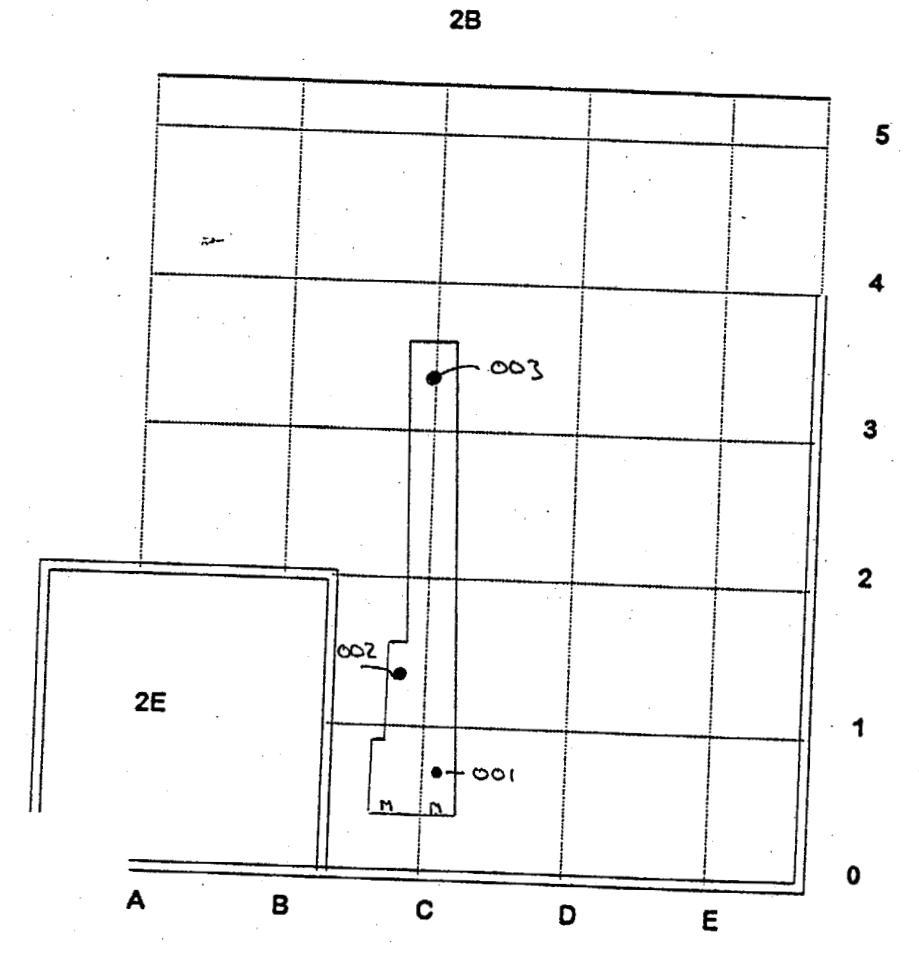
ENGELHARD PLANT ROOM 2H

- 1. Sample 002 is taken just below slab, where pipe was.
 - 2. Samples 001,003 are no 6". below clab where pipe was.

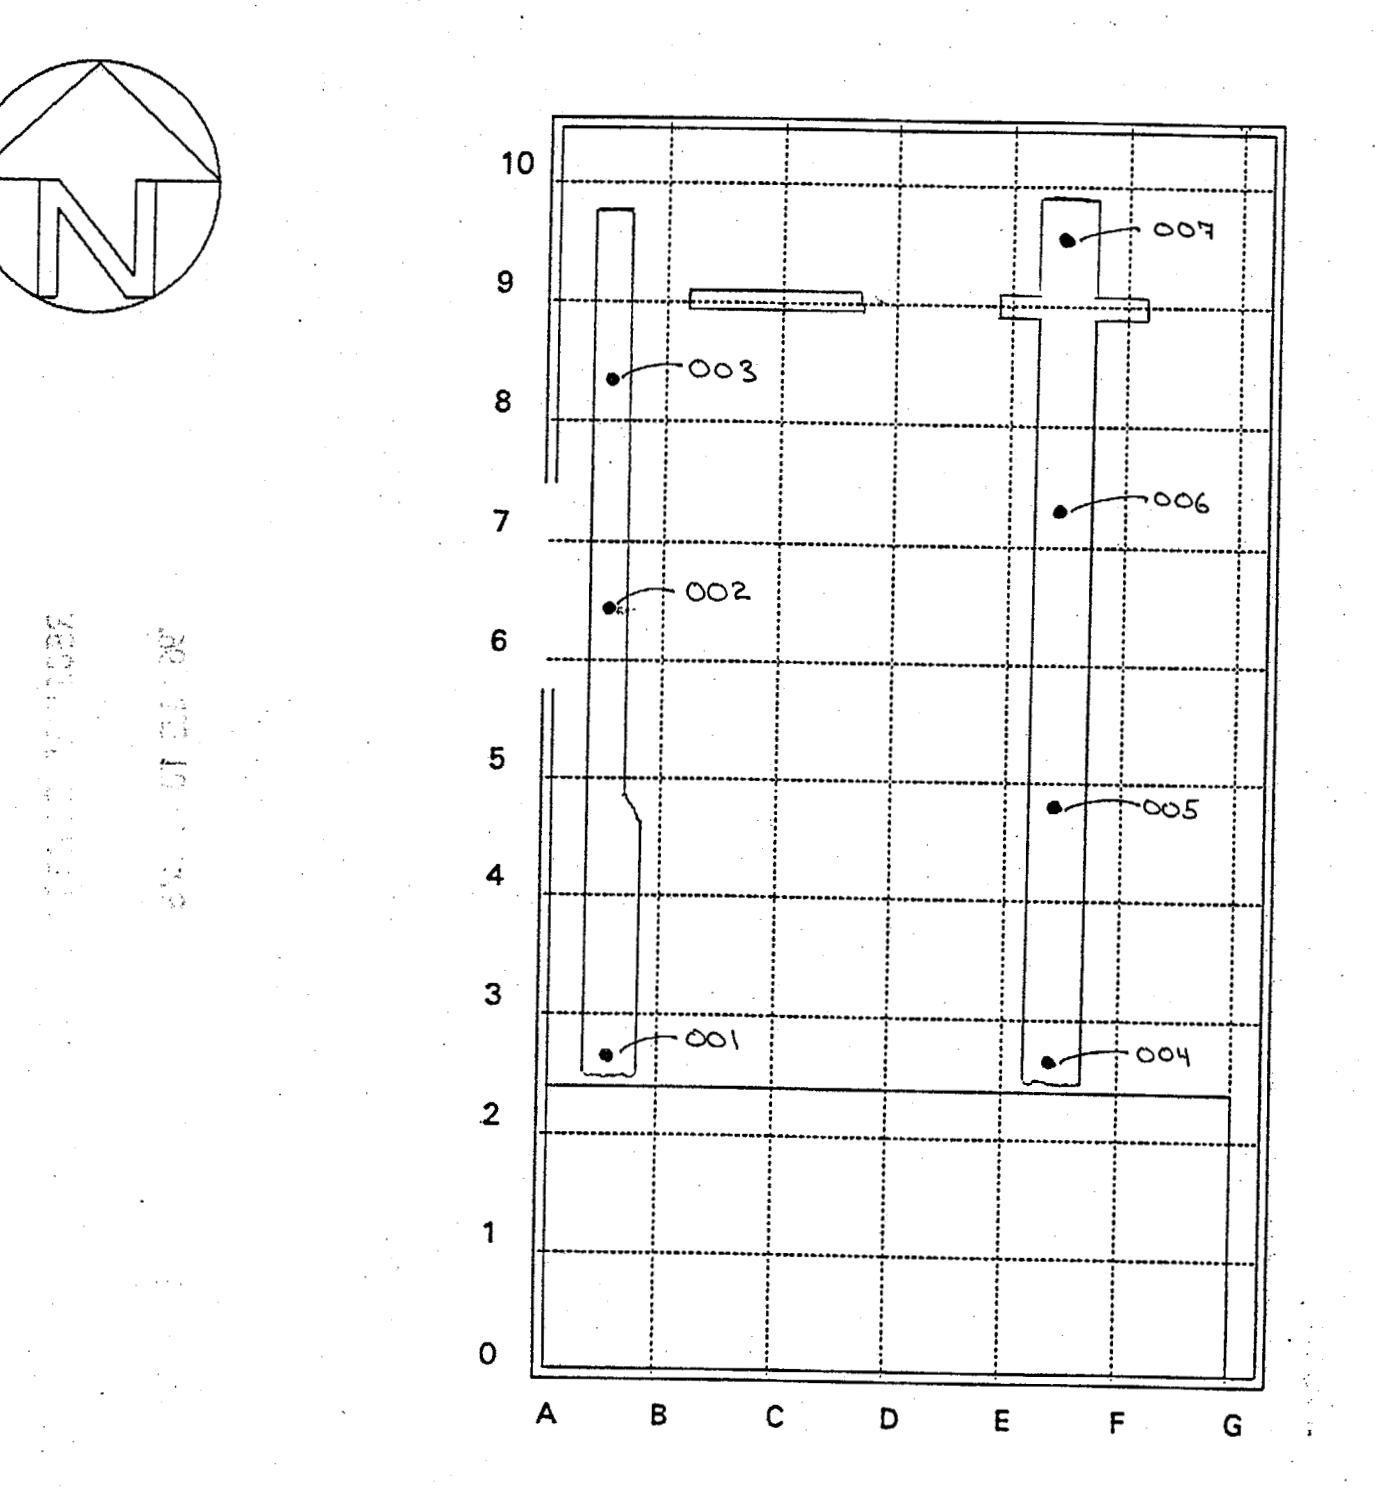
ENGELHARD PLANT ROOM 2K

Soil Sample Locations Note: Samples performed on 7-24-96, packaged into Marinellis.
