**NUREG/CR-4638/1 of 2**  
**SAND86-0839/1 of 2**  
**RP**  
**Printed September 1986**

# **Transient Fire Environment Cable Damageability Test Results: Phase I**

**W. T. Wheelis**

TRANSIENT FIRE ENVIRONMENT CABLE  
DAMAGEABILITY TEST RESULTS:  
PHASE I

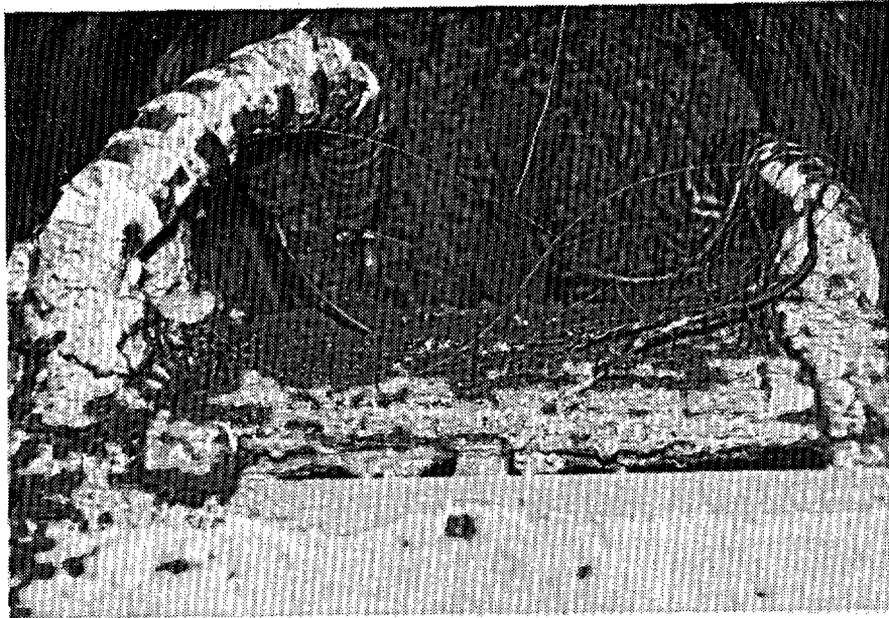
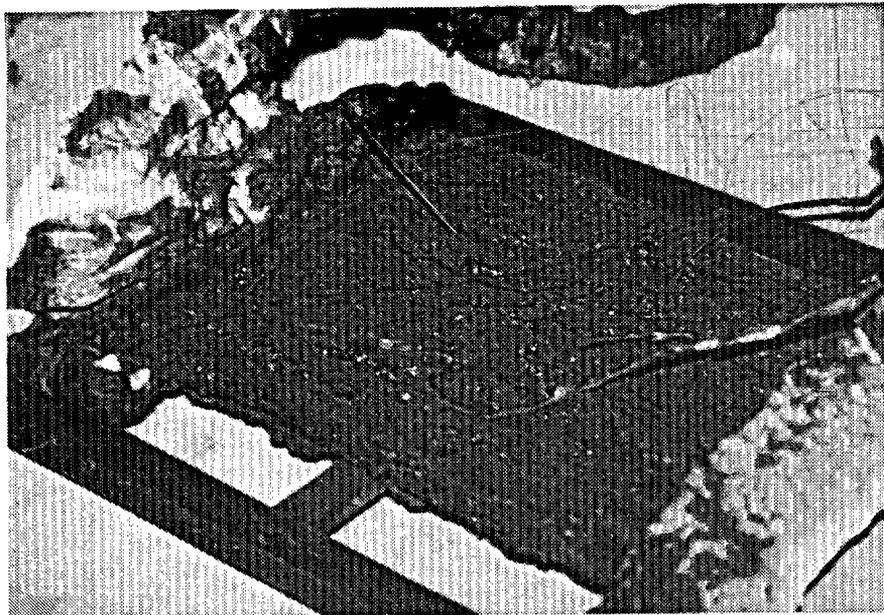
Figure 11. Unqualified Cable After Exposure, Test A

<u>Test #</u>	<u>Cable Type</u>	<u>Electrical Failure</u>		<u>Comments</u>
		<u>Yes</u>	<u>No</u>	
A	UQ	X		Heavy smoke, cables fused together.
B	Q	X		Heavy smoke, cables brittle, blistered.
1	UQ	X		Heavy smoke, cables fused together.
2	Q		X	Heavy smoke, cables brittle, blistered.
3	UQ	X		Same as # 1.
4	Q		X	Test performed as verification of # 2 results. Same results, effects observed.
5	UQ		X	No smoke produced, no apparent physical damage observed.
6	UQ		X	Light smoke produced. Cables closest to fan had some swelling, browning occur.
7	UQ	X		Heavy smoke, cables severely damaged. Upon removal from chamber, only bare conductors left.
8	Q		X	Light smoke, cables blistered. <sup>+</sup>
9	Q	X		Heavy smoke, cables severely damaged along one third of their length (closest to fan).
10	UQ		X	Light smoke, outer jacket showed some melting.
11	Q		X	No smoke produced, no apparent physical damage observed.

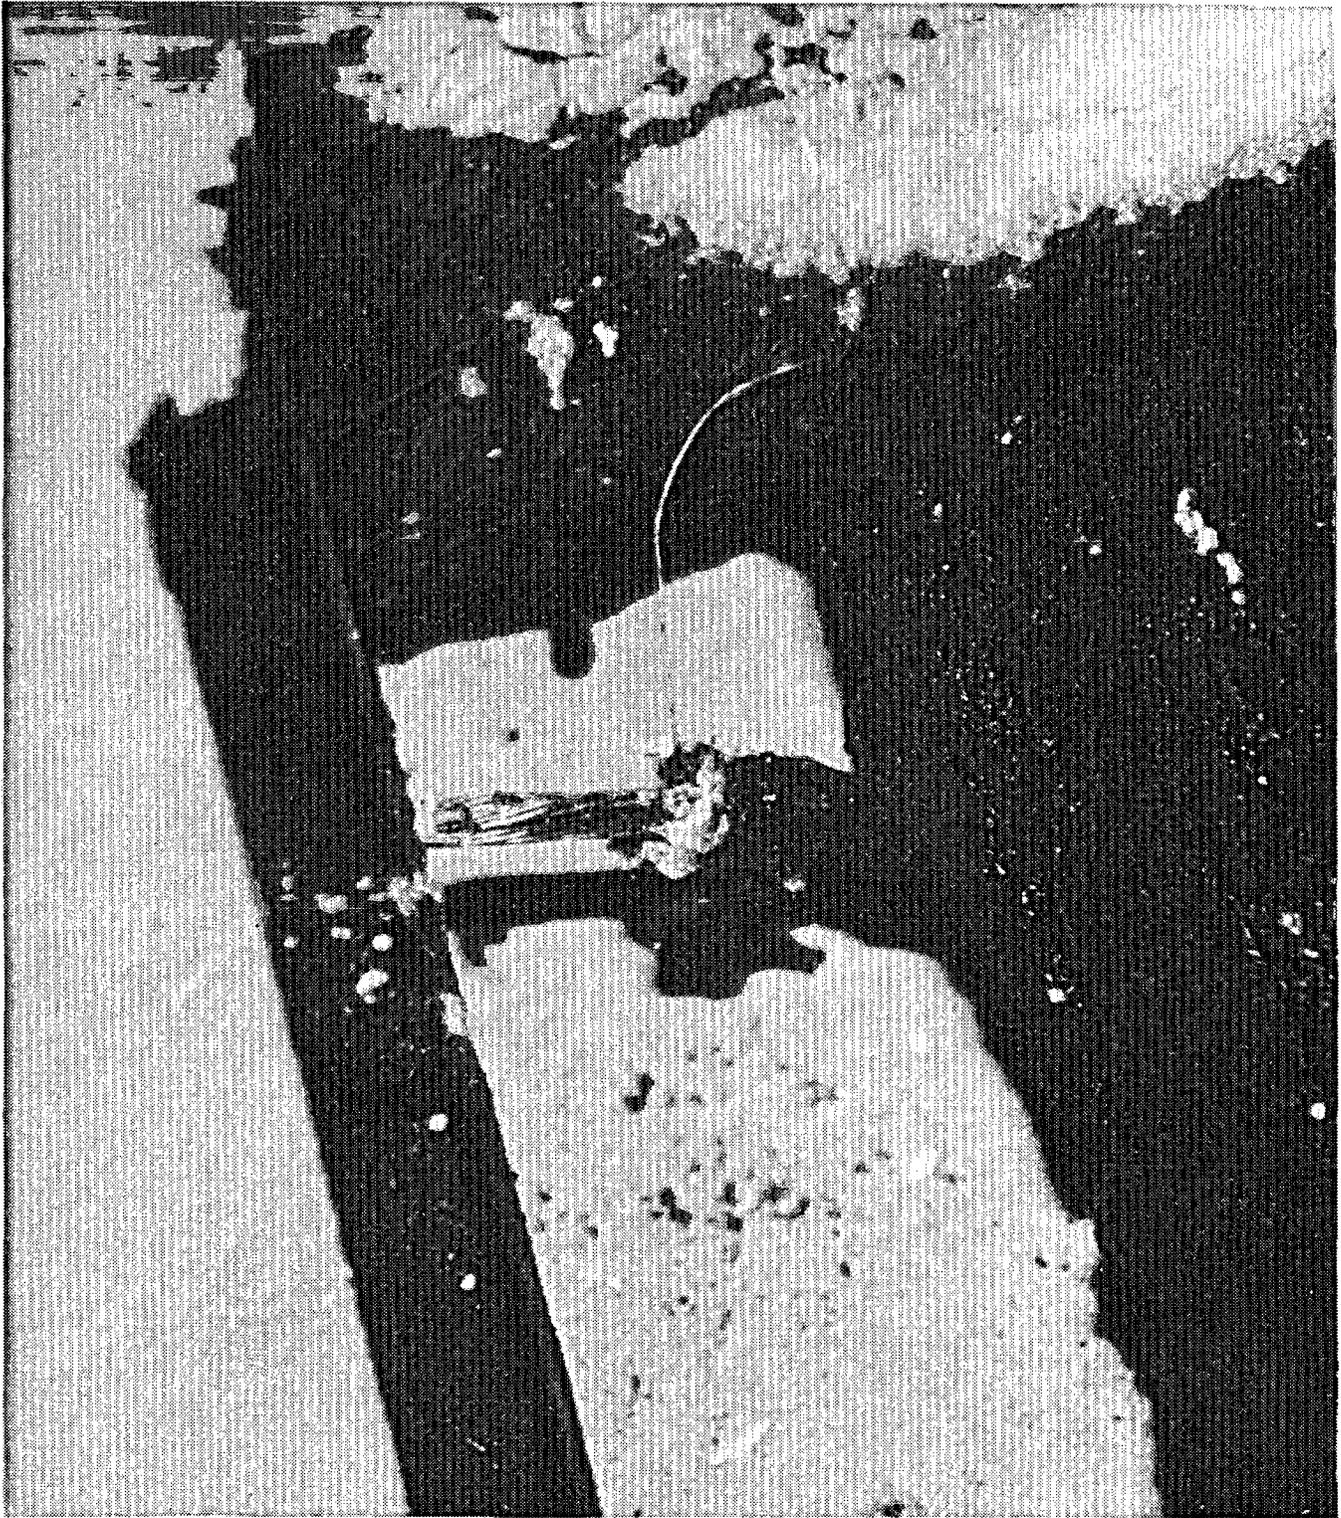
Figure 28. End Effect for Unqualified Cable, Test A

Figures 28 and 29 show why end effects are important and can lead to failure. These two figures show the end of the unqualified and qualified cabling that was wrapped. Not only end effects but also the effects of wrapping the cable are seen in these two figures. In Figure 28, the unqualified cable "looks" like it has been completely consumed by fire. This may have been caused by the fact that the end was wrapped. One possible explanation for this end wrapping effect is that as the temperature in the chamber heated up, the PVC produced more and more pyrolyzates. At every location in the chamber, except on the

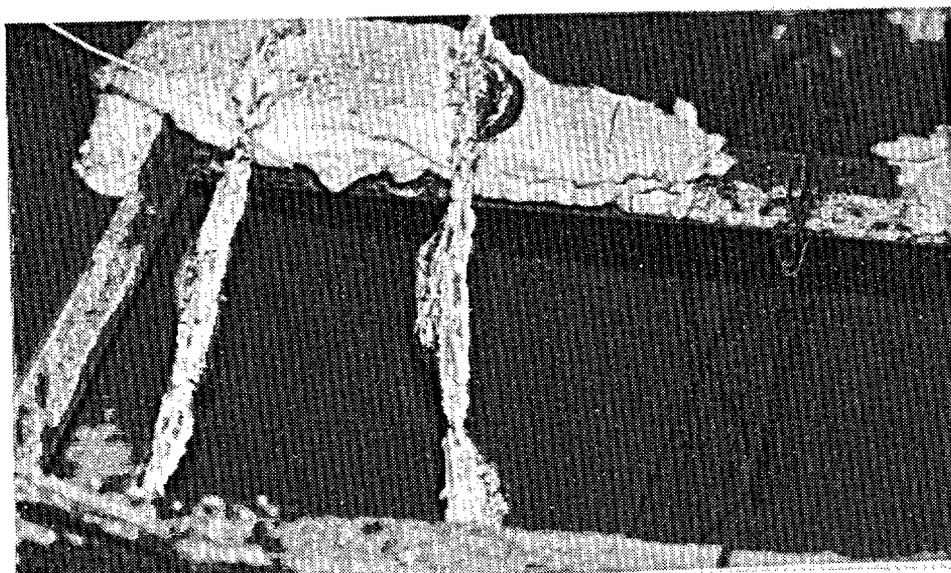
Figure 55. Unqualified Cable After Exposure, Test 7

In examining the two figures mentioned above, it is apparent that major damage occurs to the cables. In addition, Figure 56 shows that the most severe damage occurs close to the chambers installed fan. Convective heat transfer apparently has a large effect on cable failure. Figure 57 is a plot of the air flow (in feet per minute) measured along the left cable. Note that the air flow rate is highest near the chamber fan and drops off rapidly toward the other end of the chamber. Figure 58 is a composite view showing the left cable and its damage versus the air flow rate measured directly above it. This figure graphically indicates that convective heat transfer plays a vital role in damaging cables. It also indicates why the electrical failure times that were observed in Section 2.5.2 (cable tray tests) were different than the individual cable tests. During the cable tray tests, instrumented cabling was exposed to a much lower air flow region (since it was shielded by other cables and exposed cable was approximately 12 inches from the fan), thus convective heat transfer was less. In fact, several air flow measurements taken inside the cable tray configuration show even smaller air flows than the smallest observed air flow in the single cable tests.

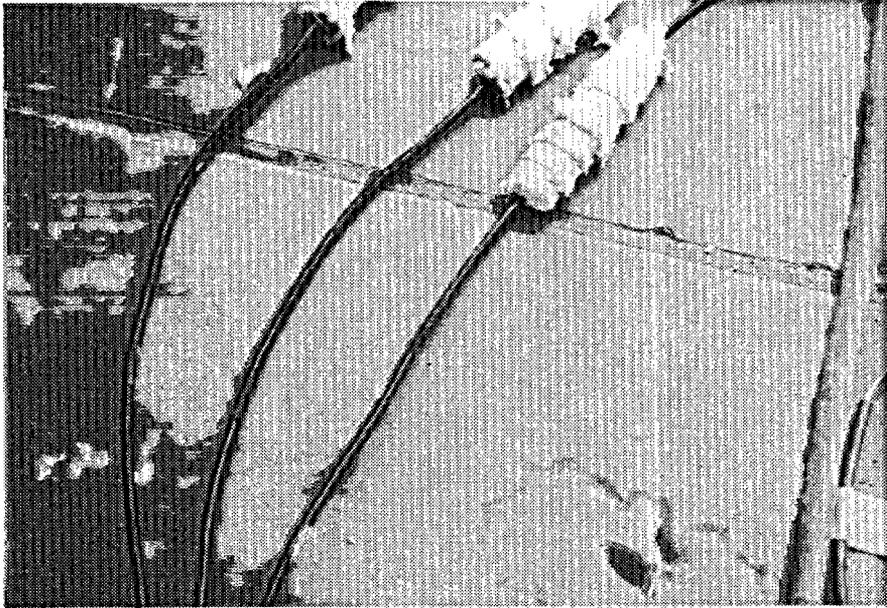
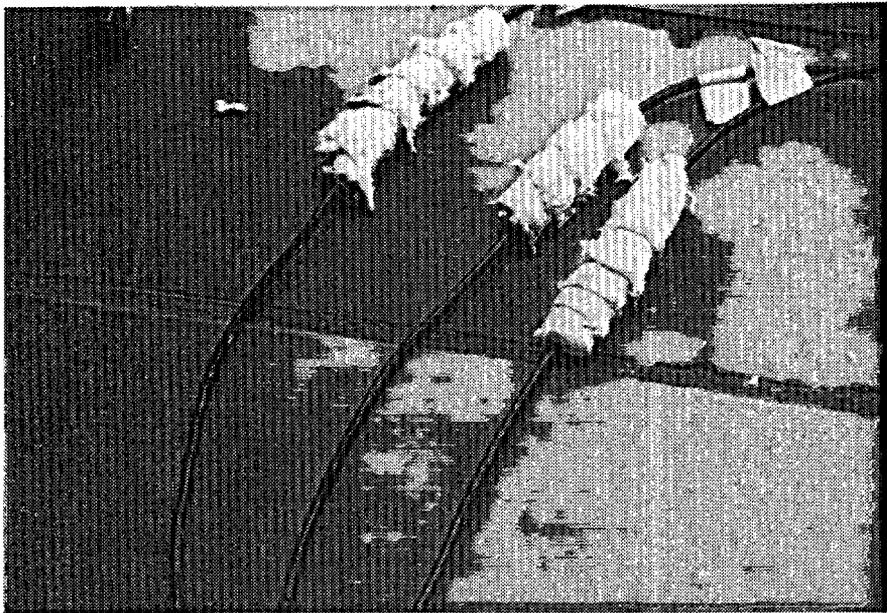
Figure 59. Unqualified Cable After Simulated Suppression, Test 10

Tests 5 and 6 simulated suppression system actuation. Suppression was simulated by air cooldown rather than the actual introduction of a suppression agent. This was done to determine if the cables would survive a less severe temperature profile that was based on when the suppression systems electrically initiated in the 20-foot tests. Air cooldown was used to ensure that any failures that might occur at these temperatures could be attributed to temperature and not suppression agents. In both tests, no electrical failure was noted. Test 5, which interrupted the Test #1 profile of the 20-foot separation tests, did not even produce any smoke. After the test the cables were barely warm to the touch. Although no failures occurred in Test 6, some smoke was produced, the cables near the front of the chamber (i.e., near the fan) showed some signs

of blistering, were brown, and were warm and pliable after the test. Thus, based on these tests, it would appear that for Test 5, if water suppression had occurred, it would not have caused damage. In Test 6, because of the blistering and browning of the cable, the application of water might have led to electrical failure.
