- Subject: Response to Request for Additional Information on ANO-2 Steam Generator Tube Inservice Inspection Report Arkansas Nuclear One – Unit 2 Docket No. 50-368 License No. NPF-6
- REFERENCE: 1 Entergy letter dated March 16, 2006, Steam Generator Tube Inservice Inspection Report (2CAN030601)

Arkansas Nuclear One, Unit 2

Response to NRC Request for Additional Information on Steam Generator Tubing Inservice Inspection Report

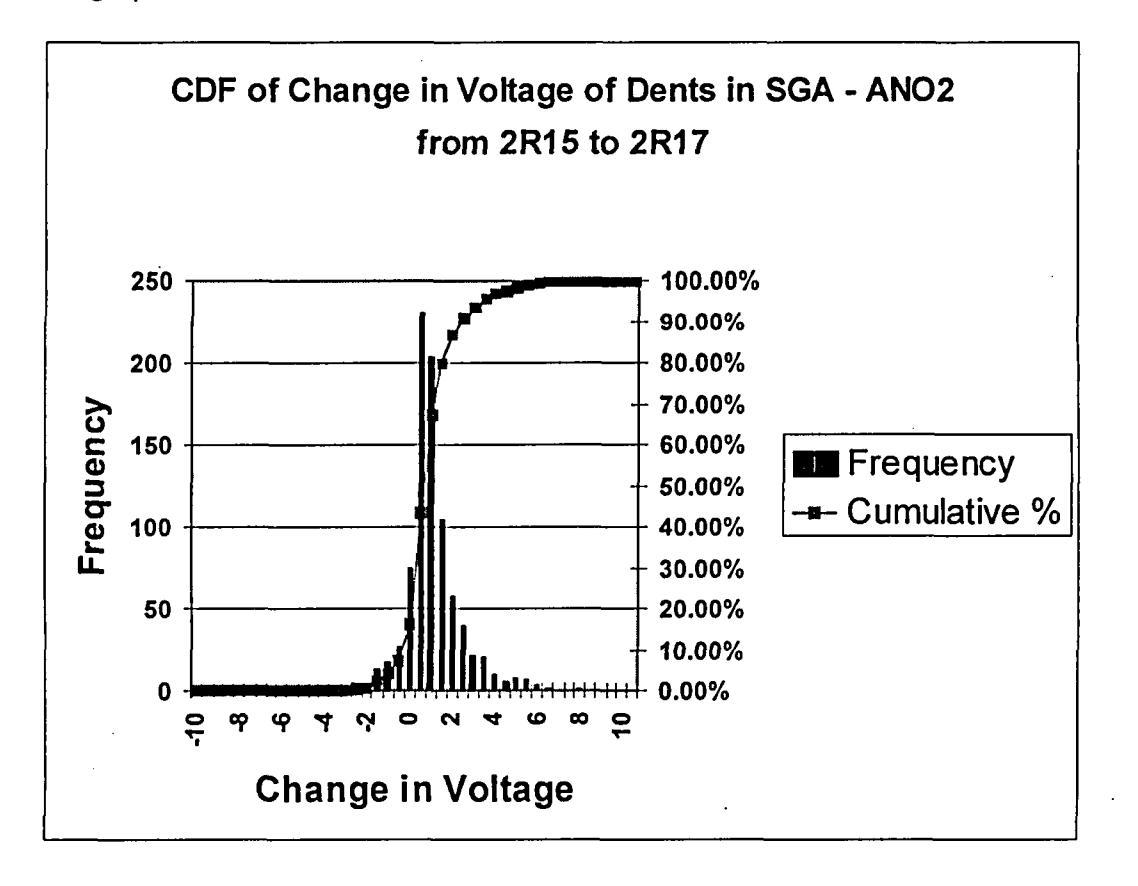
Dents/dings are identified with the bobbin campaign. The scope from 2R17 was 54% of the tube population. A review was performed to compare the dents/dings from 2R15 (spring 2002) to 2R17 (spring 2005). 2R15 was the first inservice inspection (ISI) after one cycle of operation and included 100% of the tubing. Both generator results were consistent with steam generator A (SGA) having the largest population of dents. Therefore, for this report, SGA data is being reported. A cumulative distribution factor (CDF) of the change in voltage for dents identified in both outages was performed. The mean change was approximately 0.6 volts which is considered an insignificant change based on the technique. This is presented in the graph below:

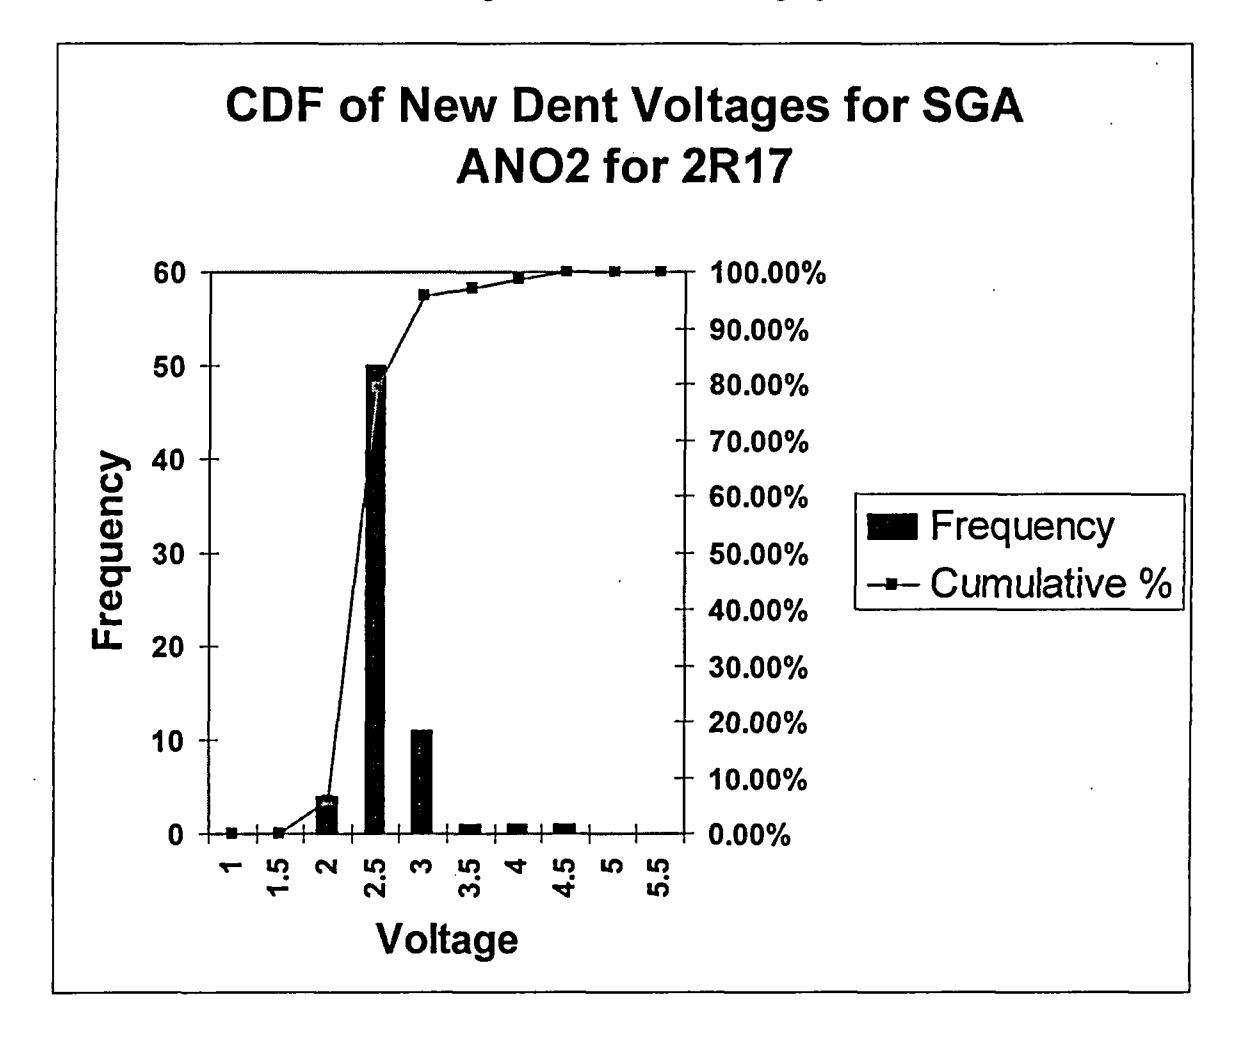
A review was performed of newly identified dents in 2R17. These were determined to be a function of the threshold limit of 2.0 volts as the vast majority of the newly reported dents were at this value. From the graph below, the majority of the dents remain at or near the detection threshold. Based on this data, the relative condition of the dents in the ANO-2 steam generators is not changing.
