Oyster Creek Nuclear Generating Station License Extension:

Drywell Shell Corrosion

Presentation to the ACRS October 3,-2006 by Richard Webster, Esq., Rutgers Environmental Law Clinic & Paul Gunter, Nuclear Information and Resource Service

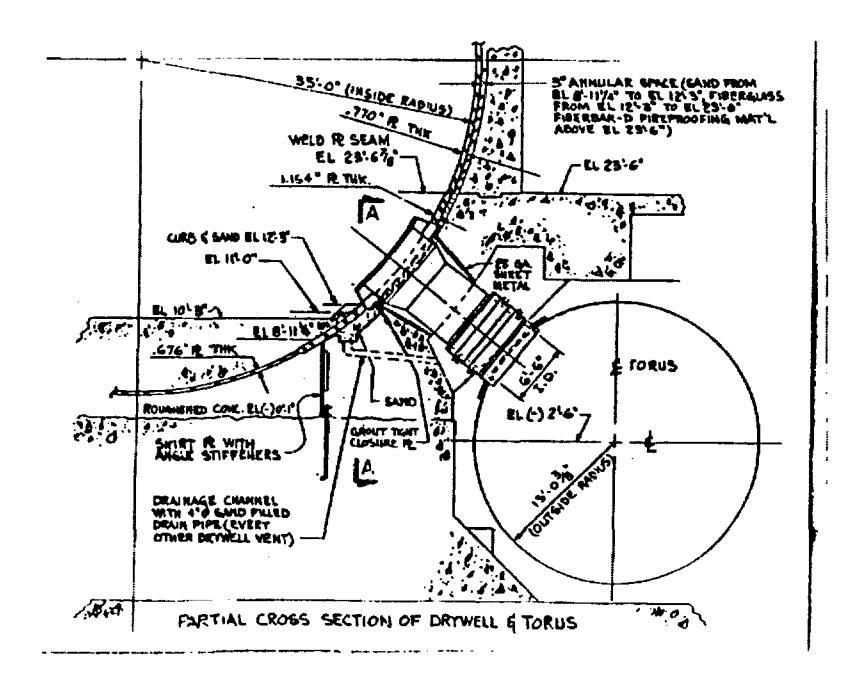
Embedded Region in 1992

- When sand was removed in 1992 the sand bed floor was unfinished, water had ponded on the floor, and the floor had deep craters, probably due to corrosion of rebar
- Until 1992 no seal was present between the shell and the concrete to reduce penetration of water into gaps
- Moisture from groundwater has not been ruled out
