Please find the attached memorandum dated July 26, 2006 from Dr. Rudolf Hausler of Corro-Consulta. It regards the age management review of inaccessible and embedded regions of the Oyster Creek drywell liner and other General Electric Mark I Boiling Water Reactors. Dr. Hausler is identified as our corrosion expert in support of an Atomic Safety Licensing Board (ASLB) hearing on the contention regarding the age management review of severe corrosion of the all important containment component at Oyster Creek nuclear generating station in Lacey Township, New Jersey.

**Memorandum**

**Subject:** Oyster Creek, Drywell Liner  
Embedded Region Issues

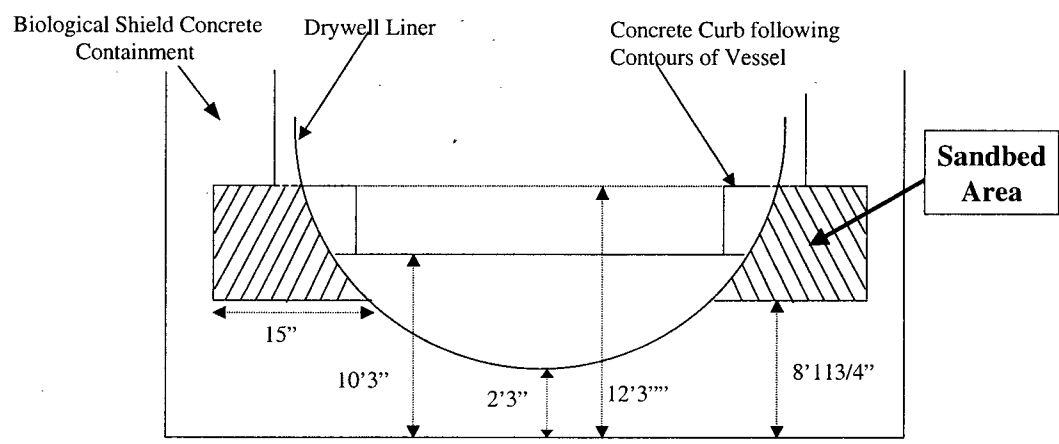
Figure 3

Figures 1 and 2 are sketches of the location of the sandbed area and its dimensions (Fig. 2). In view of the small access hole (20" diameter) and the even smaller sandbed dimensions (15" wide) and the resulting very confined work area one needs to wonder just how effective the repairs of the concrete floor and subsequent coating and sealing of the crevice might have been. Similarly, considering the extension of the sandbed area of 5 to 7 feet either side of the access hole, and its narrowness, one needs to ask just how thorough visual inspection can really be.

**Schematic Drawing of Lower Spherical Section of Drywell Liner**  
(not to size)

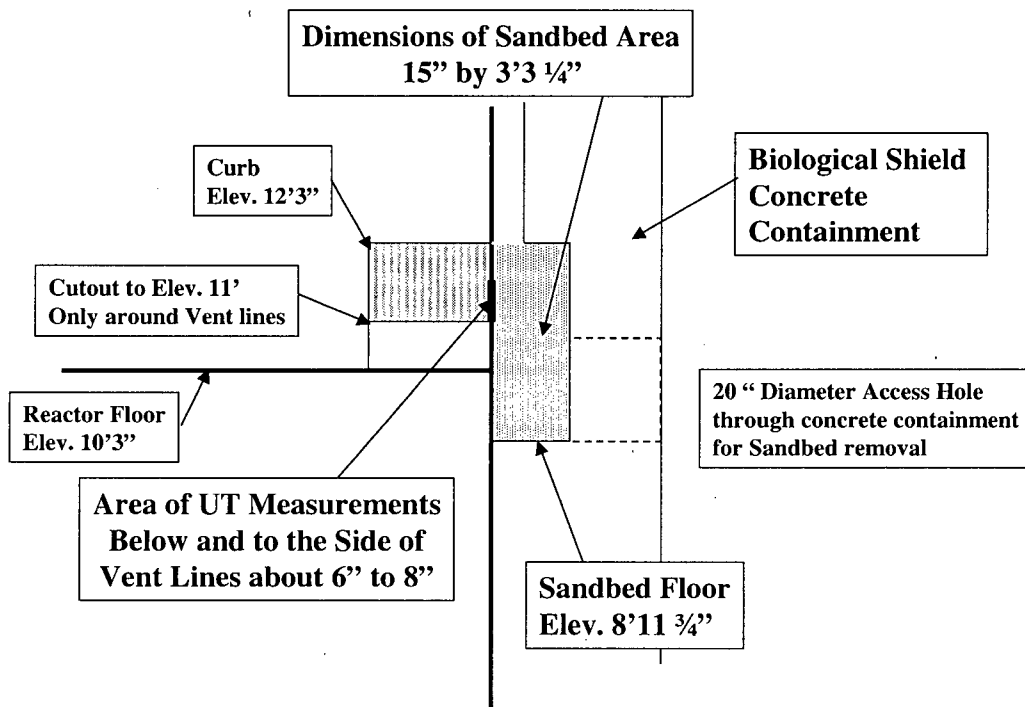
Figure 4

### Schematic Cross Section through Sandbed Area
