# Oyster Creek 1R21 Outage

### Communication Package Related to Drywell Shell Inspections October 23, 2006

# **1R21** Drywell Inspections

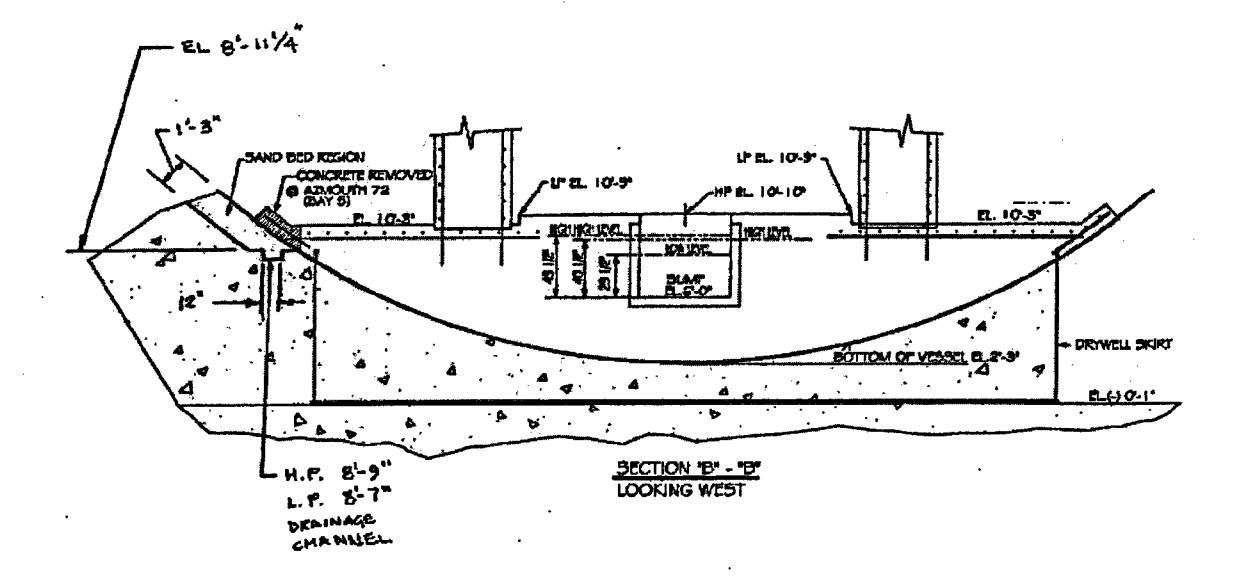
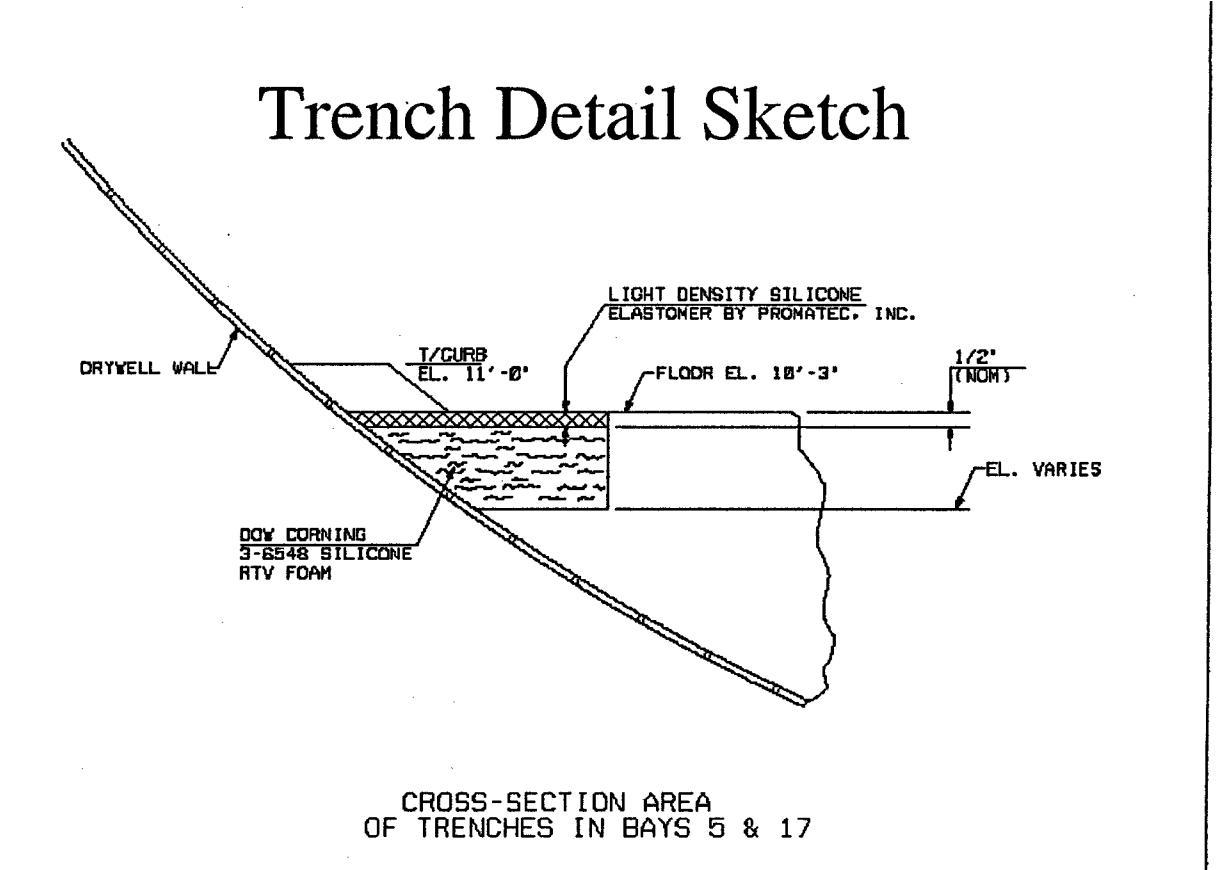
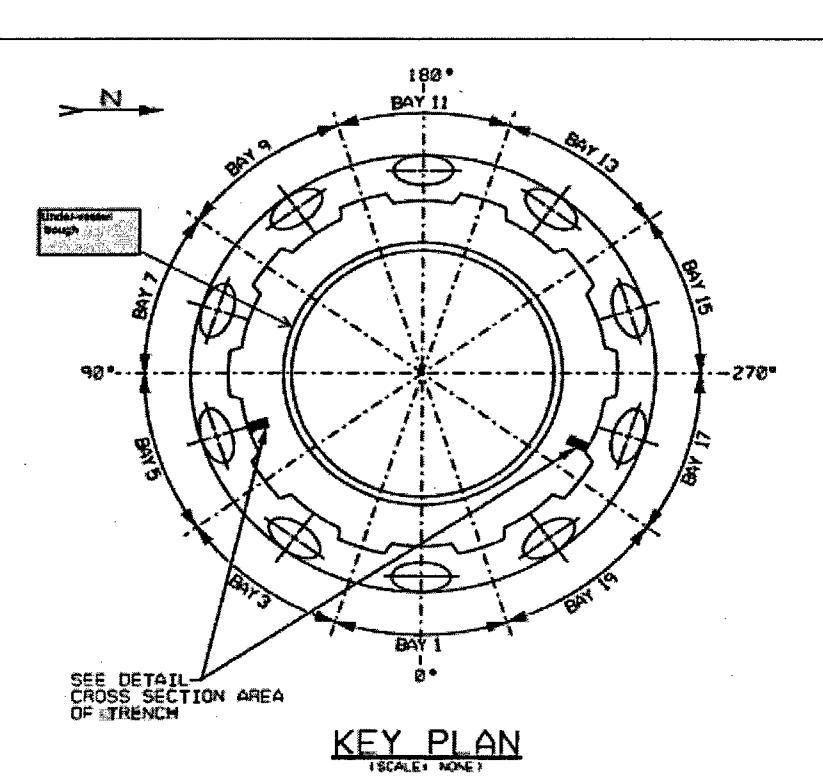
### Sketch Showing Lower Drywell - Sandbed, Trench and Sump

- When performing planned Non Destructive Examinations of the Drywell Shell from inside the Drywell, water was found in a trench area below the floor elevation.
- A similar condition was identified in the mid 1990s and documented in the corrective action process.
- The source of this water needs to be understood and addressed, and any impact on the drywell shell or concrete evaluated and addressed.

- The Drywell floor drain sump is located within the under-vessel area room
- A concrete trough encircles the under-vessel area to channel any leakage in the drywell to the drywell sump

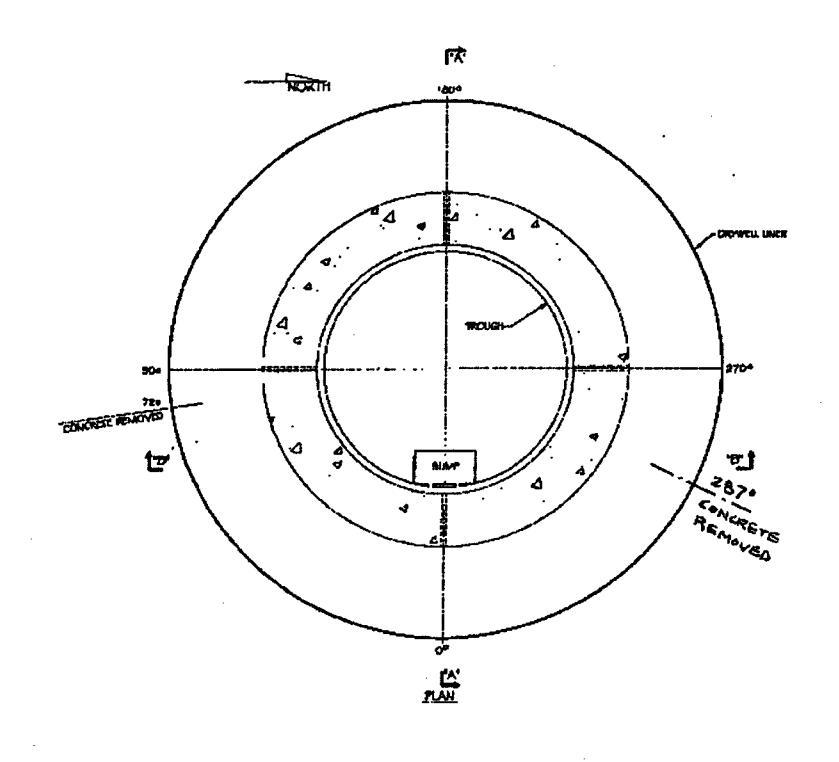
# Top View – Drywell Floor Sketch

- Surface of drywell shell visible from trenches in Bays 5 and 17 exhibited a surface layer of iron oxide
- Approximately 5" of water found in bottom of trench in Bay # 5, and trench in Bay 17 had only dampness
- Connection between under-vessel area trough and floor drain sump potentially allowing water leakage
- Trough located in the under-vessel area is not lined, potentially allowing water passage into the concrete slab

- Visual Examination (VT-1) of floor drain sump liner to look for evidence of a leak path
- Tracer test aimed at determining whether under-vessel trough is in communication with trench in Bay 5
- Development of contingency repair to trough to address likely water source into trench
- Complete non destructive examination and analysis of Drywell shell in trench areas
- Perform evaluation of the impact of water that may exist beneath concrete surface on drywell shell
- Development of contingency repair to caulk intersection of Drywell Shell and concrete slab curb
