# Rio Algom Mining LLC

Re: **license SUA-1473, Docket No. 40-8905**  
**License Condition #34**

**Rio Algom Mining LLC**  
**License SUA-1473, Docket No. 40-8905**  
**Proposed Corrective Action for Beryllium in Well 36-06**

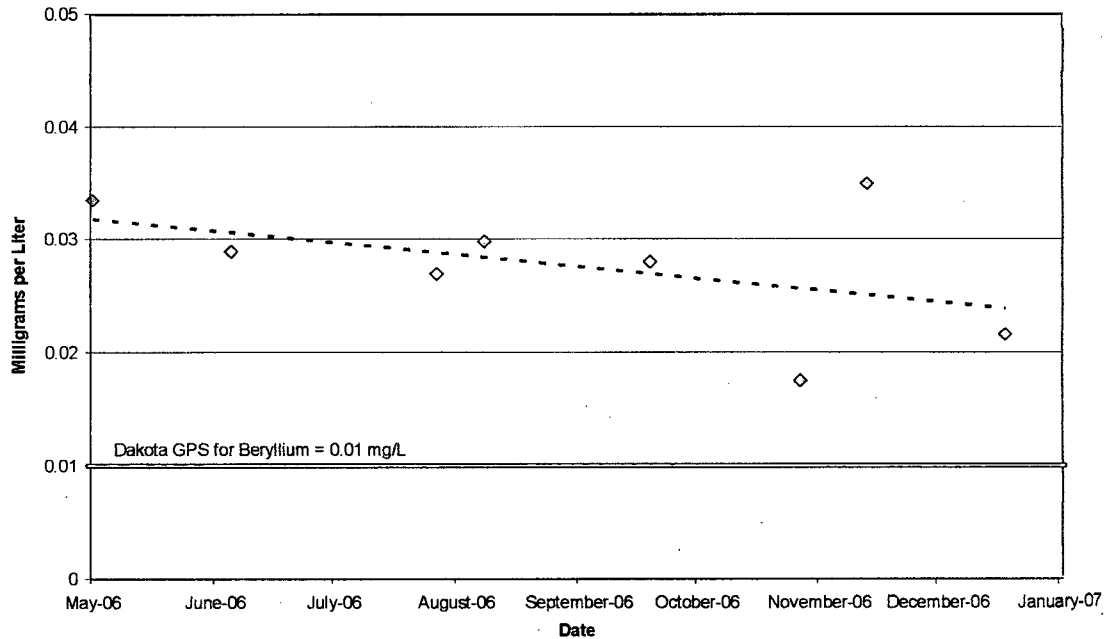
Chart 1

RAM has discussed this phenomenon with 36-06 during past meetings with NRC and both parties concurred that fluctuations in well water quality appear to be linked to surface reclamation work. The latest increase trended correlated with surface field work in the vicinity of the well. More recently, that trend has leveled and RAM anticipates that the concentration trend will begin to decline over time. The analytical results for beryllium that have been obtained from the monthly sampling are exhibiting this downward trend in concentrations (Chart 1).

Montior Well 36-06  
Beryllium Concentration

RAM proposes to continue monthly monitoring of well 36-06 for beryllium so that additional data will be available in evaluating the beryllium concentrations. Monthly sampling will continue to June 30, 2007.

Assessment of the beryllium concentration will be performed and in the event the existing concentration remains above the GPS, RAM will continue the monthly sampling and will develop a plan to address the situation. This plan will include an assessment of how the GPS was established and possible corrective actions to remedy the situation.
