Subject: Routine Inspection No. 040-07102/90-001

Report No. 040-07102/90-001

Facility Name: Shieldalloy Metallurgical Corporation

Routine, Announced Safety Inspection Conducted May 2-3, 1990 (Report No. 040-07102/90-001)

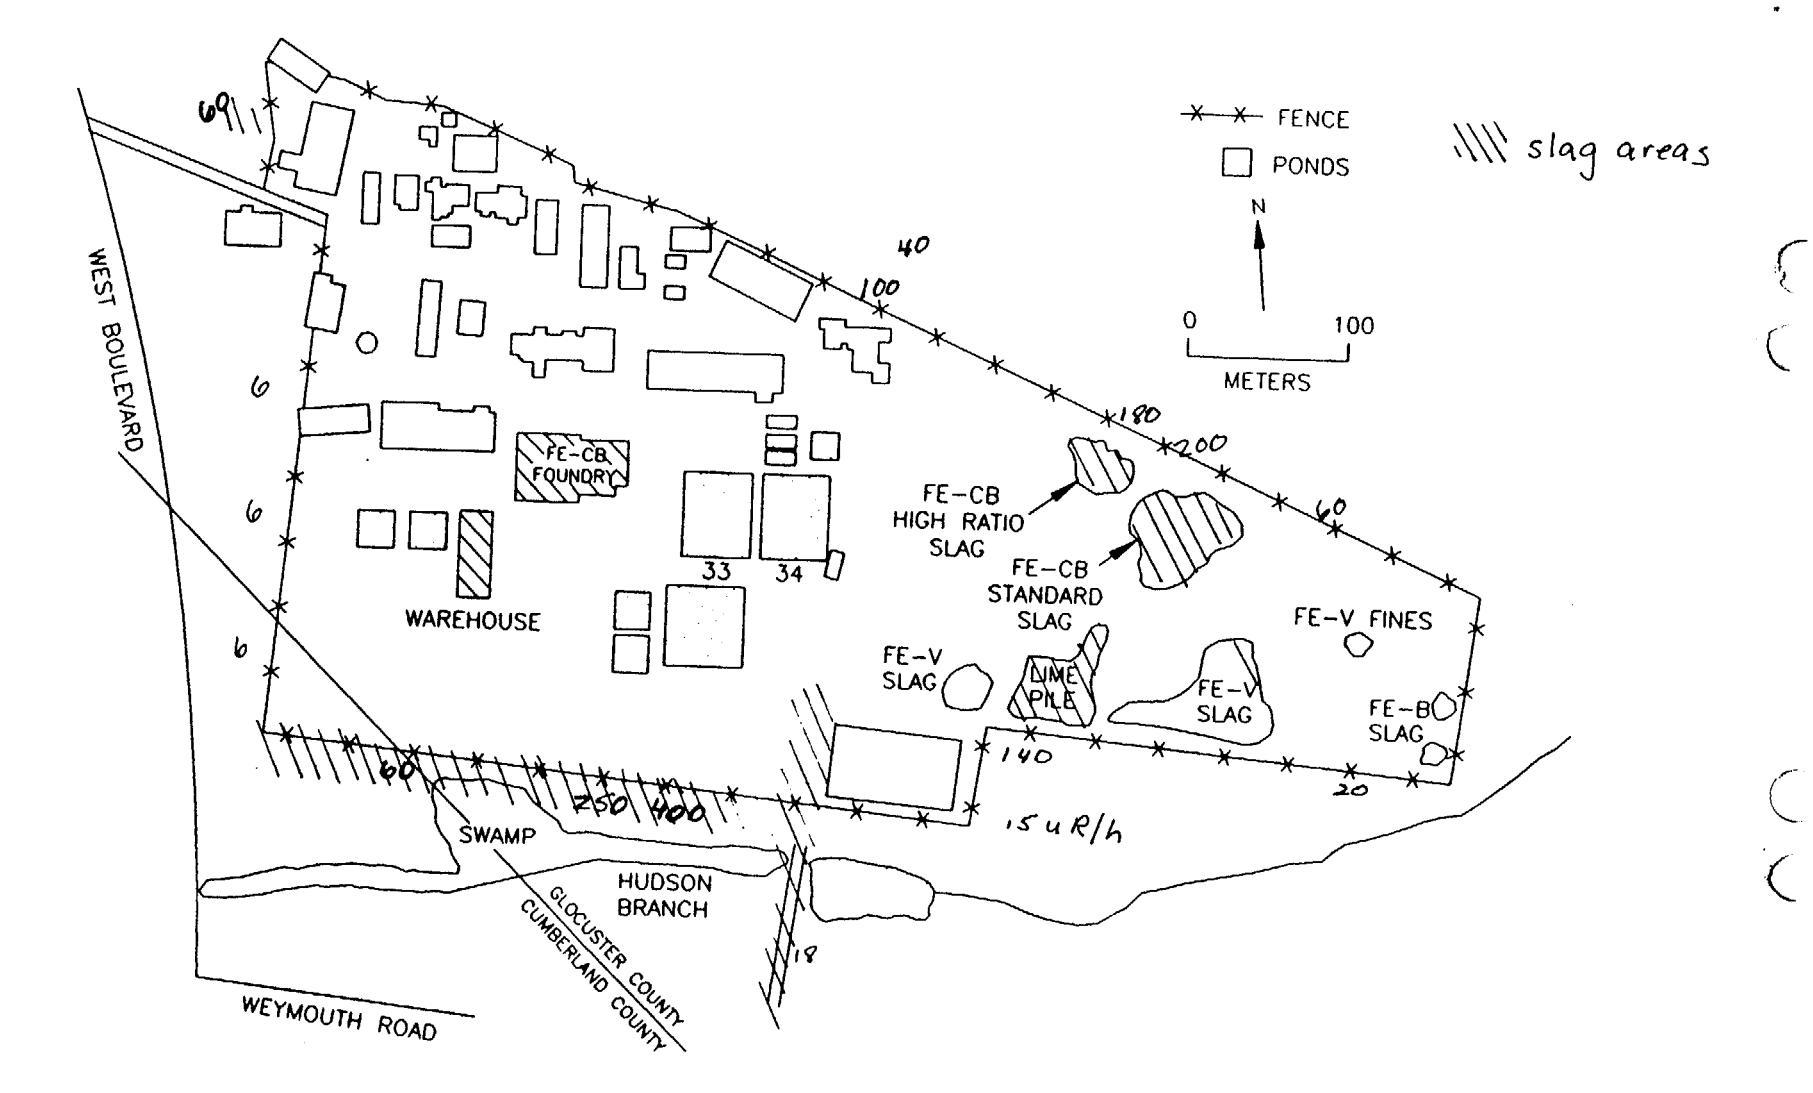
Radiation level surveys were performed outside of the fenced area by the inspectors with representatives of the State of New Jersey Department of Environmental Protection (NJDEP) and Region II of the Environmental Protection Agency. Results of this survey are included as Attachment B of this report. Radioactive slag appears to have been used in two areas as support material to build up the ground level. The first area begins at the corner of the fence along Weymouth road and extends along the fenceline to the access road, and about 10 feet from the fence. Radiation levels of 300-400 uR/h were noted in this area, but dropped to less than 20 uR/h at a distance of 25 feet from the fence. The second area is the access road from Weymouth Road through a gate into the fenced site. It is not known if the slag in the access road is ferro-columbium or ferro-vanadium.

Ambient radiation levels at the fence along the landfill range from 40 uR/h to 200 uR/h. The maximum radiation level at the fence by the ferro-columbium slag piles was 200 uR/h, and dropped to 40 uR/h at a distance of approximately 25 feet from the fence. A small area by the transformer station at the front of the property measured 60 uR/h.

Unrestricted Area Radiation Level Survey Results

Layout of the Shieldalloy Plant in Newfield, New Jersey Radiation levels in microroentgen per hour.
